Profile/Photo Observation Report

Date:	05/05/2018	Weather:		Coding:	PACP 6.0
Pipe Length (ft):		Owner:	City of Hobart	Pre Clean:	No Pre-Cleaning
P.O.#:	187	Surveyor:	M. Pielacha	PSR:	P-805-018-023
Customer:	City of Hobart	Clean Date:		Shape:	C

Street:	5th Street	Flow Control:	Not Controlled
City:	Hobart, IN	Year Renewed:	
Location:	Light Highway	Tape/Media #:	DEP 187
Purpose:	Routine Assessment	Dia/Height:	20"
Use:	Sanitary	Material:	VCP
Drain Area:		Lining:	
Category:	NA		
Comment:	5-21-2018		
Location Details:		Direction of Survey:	Downstream
US MH:	M-805-023	DS MH:	M-805-018
		Total Length Surveyed (ft):	4.4

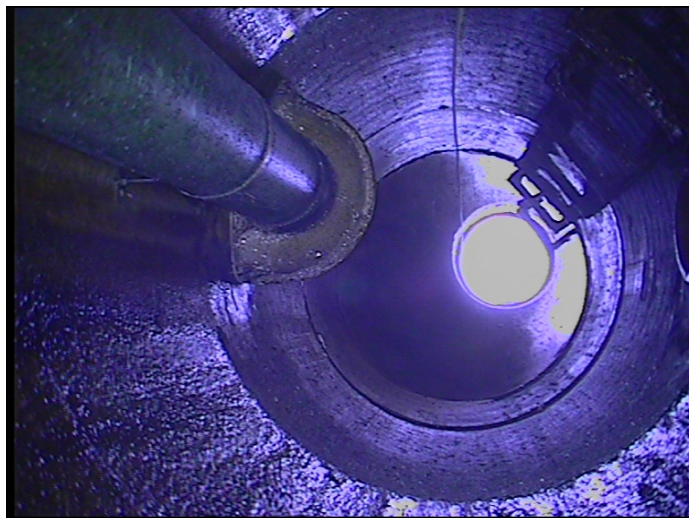
Code: **AMH**
Description: **Manhole**

Distance (ft): **.0**
Structural Grade: **0**
O&M Grade: **0**
Clock Start/From:
Clock To:
1st Value:
2nd Value:
Value Percent:
Continuous Index:
Within 8" of Joint: **NO**
Remarks: **M-805-023**

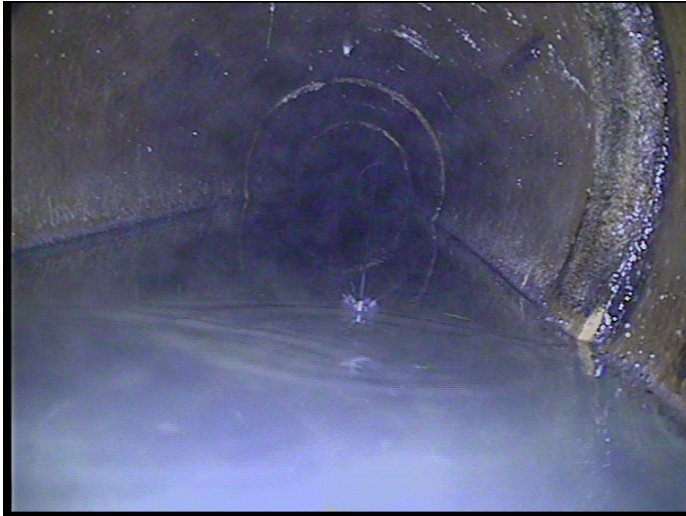
Code: **MWL**
Description: **Water Level**

Distance (ft): **.0**
Structural Grade: **0**
O&M Grade: **0**
Clock Start/From:
Clock To:
1st Value:
2nd Value:
Value Percent: **15.000**
Continuous Index:
Within 8" of Joint: **NO**
Remarks:

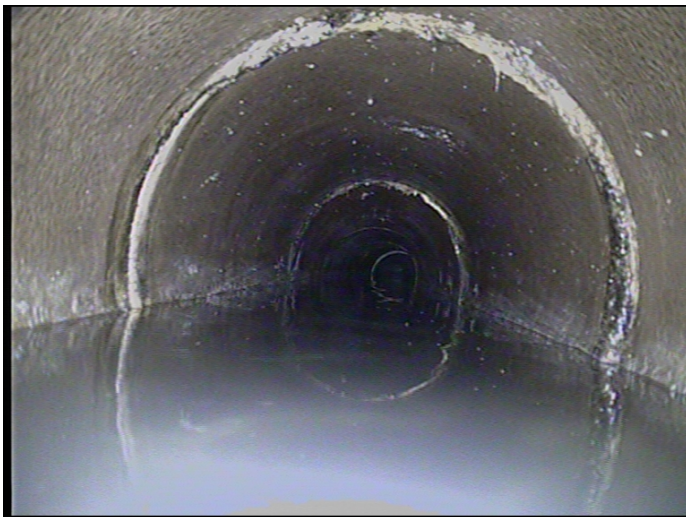
Code: **DSF**
Description: **Deposits Settled Fine**

Distance (ft): **2.4**
Structural Grade: **0**
O&M Grade: **3**
Clock Start/From: **4**
Clock To: **8**
1st Value:
2nd Value:
Value Percent: **20.000**
Continuous Index:
Within 8" of Joint: **YES**
Remarks:

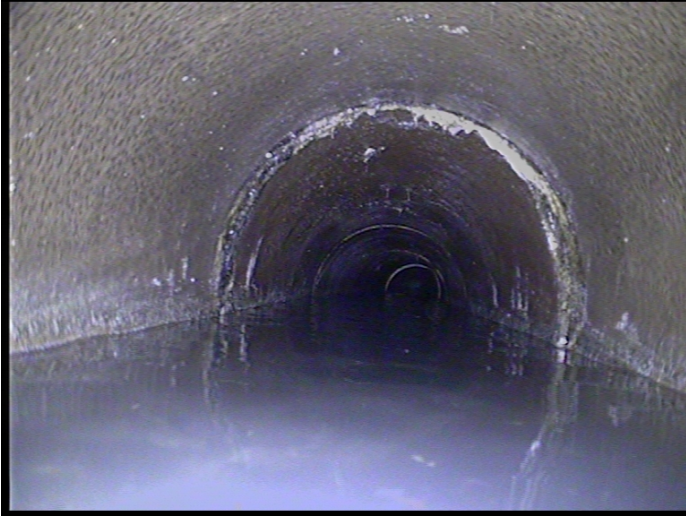
Code:	MSA
Description:	Abandoned Survey
Distance (ft):	4.4
Structural Grade:	0
O&M Grade:	0
Clock Start/From:	
Clock To:	
1st Value:	
2nd Value:	
Value Percent:	
Continuous Index:	
Within 8" of Joint:	NO
Remarks:	sediment
