## Profile/Photo Observation Report

Date:	<b>03/01/2024</b>	Weather:		Coding:	<b>PACP 7.0</b>
Pipe Length (ft):	<b>321.0</b>	Owner:	<b>City of Hobart</b>	Pre Clean:	<b>Heavy Cleaning</b>
P.O.#:		Surveyor:	<b>S. Bucklin</b>	PSR:	<b>P-805-018-023</b>
Customer:	<b>City of Hobart</b>	Clean Date:	<b>09/05/2022</b>	Shape:	<b>C</b>

Street:	<b>E 5TH ST</b>	Flow Control:	<b>Not Controlled</b>
City:	<b>Hobart, IN</b>	Year Renewed:	
Location:	<b>Local rural streets with light traffic, t</b>	Tape/Media #:	
Purpose:	<b>Sewer System Evaluation Survey (SS</b>	Dia/Height:	<b>21"</b>
Use:	<b>Sanitary Sewage Pipe</b>	Material:	<b>VCP</b>
Drain Area:		Lining:	<b>None</b>
Category:	<b>NA</b>		
Comment:			
Location Details:		Direction of Survey:	<b>Downstream</b>
US MH:	<b>M-805-023</b>	DS MH:	<b>M-805-018</b>
		Total Length Surveyed (ft):	<b>324.0</b>

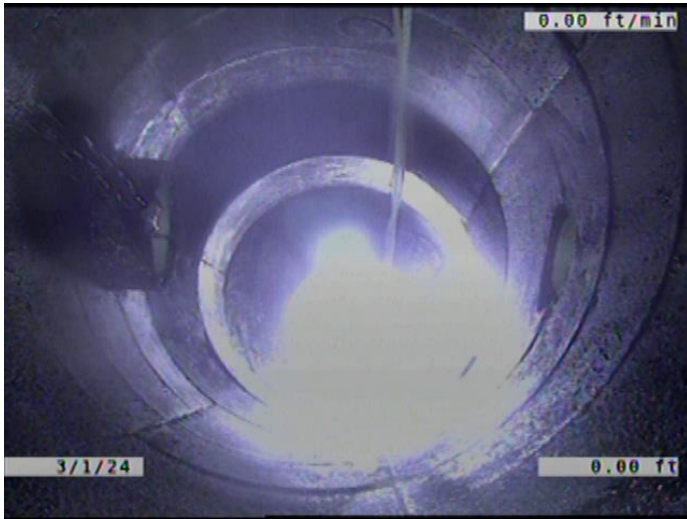
Code: **AMH**  
 Description: **Manhole**

Distance (ft): **.0**  
 Structural Grade: **0**  
 O&M Grade: **0**  
 Clock Start/From:  
 Clock To:  
 1st Value:  
 2nd Value:  
 Value Percent:  
 Continuous Index:  
 Within 8" of Joint: **NO**  
 Remarks: **M-805-023**

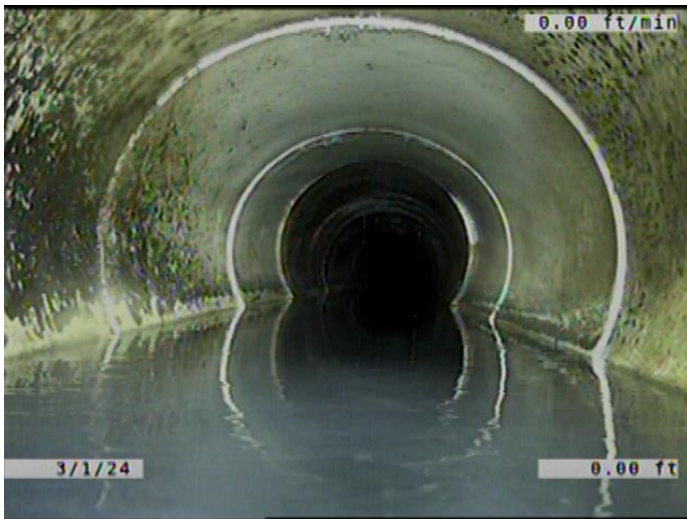
Code: **MWL**  
 Description: **Miscellaneous Water Level**

Distance (ft): **.0**  
 Structural Grade: **0**  
 O&M Grade: **0**  
 Clock Start/From:  
 Clock To:  
 1st Value:  
 2nd Value:  
 Value Percent: **20.000**  
 Continuous Index:  
 Within 8" of Joint: **NO**  
 Remarks:

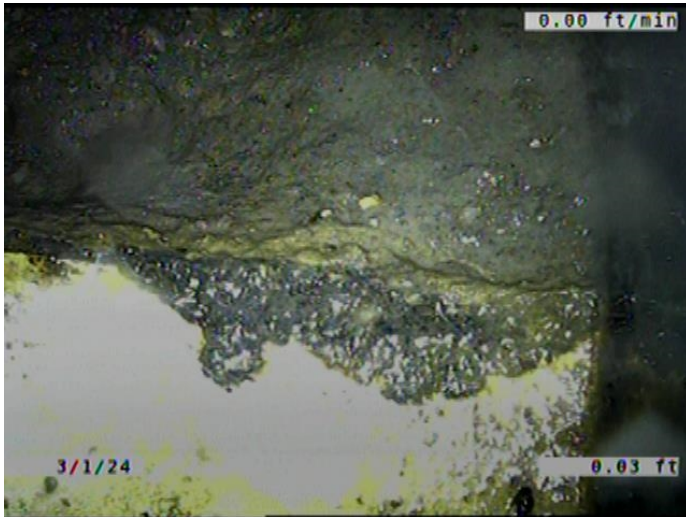
Code: **DAE**  
Description: **Deposits Attached Encrustation**

Distance (ft): **.0**  
Structural Grade: **0**  
O&M Grade: **2**  
Clock Start/From: **8**  
Clock To: **4**  
1st Value:  
2nd Value:  
Value Percent: **5.000**  
Continuous Index:  
Within 8" of Joint: **YES**  
Remarks:

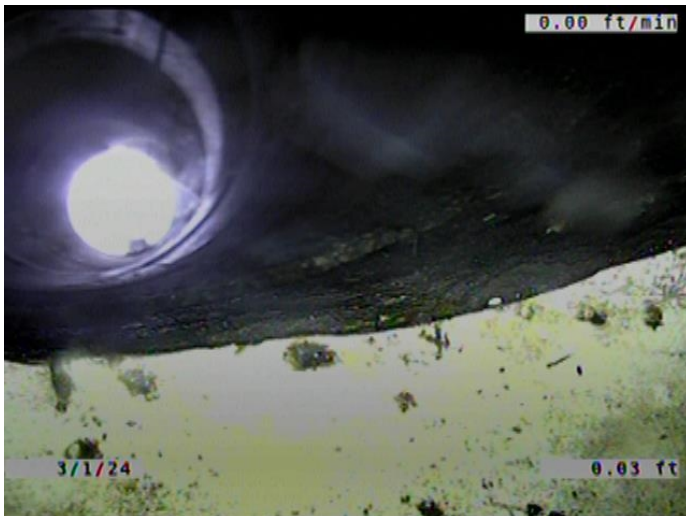
Code: **RPR**  
Description: **Point Repair Replacement**

Distance (ft): **.0**  
Structural Grade: **0**  
O&M Grade: **0**  
Clock Start/From:  
Clock To:  
1st Value:  
2nd Value:  
Value Percent:  
Continuous Index: **S01**  
Within 8" of Joint: **YES**  
Remarks: **REPLACED WITH PVC.**

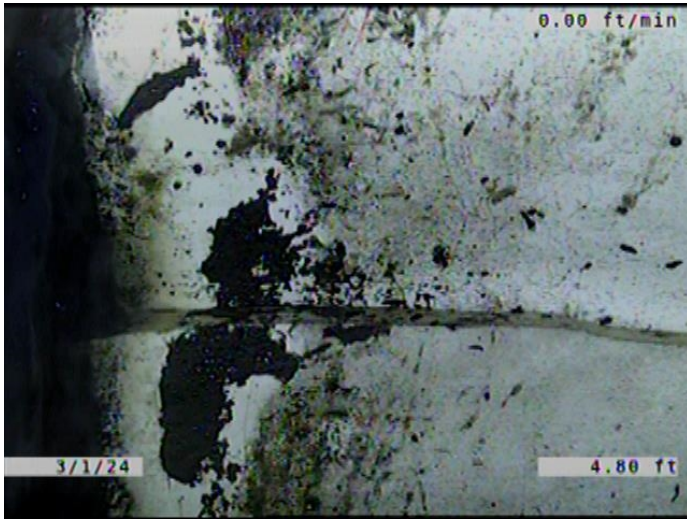
Code:	<b>MGO</b>
Description:	<b>Miscellaneous General Observation</b>
Distance (ft):	<b>4.8</b>
Structural Grade:	<b>0</b>
O&M Grade:	<b>0</b>
Clock Start/From:	
Clock To:	
1st Value:	
2nd Value:	
Value Percent:	
Continuous Index:	
Within 8" of Joint:	<b>NO</b>
Remarks:	<b>JOINT/ PIPES NOT PUSHED ALL THE WAY TOGETHER WHEN INSTALLED</b>

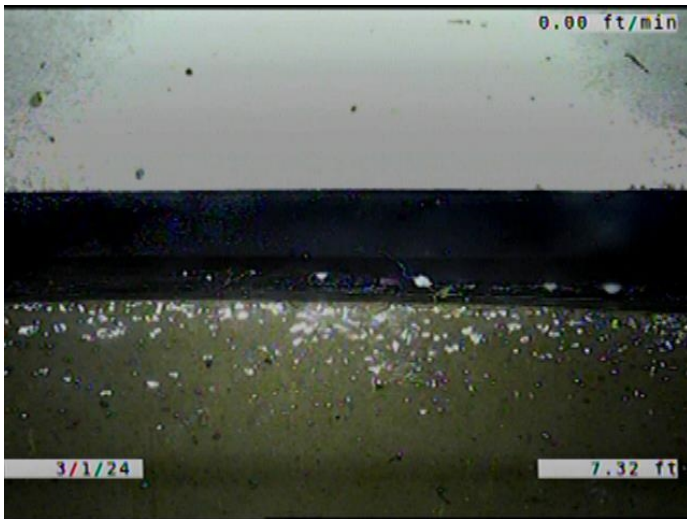
Code:	<b>RPR</b>
Description:	<b>Point Repair Replacement</b>
Distance (ft):	<b>7.3</b>
Structural Grade:	<b>0</b>
O&M Grade:	<b>0</b>
Clock Start/From:	
Clock To:	
1st Value:	
2nd Value:	
Value Percent:	
Continuous Index:	<b>F01</b>
Within 8" of Joint:	<b>YES</b>
Remarks:	<b>REPLACED WITH PVC.</b>

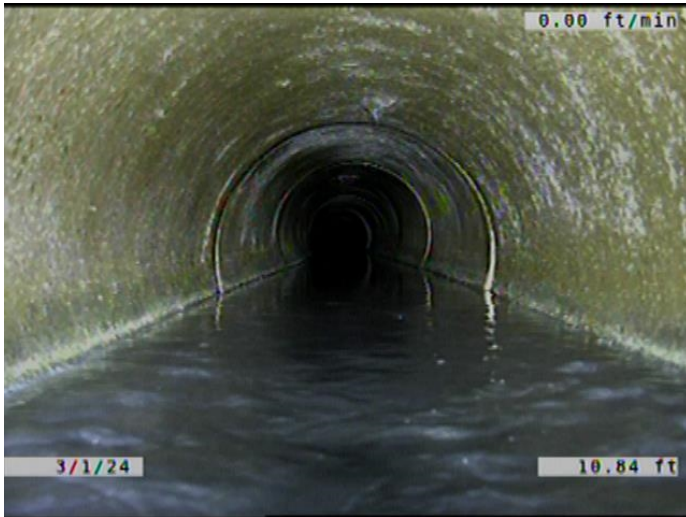
Code: **MWLS**  
Description: **Miscellaneous Water Level Sag**

Distance (ft): **10.8**  
Structural Grade: **2**  
O&M Grade: **0**  
Clock Start/From:  
Clock To:  
1st Value:  
2nd Value:  
Value Percent: **30.000**  
Continuous Index: **S02**  
Within 8" of Joint: **NO**  
Remarks:

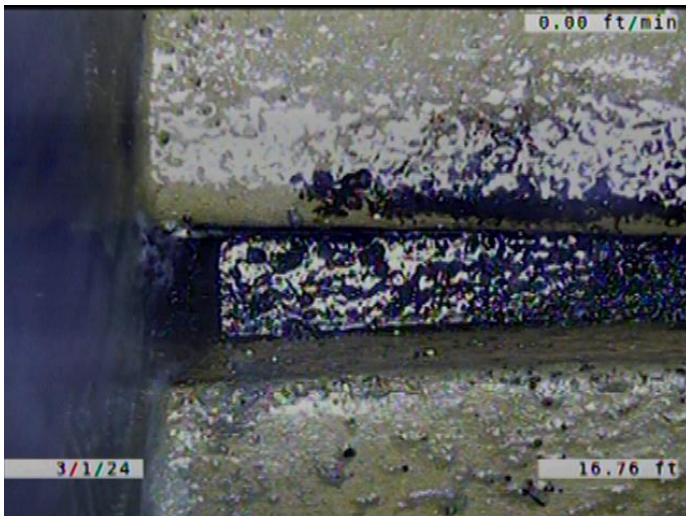
Code: **JAM**  
Description: **Joint Angular Medium**

Distance (ft): **16.8**  
Structural Grade: **3**  
O&M Grade: **0**  
Clock Start/From:  
Clock To:  
1st Value:  
2nd Value:  
Value Percent:  
Continuous Index:  
Within 8" of Joint: **NO**  
Remarks:

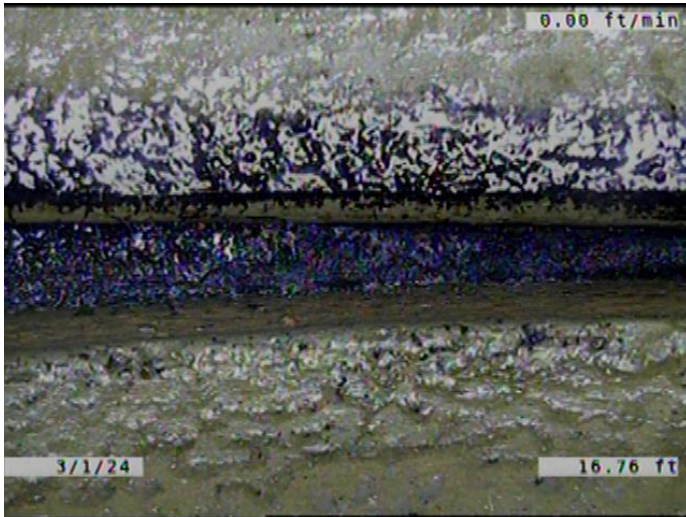
Code:	<b>DAE</b>
Description:	<b>Deposits Attached Encrustation</b>
Distance (ft):	<b>16.8</b>
Structural Grade:	<b>0</b>
O&M Grade:	<b>2</b>
Clock Start/From:	<b>8</b>
Clock To:	<b>4</b>
1st Value:	
2nd Value:	
Value Percent:	<b>5.000</b>
Continuous Index:	<b>S03</b>
Within 8" of Joint:	<b>YES</b>
Remarks:

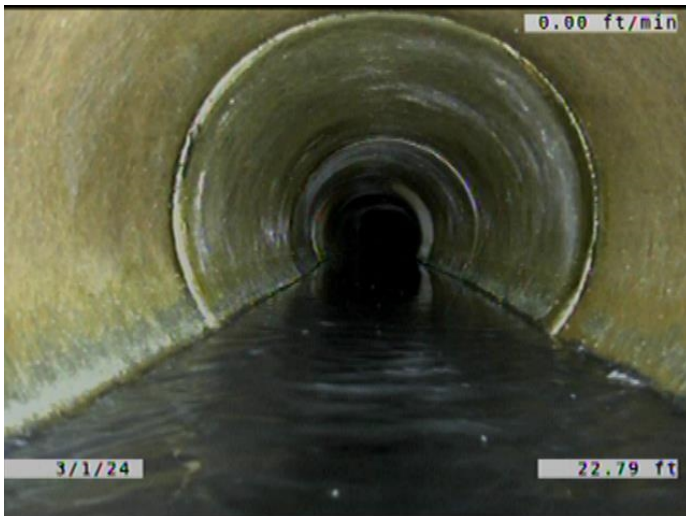
Code:	<b>MWLS</b>
Description:	<b>Miscellaneous Water Level Sag</b>
Distance (ft):	<b>22.8</b>
Structural Grade:	<b>2</b>
O&M Grade:	<b>0</b>
Clock Start/From:	
Clock To:	
1st Value:	
2nd Value:	
Value Percent:	<b>30.000</b>
Continuous Index:	<b>F02</b>
Within 8" of Joint:	<b>NO</b>
Remarks:

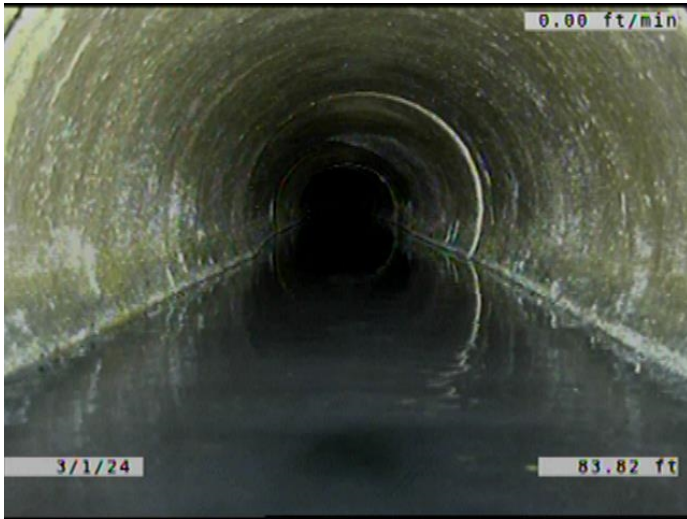
Code: **MWLS**  
Description: **Miscellaneous Water Level Sag**

Distance (ft): **83.8**  
Structural Grade: **2**  
O&M Grade: **0**  
Clock Start/From:  
Clock To:  
1st Value:  
2nd Value:  
Value Percent: **30.000**  
Continuous Index: **S04**  
Within 8" of Joint: **NO**  
Remarks:

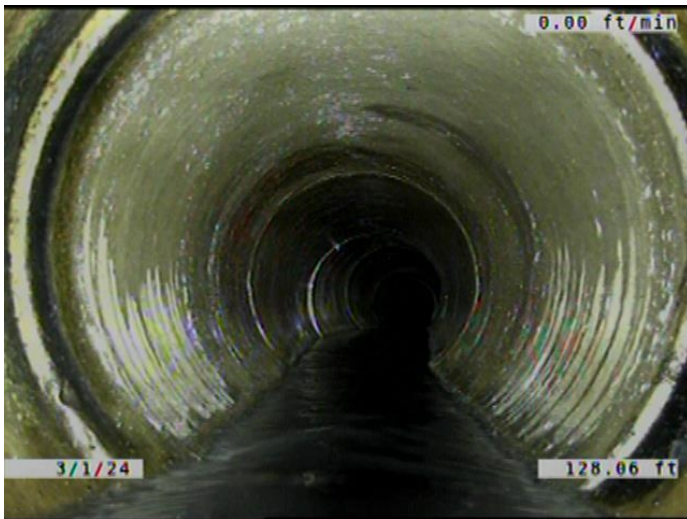
Code: **MWLS**  
Description: **Miscellaneous Water Level Sag**

Distance (ft): **128.1**  
Structural Grade: **2**  
O&M Grade: **0**  
Clock Start/From:  
Clock To:  
1st Value:  
2nd Value:  
Value Percent: **30.000**  
Continuous Index: **F04**  
Within 8" of Joint: **NO**  
Remarks:

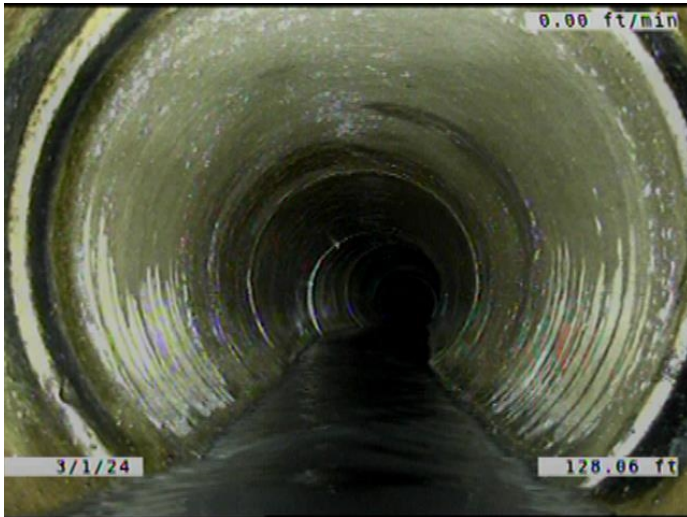
Code: **MWL**  
Description: **Miscellaneous Water Level**

Distance (ft): **128.1**  
Structural Grade: **0**  
O&M Grade: **0**  
Clock Start/From:  
Clock To:  
1st Value:  
2nd Value:  
Value Percent: **10.000**  
Continuous Index:  
Within 8" of Joint: **NO**  
Remarks:

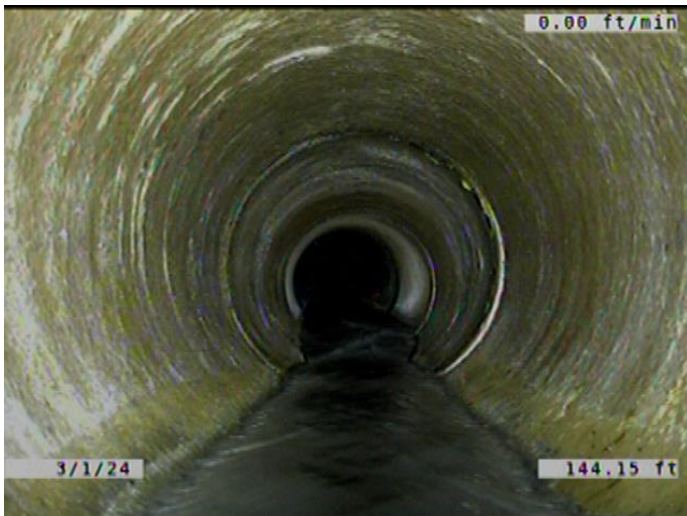
Code: **LD**  
Description: **Line Down**

Distance (ft): **144.2**  
Structural Grade: **0**  
O&M Grade: **1**  
Clock Start/From:  
Clock To:  
1st Value:  
2nd Value:  
Value Percent: **5.000**  
Continuous Index:  
Within 8" of Joint: **NO**  
Remarks:

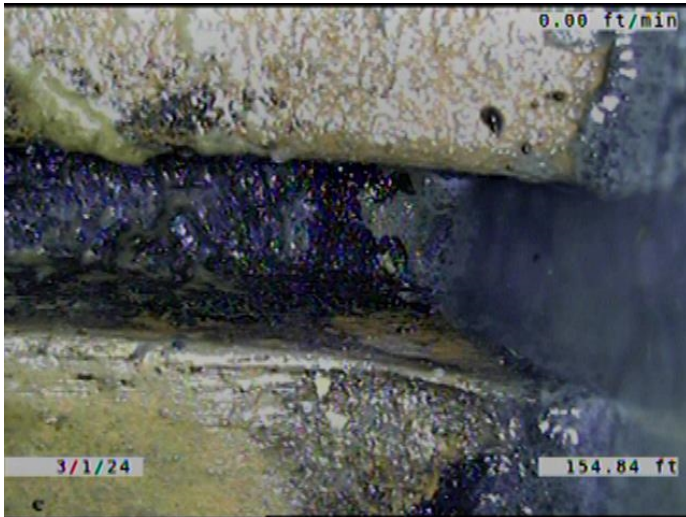
Code: **JAM**  
Description: **Joint Angular Medium**

Distance (ft): **154.8**  
Structural Grade: **3**  
O&M Grade: **0**  
Clock Start/From:  
Clock To:  
1st Value:  
2nd Value:  
Value Percent:  
Continuous Index:  
Within 8" of Joint: **NO**  
Remarks:

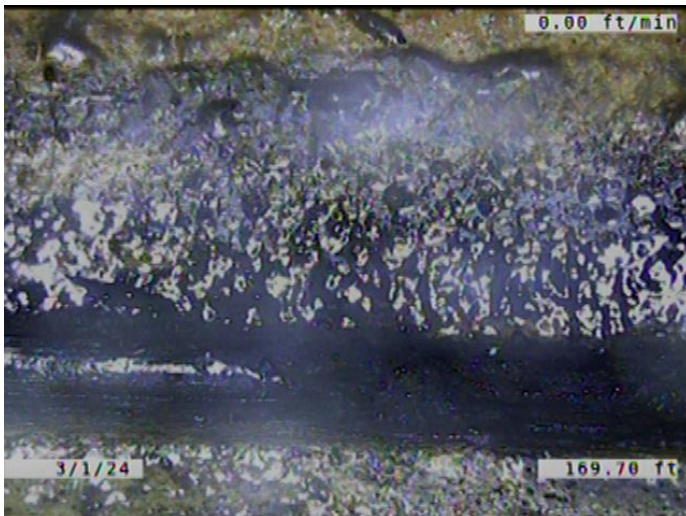
Code: **IRJ**  
Description: **Infiltration Runner Joint**

Distance (ft): **169.7**  
Structural Grade: **0**  
O&M Grade: **4**  
Clock Start/From: **11**  
Clock To: **1**  
1st Value:  
2nd Value:  
Value Percent:  
Continuous Index:  
Within 8" of Joint: **YES**  
Remarks:

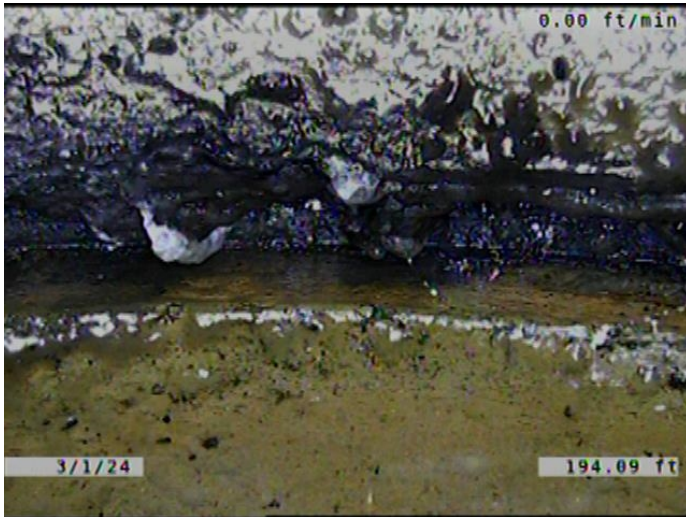
Code: **IDJ**  
Description: **Infiltration Dripper Joint**

Distance (ft): **194.1**  
Structural Grade: **0**  
O&M Grade: **3**  
Clock Start/From: **11**  
Clock To: **12**  
1st Value:  
2nd Value:  
Value Percent:  
Continuous Index:  
Within 8" of Joint: **YES**  
Remarks:

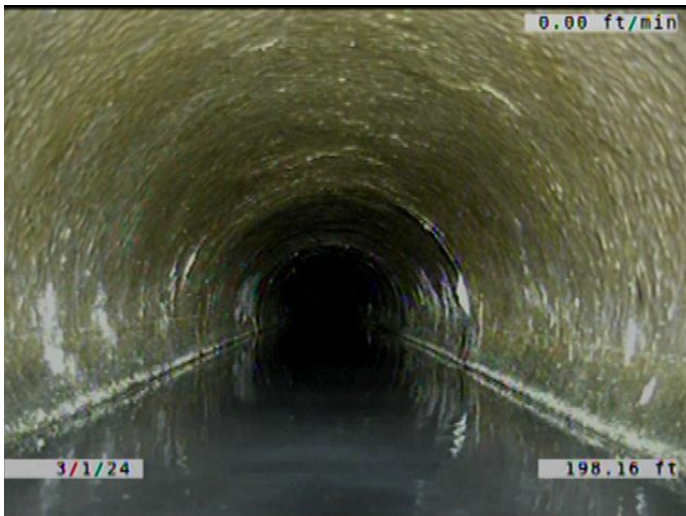
Code: **MWL**  
Description: **Miscellaneous Water Level**

Distance (ft): **198.2**  
Structural Grade: **0**  
O&M Grade: **0**  
Clock Start/From:  
Clock To:  
1st Value:  
2nd Value:  
Value Percent: **25.000**  
Continuous Index:  
Within 8" of Joint: **NO**  
Remarks:

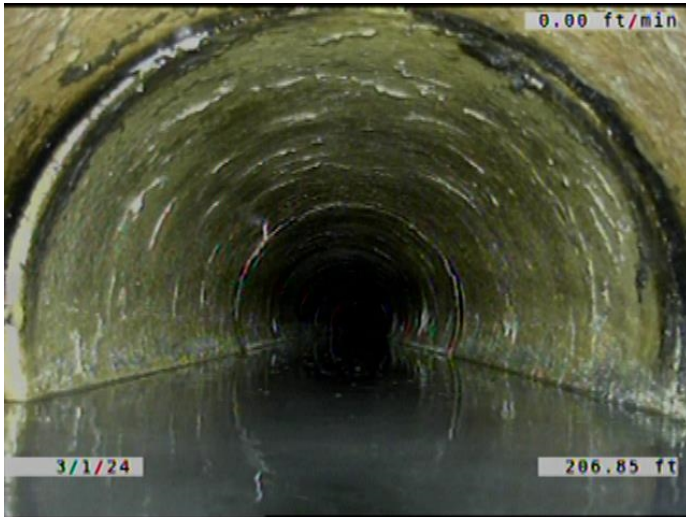
Code: **MWL**  
 Description: **Miscellaneous Water Level**

Distance (ft): **206.8**  
 Structural Grade: **0**  
 O&M Grade: **0**  
 Clock Start/From:  
 Clock To:  
 1st Value:  
 2nd Value:  
 Value Percent: **35.000**  
 Continuous Index:  
 Within 8" of Joint: **NO**  
 Remarks:

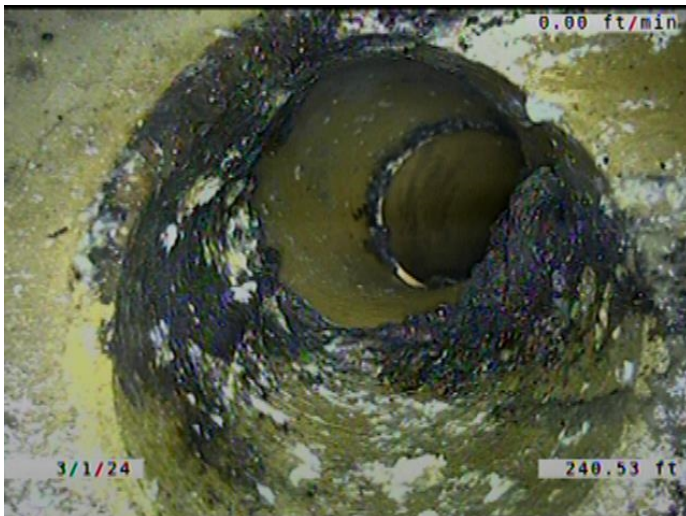
Code: **TF**  
 Description: **Tap Factory**

Distance (ft): **240.5**  
 Structural Grade: **0**  
 O&M Grade: **0**  
 Clock Start/From: **1**  
 Clock To:  
 1st Value: **6.000**  
 2nd Value:  
 Value Percent:  
 Continuous Index:  
 Within 8" of Joint: **YES**  
 Remarks: **CONSTANTLY RUNNING WATER.**

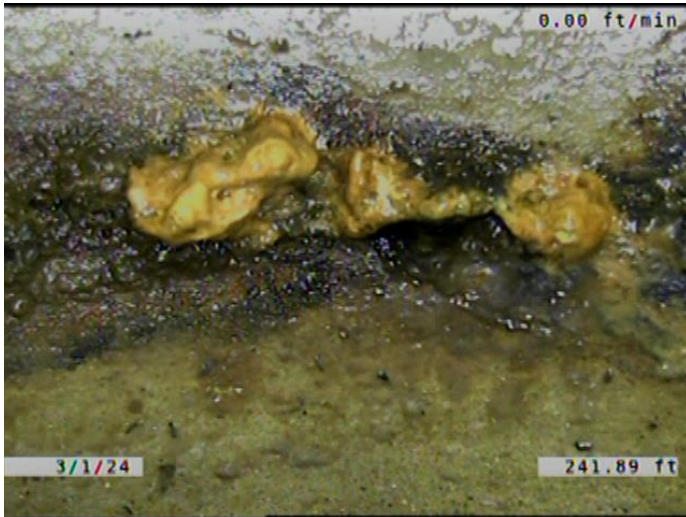
Code: IDJ  
Description: Infiltration Dripper Joint

Distance (ft): 241.9  
Structural Grade: 0  
O&M Grade: 3  
Clock Start/From: 11  
Clock To: 12  
1st Value:  
2nd Value:  
Value Percent:  
Continuous Index:  
Within 8" of Joint: YES  
Remarks:

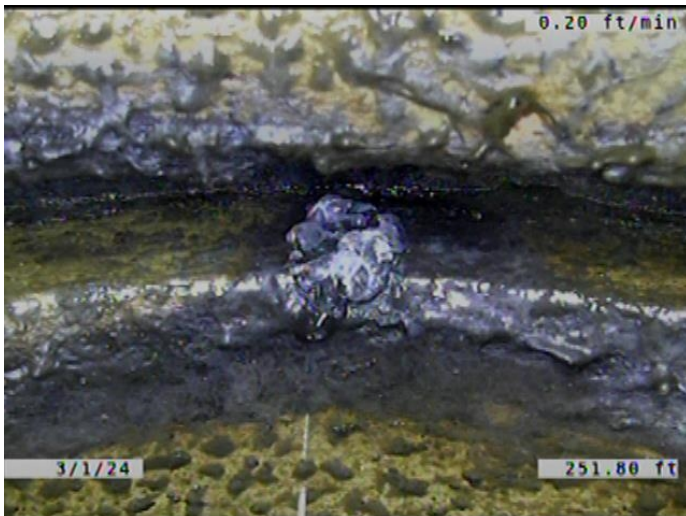
Code: IDJ  
Description: Infiltration Dripper Joint

Distance (ft): 251.8  
Structural Grade: 0  
O&M Grade: 3  
Clock Start/From: 12  
Clock To:  
1st Value:  
2nd Value:  
Value Percent:  
Continuous Index:  
Within 8" of Joint: YES  
Remarks:

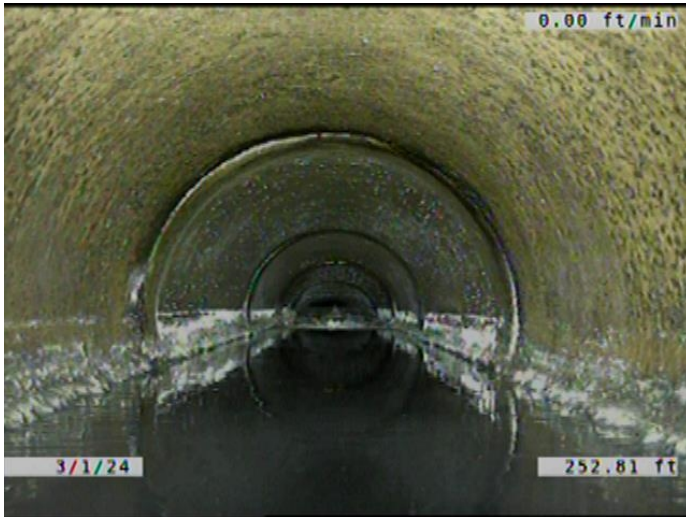
Code: **DAGS**  
Description: **Deposits Attached Grease**

Distance (ft): **252.8**  
Structural Grade: **0**  
O&M Grade: **2**  
Clock Start/From: **3**  
Clock To: **9**  
1st Value:  
2nd Value:  
Value Percent: **5.000**  
Continuous Index: **S05**  
Within 8" of Joint: **YES**  
Remarks:

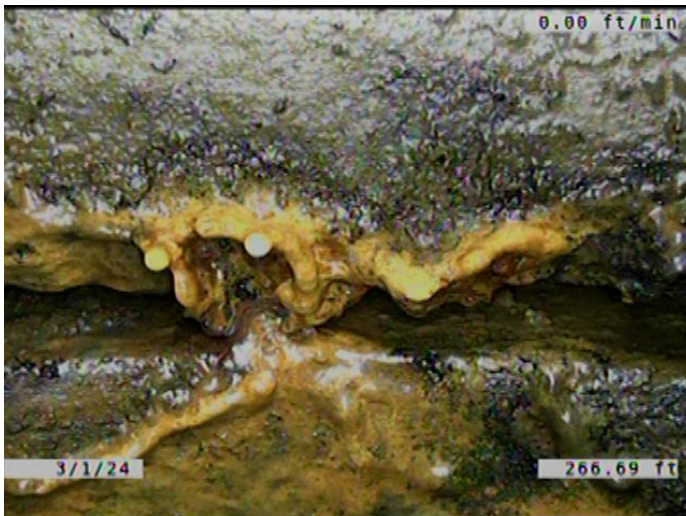
Code: **IDJ**  
Description: **Infiltration Dripper Joint**

Distance (ft): **266.7**  
Structural Grade: **0**  
O&M Grade: **3**  
Clock Start/From: **11**  
Clock To: **12**  
1st Value:  
2nd Value:  
Value Percent:  
Continuous Index:  
Within 8" of Joint: **YES**  
Remarks:

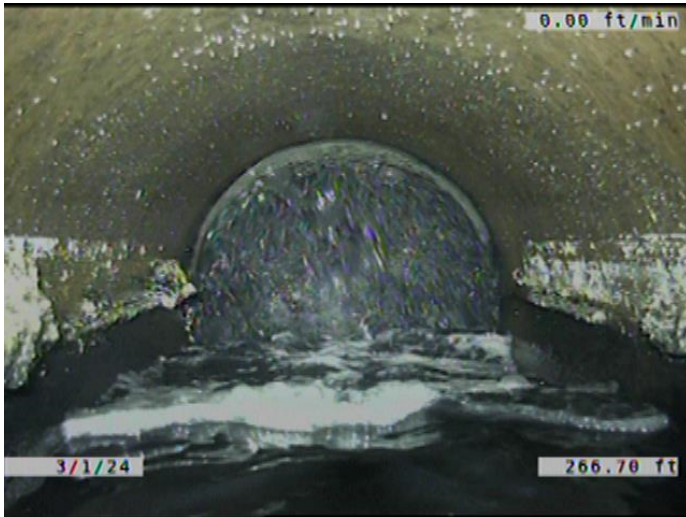
Code: **MWLS**  
Description: **Miscellaneous Water Level Sag**

Distance (ft): **266.7**  
Structural Grade: **5**  
O&M Grade: **0**  
Clock Start/From:  
Clock To:  
1st Value:  
2nd Value:  
Value Percent: **85.000**  
Continuous Index: **S06**  
Within 8" of Joint: **NO**  
Remarks:

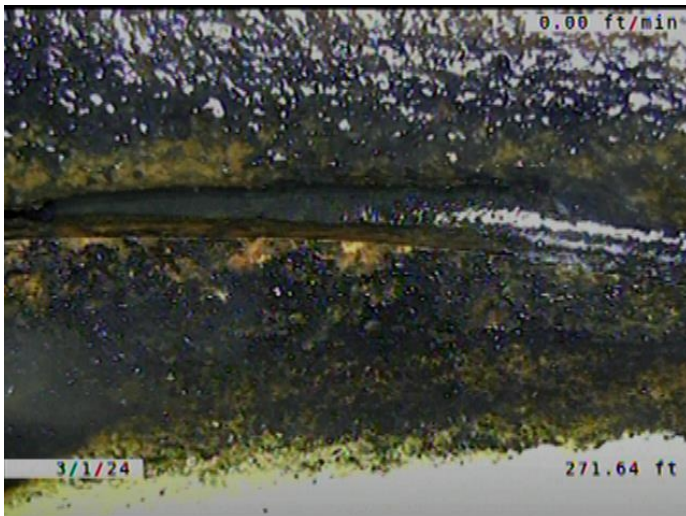
Code: **RPRD**  
Description: **Point Repair Replacement Defective**

Distance (ft): **271.6**  
Structural Grade: **4**  
O&M Grade: **0**  
Clock Start/From:  
Clock To:  
1st Value:  
2nd Value:  
Value Percent:  
Continuous Index: **S08**  
Within 8" of Joint: **YES**  
Remarks: **REPLACED WITH PVC**

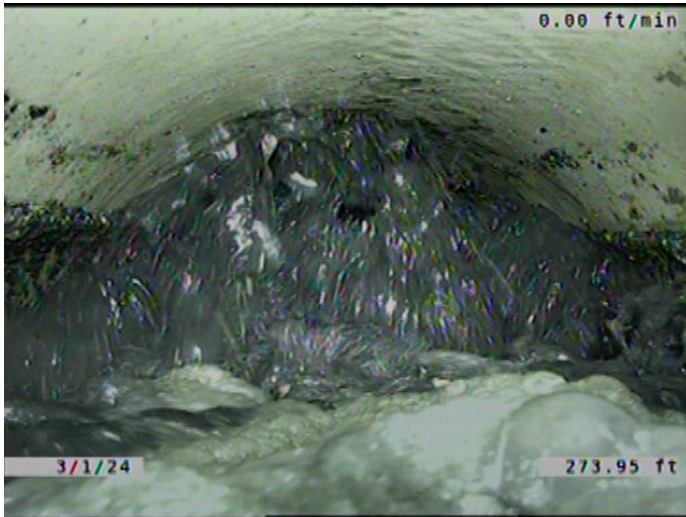
Code:	<b>MGO</b>
Description:	<b>Miscellaneous General Observation</b>
Distance (ft):	<b>274.0</b>
Structural Grade:	<b>0</b>
O&M Grade:	<b>0</b>
Clock Start/From:	
Clock To:	
1st Value:	
2nd Value:	
Value Percent:	
Continuous Index:	
Within 8" of Joint:	<b>NO</b>
Remarks:	<b>-10% INCLINE AT THIS POINT.</b>

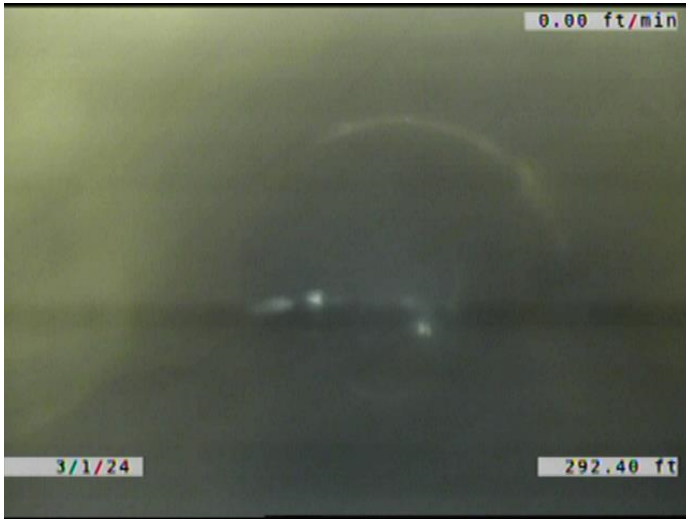
Code: **MCU**  
Description: **Miscellaneous Camera Underwater**

Distance (ft): **292.4**  
Structural Grade: **0**  
O&M Grade: **4**  
Clock Start/From:  
Clock To:  
1st Value:  
2nd Value:  
Value Percent:  
Continuous Index: **F07**  
Within 8" of Joint: **NO**  
Remarks:

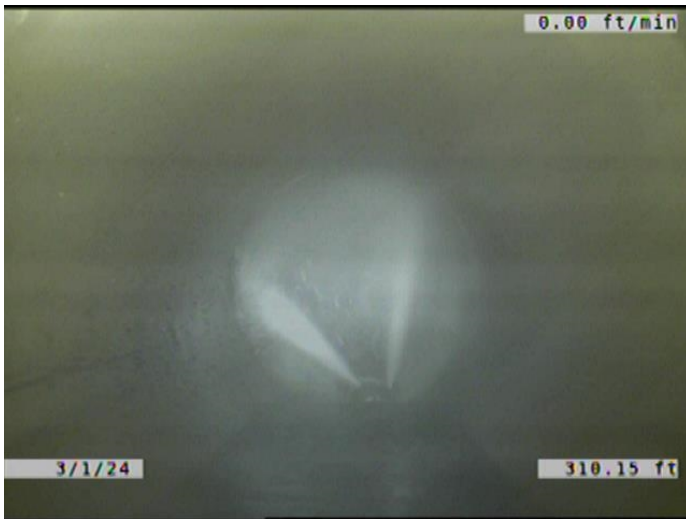
Code: **MWLS**  
Description: **Miscellaneous Water Level Sag**

Distance (ft): **310.2**  
Structural Grade: **5**  
O&M Grade: **0**  
Clock Start/From:  
Clock To:  
1st Value:  
2nd Value:  
Value Percent: **85.000**  
Continuous Index: **F06**  
Within 8" of Joint: **NO**  
Remarks:

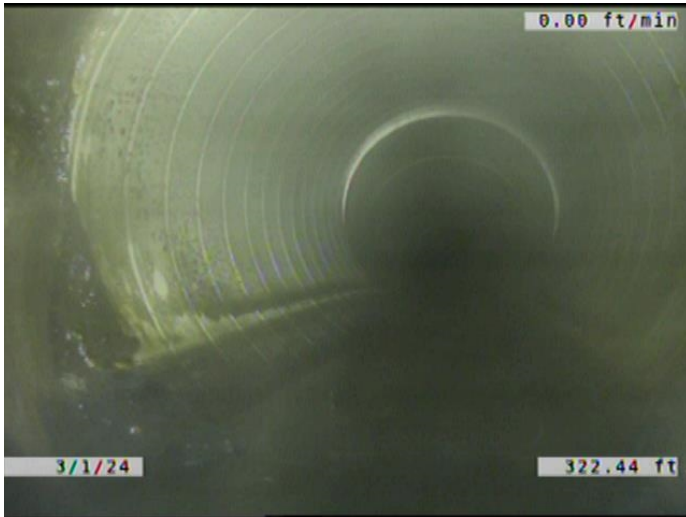
Code: **DAGS**  
Description: **Deposits Attached Grease**

Distance (ft): **322.4**  
Structural Grade: **0**  
O&M Grade: **2**  
Clock Start/From: **3**  
Clock To: **9**  
1st Value:  
2nd Value:  
Value Percent: **5.000**  
Continuous Index: **F05**  
Within 8" of Joint: **YES**  
Remarks:

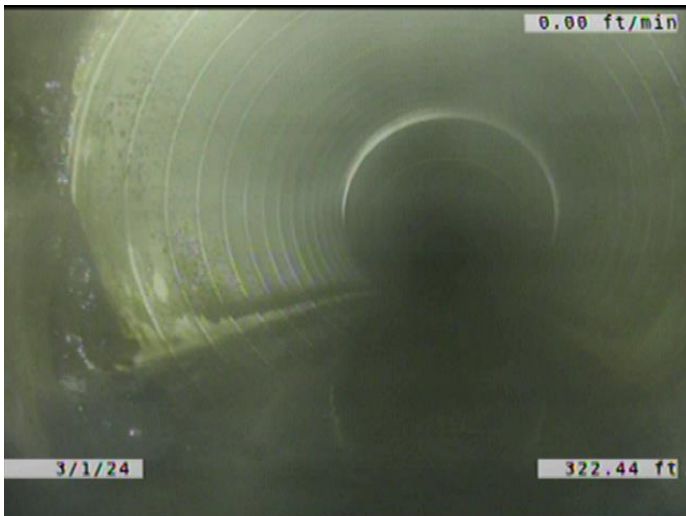
Code: **DAE**  
Description: **Deposits Attached Encrustation**

Distance (ft): **322.4**  
Structural Grade: **0**  
O&M Grade: **2**  
Clock Start/From: **8**  
Clock To: **4**  
1st Value:  
2nd Value:  
Value Percent: **5.000**  
Continuous Index: **F03**  
Within 8" of Joint: **YES**  
Remarks:

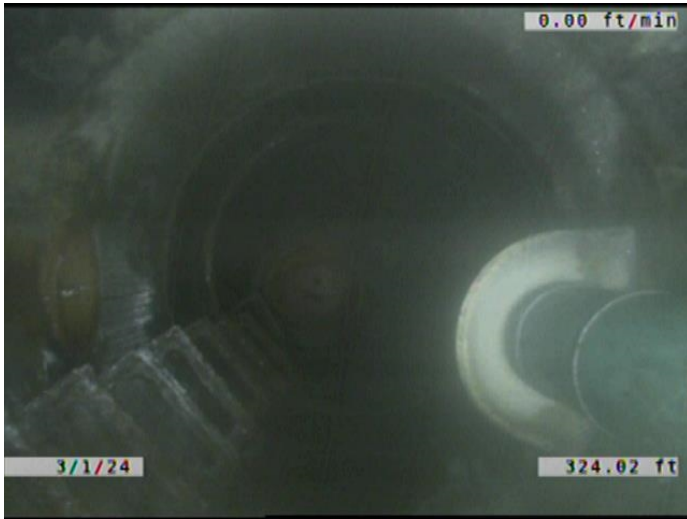
Code:	AMH
Description:	Manhole
Distance (ft):	324.0
Structural Grade:	0
O&M Grade:	0
Clock Start/From:	
Clock To:	
1st Value:	
2nd Value:	
Value Percent:	
Continuous Index:	
Within 8" of Joint:	NO
Remarks:	M-805-018
