Profile/Photo Observation Report

| Pipe Length (ft): | 201.6 | Owner: | City of Hobart | Pre Clean: | Heavy Cleaning |

| Street: | South Joliet Street | Flow Control: | Not Controlled |

| US MH: | M-805-023 | DS MH: | M-805-022 | Total Length Surveyed (ft): | 200.4 |

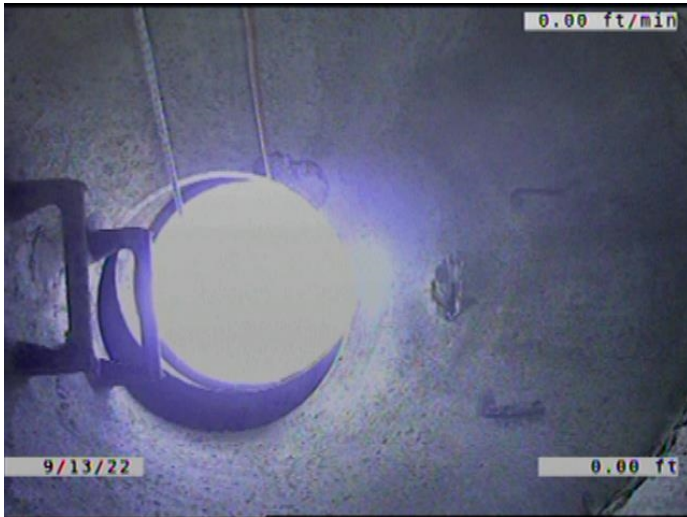
Code: **AMH**
Description: **Manhole**

Distance (ft): **.0**
Structural Grade: **0**
O&M Grade: **0**
Clock Start/From:
Clock To:
1st Value:
2nd Value:
Value Percent:
Continuous Index:
Within 8" of Joint: **NO**
Remarks: **M-805-023**

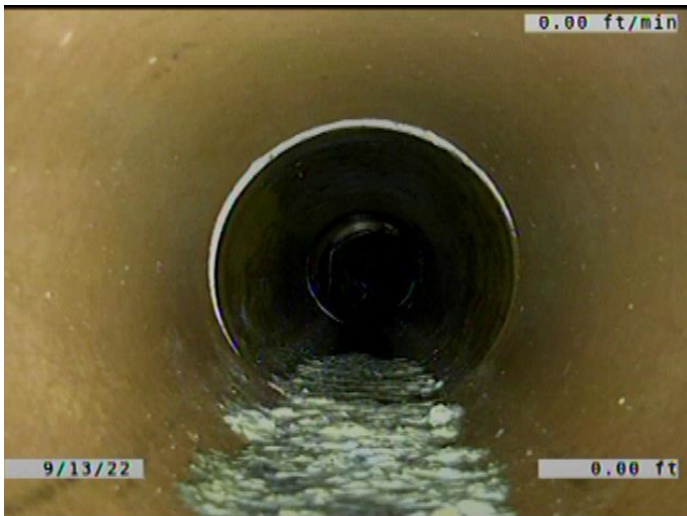
Code: **MWL**
Description: **Miscellaneous Water Level**

Distance (ft): **.0**
Structural Grade: **0**
O&M Grade: **0**
Clock Start/From:
Clock To:
1st Value:
2nd Value:
Value Percent: **5.000**
Continuous Index:
Within 8" of Joint: **NO**
Remarks:

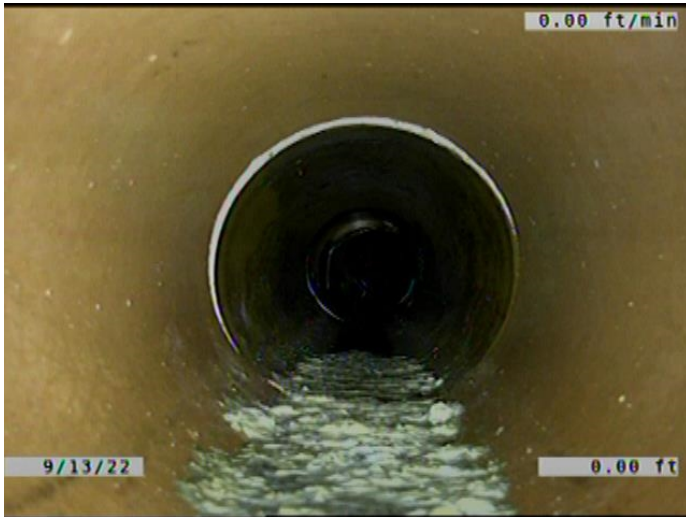
Code: **DSF**
 Description: **Deposits Settled Fine**

Distance (ft): **.0**
 Structural Grade: **0**
 O&M Grade: **2**
 Clock Start/From: **5**
 Clock To: **7**
 1st Value:
 2nd Value:
 Value Percent: **5.000**
 Continuous Index: **S01**
 Within 8" of Joint: **YES**
 Remarks:

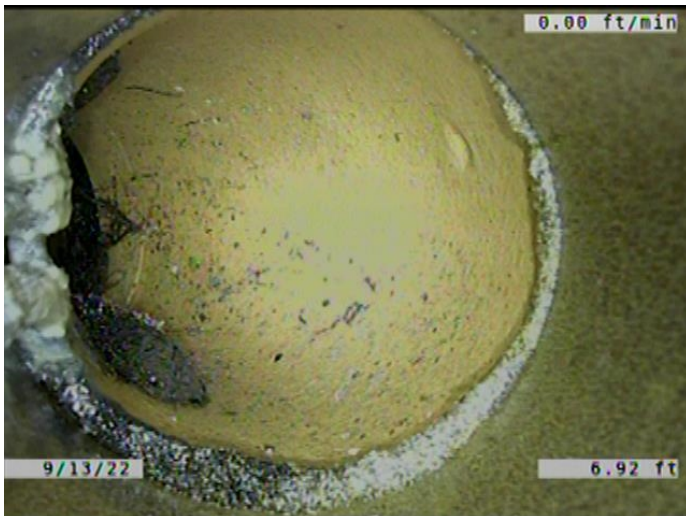
Code: **TBI**
 Description: **Tap Break-in Intruding**

Distance (ft): **6.9**
 Structural Grade: **0**
 O&M Grade: **2**
 Clock Start/From: **11**
 Clock To:
 1st Value: **6.000**
 2nd Value: **1.000**
 Value Percent:
 Continuous Index:
 Within 8" of Joint: **YES**
 Remarks:

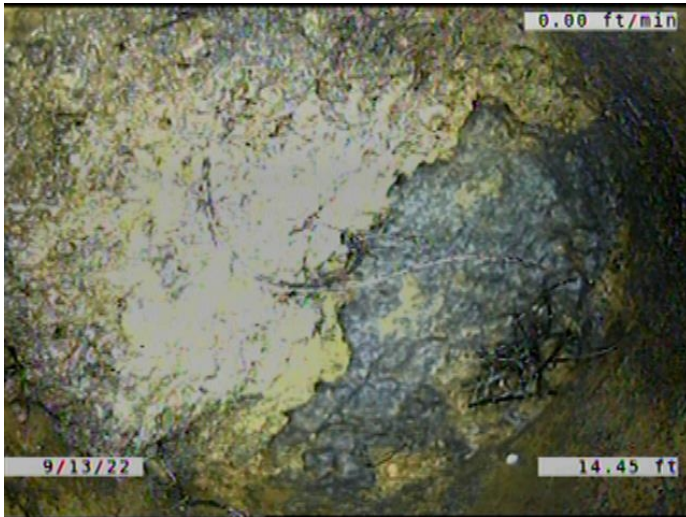
Code: **TFD**
Description: **Tap Factory Defective**

Distance (ft): **14.4**
Structural Grade: **0**
O&M Grade: **3**
Clock Start/From: **11**
Clock To:
1st Value: **6.000**
2nd Value:
Value Percent:
Continuous Index:
Within 8" of Joint: **YES**
Remarks: **100% PLUGGED.**

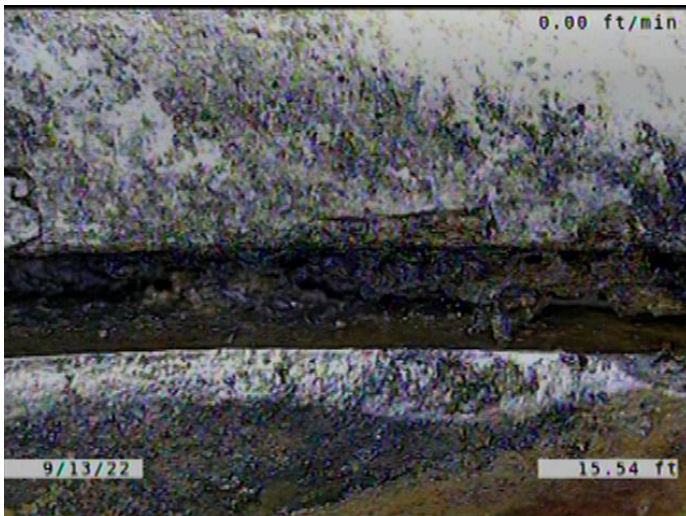
Code: **DAE**
Description: **Deposits Attached Encrustation**

Distance (ft): **15.5**
Structural Grade: **0**
O&M Grade: **2**
Clock Start/From: **8**
Clock To: **4**
1st Value:
2nd Value:
Value Percent: **5.000**
Continuous Index: **S02**
Within 8" of Joint: **YES**
Remarks:

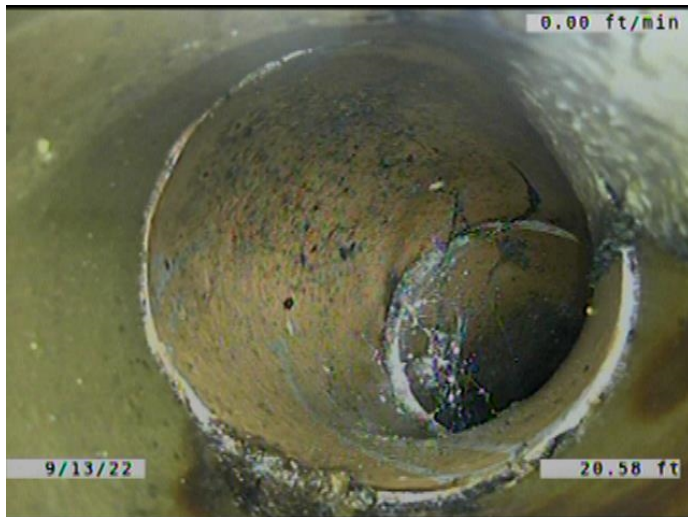
Code: **TF**
Description: **Tap Factory**

Distance (ft): **20.6**
Structural Grade: **0**
O&M Grade: **0**
Clock Start/From: **1**
Clock To:
1st Value: **6.000**
2nd Value:
Value Percent:
Continuous Index:
Within 8" of Joint: **YES**
Remarks: **CONSTANTLY RUNNING WATER.**

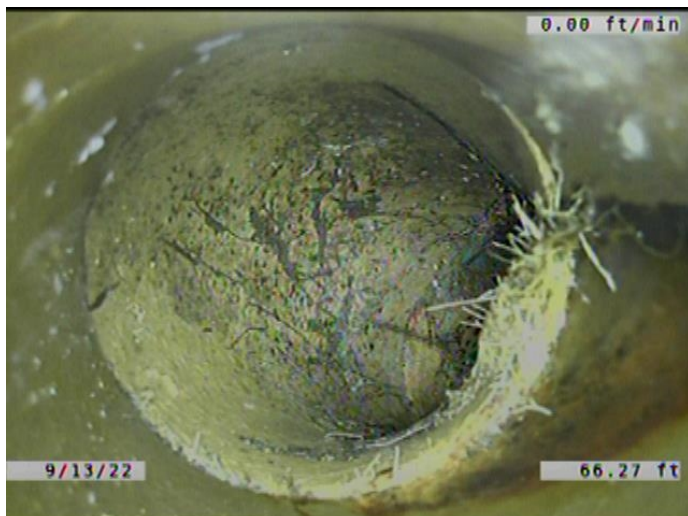
Code: **TF**
Description: **Tap Factory**

Distance (ft): **66.3**
Structural Grade: **0**
O&M Grade: **0**
Clock Start/From: **1**
Clock To:
1st Value: **6.000**
2nd Value:
Value Percent:
Continuous Index:
Within 8" of Joint: **YES**
Remarks: **ROOTS GROWING FROM THE SERVICE TO MAIN CONNECTION .**

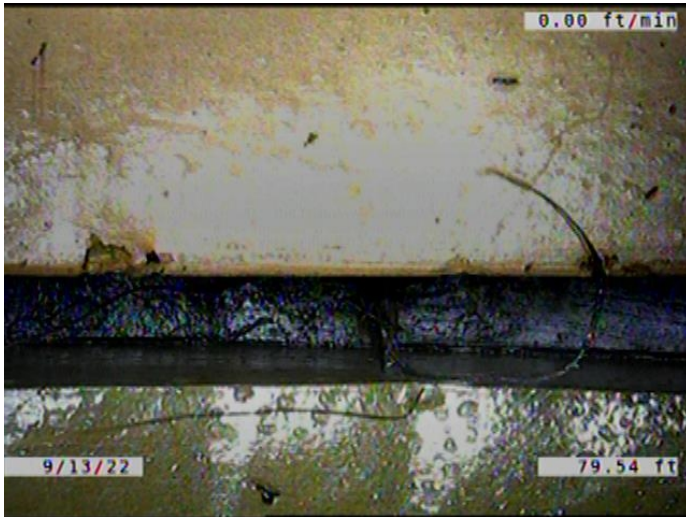
Code: **RFJ**
 Description: **Roots Fine Joint**

Distance (ft): **79.5**
 Structural Grade: **0**
 O&M Grade: **1**
 Clock Start/From: **9**
 Clock To: **3**
 1st Value:
 2nd Value:
 Value Percent:
 Continuous Index: **S03**
 Within 8" of Joint: **YES**
 Remarks:

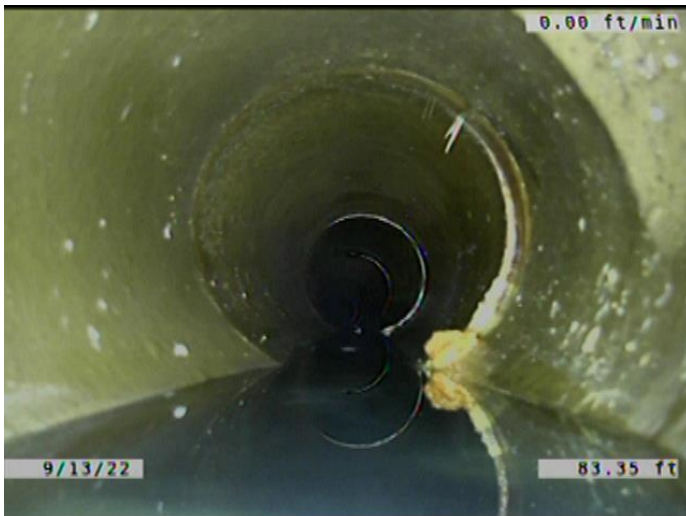
Code: **MWLS**
 Description: **Miscellaneous Water Level Sag**

Distance (ft): **83.3**
 Structural Grade: **2**
 O&M Grade: **0**
 Clock Start/From:
 Clock To:
 1st Value:
 2nd Value:
 Value Percent: **15.000**
 Continuous Index:
 Within 8" of Joint: **NO**
 Remarks:

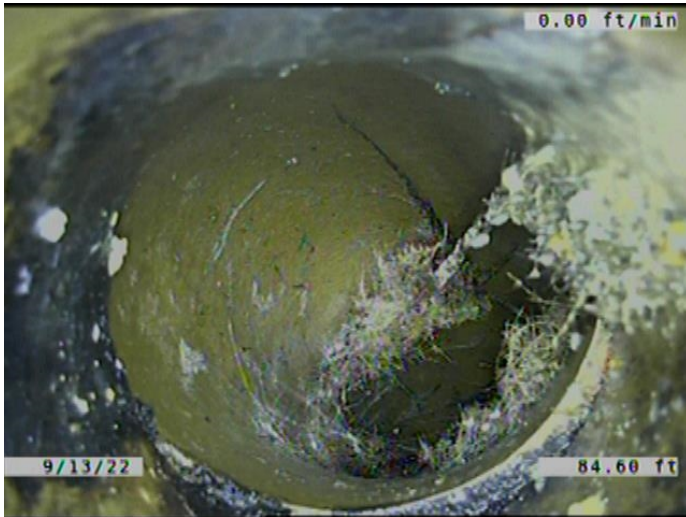
Code: **TF**
 Description: **Tap Factory**

Distance (ft): **84.6**
 Structural Grade: **0**
 O&M Grade: **0**
 Clock Start/From: **2**
 Clock To:
 1st Value: **6.000**
 2nd Value:
 Value Percent:
 Continuous Index:
 Within 8" of Joint: **YES**
 Remarks:

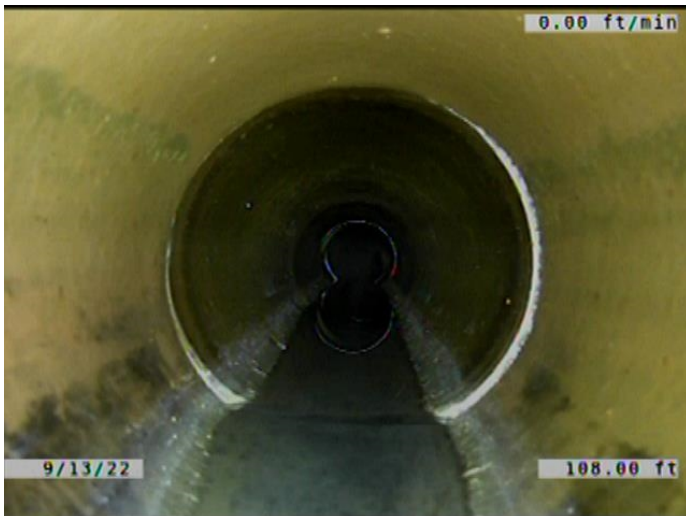
Code: **MWLS**
 Description: **Miscellaneous Water Level Sag**

Distance (ft): **108.0**
 Structural Grade: **2**
 O&M Grade: **0**
 Clock Start/From:
 Clock To:
 1st Value:
 2nd Value:
 Value Percent: **10.000**
 Continuous Index: **S04**
 Within 8" of Joint: **NO**
 Remarks:

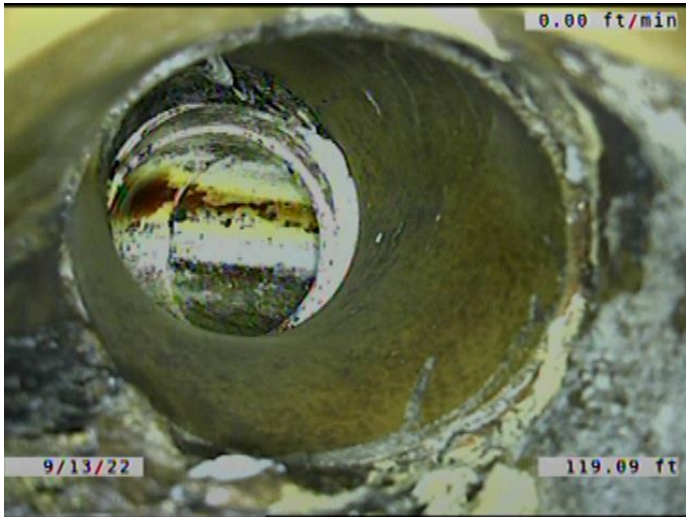
| Code: | TF |
| Description: | Tap Factory |
| Distance (ft): | 119.1 |
| Remarks: | ROOTS GROWING AND ENCRUSTATION COMING FROM THE |

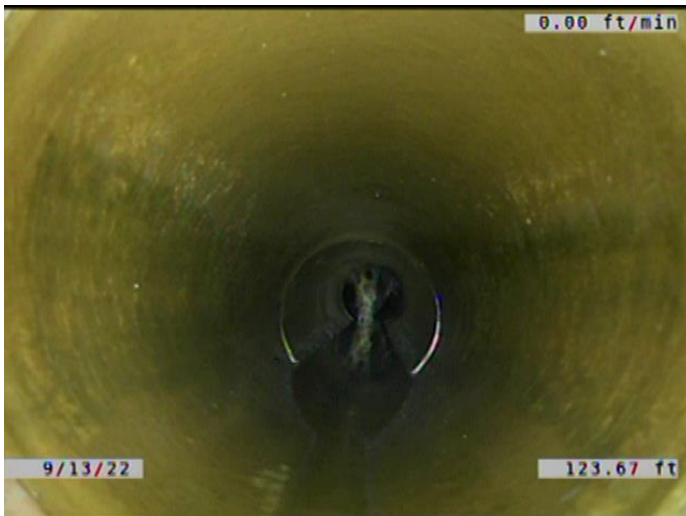
| Code: | MWLS |
| Description: | Miscellaneous Water Level Sag |
| Distance (ft): | 123.7 |
| Value Percent: | 10.000 |

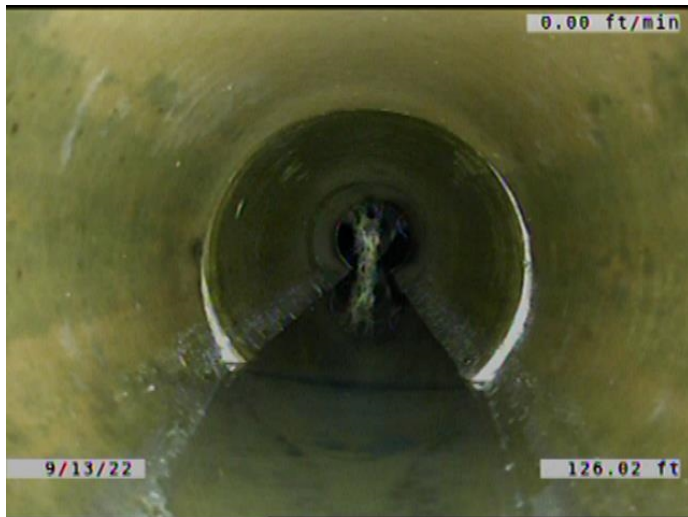
Code: **MWLS**
 Description: **Miscellaneous Water Level Sag**

Distance (ft): **126.0**
 Structural Grade: **2**
 O&M Grade: **0**
 Clock Start/From:
 Clock To:
 1st Value:
 2nd Value:
 Value Percent: **10.000**
 Continuous Index: **S05**
 Within 8" of Joint: **NO**
 Remarks:

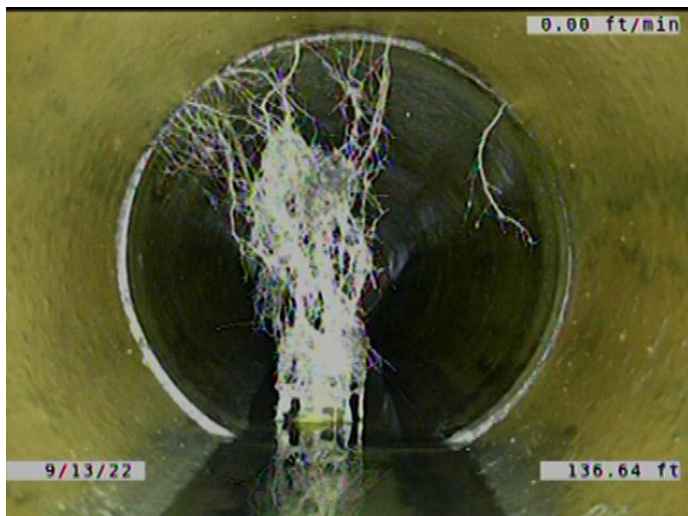
Code: **RMJ**
 Description: **Roots Medium Joint**

Distance (ft): **136.6**
 Structural Grade: **0**
 O&M Grade: **3**
 Clock Start/From: **10**
 Clock To: **2**
 1st Value:
 2nd Value:
 Value Percent: **15.000**
 Continuous Index:
 Within 8" of Joint: **YES**
 Remarks:

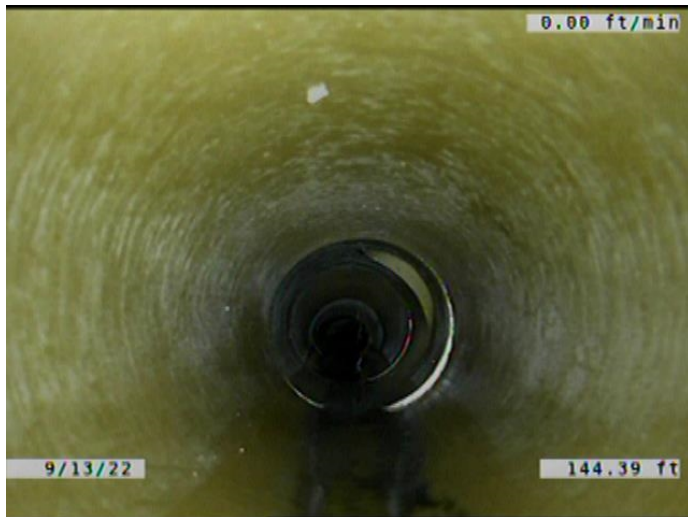
Code: **MWLS**
 Description: **Miscellaneous Water Level Sag**

Distance (ft): **144.4**
 Structural Grade: **2**
 O&M Grade: **0**
 Clock Start/From:
 Clock To:
 1st Value:
 2nd Value:
 Value Percent: **10.000**
 Continuous Index: **F05**
 Within 8" of Joint: **NO**
 Remarks:

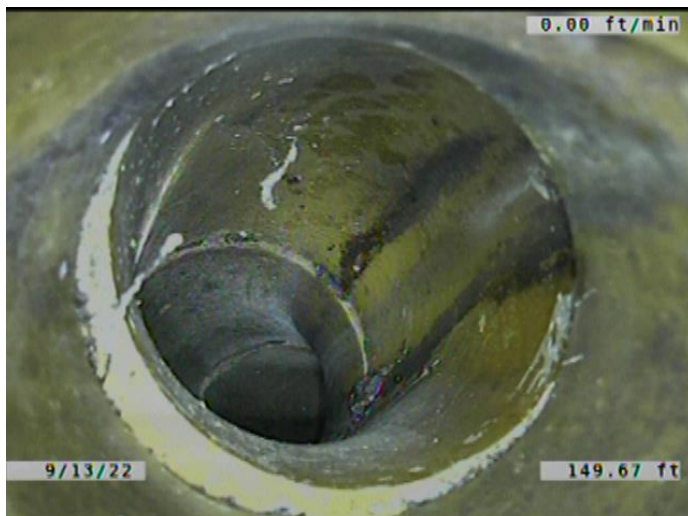
Code: **TF**
 Description: **Tap Factory**

Distance (ft): **149.7**
 Structural Grade: **0**
 O&M Grade: **0**
 Clock Start/From: **2**
 Clock To:
 1st Value: **6.000**
 2nd Value:
 Value Percent:
 Continuous Index:
 Within 8" of Joint: **YES**
 Remarks:

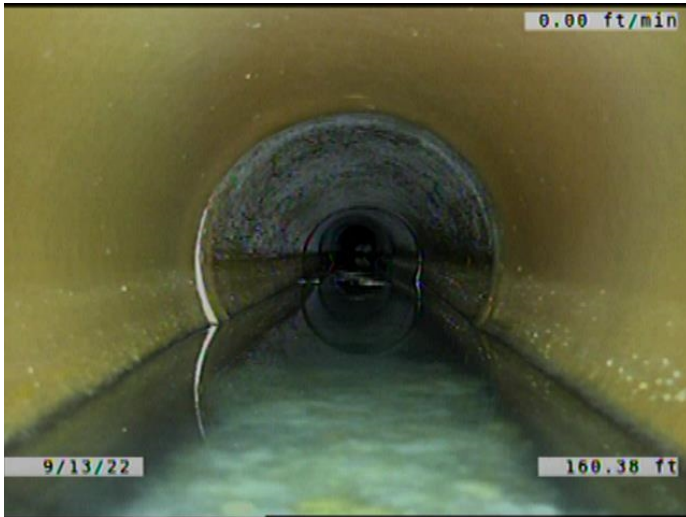
Code: **MWL**
Description: **Miscellaneous Water Level**

Distance (ft): **160.4**
Structural Grade: **0**
O&M Grade: **0**
Clock Start/From:
Clock To:
1st Value:
2nd Value:
Value Percent: **15.000**
Continuous Index:
Within 8" of Joint: **NO**
Remarks:

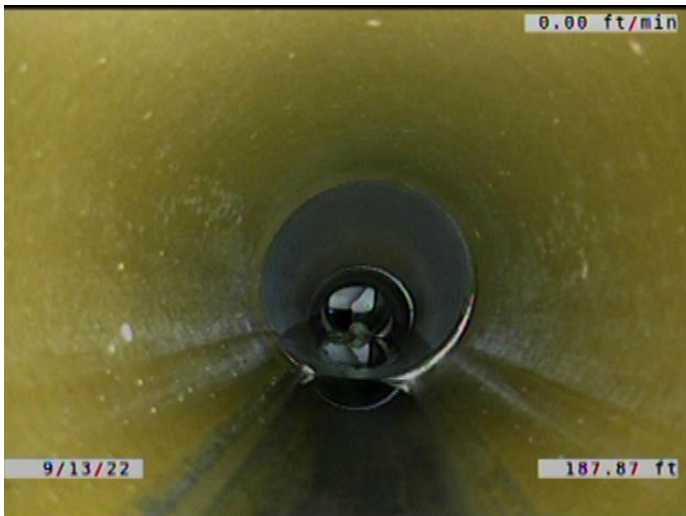
Code: **MWL**
Description: **Miscellaneous Water Level**

Distance (ft): **187.9**
Structural Grade: **0**
O&M Grade: **0**
Clock Start/From:
Clock To:
1st Value:
2nd Value:
Value Percent: **5.000**
Continuous Index:
Within 8" of Joint: **NO**
Remarks:

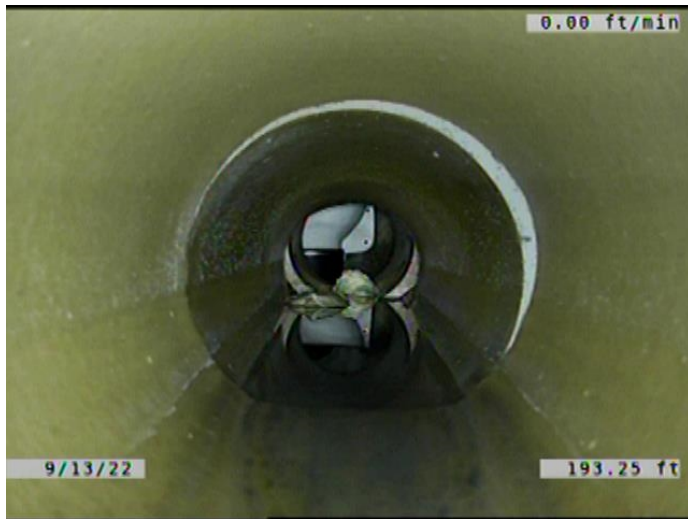
Code: **MWLS**
Description: **Miscellaneous Water Level Sag**

Distance (ft): **193.2**
Structural Grade: **2**
O&M Grade: **0**
Clock Start/From:
Clock To:
1st Value:
2nd Value:
Value Percent: **10.000**
Continuous Index: **S06**
Within 8" of Joint: **NO**
Remarks:

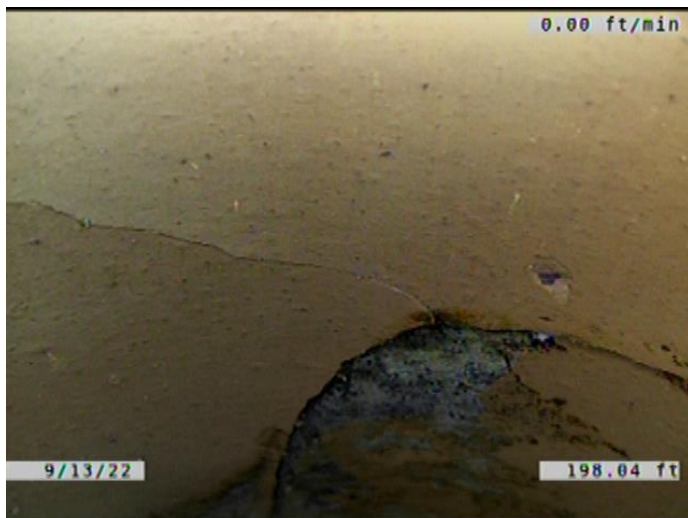
Code: **B**
Description: **Broken**

Distance (ft): **198.0**
Structural Grade: **4**
O&M Grade: **0**
Clock Start/From: **12**
Clock To: **12**
1st Value:
2nd Value:
Value Percent:
Continuous Index:
Within 8" of Joint: **YES**
Remarks:

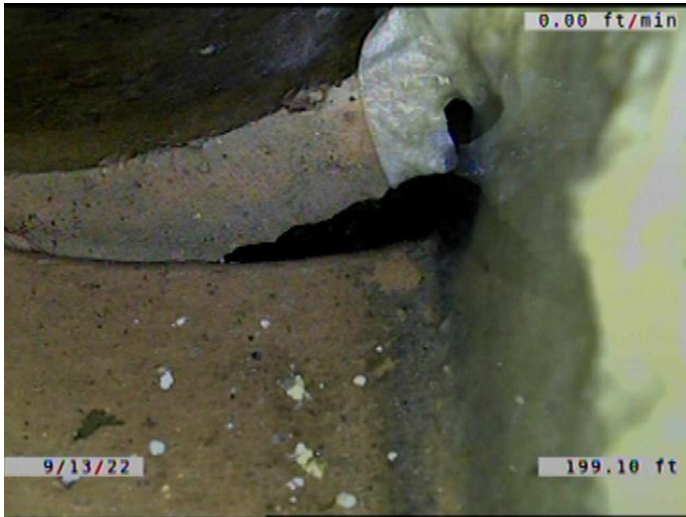
Code: **JOLD**
Description: **Joint Offset Large Defective**

Distance (ft): **199.1**
Structural Grade: **4**
O&M Grade: **0**
Clock Start/From:
Clock To:
1st Value:
2nd Value:
Value Percent:
Continuous Index:
Within 8" of Joint: **NO**
Remarks: **SOIL VISIBL.E.**

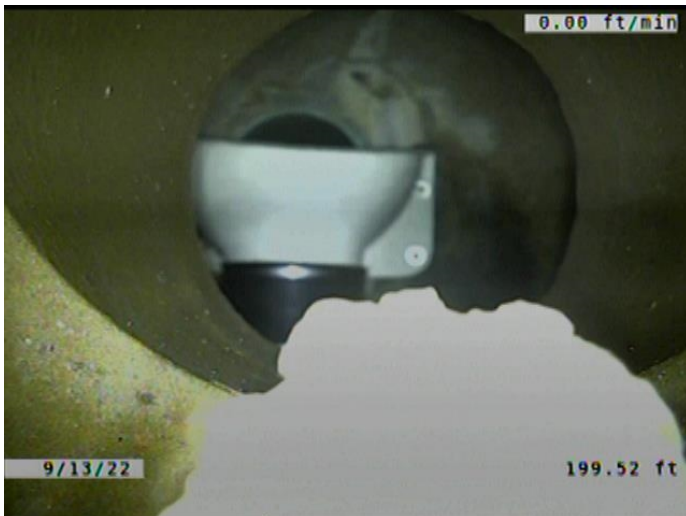
Code: **MWLS**
Description: **Miscellaneous Water Level Sag**

Distance (ft): **199.5**
Structural Grade: **2**
O&M Grade: **0**
Clock Start/From:
Clock To:
1st Value:
2nd Value:
Value Percent: **10.000**
Continuous Index: **F06**
Within 8" of Joint: **NO**
Remarks:

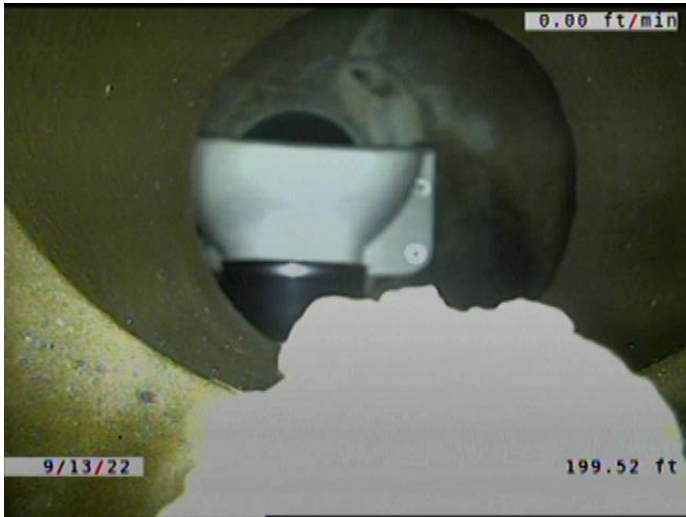
Code: **DAE**
Description: **Deposits Attached Encrustation**

Distance (ft): **199.5**
Structural Grade: **0**
O&M Grade: **2**
Clock Start/From: **8**
Clock To: **4**
1st Value:
2nd Value:
Value Percent: **5.000**
Continuous Index: **F02**
Within 8" of Joint: **YES**
Remarks:

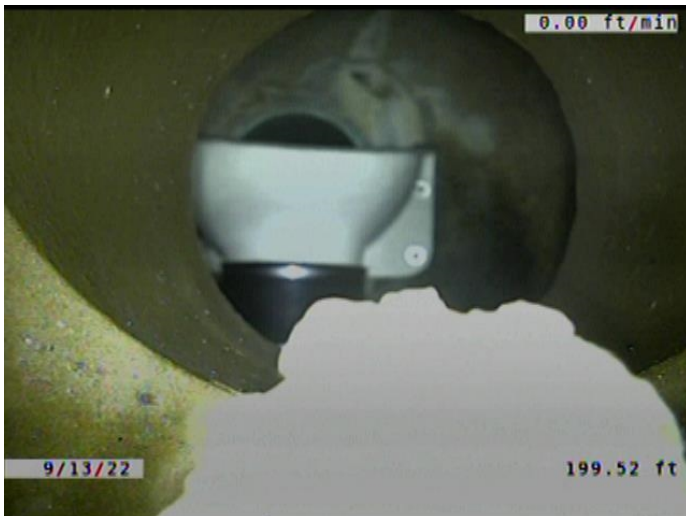
Code: **RFJ**
Description: **Roots Fine Joint**

Distance (ft): **199.5**
Structural Grade: **0**
O&M Grade: **1**
Clock Start/From: **9**
Clock To: **3**
1st Value:
2nd Value:
Value Percent:
Continuous Index: **F03**
Within 8" of Joint: **YES**
Remarks:

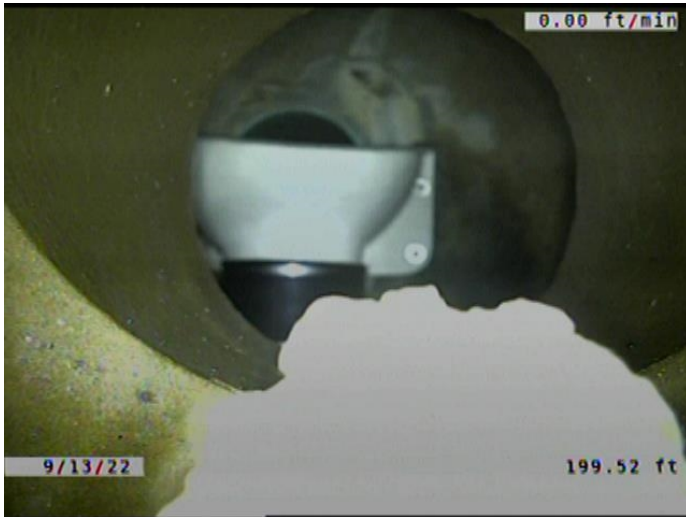
Code: **DSF**
 Description: **Deposits Settled Fine**

Distance (ft): **199.5**
 Structural Grade: **0**
 O&M Grade: **2**
 Clock Start/From: **5**
 Clock To: **7**
 1st Value:
 2nd Value:
 Value Percent: **5.000**
 Continuous Index: **F01**
 Within 8" of Joint: **YES**
 Remarks:

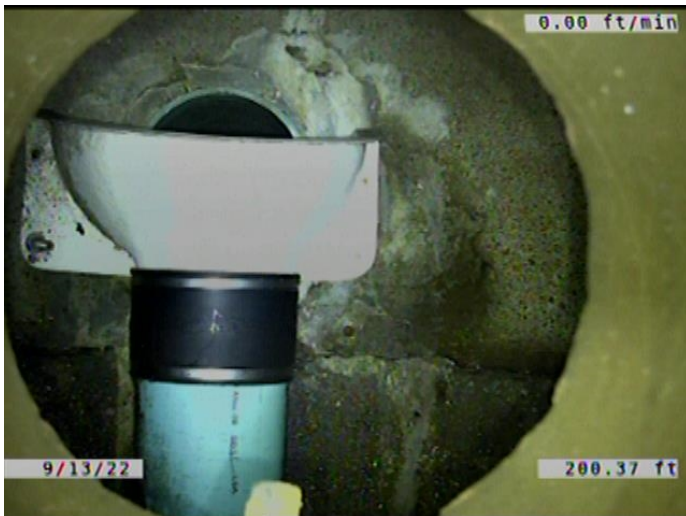
Code: **AMH**
 Description: **Manhole**

Distance (ft): **200.4**
 Structural Grade: **0**
 O&M Grade: **0**
 Clock Start/From:
 Clock To:
 1st Value:
 2nd Value:
 Value Percent:
 Continuous Index:
 Within 8" of Joint: **NO**
 Remarks: **M-805-022**
