Profile/Photo Observation Report

Date:	04/21/2018	Weather:		Coding:	PACP 6.0
Pipe Length (ft):	201.6	Owner:	NA	Pre Clean:	Not Known
P.O.#:		Surveyor:	Erik Redinger	PSR:	P-805-022-023
Customer:		Clean Date:	01/01/1900	Shape:	C

Street:	E 5TH ST	Flow Control:	Not Controlled
City:	Hobart, IN	Year Renewed:	
Location:	Light Highway	Tape/Media #:	
Purpose:	Maintenance Related	Dia/Height:	10"
Use:	Sanitary	Material:	VCP
Drain Area:	NA	Lining:	Cured in Place
Category:	NA		
Comment:	heavy silt at 41'.-flow reversed.		
Location Details:		Direction of Survey:	Upstream
US MH:	M-805-023	DS MH:	M-805-022
		Total Length Surveyed (ft):	42.7

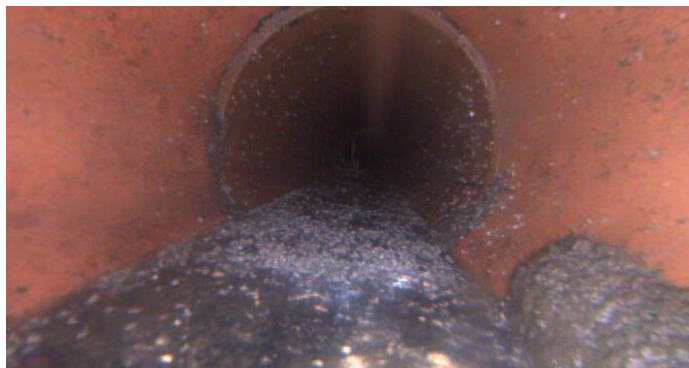
Code: **AMH**
Description: **Manhole**

Distance (ft): **.0**
Structural Grade: **0**
O&M Grade: **0**
Clock Start/From:
Clock To:
1st Value:
2nd Value:
Value Percent:
Continuous Index:
Within 8" of Joint: **NO**
Remarks: **M-805-022**

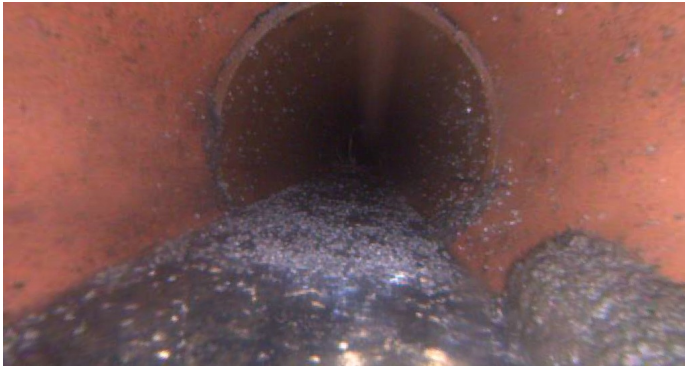
Code:	MWL
Description:	Water Level

Distance (ft):	.0
Structural Grade:	0
O&M Grade:	0
Clock Start/From:	
Clock To:	
1st Value:	
2nd Value:	
Value Percent:	10.000
Continuous Index:	
Within 8" of Joint:	NO
Remarks:

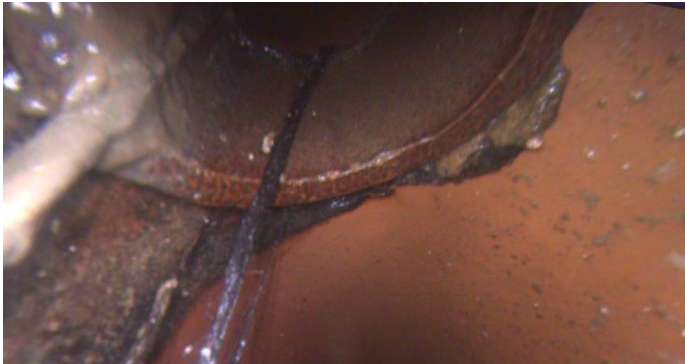
Code:	TBD
Description:	Tap Break-in Defective

Distance (ft):	6.9
Structural Grade:	0
O&M Grade:	3
Clock Start/From:	10
Clock To:	
1st Value:	4.000
2nd Value:	
Value Percent:	
Continuous Index:	
Within 8" of Joint:	
Remarks:	RFL

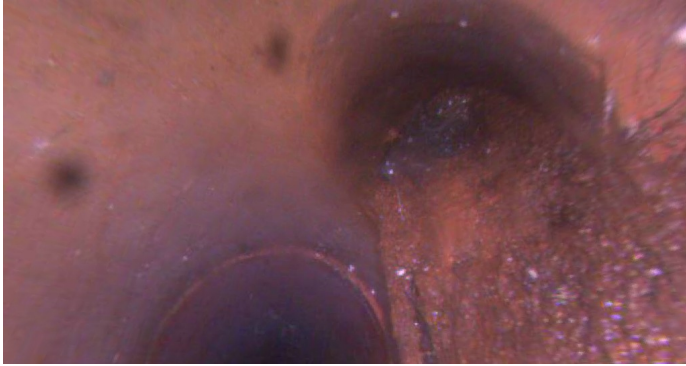
Code: **TFD**
Description: **Tap Factory Defective**

Distance (ft): **15.2**
Structural Grade: **0**
O&M Grade: **2**
Clock Start/From: **10**
Clock To:
1st Value: **4.000**
2nd Value:
Value Percent:
Continuous Index:
Within 8" of Joint:
Remarks: **RML**

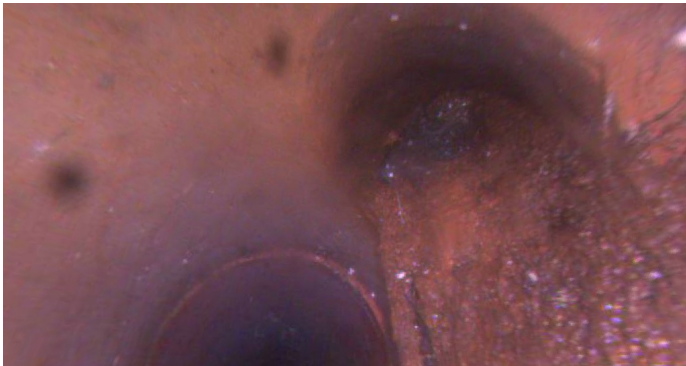
Code: **RML**
Description: **Roots Medium Lateral**

Distance (ft): **15.2**
Structural Grade: **0**
O&M Grade: **3**
Clock Start/From: **10**
Clock To: **1**
1st Value:
2nd Value:
Value Percent: **10.000**
Continuous Index:
Within 8" of Joint: **NO**
Remarks:

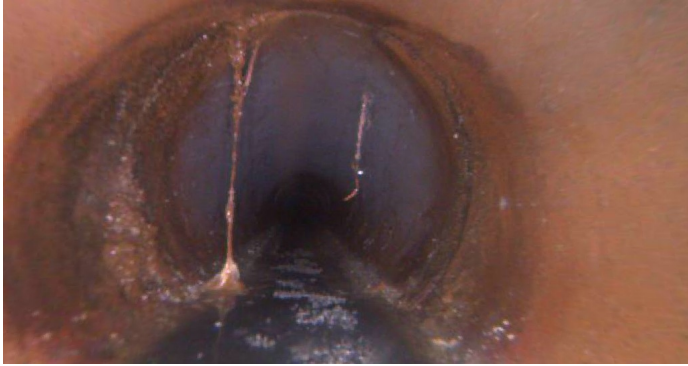
Code:	DAZ
Description:	Deposits Attached Other
Distance (ft):	15.2
Structural Grade:	0
O&M Grade:	2
Clock Start/From:	7
Clock To:	5
1st Value:	
2nd Value:	
Value Percent:	5.000
Continuous Index:	
Within 8" of Joint:	YES
Remarks:

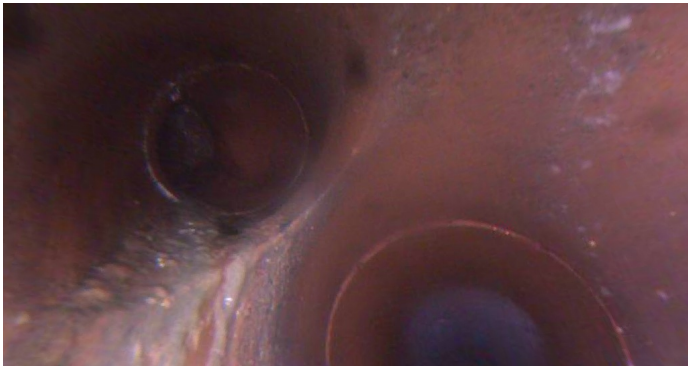
Code:	TF
Description:	Tap Factory
Distance (ft):	21.0
Structural Grade:	0
O&M Grade:	0
Clock Start/From:	2
Clock To:	
1st Value:	4.000
2nd Value:	
Value Percent:	
Continuous Index:	
Within 8" of Joint:	
Remarks:

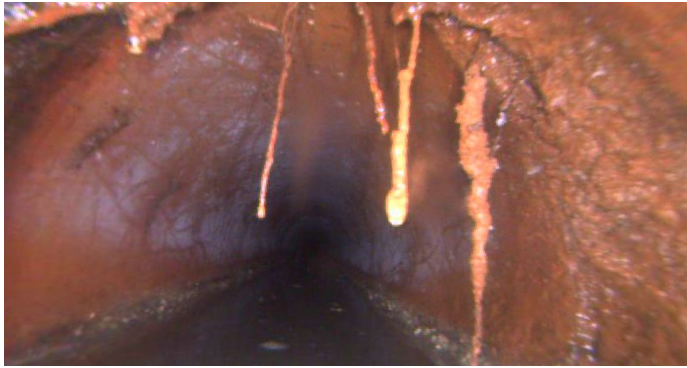
Code:	DAZ
Description:	Deposits Attached Other
Distance (ft):	41.9
Structural Grade:	0
O&M Grade:	2
Clock Start/From:	7
Clock To:	5
1st Value:	
2nd Value:	
Value Percent:	5.000
Continuous Index:	
Within 8" of Joint:	YES
Remarks:

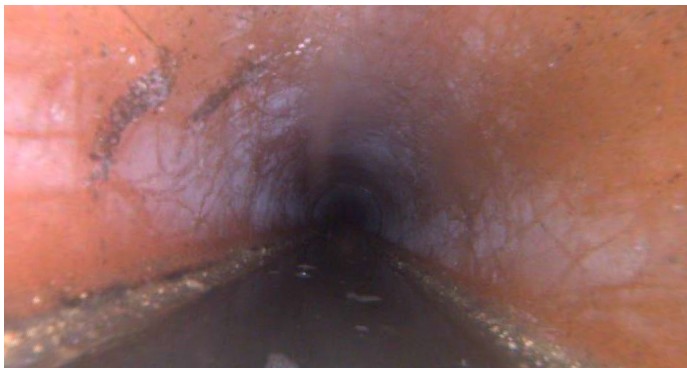
Code:	MSA
Description:	Abandoned Survey
Distance (ft):	42.7
Structural Grade:	0
O&M Grade:	0
Clock Start/From:	
Clock To:	
1st Value:	
2nd Value:	
Value Percent:	
Continuous Index:	
Within 8" of Joint:	NO
Remarks:	DAZ
