## Profile/Photo Observation Report

Date:	<b>04/21/2018</b>	Weather:		Coding:	<b>PACP 6.0</b>
Pipe Length (ft):	<b>201.6</b>	Owner:	<b>NA</b>	Pre Clean:	<b>Not Known</b>
P.O.#:		Surveyor:	<b>Erik Redinger</b>	PSR:	<b>P-805-022-023</b>
Customer:		Clean Date:	<b>01/01/1900</b>	Shape:	<b>C</b>

Street:	<b>Capitol</b>	Flow Control:	<b>Not Controlled</b>
City:	<b>Hobart, IN</b>	Year Renewed:	
Location:	<b>Light Highway</b>	Tape/Media #:	
Purpose:	<b>Maintenance Related</b>	Dia/Height:	<b>10"</b>
Use:	<b>Sanitary</b>	Material:	<b>VCP</b>
Drain Area:	<b>NA</b>	Lining:	<b>Cured in Place</b>
Category:	<b>NA</b>		
Comment:	<b>heavy silt at 41'.-flow reversed.</b>		
Location Details:		Direction of Survey:	<b>Upstream</b>
US MH:	<b>M-805-023</b>	DS MH:	<b>M-805-022</b>
		Total Length Surveyed (ft):	<b>42.7</b>

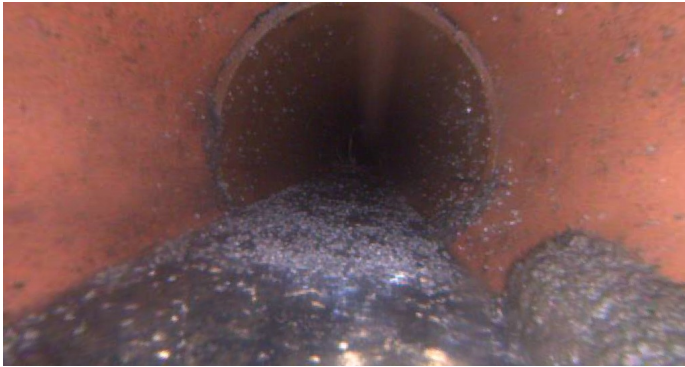
Code: **MWL**  
Description: **Water Level**

Distance (ft): **.0**  
Structural Grade: **0**  
O&M Grade: **0**  
Clock Start/From:  
Clock To:  
1st Value:  
2nd Value:  
Value Percent: **10.000**  
Continuous Index:  
Within 8" of Joint: **NO**  
Remarks:

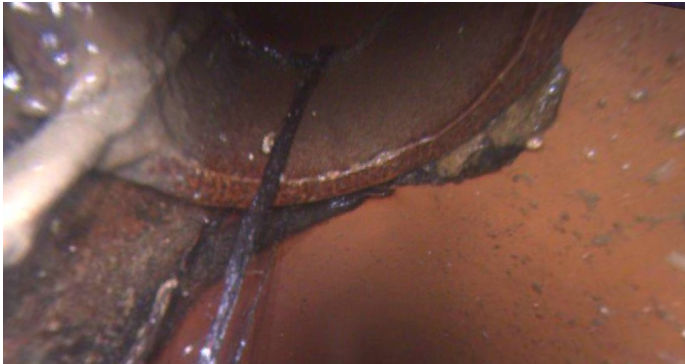
Code: **TBD**  
Description: **Tap Break-in Defective**

Distance (ft): **6.9**  
Structural Grade: **0**  
O&M Grade: **3**  
Clock Start/From: **10**  
Clock To:  
1st Value: **4.000**  
2nd Value:  
Value Percent:  
Continuous Index:  
Within 8" of Joint:  
Remarks: **RFL**

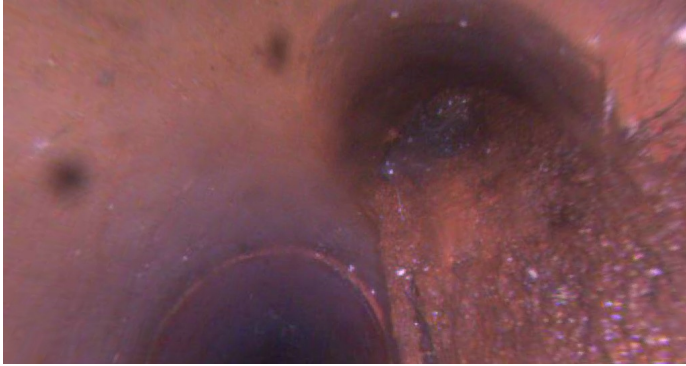
Code: **TFD**  
Description: **Tap Factory Defective**

Distance (ft): **15.2**  
Structural Grade: **0**  
O&M Grade: **2**  
Clock Start/From: **10**  
Clock To:  
1st Value: **4.000**  
2nd Value:  
Value Percent:  
Continuous Index:  
Within 8" of Joint:  
Remarks: **RML**

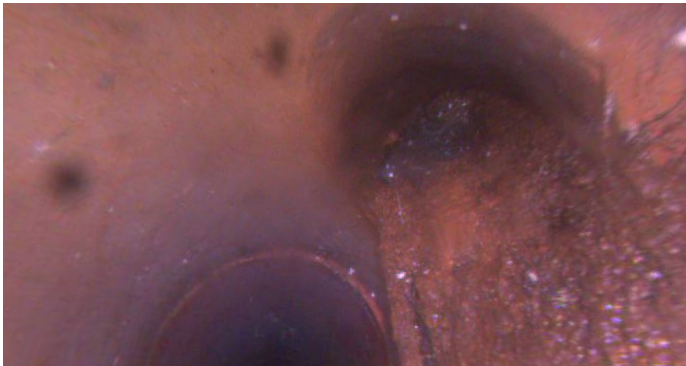
Code: **RML**  
Description: **Roots Medium Lateral**

Distance (ft): **15.2**  
Structural Grade: **0**  
O&M Grade: **3**  
Clock Start/From: **10**  
Clock To: **1**  
1st Value:  
2nd Value:  
Value Percent: **10.000**  
Continuous Index:  
Within 8" of Joint: **NO**  
Remarks:

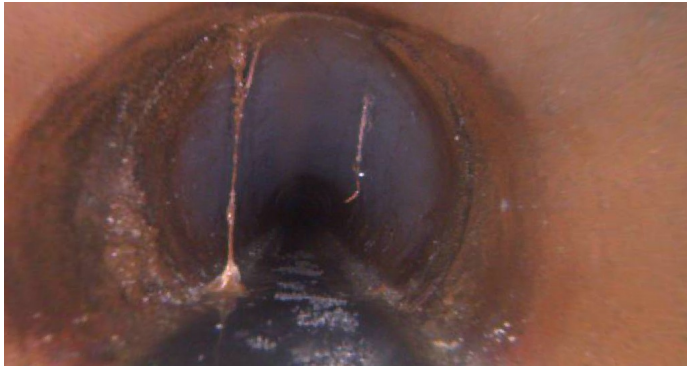
Code:	<b>DAZ</b>
Description:	<b>Deposits Attached Other</b>
Distance (ft):	<b>15.2</b>
Structural Grade:	<b>0</b>
O&M Grade:	<b>2</b>
Clock Start/From:	<b>7</b>
Clock To:	<b>5</b>
1st Value:	
2nd Value:	
Value Percent:	<b>5.000</b>
Continuous Index:	
Within 8" of Joint:	<b>YES</b>
Remarks:

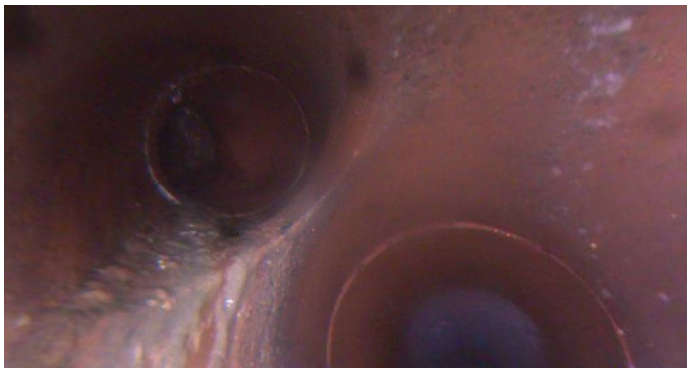
Code:	<b>TF</b>
Description:	<b>Tap Factory</b>
Distance (ft):	<b>21.0</b>
Structural Grade:	<b>0</b>
O&M Grade:	<b>0</b>
Clock Start/From:	<b>2</b>
Clock To:	
1st Value:	<b>4.000</b>
2nd Value:	
Value Percent:	
Continuous Index:	
Within 8" of Joint:	
Remarks:

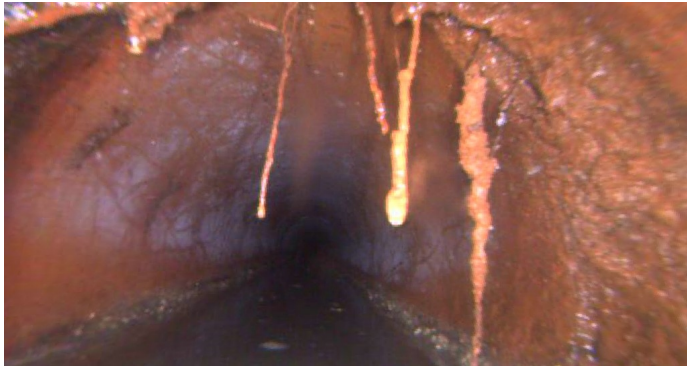
Code:	<b>DAZ</b>
Description:	<b>Deposits Attached Other</b>
Distance (ft):	<b>41.9</b>
Structural Grade:	<b>0</b>
O&M Grade:	<b>2</b>
Clock Start/From:	<b>7</b>
Clock To:	<b>5</b>
1st Value:	
2nd Value:	
Value Percent:	<b>5.000</b>
Continuous Index:	
Within 8" of Joint:	<b>YES</b>
Remarks:

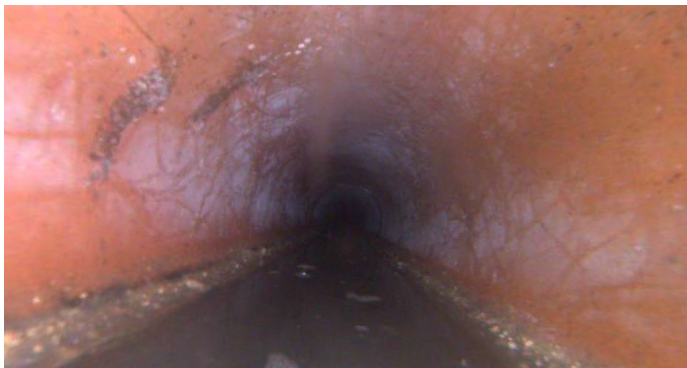
Code:	<b>MSA</b>
Description:	<b>Abandoned Survey</b>
Distance (ft):	<b>42.7</b>
Structural Grade:	<b>0</b>
O&M Grade:	<b>0</b>
Clock Start/From:	
Clock To:	
1st Value:	
2nd Value:	
Value Percent:	
Continuous Index:	
Within 8" of Joint:	<b>NO</b>
Remarks:	<b>DAZ</b>
