Profile/Photo Observation Report

Date:	04/21/2018	Weather:		Coding:	PACP 6.0
Pipe Length (ft):	280.6	Owner:	NA	Pre Clean:	Not Known
P.O.#:		Surveyor:	Mark Ruby	PSR:	P-805-024-023
Customer:		Clean Date:	01/01/1900	Shape:	C

Street:	Capitol	Flow Control:	Not Controlled
City:	Hobart, IN	Year Renewed:	
Location:	Alley	Tape/Media #:	
Purpose:	Maintenance Related	Dia/Height:	10"
Use:	Sanitary	Material:	PVC
Drain Area:	NA	Lining:	Cured in Place
Category:	NA		
Comment:	unknown near tap at 124'.		
Location Details:		Direction of Survey:	Upstream
US MH:	M-805-023	DS MH:	M-805-024
		Total Length Surveyed (ft):	125.3

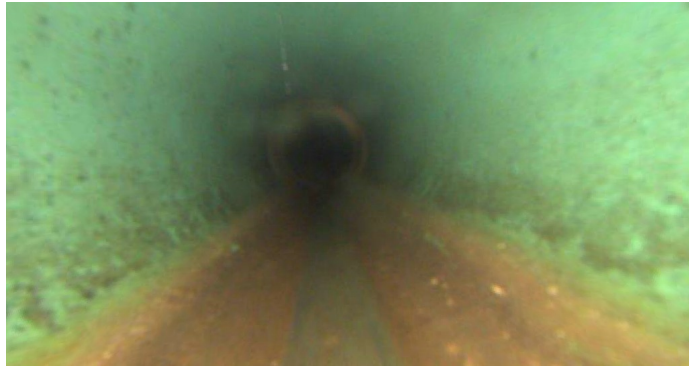
Code:	MWL
Description:	Water Level
Distance (ft):	.0
Structural Grade:	0
O&M Grade:	0
Clock Start/From:	
Clock To:	
1st Value:	
2nd Value:	
Value Percent:	10.000
Continuous Index:	
Within 8" of Joint:	NO
Remarks:

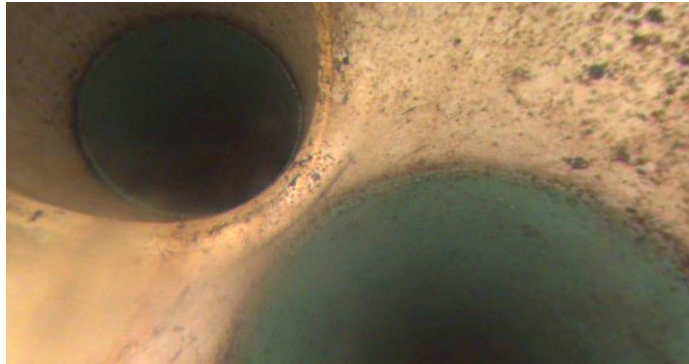
Code:	TF
Description:	Tap Factory
Distance (ft):	4.2
Structural Grade:	0
O&M Grade:	0
Clock Start/From:	2
Clock To:	
1st Value:	4.000
2nd Value:	
Value Percent:	
Continuous Index:	
Within 8" of Joint:	
Remarks:

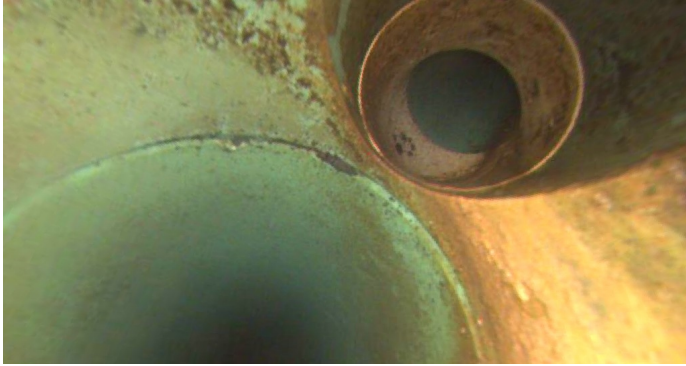
Code: **TF**
Description: **Tap Factory**

Distance (ft): **14.3**
Structural Grade: **0**
O&M Grade: **0**
Clock Start/From: **10**
Clock To:
1st Value: **4.000**
2nd Value:
Value Percent:
Continuous Index:
Within 8" of Joint:
Remarks:

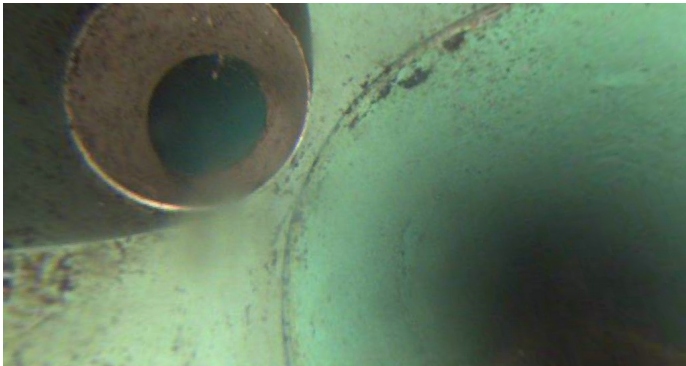
Code: **TF**
Description: **Tap Factory**

Distance (ft): **44.4**
Structural Grade: **0**
O&M Grade: **0**
Clock Start/From: **2**
Clock To:
1st Value: **4.000**
2nd Value:
Value Percent:
Continuous Index:
Within 8" of Joint:
Remarks:

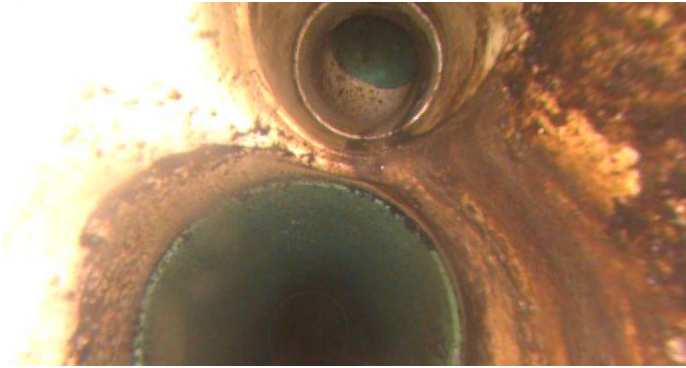
Code: **TF**
Description: **Tap Factory**

Distance (ft): **57.2**
Structural Grade: **0**
O&M Grade: **0**
Clock Start/From: **11**
Clock To:
1st Value: **4.000**
2nd Value:
Value Percent:
Continuous Index:
Within 8" of Joint:
Remarks:

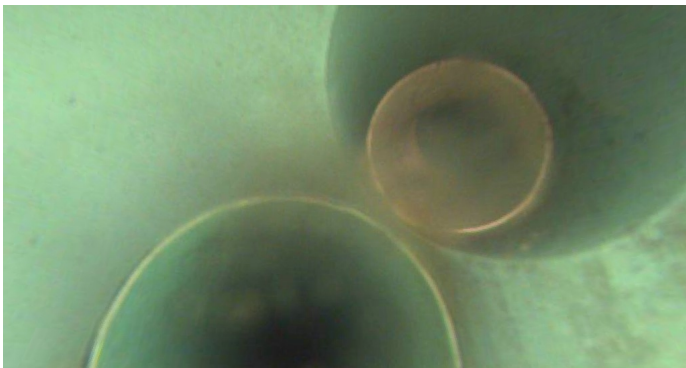
Code: **TF**
Description: **Tap Factory**

Distance (ft): **122.6**
Structural Grade: **0**
O&M Grade: **0**
Clock Start/From: **2**
Clock To:
1st Value: **4.000**
2nd Value:
Value Percent:
Continuous Index:
Within 8" of Joint:
Remarks:

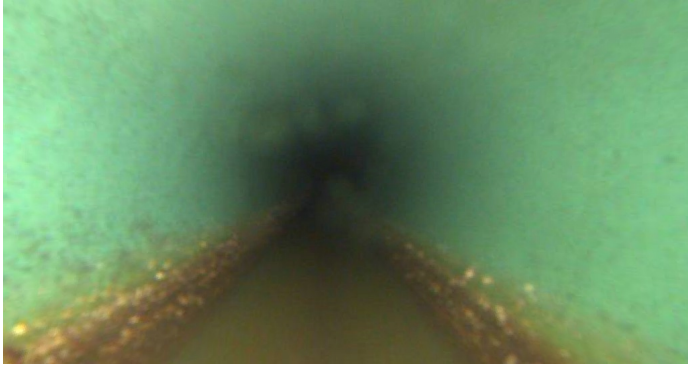
Code:	MSA
Description:	Abandoned Survey
Distance (ft):	125.3
Structural Grade:	0
O&M Grade:	0
Clock Start/From:	
Clock To:	
1st Value:	
2nd Value:	
Value Percent:	
Continuous Index:	
Within 8" of Joint:	NO
Remarks:	No blockage
