Profile/Photo Observation Report

Date:	05/05/2018	Weather:		Coding:	PACP 6.0
Pipe Length (ft):		Owner:	City of Hobart	Pre Clean:	No Pre-Cleaning
P.O.#:	189	Surveyor:	M. Pielacha	PSR:	P-805-023-027
Customer:	City of Hobart	Clean Date:		Shape:	C

Street:	5th Street	Flow Control:	Not Controlled
City:	Hobart, IN	Year Renewed:	
Location:	Light Highway	Tape/Media #:	DEP 189
Purpose:	Routine Assessment	Dia/Height:	20"
Use:	Sanitary	Material:	VCP
Drain Area:		Lining:	
Category:	NA		
Comment:	5-21-2018		
Location Details:		Direction of Survey:	Upstream
US MH:	M-805-027	DS MH:	M-805-023
		Total Length Surveyed (ft):	5.0

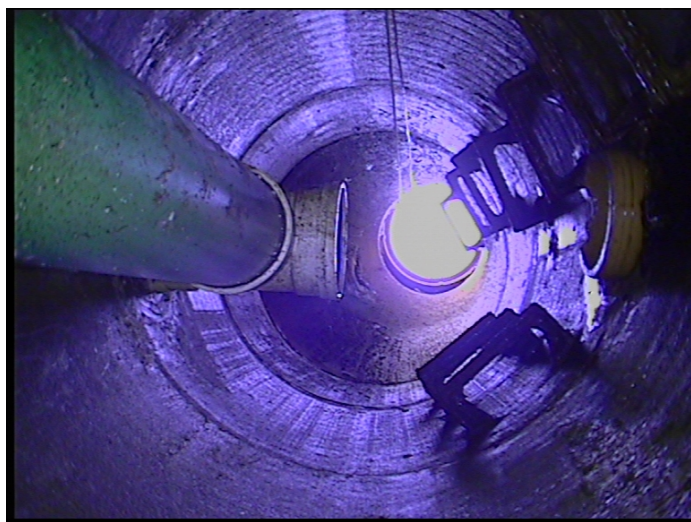
Code: **AMH**
Description: **Manhole**

Distance (ft): **.0**
Structural Grade: **0**
O&M Grade: **0**
Clock Start/From:
Clock To:
1st Value:
2nd Value:
Value Percent:
Continuous Index:
Within 8" of Joint: **NO**
Remarks: **M-805-027**

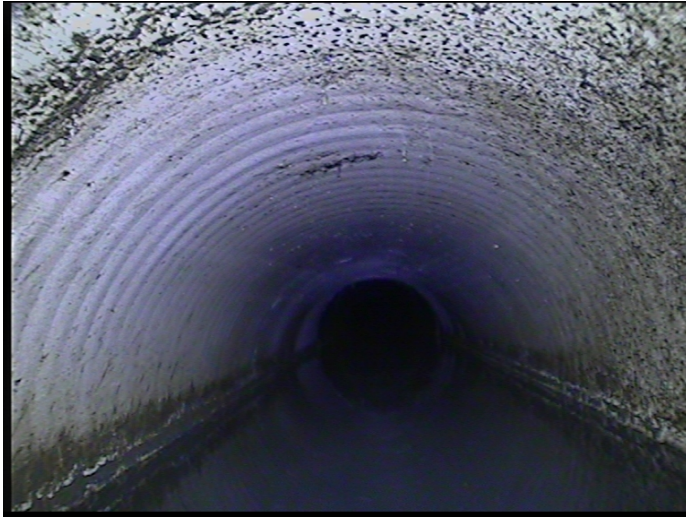
Code: **MWL**
Description: **Water Level**

Distance (ft): **.0**
Structural Grade: **0**
O&M Grade: **0**
Clock Start/From:
Clock To:
1st Value:
2nd Value:
Value Percent: **20.000**
Continuous Index:
Within 8" of Joint: **NO**
Remarks:

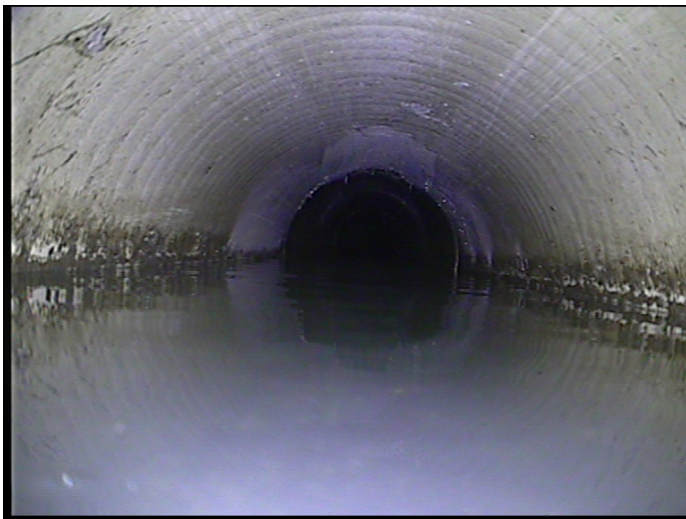
Code: **DSF**
Description: **Deposits Settled Fine**

Distance (ft): **5.0**
Structural Grade: **0**
O&M Grade: **3**
Clock Start/From: **4**
Clock To: **8**
1st Value:
2nd Value:
Value Percent: **20.000**
Continuous Index:
Within 8" of Joint: **NO**
Remarks:

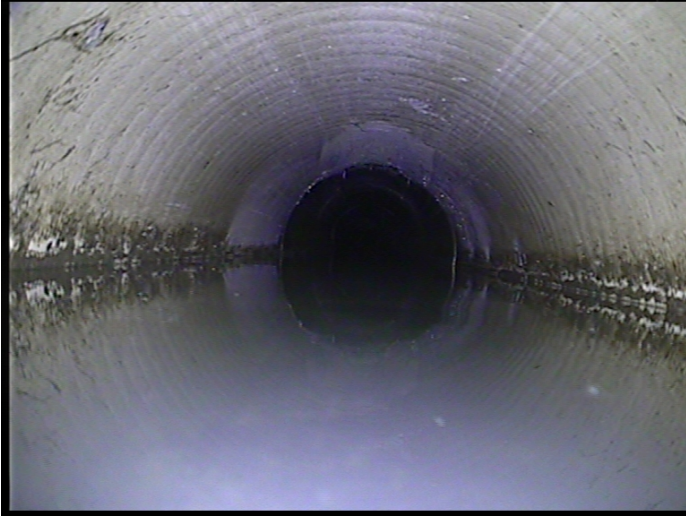
Code:	MSA
Description:	Abandoned Survey
Distance (ft):	5.0
Structural Grade:	0
O&M Grade:	0
Clock Start/From:	
Clock To:	
1st Value:	
2nd Value:	
Value Percent:	
Continuous Index:	
Within 8" of Joint:	NO
Remarks:	deep sediment
