Profile/Photo Observation Report

Date:	03/01/2024	Weather:		Coding:	PACP 7.0
Pipe Length (ft):	327.0	Owner:	City of Hobart	Pre Clean:	Heavy Cleaning
P.O.#:		Surveyor:	S. Bucklin	PSR:	P-805-023-027
Customer:	City of Hobart	Clean Date:	09/09/2022	Shape:	C

Street:	E 5TH ST	Flow Control:	Not Controlled
City:	Hobart, IN	Year Renewed:	
Location:	Local rural streets with light traffic, t	Tape/Media #:	
Purpose:	Sewer System Evaluation Survey (SS	Dia/Height:	21"
Use:	Sanitary Sewage Pipe	Material:	PE
Drain Area:		Lining:	None
Category:	NA		
Comment:			
Location Details:		Direction of Survey:	Downstream
US MH:	M-805-027	DS MH:	M-805-023
		Total Length Surveyed (ft):	333.1

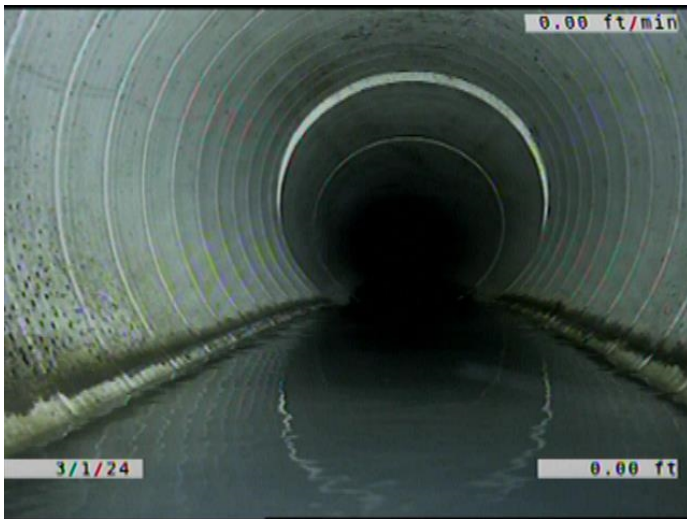
Code: **MWL**
Description: **Miscellaneous Water Level**

Distance (ft): **.0**
Structural Grade: **0**
O&M Grade: **0**
Clock Start/From:
Clock To:
1st Value:
2nd Value:
Value Percent: **15.000**
Continuous Index:
Within 8" of Joint: **NO**
Remarks:

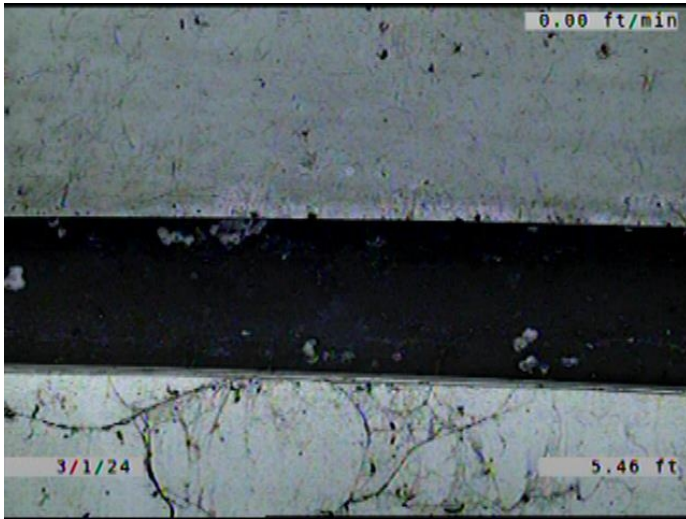
Code: **JAL**
Description: **Joint Angular Large**

Distance (ft): **5.5**
Structural Grade: **4**
O&M Grade: **0**
Clock Start/From:
Clock To:
1st Value:
2nd Value:
Value Percent:
Continuous Index:
Within 8" of Joint: **NO**
Remarks:

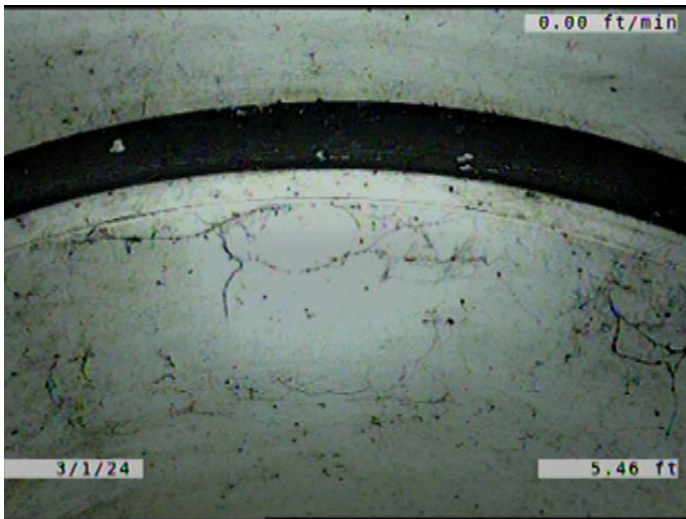
Code: **JOMD**
Description: **Joint Offset Medium Defective**

Distance (ft): **5.5**
Structural Grade: **3**
O&M Grade: **0**
Clock Start/From:
Clock To:
1st Value:
2nd Value:
Value Percent:
Continuous Index:
Within 8" of Joint: **NO**
Remarks:

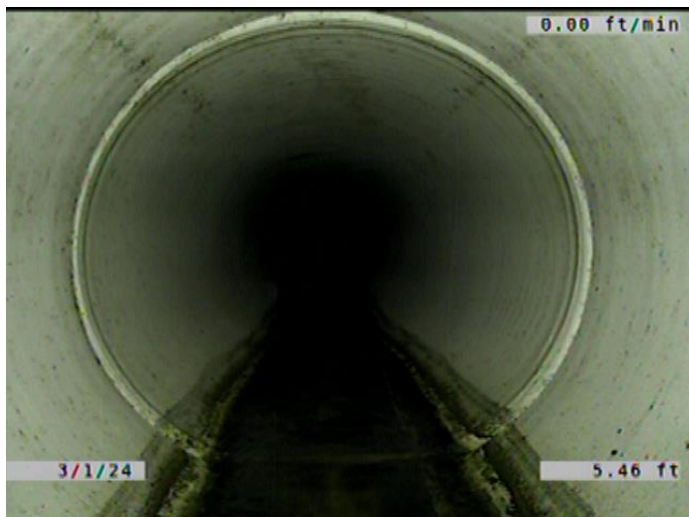
Code: **LD**
 Description: **Line Down**

Distance (ft): **5.5**
 Structural Grade: **0**
 O&M Grade: **1**
 Clock Start/From:
 Clock To:
 1st Value:
 2nd Value:
 Value Percent: **5.000**
 Continuous Index:
 Within 8" of Joint: **NO**
 Remarks:

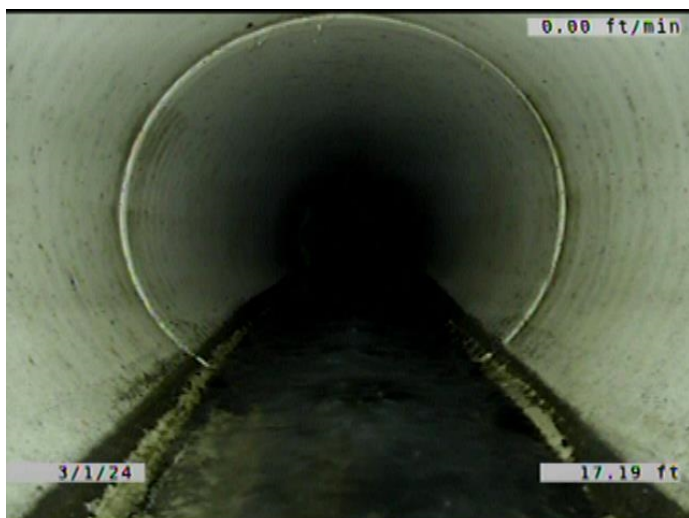
Code: **MWLS**
 Description: **Miscellaneous Water Level Sag**

Distance (ft): **17.2**
 Structural Grade: **2**
 O&M Grade: **0**
 Clock Start/From:
 Clock To:
 1st Value:
 2nd Value:
 Value Percent: **15.000**
 Continuous Index: **S01**
 Within 8" of Joint: **NO**
 Remarks:

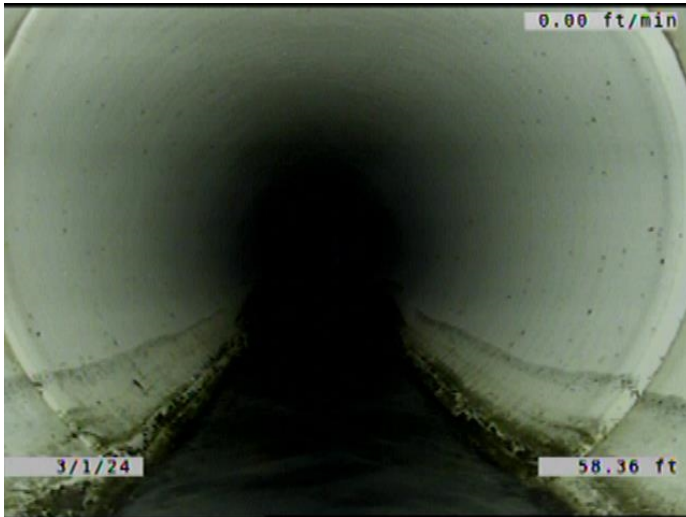
Code: **MWLS**
Description: **Miscellaneous Water Level Sag**

Distance (ft): **58.4**
Structural Grade: **2**
O&M Grade: **0**
Clock Start/From:
Clock To:
1st Value:
2nd Value:
Value Percent: **15.000**
Continuous Index: **F01**
Within 8" of Joint: **NO**
Remarks:

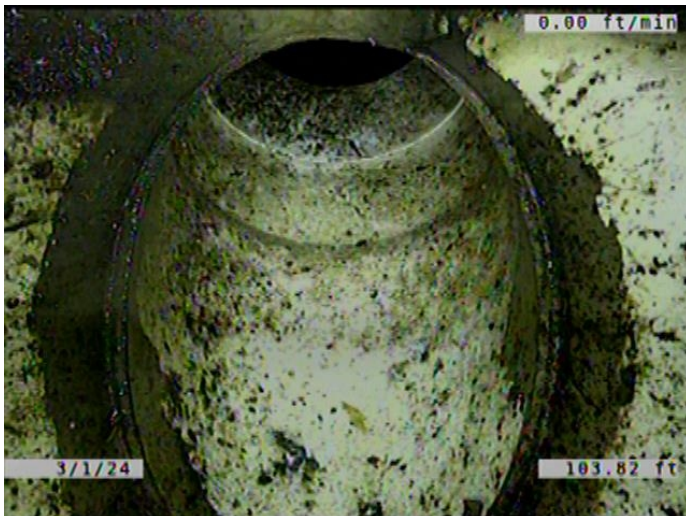
Code: **TF**
Description: **Tap Factory**

Distance (ft): **103.8**
Structural Grade: **0**
O&M Grade: **0**
Clock Start/From: **12**
Clock To:
1st Value: **6.000**
2nd Value:
Value Percent:
Continuous Index:
Within 8" of Joint: **YES**
Remarks: **CONSTANTLY RUNNING WATER.**

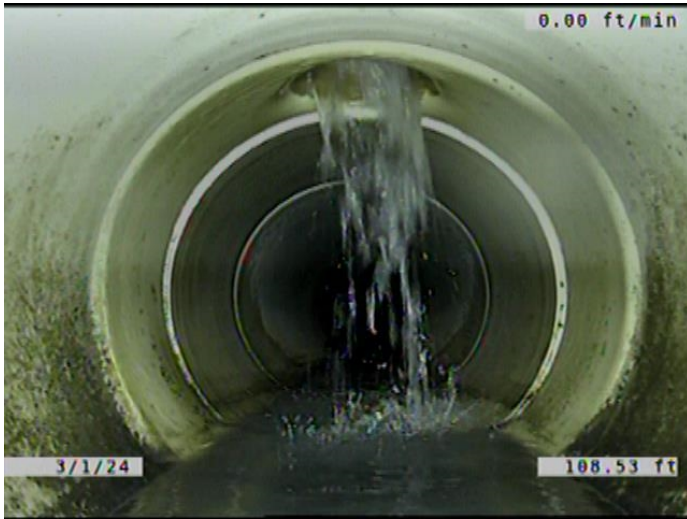
Code:	TFA
Description:	Tap Factory Activity
Distance (ft):	108.5
Structural Grade:	0
O&M Grade:	0
Clock Start/From:	12
Clock To:	
1st Value:	6.000
2nd Value:	
Value Percent:	
Continuous Index:	
Within 8" of Joint:	YES
Remarks:	A LARGE AMOUNT OF WATER HAS BEEN RUNNING FOR OVER 30 MINU

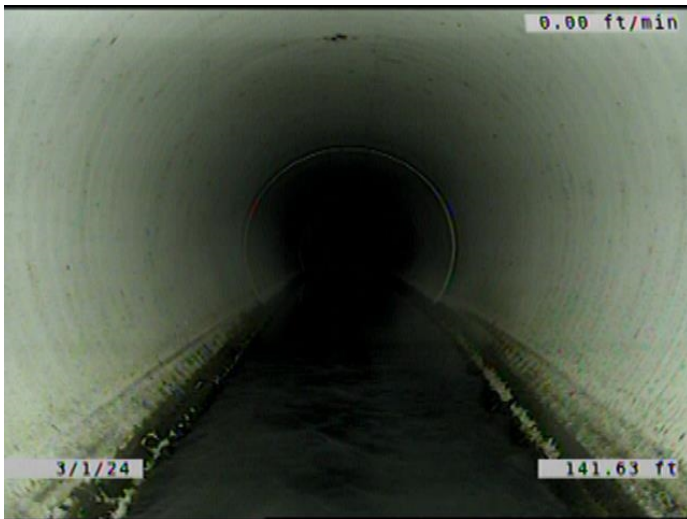
Code:	MWLS
Description:	Miscellaneous Water Level Sag
Distance (ft):	141.6
Structural Grade:	2
O&M Grade:	0
Clock Start/From:	
Clock To:	
1st Value:	
2nd Value:	
Value Percent:	15.000
Continuous Index:	S02
Within 8" of Joint:	NO
Remarks:

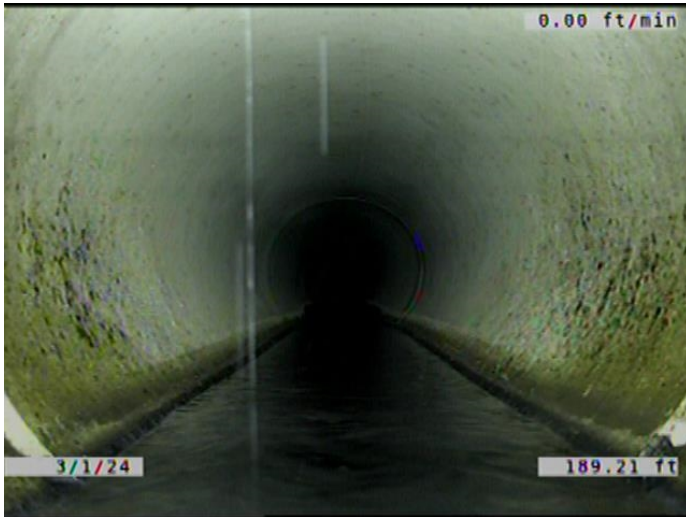
Code: **MWLS**
Description: **Miscellaneous Water Level Sag**

Distance (ft): **189.2**
Structural Grade: **2**
O&M Grade: **0**
Clock Start/From:
Clock To:
1st Value:
2nd Value:
Value Percent: **15.000**
Continuous Index: **F02**
Within 8" of Joint: **NO**
Remarks:

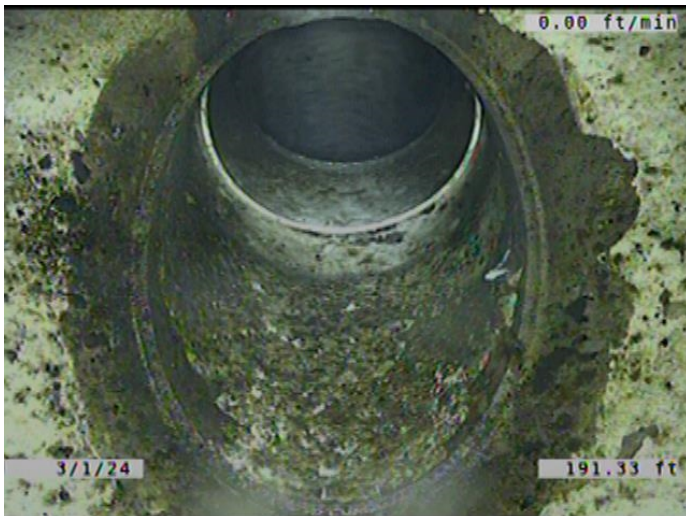
Code: **TF**
Description: **Tap Factory**

Distance (ft): **191.3**
Structural Grade: **0**
O&M Grade: **0**
Clock Start/From: **12**
Clock To:
1st Value: **6.000**
2nd Value:
Value Percent:
Continuous Index:
Within 8" of Joint: **YES**
Remarks: **CONSTANTLY RUNNING WATER.**

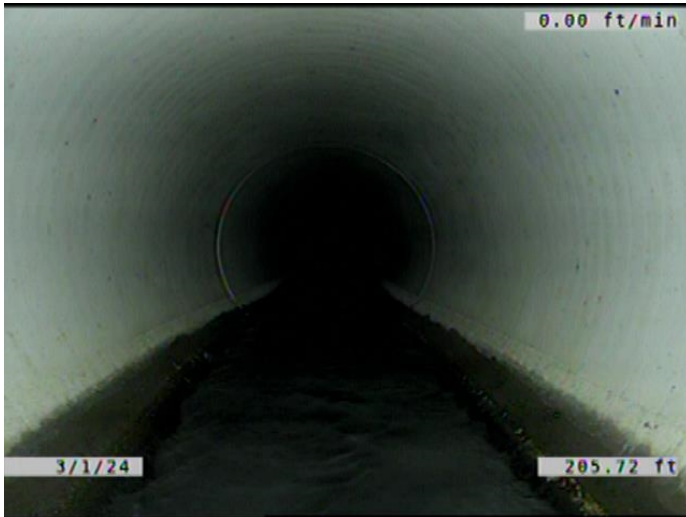
Code: **MWLS**
Description: **Miscellaneous Water Level Sag**

Distance (ft): **205.7**
Structural Grade: **2**
O&M Grade: **0**
Clock Start/From:
Clock To:
1st Value:
2nd Value:
Value Percent: **15.000**
Continuous Index: **S03**
Within 8" of Joint: **NO**
Remarks:

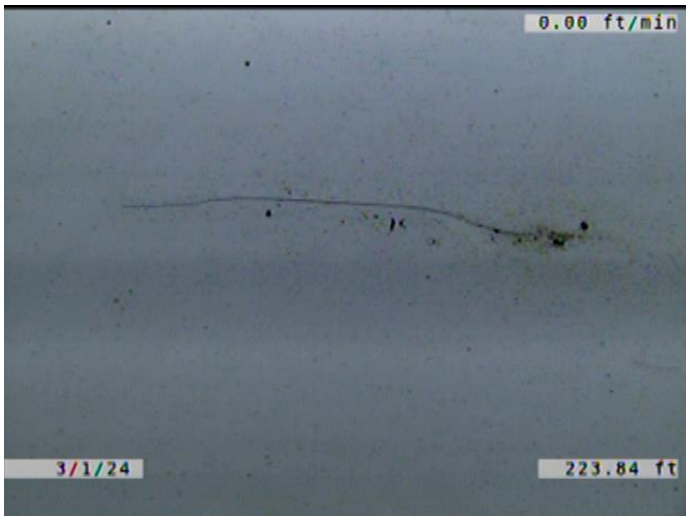
Code: **CC**
Description: **Crack Circumferential**

Distance (ft): **223.8**
Structural Grade: **1**
O&M Grade: **0**
Clock Start/From: **1**
Clock To: **2**
1st Value:
2nd Value:
Value Percent:
Continuous Index:
Within 8" of Joint: **NO**
Remarks:

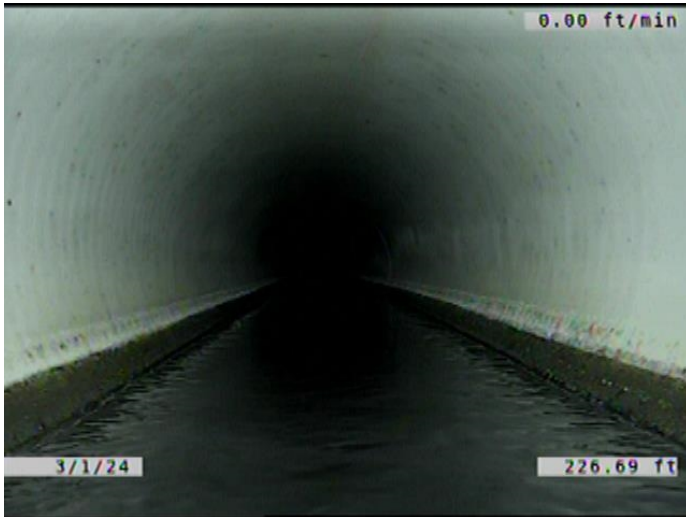
Code: **LL**
Description: **Line Left**

Distance (ft): **226.7**
Structural Grade: **0**
O&M Grade: **1**
Clock Start/From:
Clock To:
1st Value:
2nd Value:
Value Percent: **5.000**
Continuous Index:
Within 8" of Joint: **NO**
Remarks:

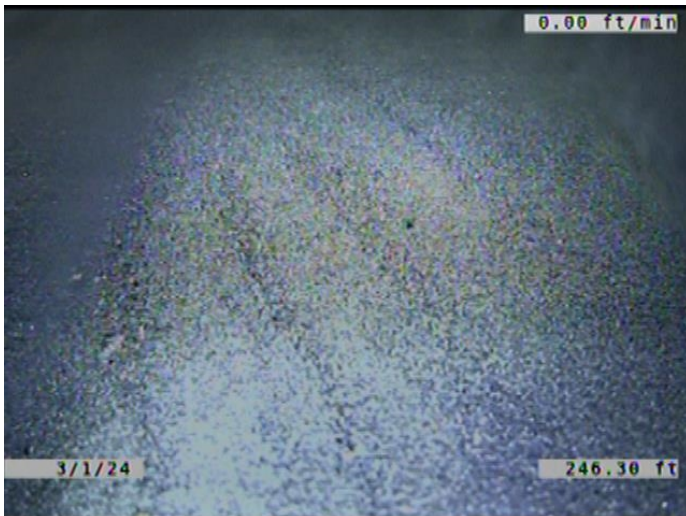
Code: **DSF**
Description: **Deposits Settled Fine**

Distance (ft): **246.0**
Structural Grade: **0**
O&M Grade: **2**
Clock Start/From: **5**
Clock To: **7**
1st Value:
2nd Value:
Value Percent: **5.000**
Continuous Index: **S04**
Within 8" of Joint: **YES**
Remarks:

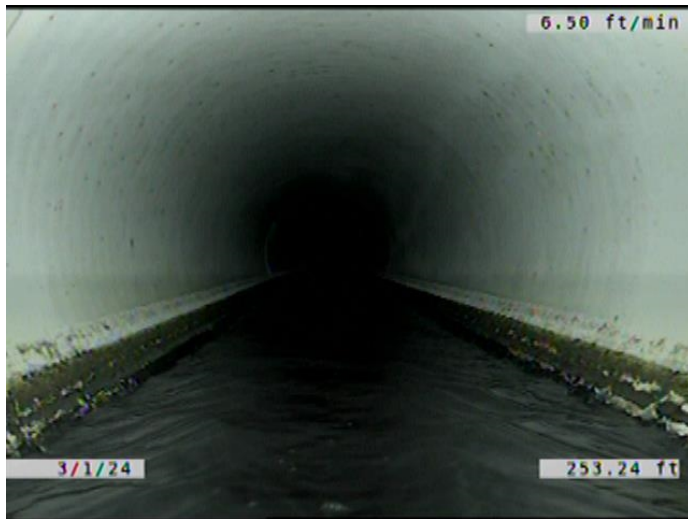
Code: **MWLS**
Description: **Miscellaneous Water Level Sag**

Distance (ft): **252.8**
Structural Grade: **2**
O&M Grade: **0**
Clock Start/From:
Clock To:
1st Value:
2nd Value:
Value Percent: **15.000**
Continuous Index: **F03**
Within 8" of Joint: **NO**
Remarks:

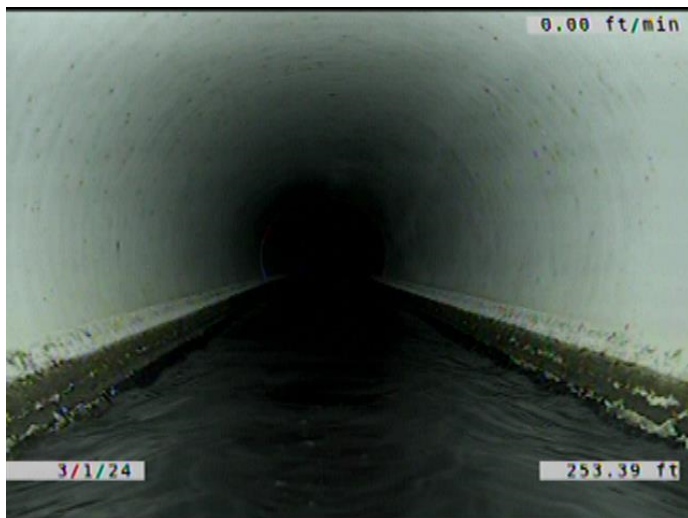
Code: **LL**
Description: **Line Left**

Distance (ft): **253.4**
Structural Grade: **0**
O&M Grade: **1**
Clock Start/From:
Clock To:
1st Value:
2nd Value:
Value Percent: **5.000**
Continuous Index:
Within 8" of Joint: **NO**
Remarks:

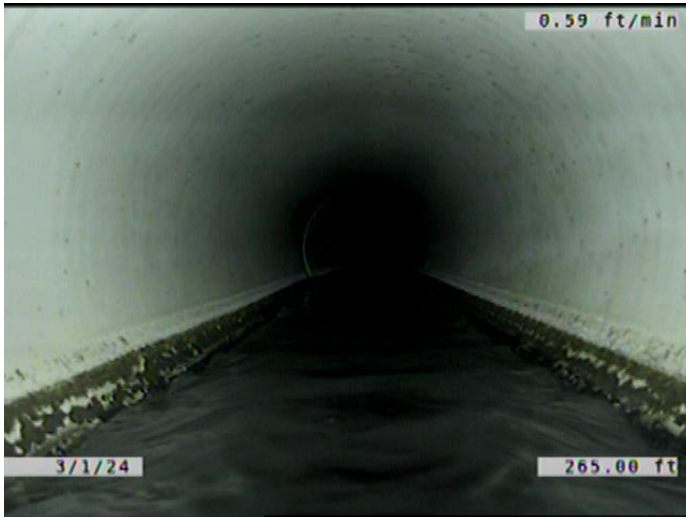
Code: **LR**
Description: **Line Right**

Distance (ft): **264.9**
Structural Grade: **0**
O&M Grade: **1**
Clock Start/From:
Clock To:
1st Value:
2nd Value:
Value Percent: **5.000**
Continuous Index:
Within 8" of Joint: **NO**
Remarks:

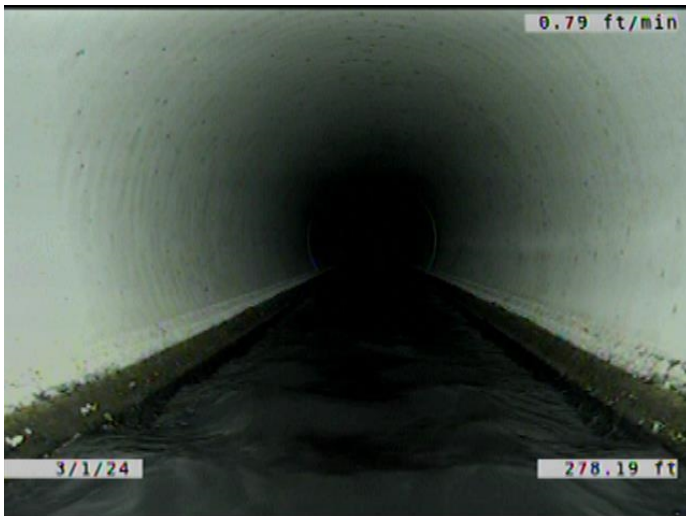
Code: **LR**
Description: **Line Right**

Distance (ft): **278.0**
Structural Grade: **0**
O&M Grade: **1**
Clock Start/From:
Clock To:
1st Value:
2nd Value:
Value Percent: **5.000**
Continuous Index:
Within 8" of Joint: **NO**
Remarks:

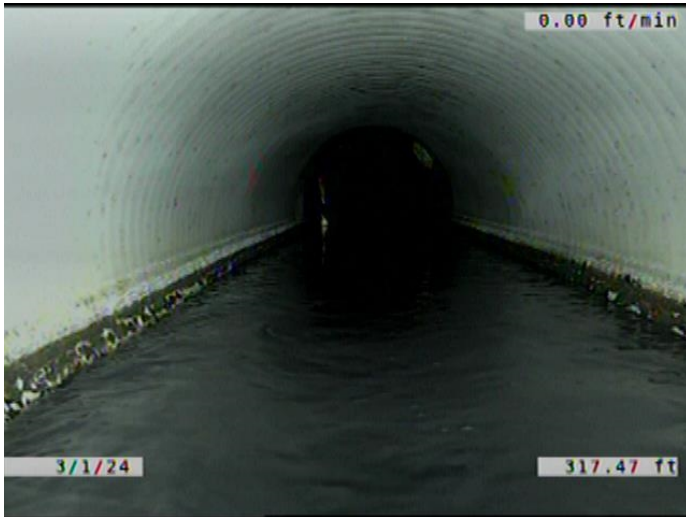
Code: **MWLS**
Description: **Miscellaneous Water Level Sag**

Distance (ft): **317.5**
Structural Grade: **2**
O&M Grade: **0**
Clock Start/From:
Clock To:
1st Value:
2nd Value:
Value Percent: **20.000**
Continuous Index: **S05**
Within 8" of Joint: **NO**
Remarks:

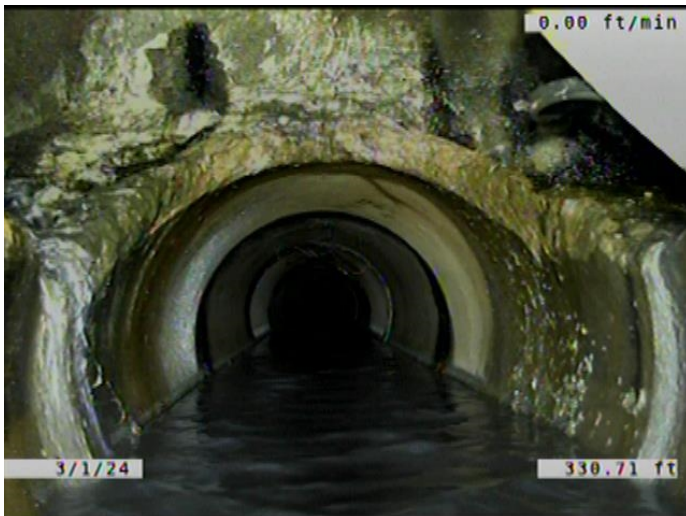
Code: **MWLS**
Description: **Miscellaneous Water Level Sag**

Distance (ft): **330.7**
Structural Grade: **2**
O&M Grade: **0**
Clock Start/From:
Clock To:
1st Value:
2nd Value:
Value Percent: **20.000**
Continuous Index: **F05**
Within 8" of Joint: **NO**
Remarks:

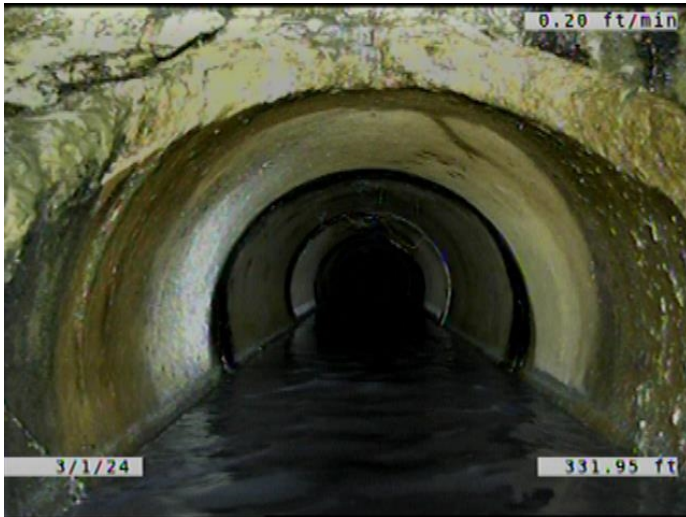
Code: **DSF**
 Description: **Deposits Settled Fine**

Distance (ft): **331.9**
 Structural Grade: **0**
 O&M Grade: **2**
 Clock Start/From: **5**
 Clock To: **7**
 1st Value:
 2nd Value:
 Value Percent: **5.000**
 Continuous Index: **F04**
 Within 8" of Joint: **YES**
 Remarks:
