Profile/Photo Observation Report

Date:	04/21/2018	Weather:		Coding:	PACP 6.0
Pipe Length (ft):	194.5	Owner:	NA	Pre Clean:	Not Known
P.O.#:		Surveyor:	Jen Costello	PSR:	P-805-026-027
Customer:		Clean Date:	01/01/1900	Shape:	C

Street:	E 5TH ST	Flow Control:	Not Controlled
City:	Hobart, IN	Year Renewed:	
Location:	Alley	Tape/Media #:	
Purpose:	Maintenance Related	Dia/Height:	10"
Use:	Sanitary	Material:	VCP
Drain Area:	NA	Lining:	Cured in Place
Category:	NA		
Comment:	debris at 12'.-flow reversed.		
Location Details:		Direction of Survey:	Upstream
US MH:	M-805-027	DS MH:	M-805-026
		Total Length Surveyed (ft):	13.4

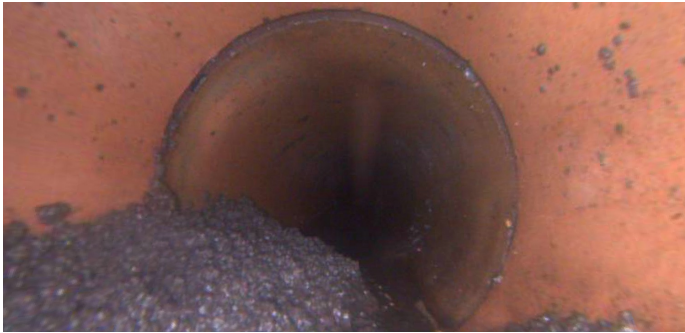
Code:	MWL
Description:	Water Level

Distance (ft):	.0
Structural Grade:	0
O&M Grade:	0
Clock Start/From:	
Clock To:	
1st Value:	
2nd Value:	
Value Percent:	5.000
Continuous Index:	
Within 8" of Joint:	NO
Remarks:

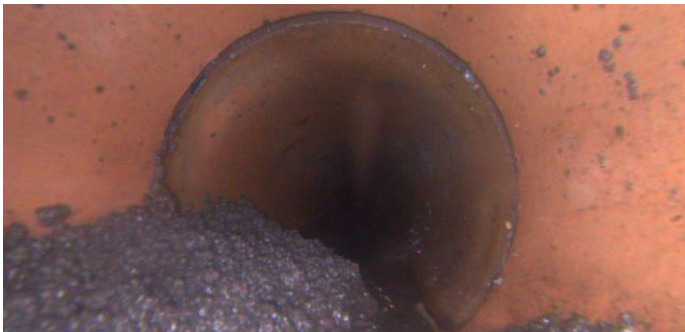
Code:	DSF
Description:	Deposits Settled Fine

Distance (ft):	.0
Structural Grade:	0
O&M Grade:	3
Clock Start/From:	6
Clock To:	9
1st Value:	
2nd Value:	
Value Percent:	20.000
Continuous Index:	
Within 8" of Joint:	YES
Remarks:

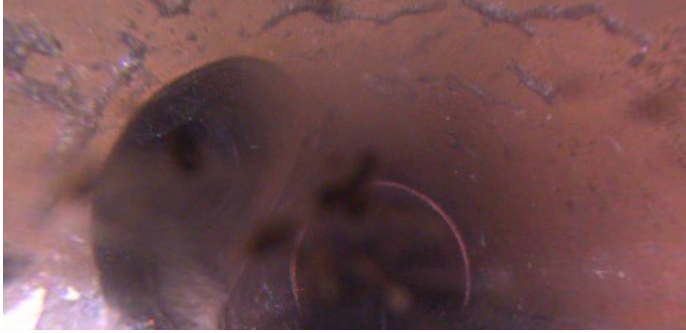
Code: **TF**
Description: **Tap Factory**

Distance (ft): **7.1**
Structural Grade: **0**
O&M Grade: **0**
Clock Start/From: **2**
Clock To:
1st Value: **4.000**
2nd Value:
Value Percent:
Continuous Index:
Within 8" of Joint:
Remarks:

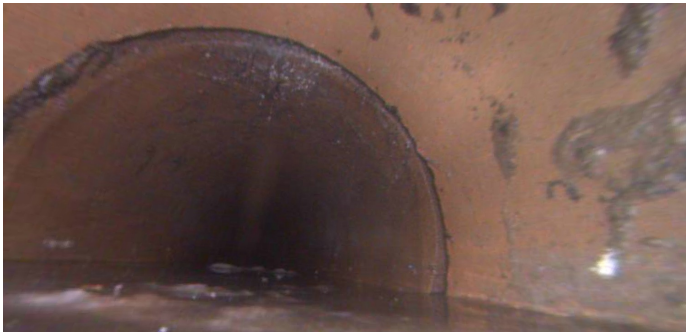
Code: **MWL**
Description: **Water Level**

Distance (ft): **7.1**
Structural Grade: **0**
O&M Grade: **0**
Clock Start/From:
Clock To:
1st Value:
2nd Value:
Value Percent: **40.000**
Continuous Index:
Within 8" of Joint: **NO**
Remarks:

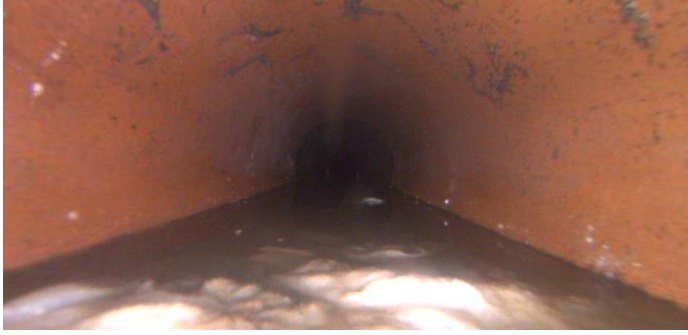
Code:	MSA
Description:	Abandoned Survey
Distance (ft):	13.4
Structural Grade:	0
O&M Grade:	0
Clock Start/From:	
Clock To:	
1st Value:	
2nd Value:	
Value Percent:	
Continuous Index:	
Within 8" of Joint:	NO
Remarks:	debris under water
