Profile/Photo Observation Report

Date:	04/21/2018	Weather:		Coding:	PACP 6.0
Pipe Length (ft):	194.5	Owner:	NA	Pre Clean:	Not Known
P.O.#:		Surveyor:	Jen Costello	PSR:	P-805-026-027
Customer:		Clean Date:	01/01/1900	Shape:	C

Street:	Capitol	Flow Control:	Not Controlled
City:	Hobart, IN	Year Renewed:	
Location:	Alley	Tape/Media #:	
Purpose:	Maintenance Related	Dia/Height:	10"
Use:	Sanitary	Material:	VCP
Drain Area:	NA	Lining:	Cured in Place
Category:	NA		
Comment:	debris at 12'. -flow reversed.		
Location Details:		Direction of Survey:	Upstream
US MH:	M-805-027	DS MH:	M-805-026
		Total Length Surveyed (ft):	13.4

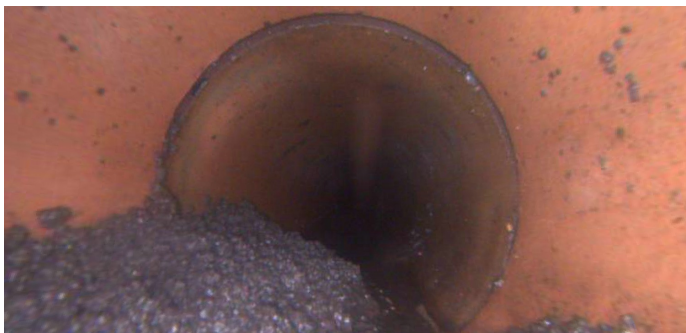
Code: **AMH**
Description: **Manhole**

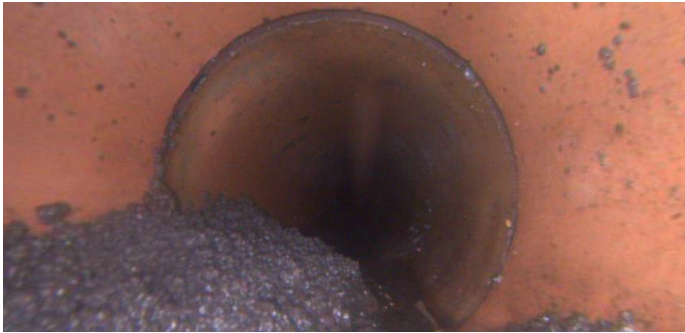
Code:	MWL
Description:	Water Level

Distance (ft):	.0
Structural Grade:	0
O&M Grade:	0
Clock Start/From:	
Clock To:	
1st Value:	
2nd Value:	
Value Percent:	5.000
Continuous Index:	
Within 8" of Joint:	NO
Remarks:

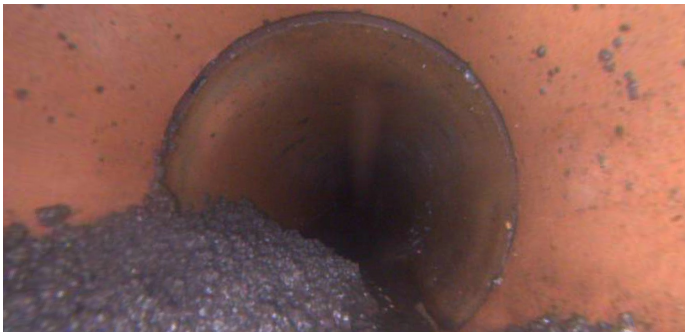
Code:	DSF
Description:	Deposits Settled Fine

Distance (ft):	.0
Structural Grade:	0
O&M Grade:	3
Clock Start/From:	6
Clock To:	9
1st Value:	
2nd Value:	
Value Percent:	20.000
Continuous Index:	
Within 8" of Joint:	YES
Remarks:

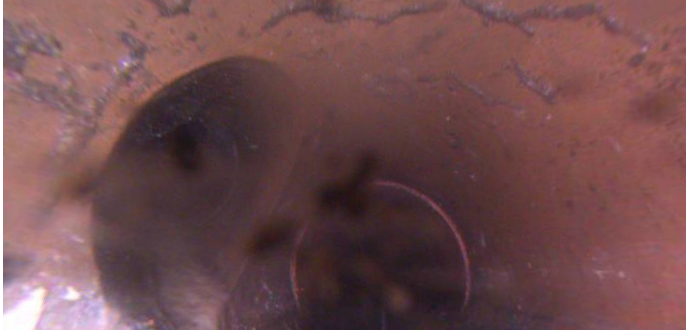
Code: **TF**
Description: **Tap Factory**

Distance (ft): **7.1**
Structural Grade: **0**
O&M Grade: **0**
Clock Start/From: **2**
Clock To:
1st Value: **4.000**
2nd Value:
Value Percent:
Continuous Index:
Within 8" of Joint:
Remarks:

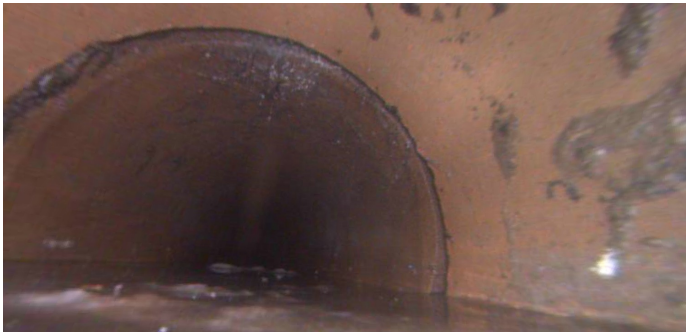
Code: **MWL**
Description: **Water Level**

Distance (ft): **7.1**
Structural Grade: **0**
O&M Grade: **0**
Clock Start/From:
Clock To:
1st Value:
2nd Value:
Value Percent: **40.000**
Continuous Index:
Within 8" of Joint: **NO**
Remarks:

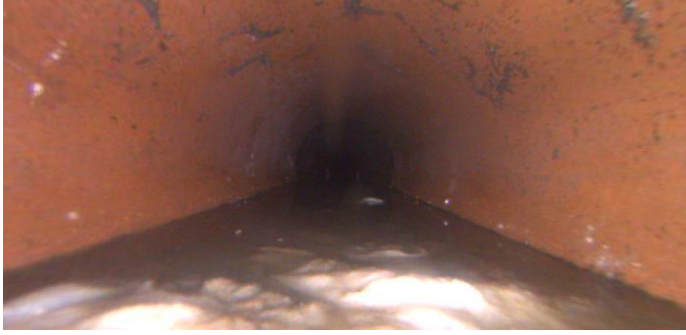
Code:	MSA
Description:	Abandoned Survey
Distance (ft):	13.4
Structural Grade:	0
O&M Grade:	0
Clock Start/From:	
Clock To:	
1st Value:	
2nd Value:	
Value Percent:	
Continuous Index:	
Within 8" of Joint:	NO
Remarks:	debris under water
