Profile/Photo Observation Report

Date:	09/14/2022	Weather:		Coding:	PACP 7.0
Pipe Length (ft):	194.0	Owner:	City of Hobart	Pre Clean:	Heavy Cleaning
P.O.#:	YES502259	Surveyor:	S. Bucklin	PSR:	P-805-026-027
Customer:	City of Hobart	Clean Date:	09/01/2022	Shape:	C

Street:	South Ohio Street	Flow Control:	Not Controlled
City:	Hobart, IN	Year Renewed:	
Location:	Alley	Tape/Media #:	
Purpose:	Routine Assessment	Dia/Height:	10"
Use:	Sanitary Sewage Pipe	Material:	VCP
Drain Area:		Lining:	None
Category:	NA		
Comment:

Location Details:		Direction of Survey:	Downstream
US MH:	M-805-027	DS MH:	M-805-026
		Total Length Surveyed (ft):	199.8

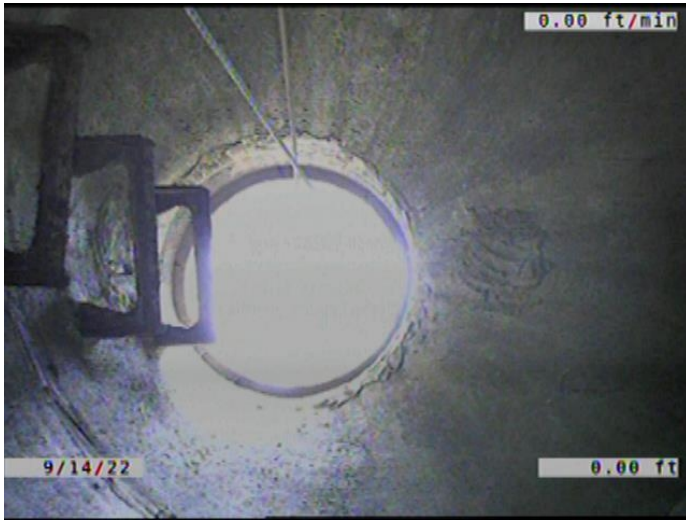
Code: **AMH**
Description: **Manhole**

Distance (ft): **.0**
Structural Grade: **0**
O&M Grade: **0**
Clock Start/From:
Clock To:
1st Value:
2nd Value:
Value Percent:
Continuous Index:
Within 8" of Joint: **NO**
Remarks: **M-805-027**

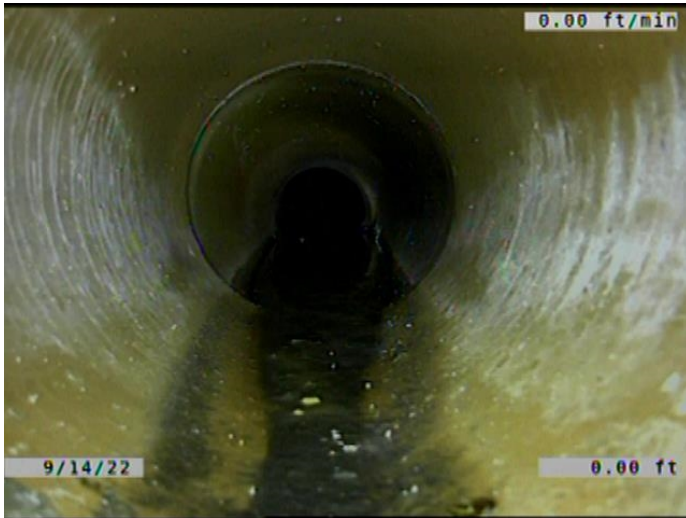
Code: **MWL**
Description: **Miscellaneous Water Level**

Distance (ft): **.0**
Structural Grade: **0**
O&M Grade: **0**
Clock Start/From:
Clock To:
1st Value:
2nd Value:
Value Percent: **5.000**
Continuous Index:
Within 8" of Joint: **NO**
Remarks:

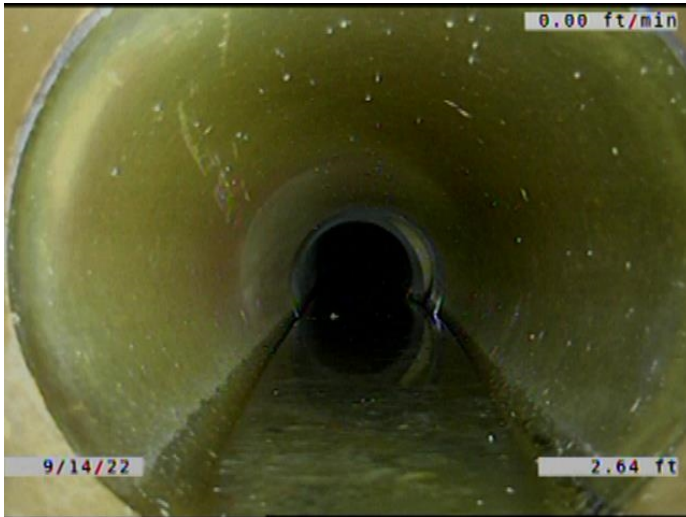
Code: **DSF**
Description: **Deposits Settled Fine**

Distance (ft): **2.6**
Structural Grade: **0**
O&M Grade: **2**
Clock Start/From: **5**
Clock To: **7**
1st Value:
2nd Value:
Value Percent: **5.000**
Continuous Index: **S01**
Within 8" of Joint: **YES**
Remarks:

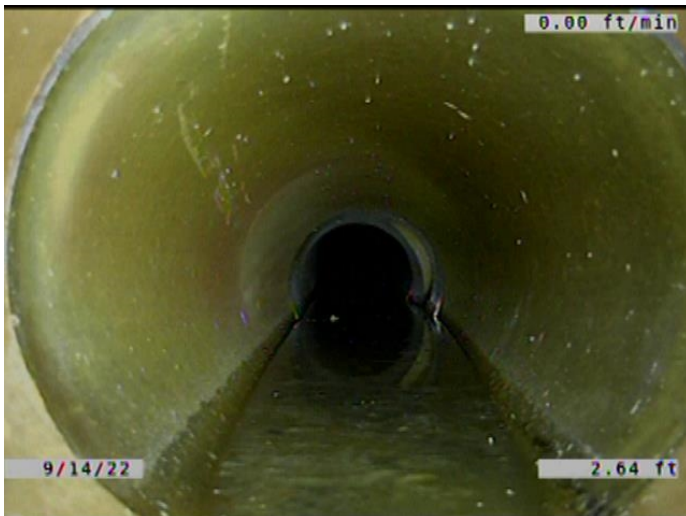
Code: **MWLS**
Description: **Miscellaneous Water Level Sag**

Distance (ft): **2.6**
Structural Grade: **2**
O&M Grade: **0**
Clock Start/From:
Clock To:
1st Value:
2nd Value:
Value Percent: **15.000**
Continuous Index: **S02**
Within 8" of Joint: **NO**
Remarks:

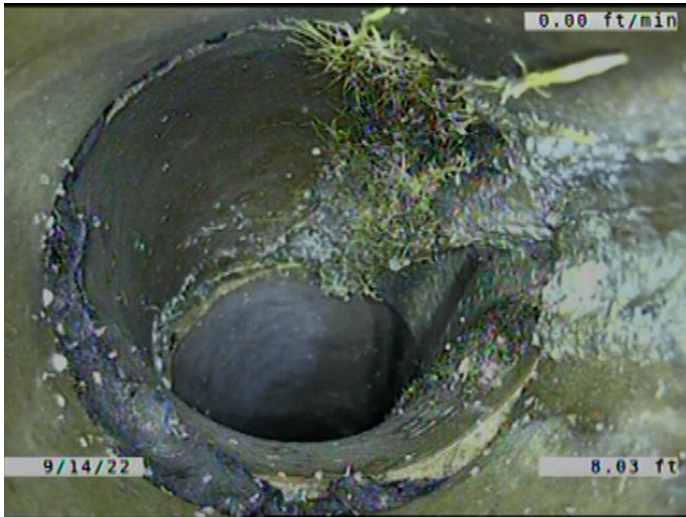
Code: **TF**
Description: **Tap Factory**

Distance (ft): **8.0**
Structural Grade: **0**
O&M Grade: **0**
Clock Start/From: **2**
Clock To:
1st Value: **6.000**
2nd Value:
Value Percent:
Continuous Index:
Within 8" of Joint: **YES**
Remarks: **ROOTS GROWING IN THE JOINTS.**

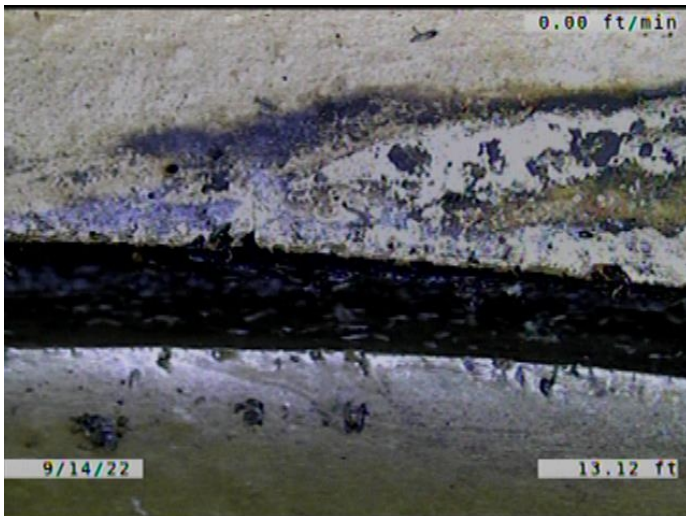
Code: **ISJ**
Description: **Infiltration Stain Joint**

Distance (ft): **13.1**
Structural Grade: **0**
O&M Grade: **1**
Clock Start/From: **1**
Clock To: **4**
1st Value:
2nd Value:
Value Percent:
Continuous Index:
Within 8" of Joint: **YES**
Remarks:

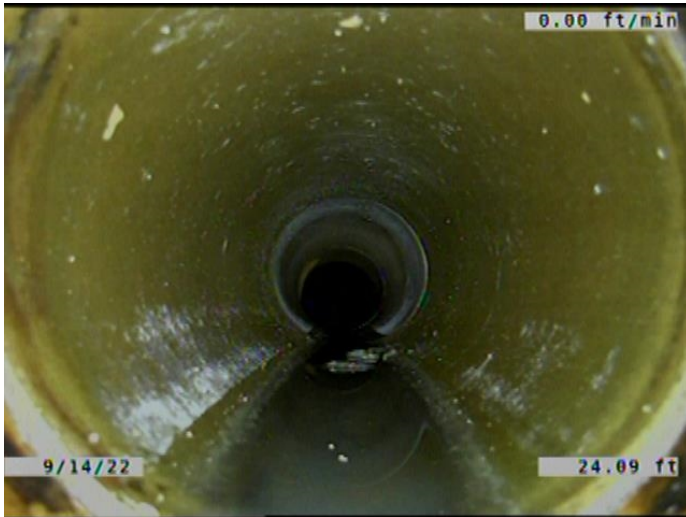
Code: **MWLS**
 Description: **Miscellaneous Water Level Sag**

Distance (ft): **24.1**
 Structural Grade: **2**
 O&M Grade: **0**
 Clock Start/From:
 Clock To:
 1st Value:
 2nd Value:
 Value Percent: **15.000**
 Continuous Index: **F02**
 Within 8" of Joint: **NO**
 Remarks:

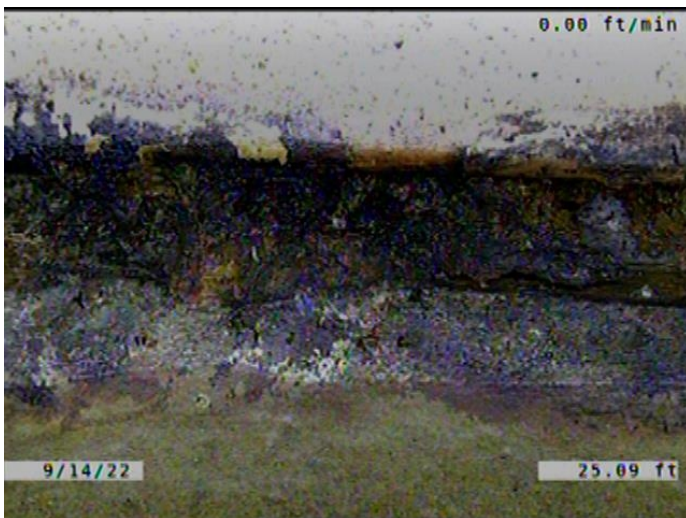
Code: **ISJ**
 Description: **Infiltration Stain Joint**

Distance (ft): **25.1**
 Structural Grade: **0**
 O&M Grade: **1**
 Clock Start/From: **8**
 Clock To: **4**
 1st Value:
 2nd Value:
 Value Percent:
 Continuous Index:
 Within 8" of Joint: **YES**
 Remarks:

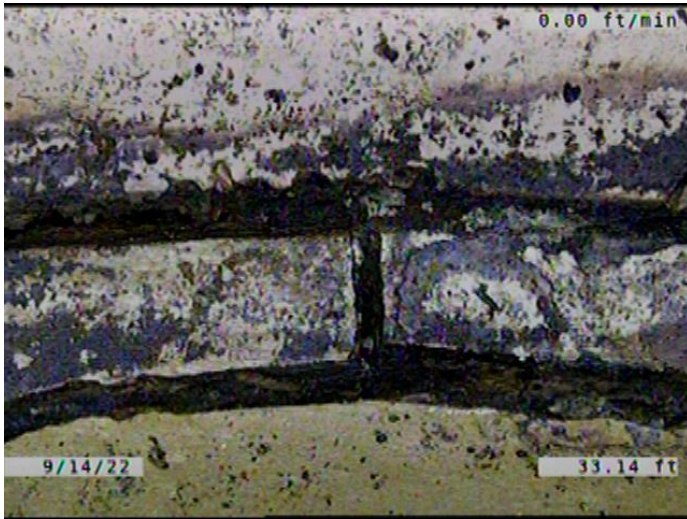
Code: **ISJ**
 Description: **Infiltration Stain Joint**

Distance (ft): **33.1**
 Structural Grade: **0**
 O&M Grade: **1**
 Clock Start/From: **7**
 Clock To: **5**
 1st Value:
 2nd Value:
 Value Percent:
 Continuous Index: **S04**
 Within 8" of Joint: **YES**
 Remarks:

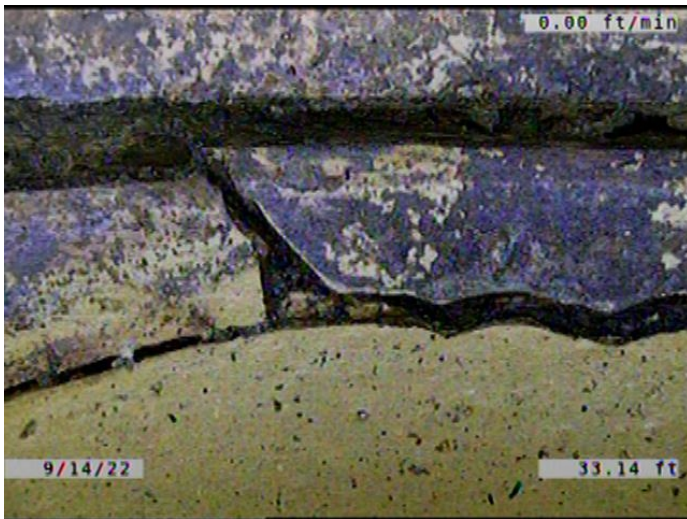
Code: **B**
 Description: **Broken**

Distance (ft): **33.1**
 Structural Grade: **4**
 O&M Grade: **0**
 Clock Start/From: **8**
 Clock To: **4**
 1st Value:
 2nd Value:
 Value Percent:
 Continuous Index:
 Within 8" of Joint: **YES**
 Remarks:

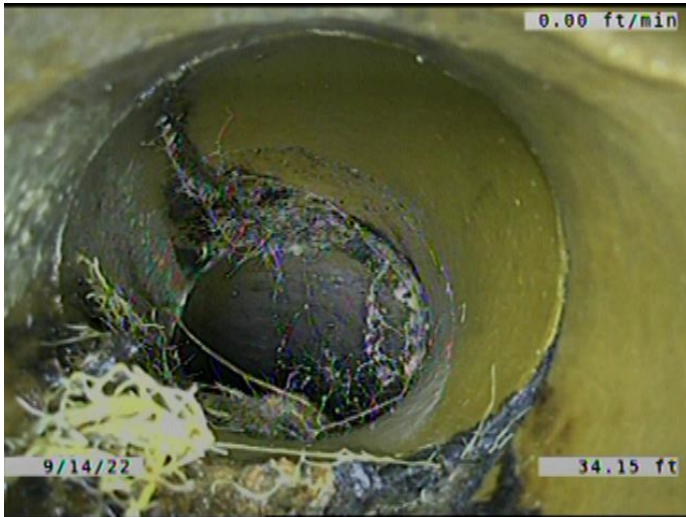
Code: **TF**
 Description: **Tap Factory**

Distance (ft): **34.2**
 Structural Grade: **0**
 O&M Grade: **0**
 Clock Start/From: **10**
 Clock To:
 1st Value: **6.000**
 2nd Value:
 Value Percent:
 Continuous Index:
 Within 8" of Joint: **YES**
 Remarks: **ENCrustATION AND ROOTS
 COMING FROM THE JOINT.**

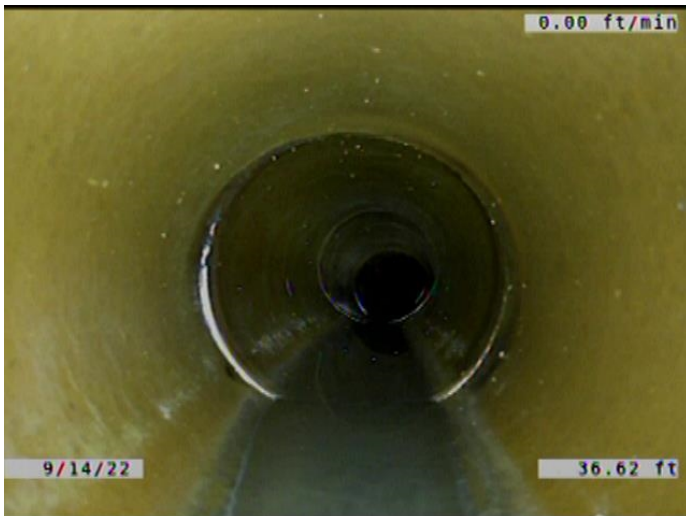
Code: **MWLS**
 Description: **Miscellaneous Water Level Sag**

Distance (ft): **36.6**
 Structural Grade: **2**
 O&M Grade: **0**
 Clock Start/From:
 Clock To:
 1st Value:
 2nd Value:
 Value Percent: **5.000**
 Continuous Index: **S03**
 Within 8" of Joint: **NO**
 Remarks:

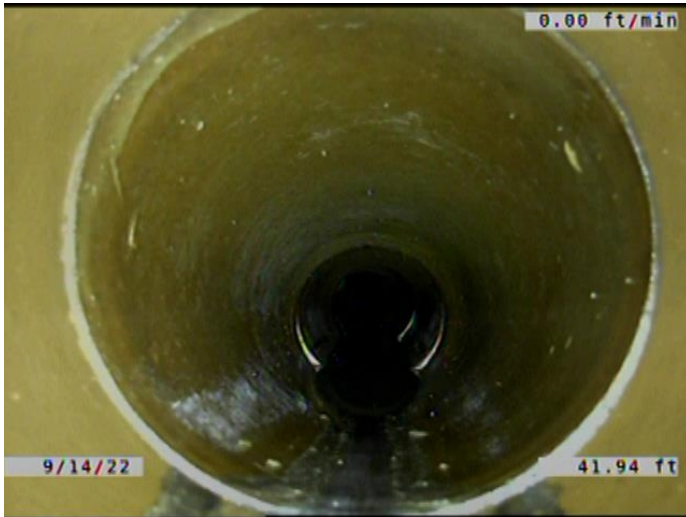
Code: **MWLS**
Description: **Miscellaneous Water Level Sag**

Distance (ft): **41.9**
Structural Grade: **2**
O&M Grade: **0**
Clock Start/From:
Clock To:
1st Value:
2nd Value:
Value Percent: **5.000**
Continuous Index: **F03**
Within 8" of Joint: **NO**
Remarks:

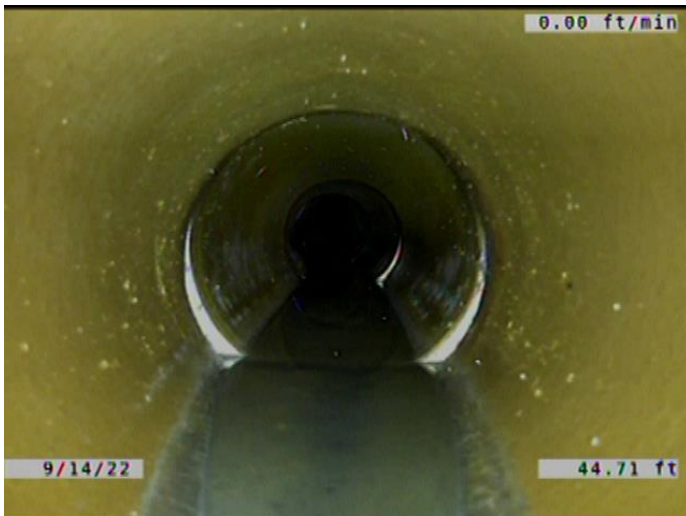
Code: **MWLS**
Description: **Miscellaneous Water Level Sag**

Distance (ft): **44.7**
Structural Grade: **2**
O&M Grade: **0**
Clock Start/From:
Clock To:
1st Value:
2nd Value:
Value Percent: **5.000**
Continuous Index: **S05**
Within 8" of Joint: **NO**
Remarks:

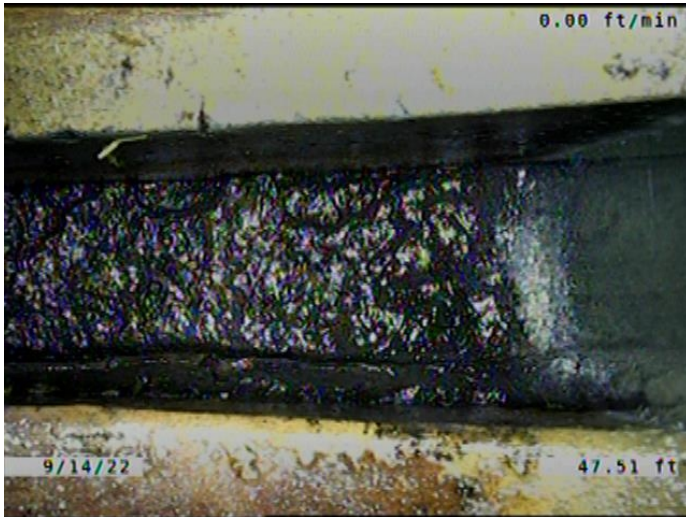
Code: **JAM**
 Description: **Joint Angular Medium**

Distance (ft): **47.5**
 Structural Grade: **3**
 O&M Grade: **0**
 Clock Start/From:
 Clock To:
 1st Value:
 2nd Value:
 Value Percent:
 Continuous Index:
 Within 8" of Joint: **NO**
 Remarks:

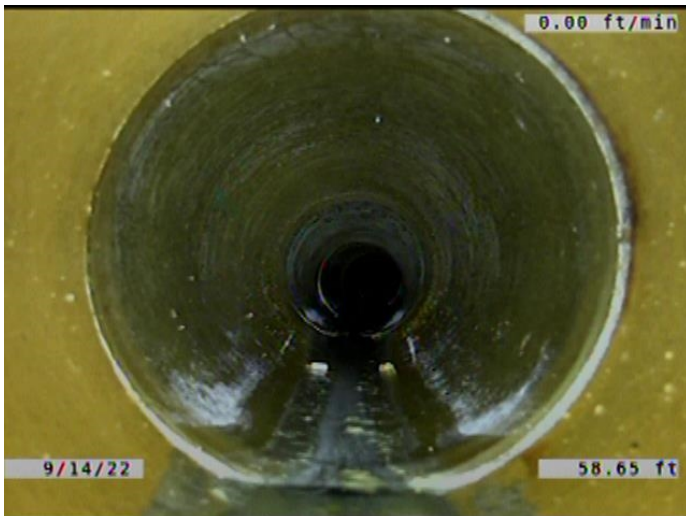
Code: **MWLS**
 Description: **Miscellaneous Water Level Sag**

Distance (ft): **58.6**
 Structural Grade: **2**
 O&M Grade: **0**
 Clock Start/From:
 Clock To:
 1st Value:
 2nd Value:
 Value Percent: **5.000**
 Continuous Index: **F05**
 Within 8" of Joint: **NO**
 Remarks:

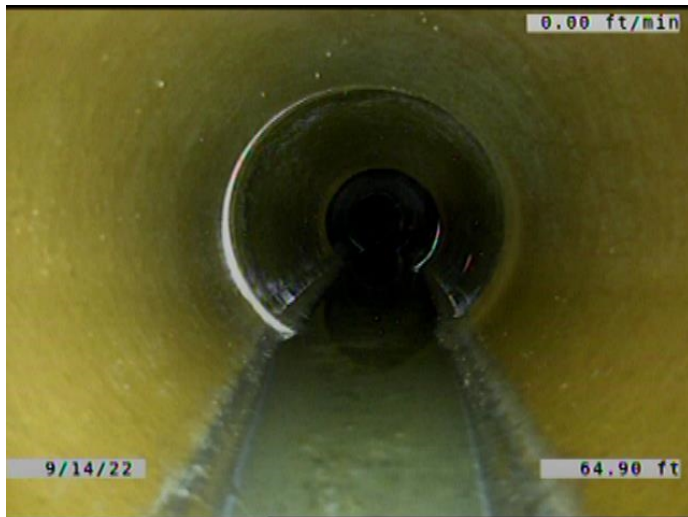
Code: **MWLS**
Description: **Miscellaneous Water Level Sag**

Distance (ft): **64.9**
Structural Grade: **2**
O&M Grade: **0**
Clock Start/From:
Clock To:
1st Value:
2nd Value:
Value Percent: **5.000**
Continuous Index: **S06**
Within 8" of Joint: **NO**
Remarks:

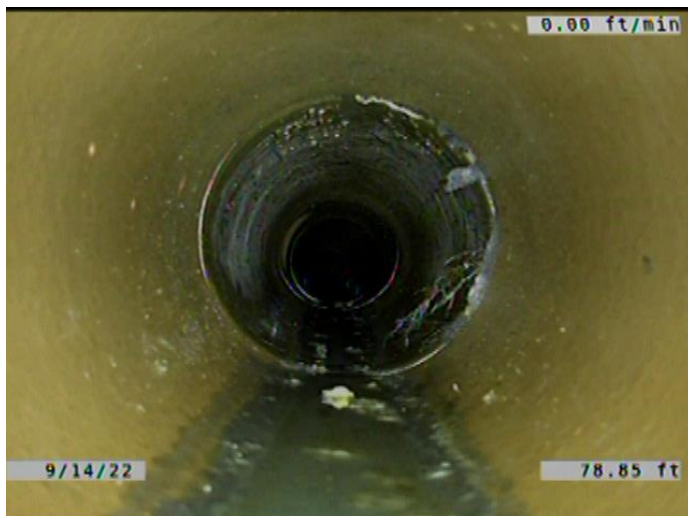
Code: **MWLS**
Description: **Miscellaneous Water Level Sag**

Distance (ft): **78.8**
Structural Grade: **2**
O&M Grade: **0**
Clock Start/From:
Clock To:
1st Value:
2nd Value:
Value Percent: **5.000**
Continuous Index: **F06**
Within 8" of Joint: **NO**
Remarks:

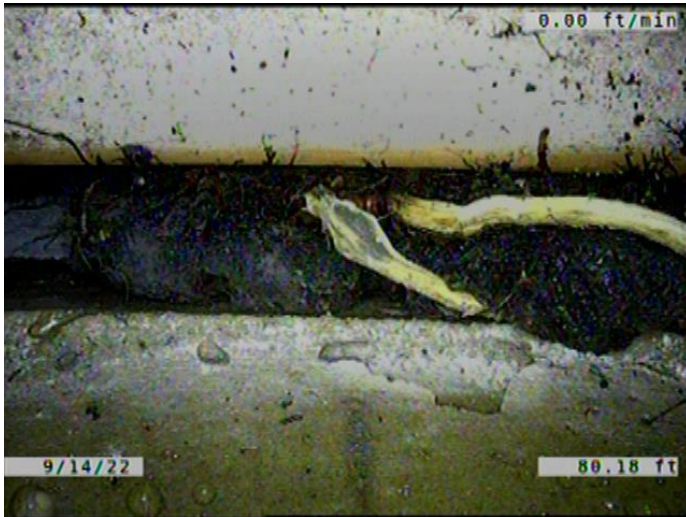
Code: **RFJ**
 Description: **Roots Fine Joint**

Distance (ft): **80.2**
 Structural Grade: **0**
 O&M Grade: **1**
 Clock Start/From: **11**
 Clock To: **4**
 1st Value:
 2nd Value:
 Value Percent:
 Continuous Index:
 Within 8" of Joint: **YES**
 Remarks:

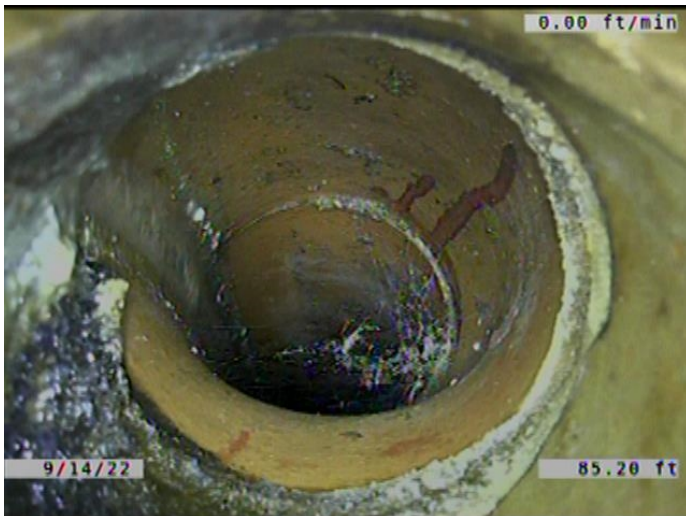
Code: **TF**
 Description: **Tap Factory**

Distance (ft): **85.2**
 Structural Grade: **0**
 O&M Grade: **0**
 Clock Start/From: **10**
 Clock To:
 1st Value: **6.000**
 2nd Value:
 Value Percent:
 Continuous Index:
 Within 8" of Joint: **YES**
 Remarks: **ENCrustATION AND ROOTS
 COMING FROM THE JOINT. CONSTA**

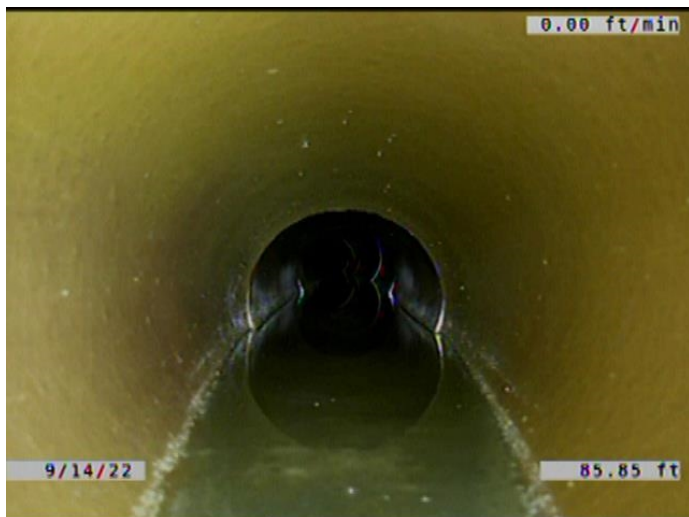
Code: **MWLS**
 Description: **Miscellaneous Water Level Sag**

Distance (ft): **85.9**
 Structural Grade: **2**
 O&M Grade: **0**
 Clock Start/From:
 Clock To:
 1st Value:
 2nd Value:
 Value Percent: **20.000**
 Continuous Index: **S07**
 Within 8" of Joint: **NO**
 Remarks:

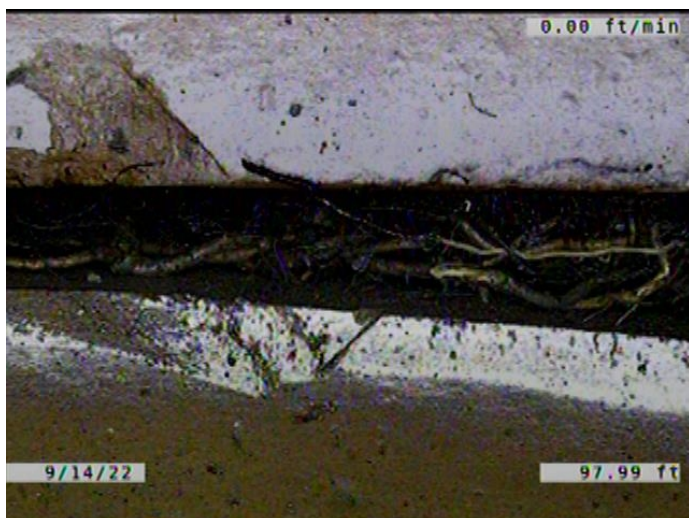
Code: **RFJ**
 Description: **Roots Fine Joint**

Distance (ft): **98.0**
 Structural Grade: **0**
 O&M Grade: **1**
 Clock Start/From: **9**
 Clock To: **3**
 1st Value:
 2nd Value:
 Value Percent:
 Continuous Index:
 Within 8" of Joint: **YES**
 Remarks:

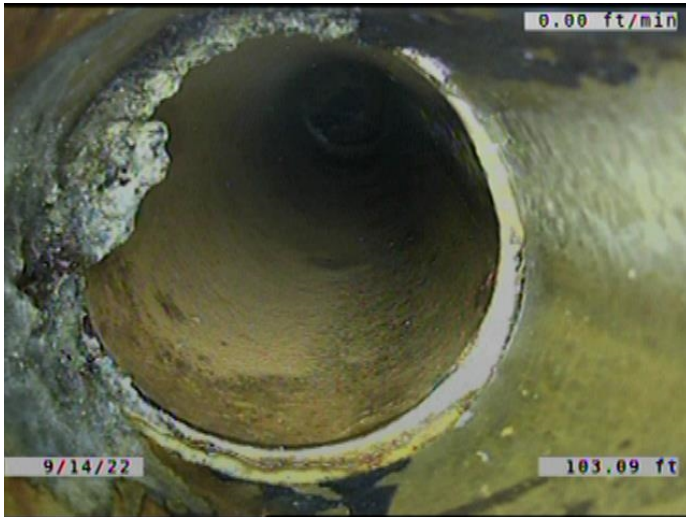
Code:	TF
Description:	Tap Factory
Distance (ft):	103.1
Structural Grade:	0
O&M Grade:	0
Clock Start/From:	2
Clock To:	
1st Value:	6.000
2nd Value:	
Value Percent:	
Continuous Index:	
Within 8" of Joint:	YES
Remarks:	ENCRUSTATION COMING FROM THE JOINT.

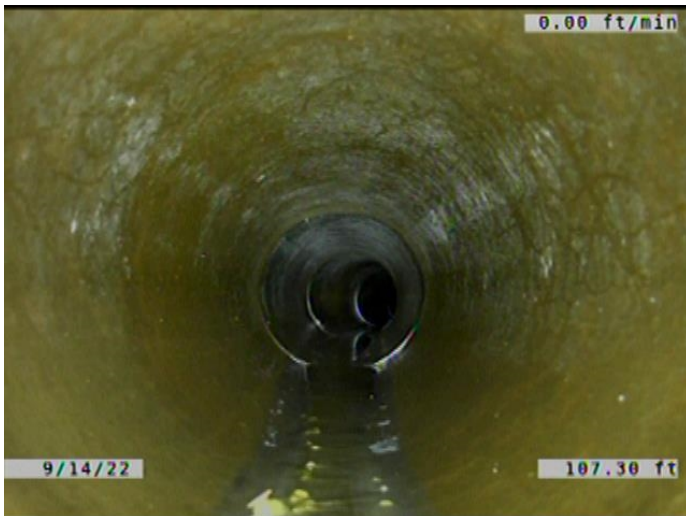
Code:	MWLS
Description:	Miscellaneous Water Level Sag
Distance (ft):	107.3
Structural Grade:	2
O&M Grade:	0
Clock Start/From:	
Clock To:	
1st Value:	
2nd Value:	
Value Percent:	20.000
Continuous Index:	F07
Within 8" of Joint:	NO
Remarks:

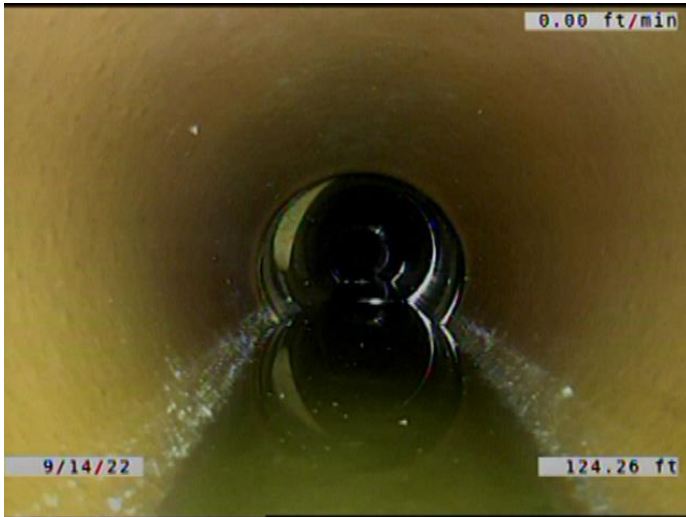
Code: **MWLS**
Description: **Miscellaneous Water Level Sag**

Distance (ft): **124.3**
Structural Grade: **2**
O&M Grade: **0**
Clock Start/From:
Clock To:
1st Value:
2nd Value:
Value Percent: **15.000**
Continuous Index: **S08**
Within 8" of Joint: **NO**
Remarks:

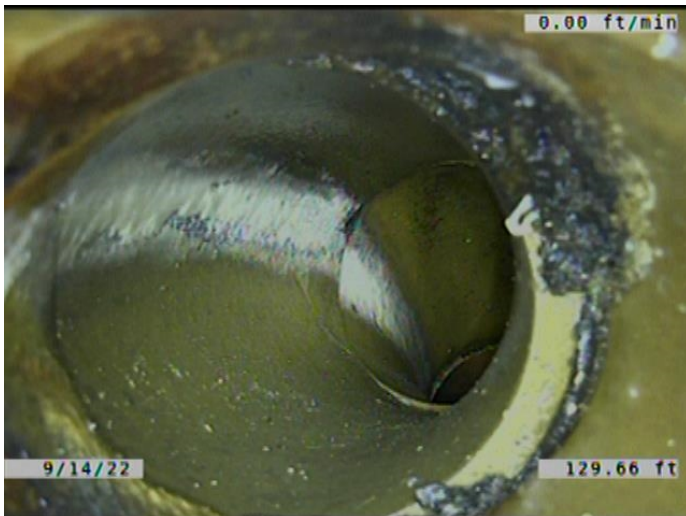
Code: **TF**
Description: **Tap Factory**

Distance (ft): **129.7**
Structural Grade: **0**
O&M Grade: **0**
Clock Start/From: **10**
Clock To:
1st Value: **6.000**
2nd Value:
Value Percent:
Continuous Index:
Within 8" of Joint: **YES**
Remarks: **ENCRUSTATION COMING FROM THE JOINT.**

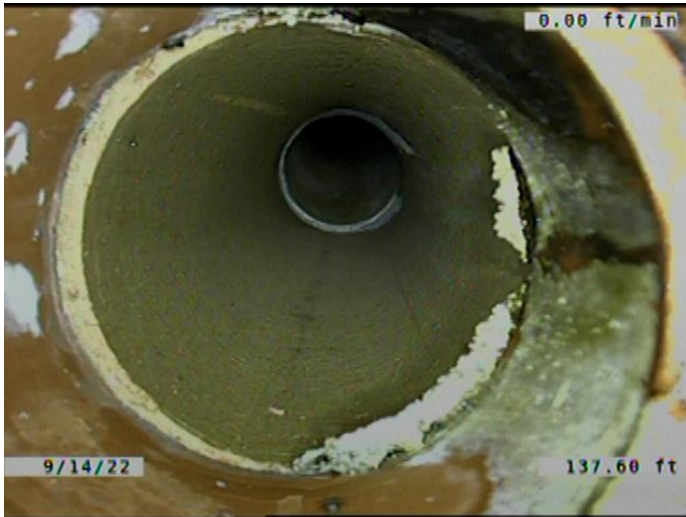
Code:	TBI
Description:	Tap Break-in Intruding
Distance (ft):	137.6
Structural Grade:	0
O&M Grade:	2
Clock Start/From:	1
Clock To:	
1st Value:	6.000
2nd Value:	1.000
Value Percent:	
Continuous Index:	
Within 8" of Joint:	YES
Remarks:	ENCRUSTATION COMING FROM THE JOINT AND AROUND THE SERVICE T

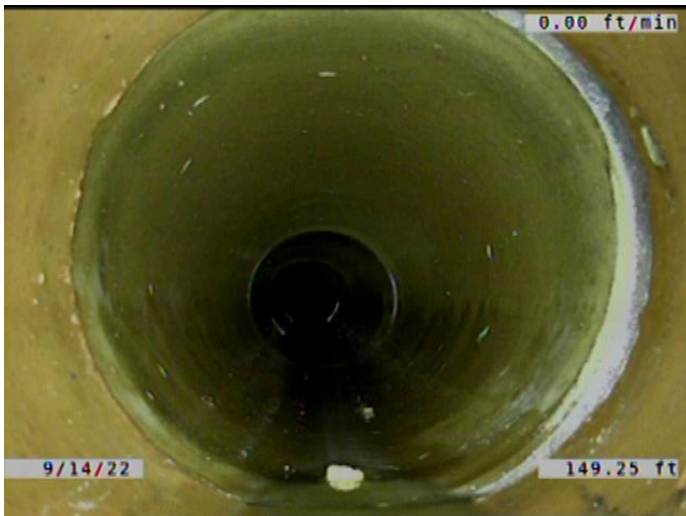
Code:	MWLS
Description:	Miscellaneous Water Level Sag
Distance (ft):	149.2
Structural Grade:	2
O&M Grade:	0
Clock Start/From:	
Clock To:	
1st Value:	
2nd Value:	
Value Percent:	15.000
Continuous Index:	F08
Within 8" of Joint:	NO
Remarks:

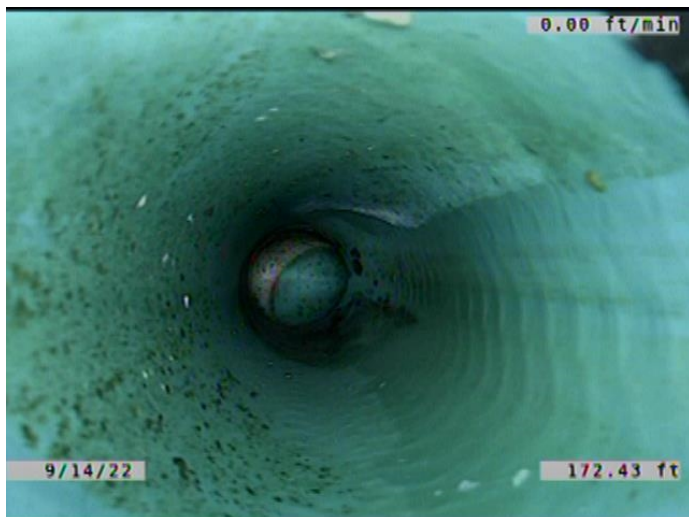
Code: **TS**
 Description: **Tap Saddle**

Distance (ft): **172.4**
 Structural Grade: **0**
 O&M Grade: **0**
 Clock Start/From: **1**
 Clock To:
 1st Value: **6.000**
 2nd Value:
 Value Percent:
 Continuous Index:
 Within 8" of Joint: **NO**
 Remarks:

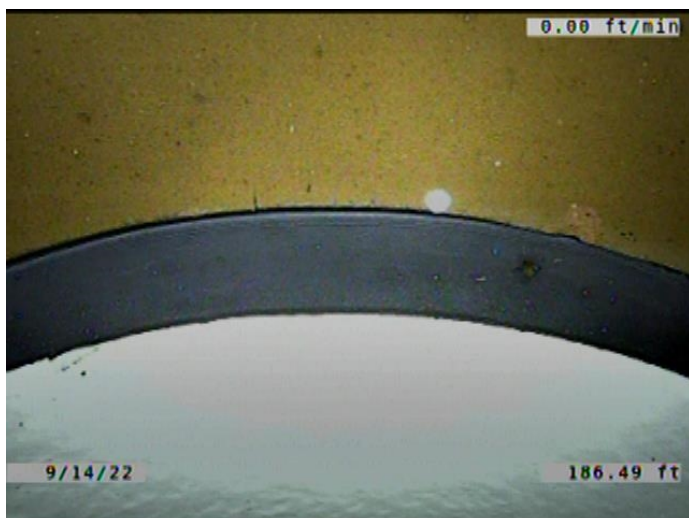
Code: **JOM**
 Description: **Joint Offset Medium**

Distance (ft): **186.5**
 Structural Grade: **3**
 O&M Grade: **0**
 Clock Start/From:
 Clock To:
 1st Value:
 2nd Value:
 Value Percent:
 Continuous Index:
 Within 8" of Joint: **NO**
 Remarks:

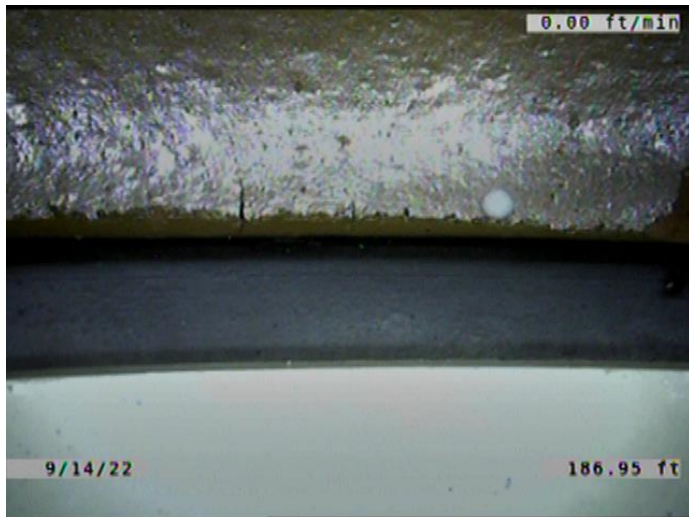
Code: **MMC**
 Description: **Miscellaneous Material Change**

Distance (ft): **186.9**
 Structural Grade: **0**
 O&M Grade: **0**
 Clock Start/From:
 Clock To:
 1st Value:
 2nd Value:
 Value Percent:
 Continuous Index:
 Within 8" of Joint: **NO**
 Remarks: **VCP TO PVC**

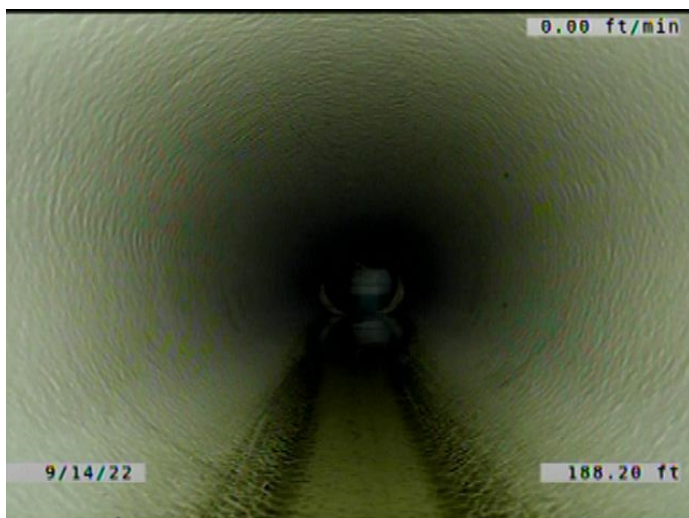
Code: **ISJ**
 Description: **Infiltration Stain Joint**

Distance (ft): **188.2**
 Structural Grade: **0**
 O&M Grade: **1**
 Clock Start/From: **7**
 Clock To: **5**
 1st Value:
 2nd Value:
 Value Percent:
 Continuous Index: **F04**
 Within 8" of Joint: **YES**
 Remarks:

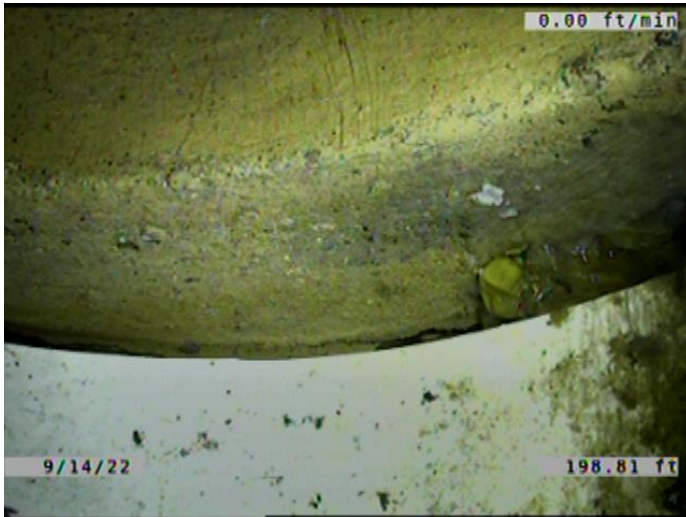
Code: **JOMD**
Description: **Joint Offset Medium Defective**

Distance (ft): **198.8**
Structural Grade: **3**
O&M Grade: **0**
Clock Start/From:
Clock To:
1st Value:
2nd Value:
Value Percent:
Continuous Index:
Within 8" of Joint: **NO**
Remarks:

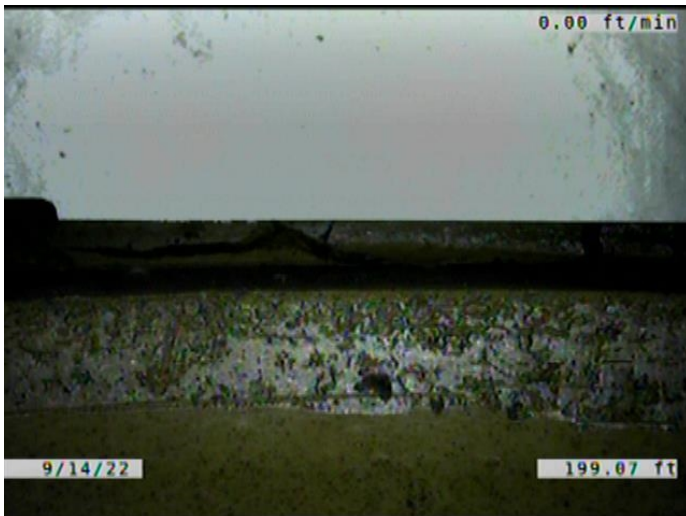
Code: **MMC**
Description: **Miscellaneous Material Change**

Distance (ft): **199.1**
Structural Grade: **0**
O&M Grade: **0**
Clock Start/From:
Clock To:
1st Value:
2nd Value:
Value Percent:
Continuous Index:
Within 8" of Joint: **NO**
Remarks: **PVC TO VCP**

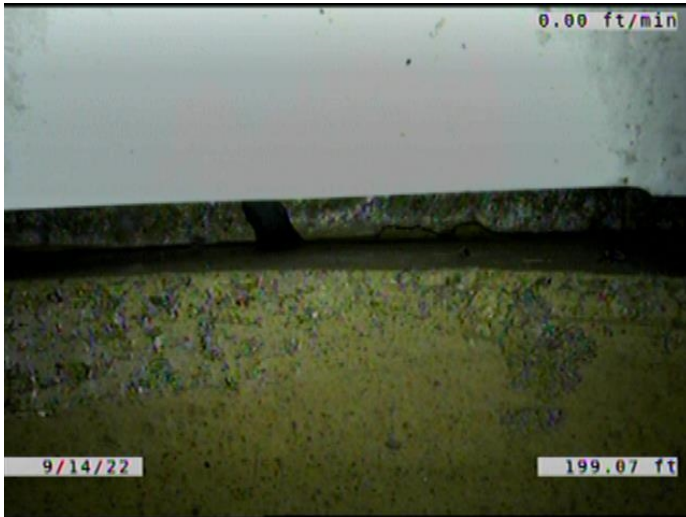
Code: **BSV**
Description: **Broken Soil Visible**

Distance (ft): **199.1**
Structural Grade: **5**
O&M Grade: **0**
Clock Start/From: **8**
Clock To: **4**
1st Value:
2nd Value:
Value Percent:
Continuous Index:
Within 8" of Joint: **YES**
Remarks:

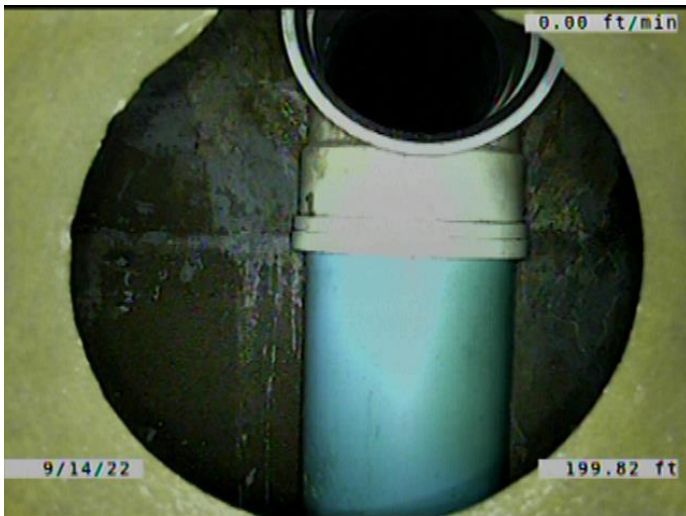
Code: **DSF**
Description: **Deposits Settled Fine**

Distance (ft): **199.8**
Structural Grade: **0**
O&M Grade: **2**
Clock Start/From: **5**
Clock To: **7**
1st Value:
2nd Value:
Value Percent: **5.000**
Continuous Index: **F01**
Within 8" of Joint: **YES**
Remarks:

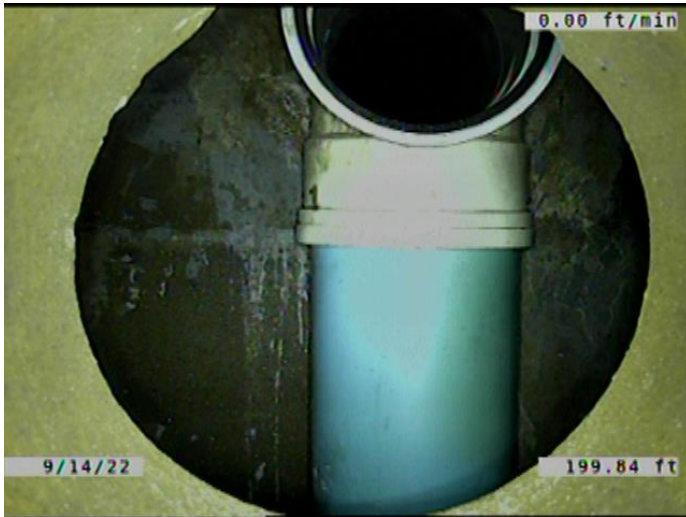
Code:	AMH
Description:	Manhole
Distance (ft):	199.8
Structural Grade:	0
O&M Grade:	0
Clock Start/From:	
Clock To:	
1st Value:	
2nd Value:	
Value Percent:	
Continuous Index:	
Within 8" of Joint:	NO
Remarks:	M-805-026
