Profile/Photo Observation Report

Date:	10/20/2021	Weather:		Coding:	PACP 6.0
Pipe Length (ft):		Owner:	Hobart, IN	Pre Clean:	Not Known
P.O.#:	909_1	Surveyor:	M. Pielacha	PSR:	P-805-028-027
Customer:	Hobart, IN	Clean Date:		Shape:	C

Street:	East 5th Street	Flow Control:	
City:	Hobart, IN	Year Renewed:	
Location:	Light Highway	Tape/Media #:	909
Purpose:	Routine Assessment	Dia/Height:	10"
Use:	Sanitary	Material:	PVC
Drain Area:		Lining:	
Category:	NA

US MH: **M-805-27** DS MH: **M-805-28** Total Length Surveyed (ft): **48.1**

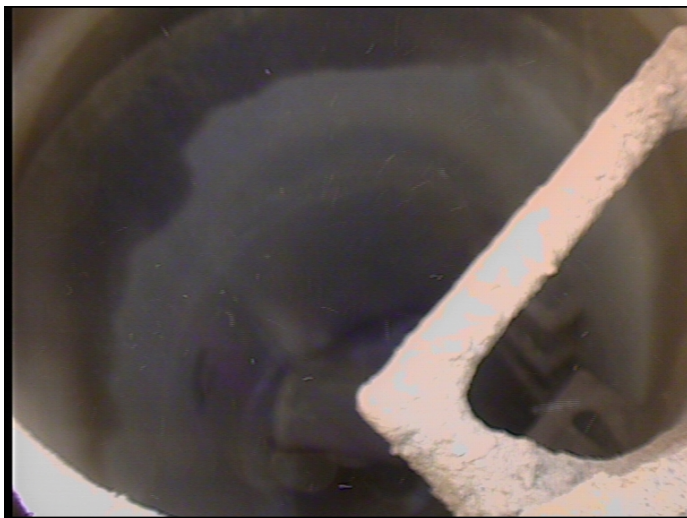
Code: **AMH**
 Description: **Manhole**

Distance (ft): **.0**
 Structural Grade: **0**
 O&M Grade: **0**
 Clock Start/From:
 Clock To:
 1st Value:
 2nd Value:
 Value Percent:
 Continuous Index:
 Within 8" of Joint: **NO**
 Remarks: **M-805-28**

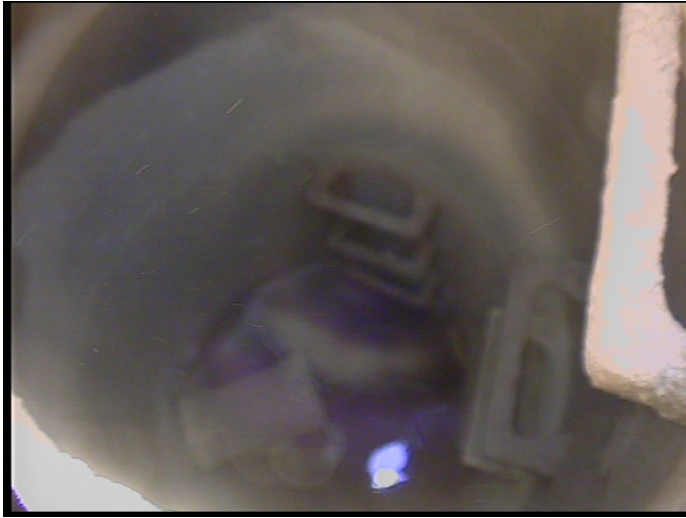
Code:	MGO
Description:	General Observation
Distance (ft):	.0
Structural Grade:	0
O&M Grade:	0
Clock Start/From:	
Clock To:	
1st Value:	
2nd Value:	
Value Percent:	
Continuous Index:	
Within 8" of Joint:	NO
Remarks:	Pausing video to insert camera into drop connection

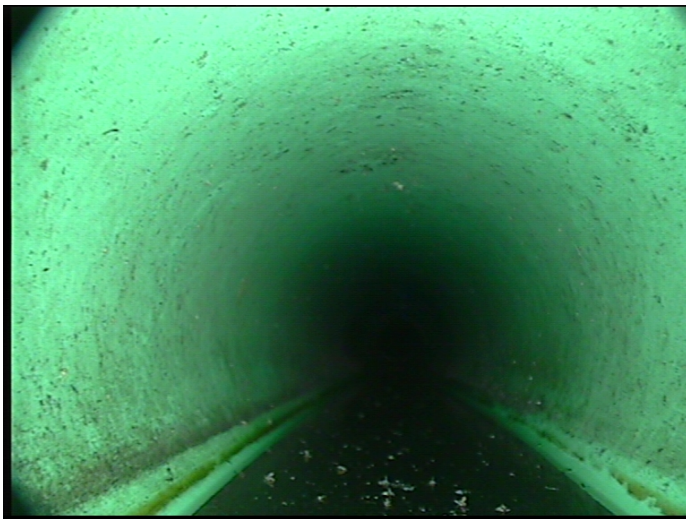
Code:	MWL
Description:	Water Level
Distance (ft):	.0
Structural Grade:	0
O&M Grade:	0
Clock Start/From:	
Clock To:	
1st Value:	
2nd Value:	
Value Percent:	5.000
Continuous Index:	
Within 8" of Joint:	NO
Remarks:

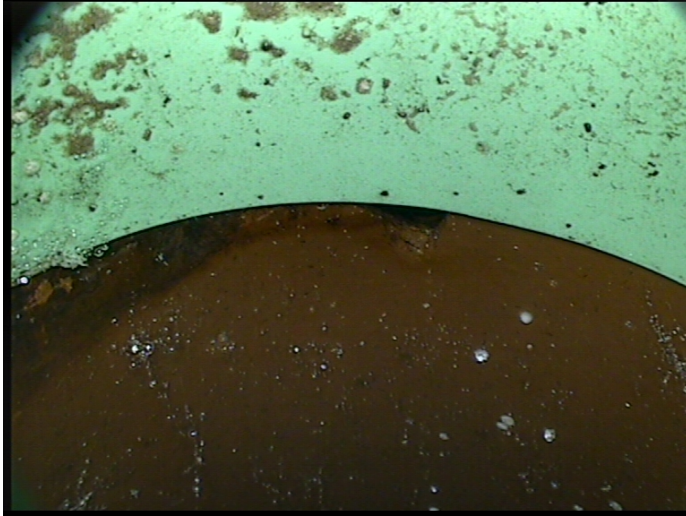
Code:	MMC
Description:	Material Change
Distance (ft):	19.3
Structural Grade:	0
O&M Grade:	0
Clock Start/From:	
Clock To:	
1st Value:	
2nd Value:	
Value Percent:	
Continuous Index:	
Within 8" of Joint:	NO
Remarks:	vcp

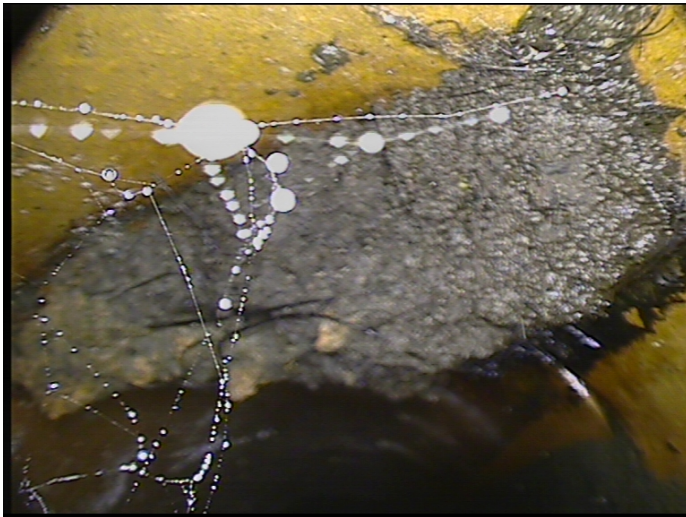
Code:	RMJ
Description:	Roots Medium Joint
Distance (ft):	22.9
Structural Grade:	0
O&M Grade:	3
Clock Start/From:	1
Clock To:	5
1st Value:	
2nd Value:	
Value Percent:	5.000
Continuous Index:	
Within 8" of Joint:	YES
Remarks:

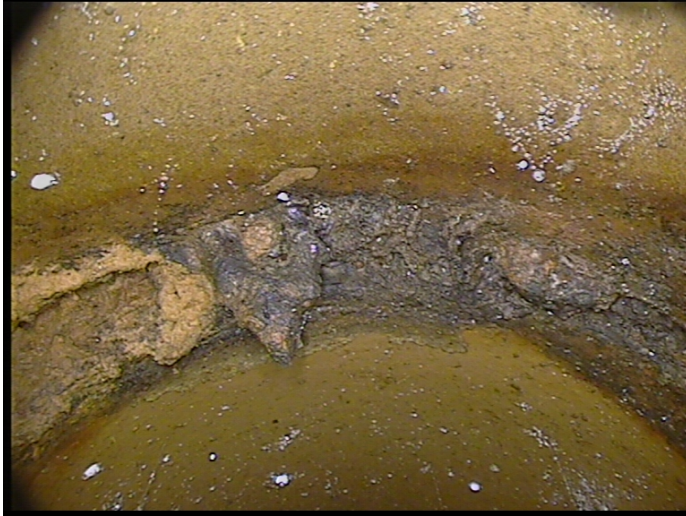
Code:	DAE
Description:	Deposits Attached Encrustation
Distance (ft):	27.0
Structural Grade:	0
O&M Grade:	2
Clock Start/From:	7
Clock To:	1
1st Value:	
2nd Value:	
Value Percent:	5.000
Continuous Index:	
Within 8" of Joint:	YES
Remarks:

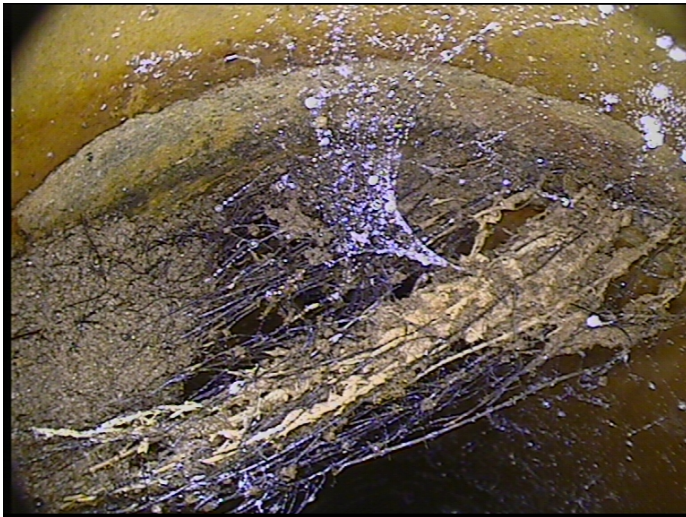
Code:	RMJ
Description:	Roots Medium Joint
Distance (ft):	42.8
Structural Grade:	0
O&M Grade:	3
Clock Start/From:	7
Clock To:	12
1st Value:	
2nd Value:	
Value Percent:	15.000
Continuous Index:	
Within 8" of Joint:	YES
Remarks:

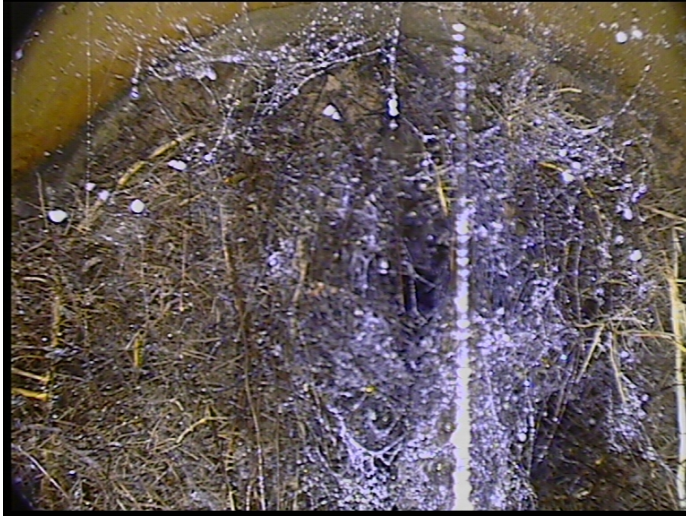
Code:	RMJ
Description:	Roots Medium Joint
Distance (ft):	46.4
Structural Grade:	0
O&M Grade:	3
Clock Start/From:	7
Clock To:	5
1st Value:	
2nd Value:	
Value Percent:	45.000
Continuous Index:	
Within 8" of Joint:	YES
Remarks:

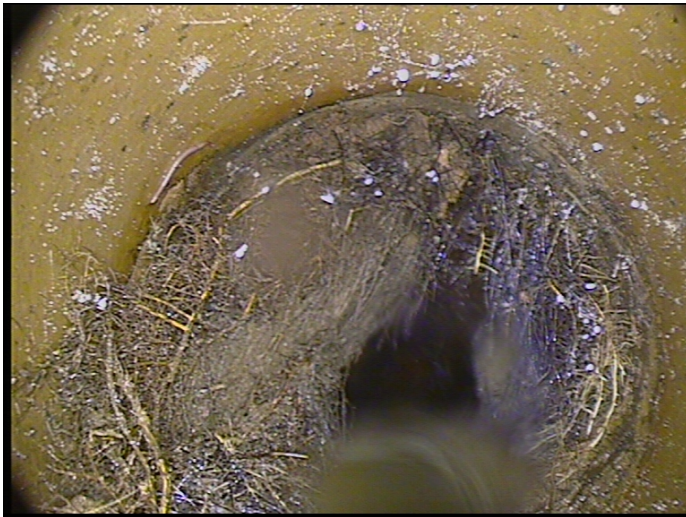
Code:	MSA
Description:	Abandoned Survey
Distance (ft):	47.4
Structural Grade:	0
O&M Grade:	0
Clock Start/From:	
Clock To:	
1st Value:	
2nd Value:	
Value Percent:	
Continuous Index:	
Within 8" of Joint:	NO
Remarks:	Large Roots
