## Profile/Photo Observation Report

Date:	<b>10/20/2021</b>	Weather:		Coding:	<b>PACP 6.0</b>
Pipe Length (ft):		Owner:	<b>Hobart, IN</b>	Pre Clean:	<b>Not Known</b>
P.O.#:	<b>903_1</b>	Surveyor:	<b>M. Pielacha</b>	PSR:	<b>P-806-021-029</b>
Customer:	<b>Hobart, IN</b>	Clean Date:		Shape:	<b>C</b>

Street:	<b>East 6th Street</b>	Flow Control:	
City:	<b>Hobart, IN</b>	Year Renewed:	
Location:	<b>Light Highway</b>	Tape/Media #:	<b>903</b>
Purpose:	<b>Routine Assessment</b>	Dia/Height:	<b>30"</b>
Use:	<b>Sanitary</b>	Material:	<b>RCP</b>
Drain Area:		Lining:

US MH: **M-805-29** DS MH: **M-806-21** Total Length Surveyed (ft): **237.9**

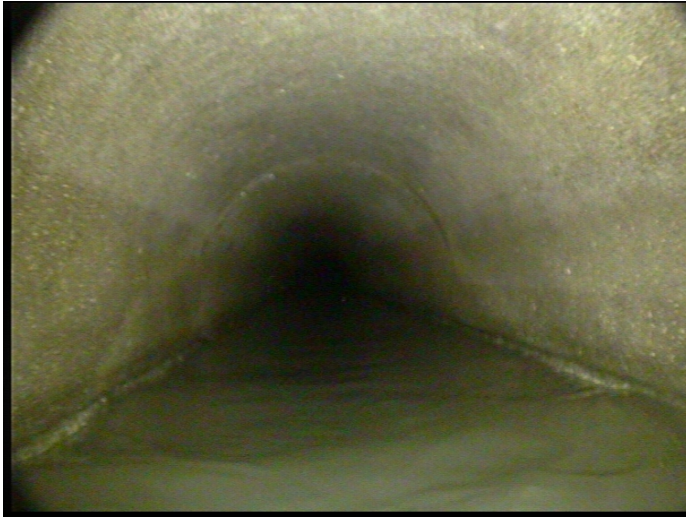
Code: **MWL**  
Description: **Water Level**

Distance (ft): **.0**  
Structural Grade: **0**  
O&M Grade: **0**  
Clock Start/From:  
Clock To:  
1st Value:  
2nd Value:  
Value Percent: **15.000**  
Continuous Index:  
Within 8" of Joint: **NO**  
Remarks:

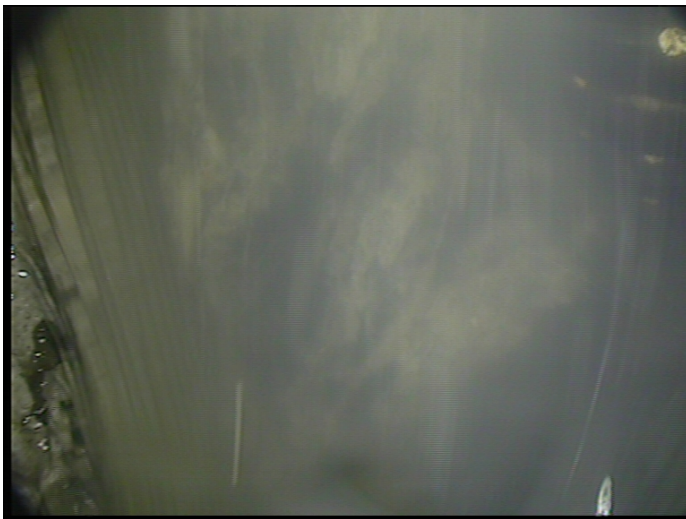
Code: **DSF**  
Description: **Deposits Settled Fine**

Distance (ft): **10.1**  
Structural Grade: **0**  
O&M Grade: **2**  
Clock Start/From: **4**  
Clock To: **8**  
1st Value:  
2nd Value:  
Value Percent: **10.000**  
Continuous Index:  
Within 8" of Joint: **NO**  
Remarks:

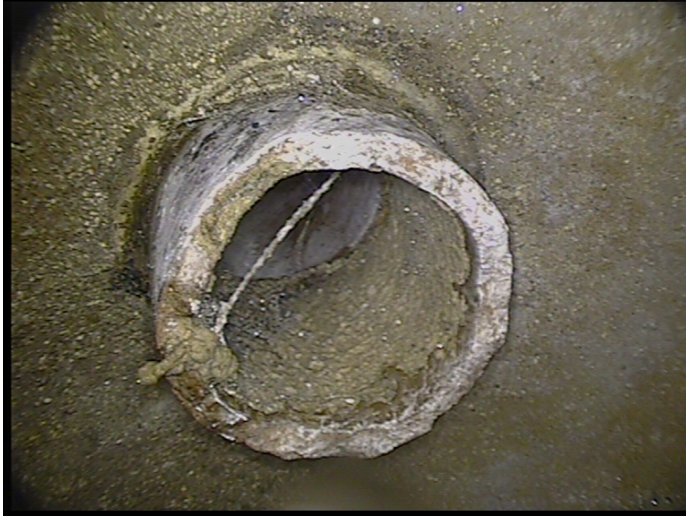
Code: **TB**  
Description: **Tap Break-in**

Distance (ft): **75.1**  
Structural Grade: **0**  
O&M Grade: **0**  
Clock Start/From: **10**  
Clock To:  
1st Value: **4.000**  
2nd Value:  
Value Percent:  
Continuous Index:  
Within 8" of Joint: **NO**  
Remarks:

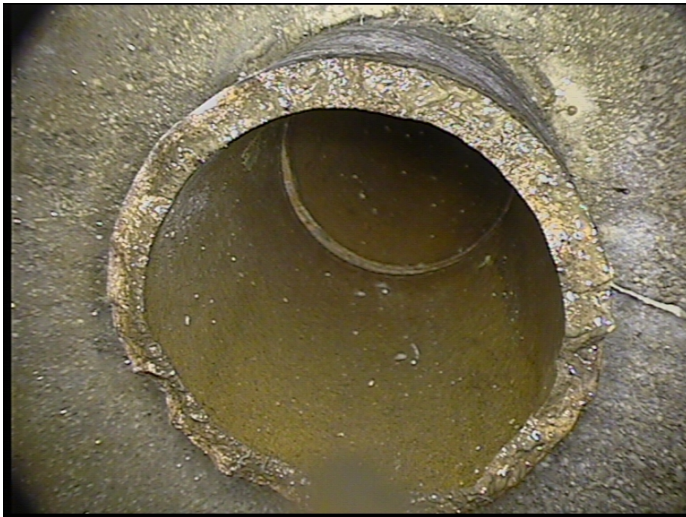
Code: **TBI**  
Description: **Tap Break-in Intruding**

Distance (ft): **76.2**  
Structural Grade: **0**  
O&M Grade: **2**  
Clock Start/From: **2**  
Clock To:  
1st Value: **4.000**  
2nd Value: **2.000**  
Value Percent:  
Continuous Index:  
Within 8" of Joint: **NO**  
Remarks:

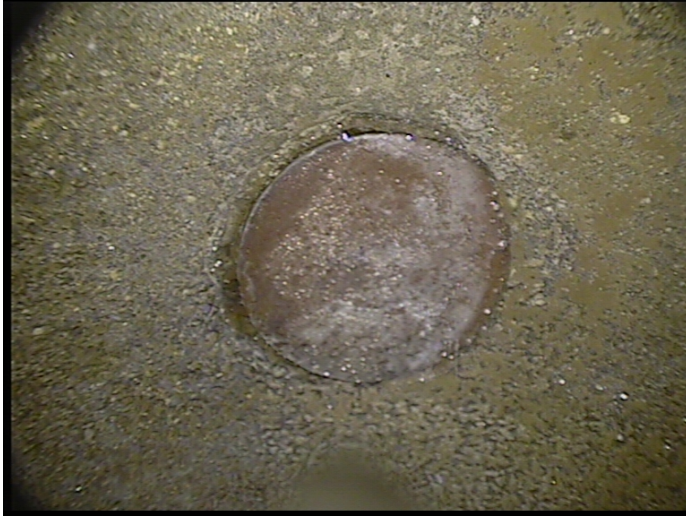
Code: **TFC**  
Description: **Tap Factory Capped**

Distance (ft): **136.1**  
Structural Grade: **0**  
O&M Grade: **0**  
Clock Start/From: **11**  
Clock To:  
1st Value: **4.000**  
2nd Value:  
Value Percent:  
Continuous Index:  
Within 8" of Joint: **NO**  
Remarks:

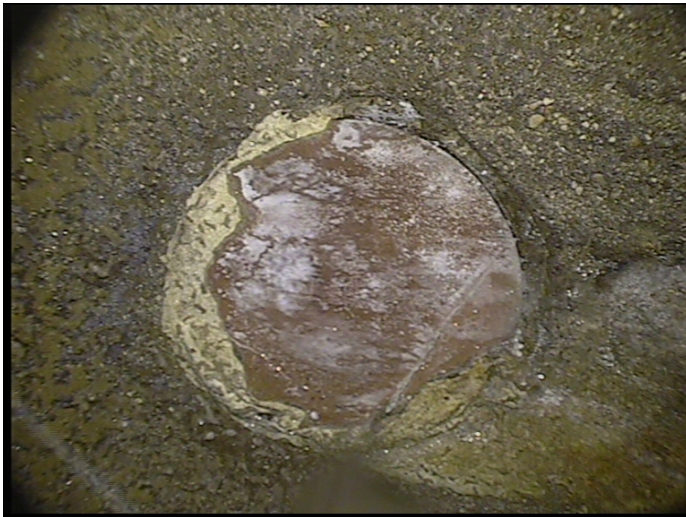
Code: **TFC**  
Description: **Tap Factory Capped**

Distance (ft): **136.7**  
Structural Grade: **0**  
O&M Grade: **0**  
Clock Start/From: **2**  
Clock To:  
1st Value: **4.000**  
2nd Value:  
Value Percent:  
Continuous Index:  
Within 8" of Joint: **NO**  
Remarks:

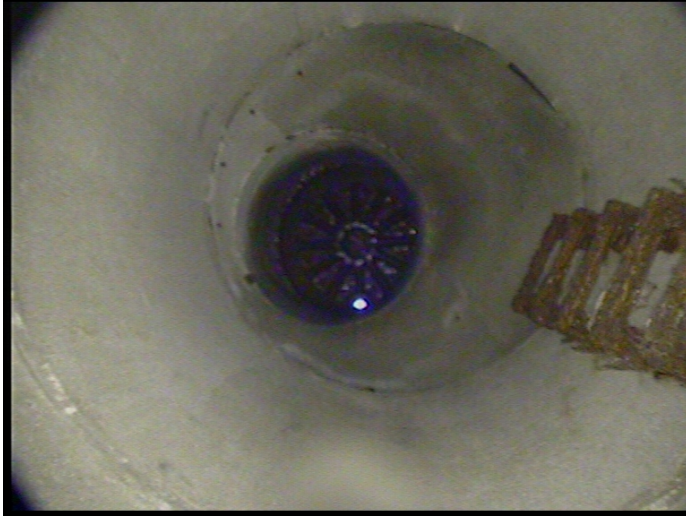
Code:	AMH
Description:	Manhole
Distance (ft):	237.9
Structural Grade:	0
O&M Grade:	0
Clock Start/From:	
Clock To:	
1st Value:	
2nd Value:	
Value Percent:	
Continuous Index:	
Within 8" of Joint:	NO
Remarks:	M-805-29
