## Profile/Photo Observation Report

Street:	<b>6th Street</b>	Flow Control:	
City:	<b>Hobart, IN</b>	Year Renewed:	
Location:	<b>Light Highway</b>	Tape/Media #:	<b>901</b>
Purpose:	<b>Routine Assessment</b>	Dia/Height:	<b>12"</b>
Use:	<b>Sanitary</b>	Material:	<b>PVC</b>
Drain Area:		Lining:	
Category:	<b>NA</b>		
Comment:

Location Details:		Direction of Survey:	<b>Downstream</b>
US MH:	<b>M-805-29</b>	DS MH:	<b>M-806-49</b>
		Total Length Surveyed (ft):	<b>43.9</b>

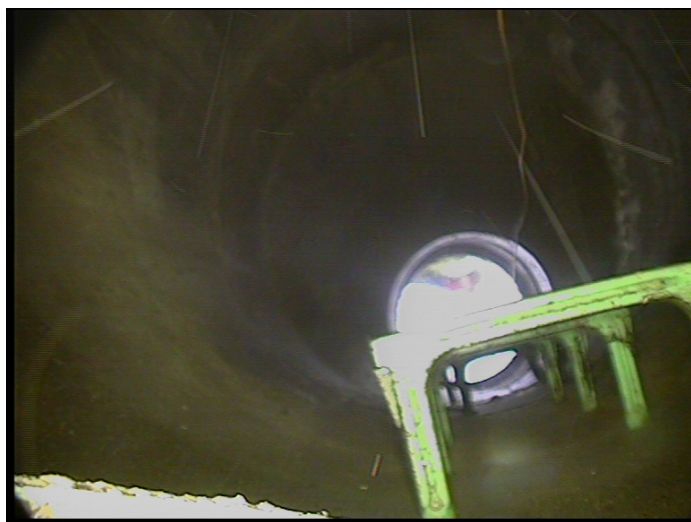
Code: **AMH**  
Description: **Manhole**

Distance (ft): **.0**  
Structural Grade: **0**  
O&M Grade: **0**  
Clock Start/From:  
Clock To:  
1st Value:  
2nd Value:  
Value Percent:  
Continuous Index:  
Within 8" of Joint: **NO**  
Remarks: **M-805-29**

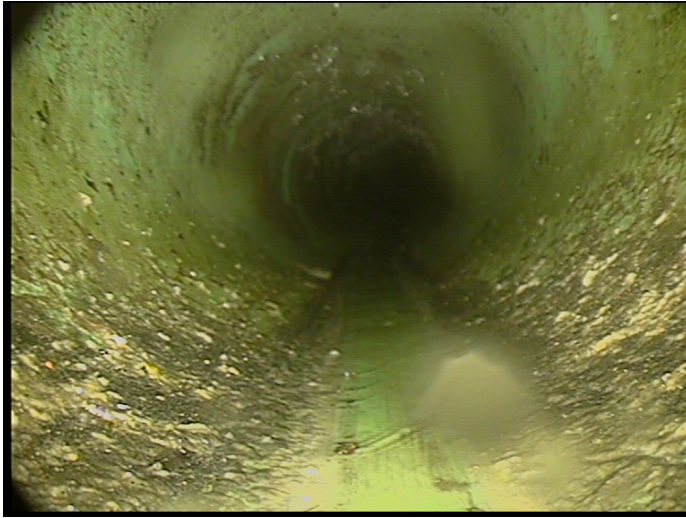
Code:	<b>MWL</b>
Description:	<b>Water Level</b>
Distance (ft):	<b>.0</b>
Structural Grade:	<b>0</b>
O&M Grade:	<b>0</b>
Clock Start/From:	
Clock To:	
1st Value:	
2nd Value:	
Value Percent:	<b>5.000</b>
Continuous Index:	
Within 8" of Joint:	<b>NO</b>
Remarks:

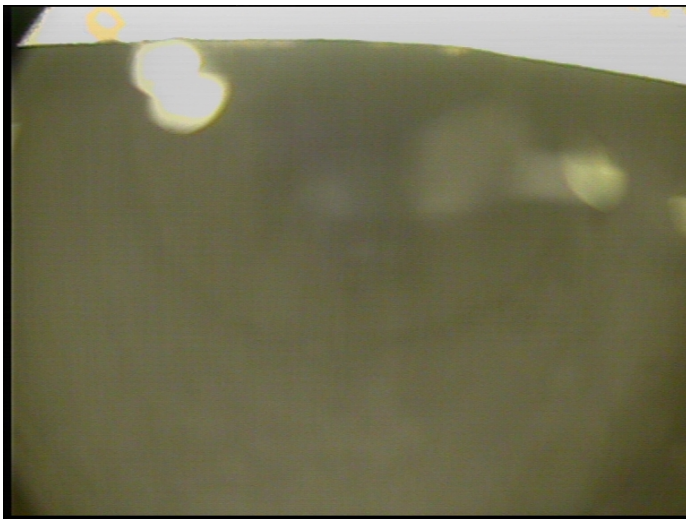
Code:	<b>AMH</b>
Description:	<b>Manhole</b>
Distance (ft):	<b>43.9</b>
Structural Grade:	<b>0</b>
O&M Grade:	<b>0</b>
Clock Start/From:	
Clock To:	
1st Value:	
2nd Value:	
Value Percent:	
Continuous Index:	
Within 8" of Joint:	<b>NO</b>
Remarks:	<b>M-806-49</b>
