Profile/Photo Observation Report

Date:	04/20/2018	Weather:		Coding:	PACP 6.0
Pipe Length (ft):	277.4	Owner:	NA	Pre Clean:	Not Known
P.O.#:		Surveyor:	Byrd Fitzgerald	PSR:	P-805-036.1-036
Customer:		Clean Date:	01/01/1900	Shape:	C

Street:	OFF S LIBERTY PL	Flow Control:	Not Controlled
City:	Hobart, IN	Year Renewed:	
Location:	Other	Tape/Media #:	
Purpose:	Not Known	Dia/Height:	12"
Use:	Sanitary	Material:	VCP
Drain Area:	NA	Lining:	
Category:	NA		
Comment:

Location Details:		Direction of Survey:	Downstream
US MH:	M-805-036	DS MH:	M-805-036.1
		Total Length Surveyed (ft):	174.2

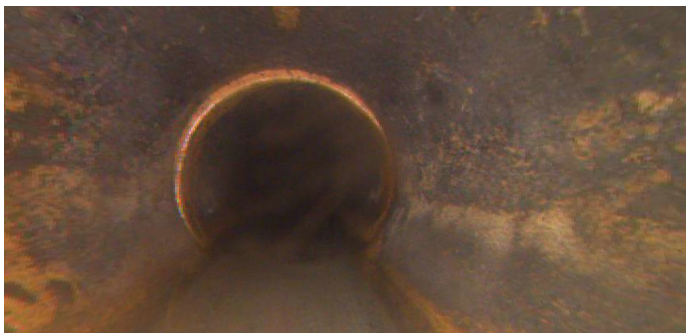
Code: **AMH**
Description: **Manhole**

Distance (ft): **.0**
Structural Grade: **0**
O&M Grade: **0**
Clock Start/From:
Clock To:
1st Value:
2nd Value:
Value Percent:
Continuous Index:
Within 8" of Joint: **NO**
Remarks: **M-805-036**

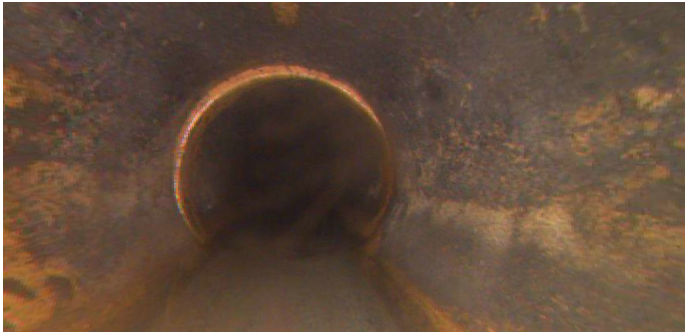
Code:	MWL
Description:	Water Level

Distance (ft):	.0
Structural Grade:	0
O&M Grade:	0
Clock Start/From:	
Clock To:	
1st Value:	
2nd Value:	
Value Percent:	5.000
Continuous Index:	
Within 8" of Joint:	NO
Remarks:

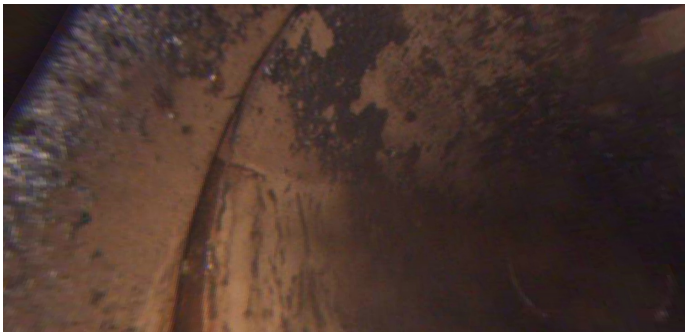
Code:	CL
Description:	Crack Longitudinal

Distance (ft):	26.2
Structural Grade:	2
O&M Grade:	0
Clock Start/From:	3
Clock To:	
1st Value:	
2nd Value:	
Value Percent:	
Continuous Index:	
Within 8" of Joint:	YES
Remarks:

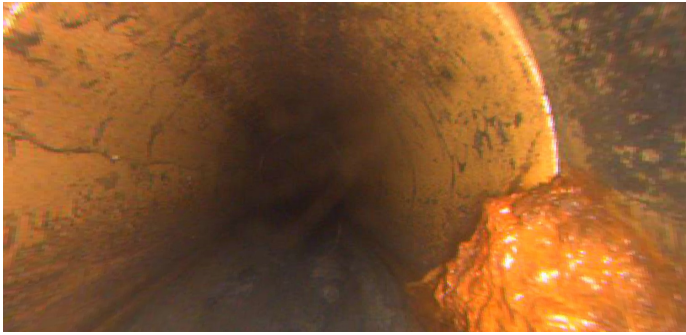
Code: **DAE**
Description: **Deposits Attached Encrustation**

Distance (ft): **34.2**
Structural Grade: **0**
O&M Grade: **2**
Clock Start/From: **4**
Clock To: **5**
1st Value:
2nd Value:
Value Percent: **5.000**
Continuous Index:
Within 8" of Joint: **YES**
Remarks:

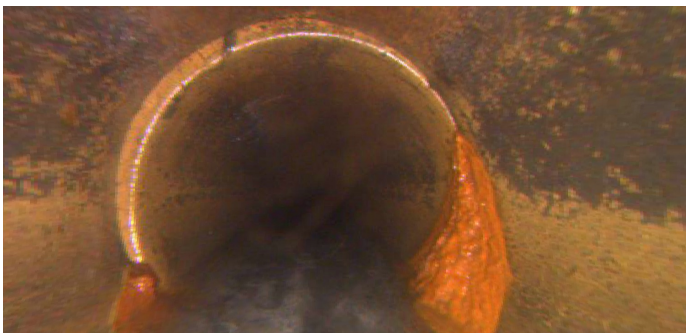
Code: **DAE**
Description: **Deposits Attached Encrustation**

Distance (ft): **39.7**
Structural Grade: **0**
O&M Grade: **2**
Clock Start/From: **7**
Clock To: **5**
1st Value:
2nd Value:
Value Percent: **5.000**
Continuous Index:
Within 8" of Joint: **YES**
Remarks:

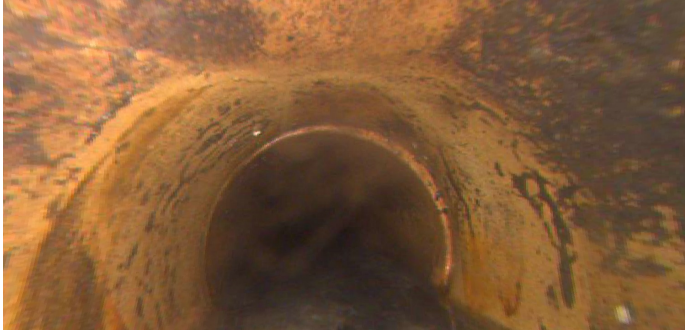
Code: **CM**
Description: **Crack Multiple**

Distance (ft): **45.2**
Structural Grade: **3**
O&M Grade: **0**
Clock Start/From: **7**
Clock To: **5**
1st Value:
2nd Value:
Value Percent:
Continuous Index: **S01**
Within 8" of Joint: **YES**
Remarks: **wandering**

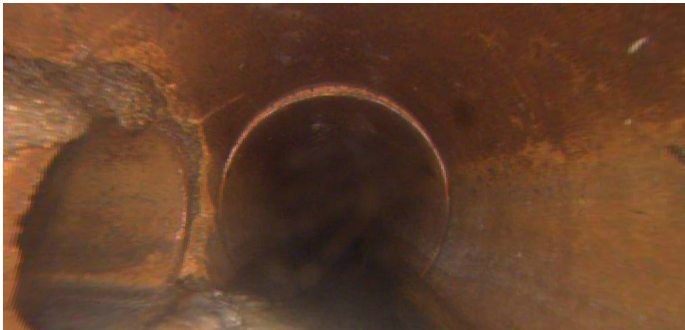
Code: **TB**
Description: **Tap Break-in**

Distance (ft): **149.1**
Structural Grade: **0**
O&M Grade: **0**
Clock Start/From: **9**
Clock To:
1st Value: **6.000**
2nd Value:
Value Percent:
Continuous Index:
Within 8" of Joint:
Remarks:

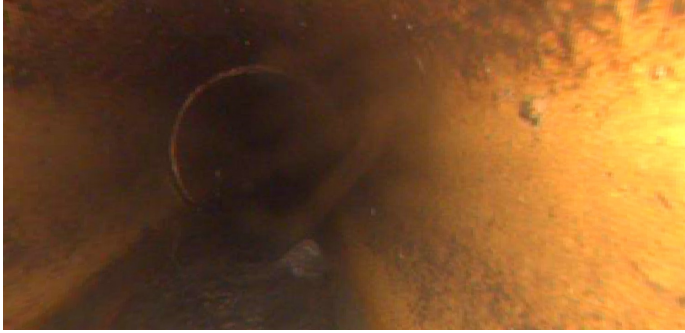
Code: **OBR**
Description: **Obstacle Rocks**

Distance (ft): **168.6**
Structural Grade: **0**
O&M Grade: **2**
Clock Start/From: **6**
Clock To:
1st Value:
2nd Value:
Value Percent: **5.000**
Continuous Index: **S02**
Within 8" of Joint: **NO**
Remarks:

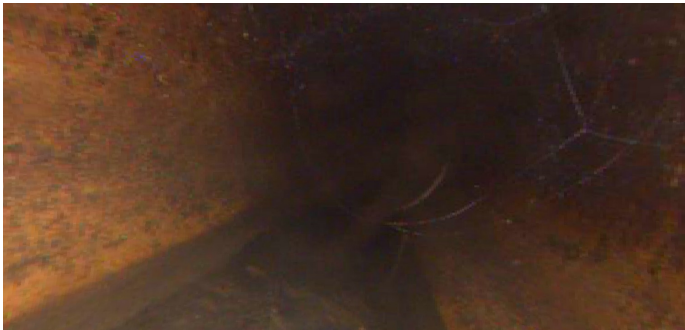
Code: **MSA**
Description: **Abandoned Survey**

Distance (ft): **174.2**
Structural Grade: **0**
O&M Grade: **0**
Clock Start/From:
Clock To:
1st Value:
2nd Value:
Value Percent:
Continuous Index:
Within 8" of Joint: **NO**
Remarks: **camera flipped/obr**

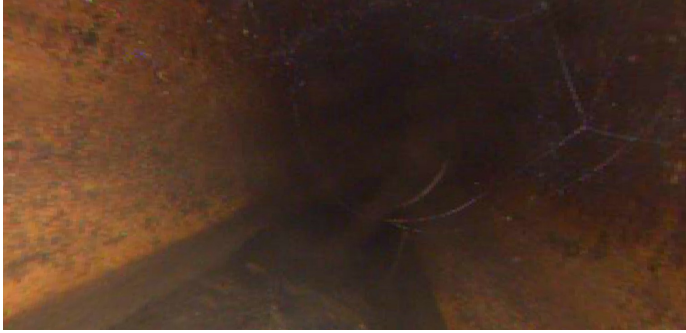
Code: **OBR**
Description: **Obstacle Rocks**

Distance (ft): **174.2**
Structural Grade: **0**
O&M Grade: **2**
Clock Start/From: **6**
Clock To:
1st Value:
2nd Value:
Value Percent: **5.000**
Continuous Index: **F02**
Within 8" of Joint: **NO**
Remarks:

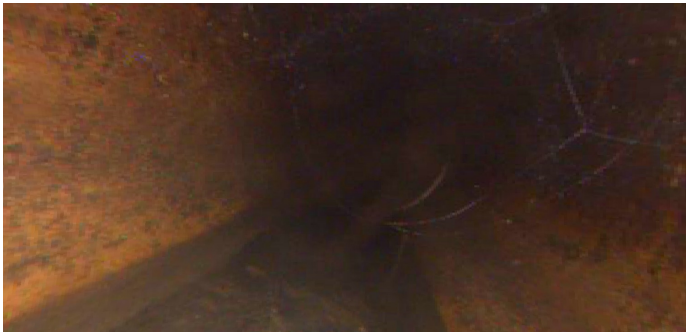
Code: **CM**
Description: **Crack Multiple**

Distance (ft): **174.2**
Structural Grade: **3**
O&M Grade: **0**
Clock Start/From: **7**
Clock To: **5**
1st Value:
2nd Value:
Value Percent:
Continuous Index: **F01**
Within 8" of Joint: **YES**
Remarks: **wandering**
