## Profile/Photo Observation Report

Date:	<b>04/20/2018</b>	Weather:		Coding:	<b>PACP 6.0</b>
Pipe Length (ft):	<b>277.4</b>	Owner:	<b>NA</b>	Pre Clean:	<b>Not Known</b>
P.O.#:		Surveyor:	<b>Byrd Fitzgerald</b>	PSR:	<b>P-805-036.1-036</b>
Customer:		Clean Date:	<b>01/01/1900</b>	Shape:	<b>C</b>

Street:	<b>Parking Lot</b>	Flow Control:	<b>Not Controlled</b>
City:	<b>Hobart, IN</b>	Year Renewed:	
Location:	<b>Other</b>	Tape/Media #:	
Purpose:	<b>Not Known</b>	Dia/Height:	<b>12"</b>
Use:	<b>Sanitary</b>	Material:	<b>VCP</b>
Drain Area:	<b>NA</b>	Lining:	
Category:	<b>NA</b>		
Comment:

Location Details:		Direction of Survey:	<b>Downstream</b>
US MH:	<b>M-805-036</b>	DS MH:	<b>M-805-036.1</b>
		Total Length Surveyed (ft):	<b>174.2</b>

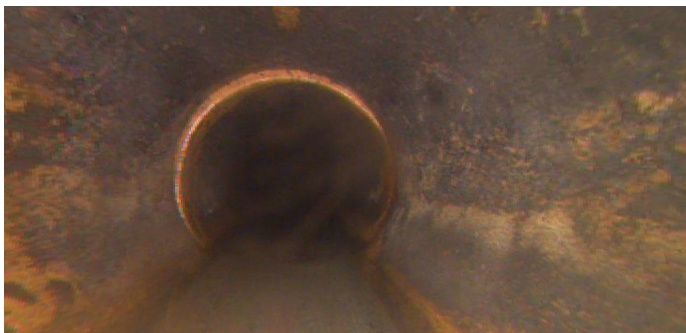
Code: **AMH**  
Description: **Manhole**

Distance (ft): **.0**  
Structural Grade: **0**  
O&M Grade: **0**  
Clock Start/From:  
Clock To:  
1st Value:  
2nd Value:  
Value Percent:  
Continuous Index:  
Within 8" of Joint: **NO**  
Remarks: **M-805-036**

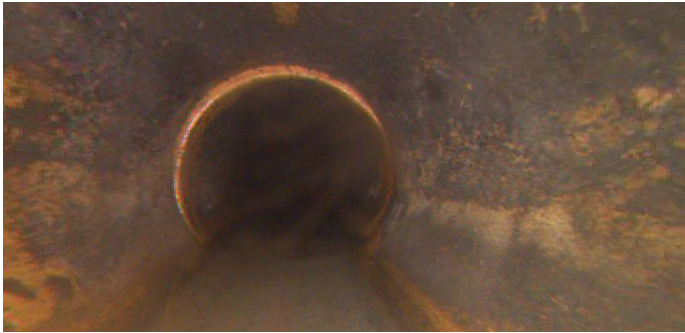
Code:	<b>MWL</b>
Description:	<b>Water Level</b>

Distance (ft):	<b>.0</b>
Structural Grade:	<b>0</b>
O&M Grade:	<b>0</b>
Clock Start/From:	
Clock To:	
1st Value:	
2nd Value:	
Value Percent:	<b>5.000</b>
Continuous Index:	
Within 8" of Joint:	<b>NO</b>
Remarks:

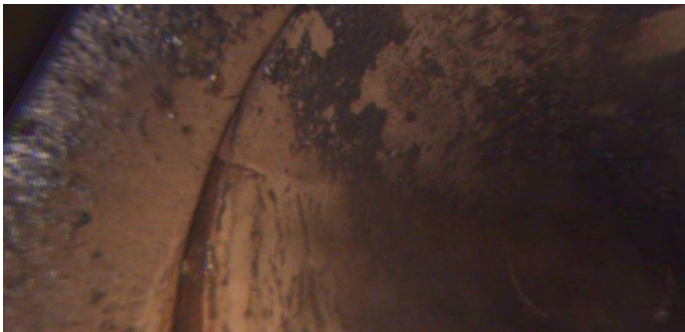
Code:	<b>CL</b>
Description:	<b>Crack Longitudinal</b>

Distance (ft):	<b>26.2</b>
Structural Grade:	<b>2</b>
O&M Grade:	<b>0</b>
Clock Start/From:	<b>3</b>
Clock To:	
1st Value:	
2nd Value:	
Value Percent:	
Continuous Index:	
Within 8" of Joint:	<b>YES</b>
Remarks:

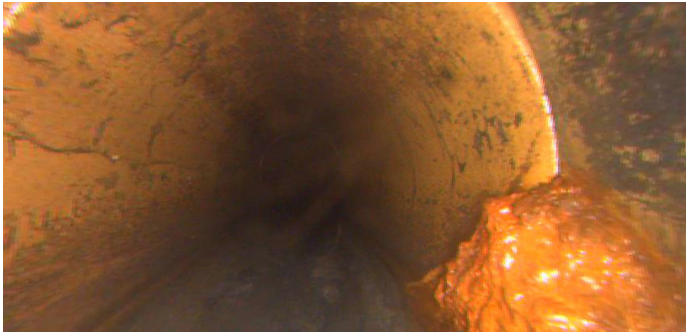
Code: **DAE**  
Description: **Deposits Attached Encrustation**

Distance (ft): **34.2**  
Structural Grade: **0**  
O&M Grade: **2**  
Clock Start/From: **4**  
Clock To: **5**  
1st Value:  
2nd Value:  
Value Percent: **5.000**  
Continuous Index:  
Within 8" of Joint: **YES**  
Remarks:

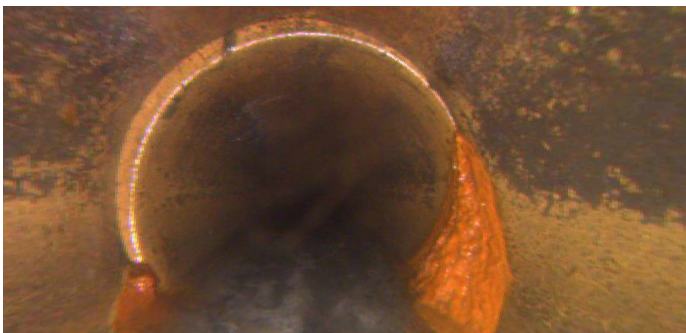
Code: **DAE**  
Description: **Deposits Attached Encrustation**

Distance (ft): **39.7**  
Structural Grade: **0**  
O&M Grade: **2**  
Clock Start/From: **7**  
Clock To: **5**  
1st Value:  
2nd Value:  
Value Percent: **5.000**  
Continuous Index:  
Within 8" of Joint: **YES**  
Remarks:

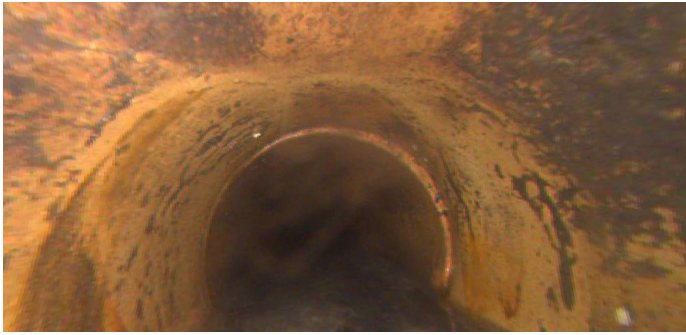
Code: **CM**  
Description: **Crack Multiple**

Distance (ft): **45.2**  
Structural Grade: **3**  
O&M Grade: **0**  
Clock Start/From: **7**  
Clock To: **5**  
1st Value:  
2nd Value:  
Value Percent:  
Continuous Index: **S01**  
Within 8" of Joint: **YES**  
Remarks: **wandering**

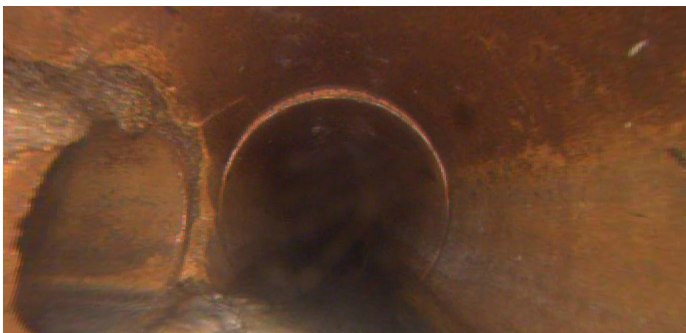
Code: **TB**  
Description: **Tap Break-in**

Distance (ft): **149.1**  
Structural Grade: **0**  
O&M Grade: **0**  
Clock Start/From: **9**  
Clock To:  
1st Value: **6.000**  
2nd Value:  
Value Percent:  
Continuous Index:  
Within 8" of Joint:  
Remarks:

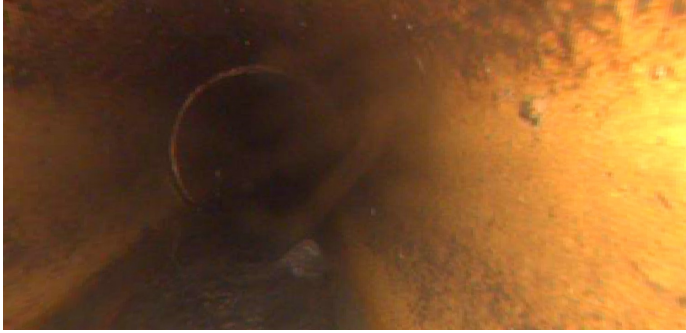
Code: **OBR**  
Description: **Obstacle Rocks**

Distance (ft): **168.6**  
Structural Grade: **0**  
O&M Grade: **2**  
Clock Start/From: **6**  
Clock To:  
1st Value:  
2nd Value:  
Value Percent: **5.000**  
Continuous Index: **S02**  
Within 8" of Joint: **NO**  
Remarks:

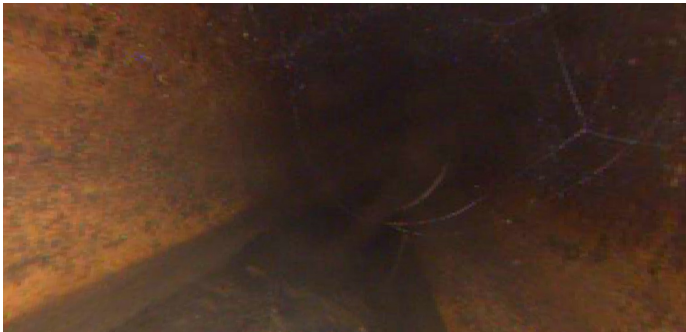
Code: **MSA**  
Description: **Abandoned Survey**

Distance (ft): **174.2**  
Structural Grade: **0**  
O&M Grade: **0**  
Clock Start/From:  
Clock To:  
1st Value:  
2nd Value:  
Value Percent:  
Continuous Index:  
Within 8" of Joint: **NO**  
Remarks: **camera flipped/obr**

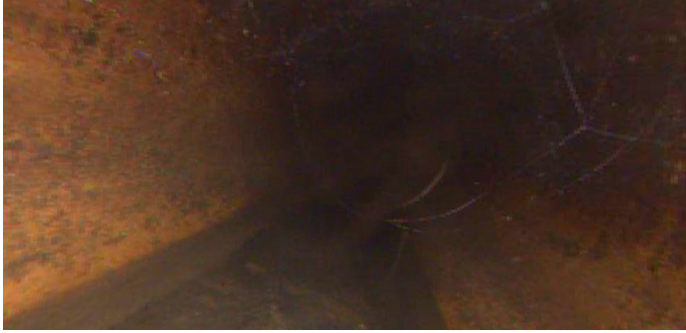
Code: **OBR**  
Description: **Obstacle Rocks**

Distance (ft): **174.2**  
Structural Grade: **0**  
O&M Grade: **2**  
Clock Start/From: **6**  
Clock To:  
1st Value:  
2nd Value:  
Value Percent: **5.000**  
Continuous Index: **F02**  
Within 8" of Joint: **NO**  
Remarks:

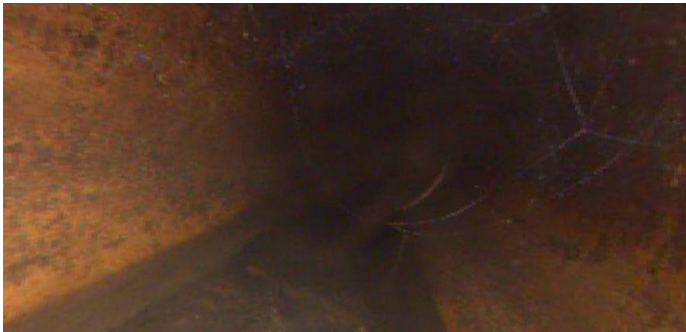
Code: **CM**  
Description: **Crack Multiple**

Distance (ft): **174.2**  
Structural Grade: **3**  
O&M Grade: **0**  
Clock Start/From: **7**  
Clock To: **5**  
1st Value:  
2nd Value:  
Value Percent:  
Continuous Index: **F01**  
Within 8" of Joint: **YES**  
Remarks: **wandering**
