Profile/Photo Observation Report

Date:	04/20/2018	Weather:		Coding:	PACP 6.0
Pipe Length (ft):	277.4	Owner:	NA	Pre Clean:	Not Known
P.O.#:		Surveyor:	Byrd Fitzgerald	PSR:	P-805-036.1-036
Customer:		Clean Date:	01/01/1900	Shape:	C

Street:	OFF S LIBERTY PL	Flow Control:	Not Controlled
City:	Hobart, IN	Year Renewed:	
Location:	Other	Tape/Media #:	
Purpose:	Not Known	Dia/Height:	12"
Use:	Sanitary	Material:	VCP
Drain Area:	NA	Lining:	
Category:	NA		
Comment:

Location Details:		Direction of Survey:	Upstream
US MH:	M-805-036	DS MH:	M-805-036.1
		Total Length Surveyed (ft):	58.5

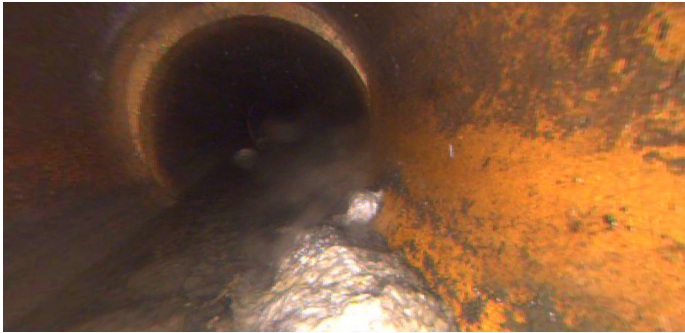
Code:	MWL
Description:	Water Level

Distance (ft):	.0
Structural Grade:	0
O&M Grade:	0
Clock Start/From:	
Clock To:	
1st Value:	
2nd Value:	
Value Percent:	5.000
Continuous Index:	
Within 8" of Joint:	NO
Remarks:

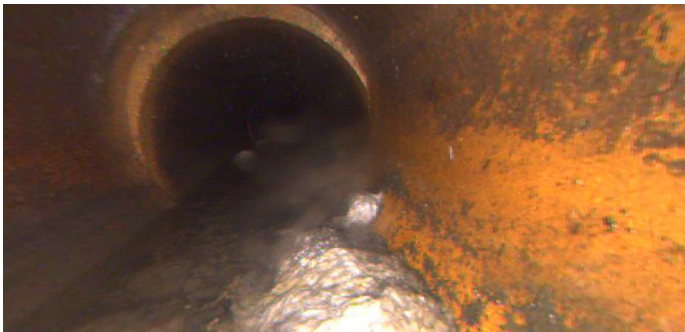
Code:	DSZ
Description:	Deposits Settled Other

Distance (ft):	.0
Structural Grade:	0
O&M Grade:	2
Clock Start/From:	6
Clock To:	
1st Value:	
2nd Value:	
Value Percent:	5.000
Continuous Index:	S01
Within 8" of Joint:	NO
Remarks:	debris

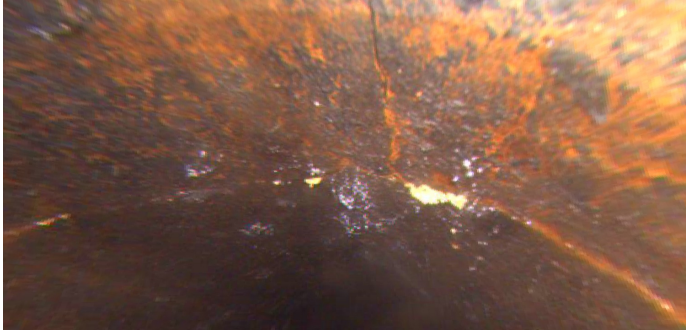
Code: **CM**
Description: **Crack Multiple**

Distance (ft): **8.5**
Structural Grade: **3**
O&M Grade: **0**
Clock Start/From: **7**
Clock To: **5**
1st Value:
2nd Value:
Value Percent:
Continuous Index: **S02**
Within 8" of Joint: **YES**
Remarks: **wandering**

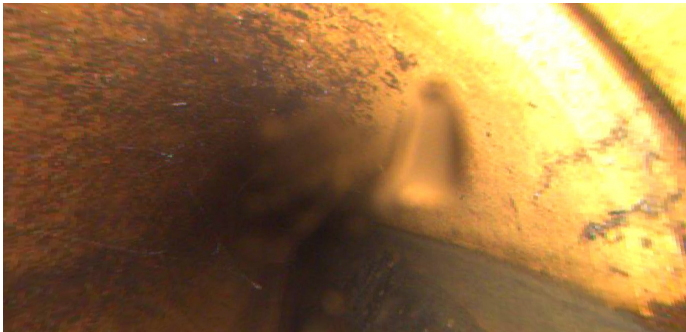
Code: **MSA**
Description: **Abandoned Survey**

Distance (ft): **58.5**
Structural Grade: **0**
O&M Grade: **0**
Clock Start/From:
Clock To:
1st Value:
2nd Value:
Value Percent:
Continuous Index:
Within 8" of Joint: **NO**
Remarks: **debris**

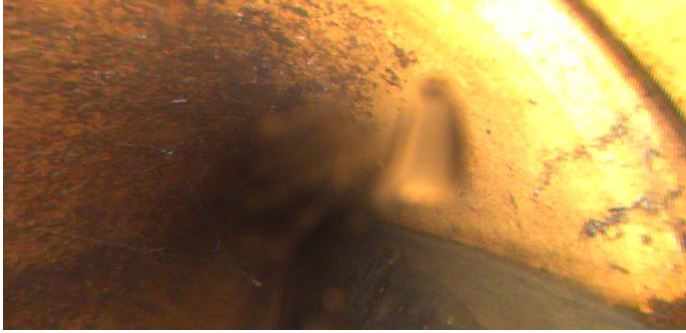
Code: **CM**
Description: **Crack Multiple**

Distance (ft): **58.5**
Structural Grade: **3**
O&M Grade: **0**
Clock Start/From: **7**
Clock To: **5**
1st Value:
2nd Value:
Value Percent:
Continuous Index: **F02**
Within 8" of Joint: **YES**
Remarks: **wandering**

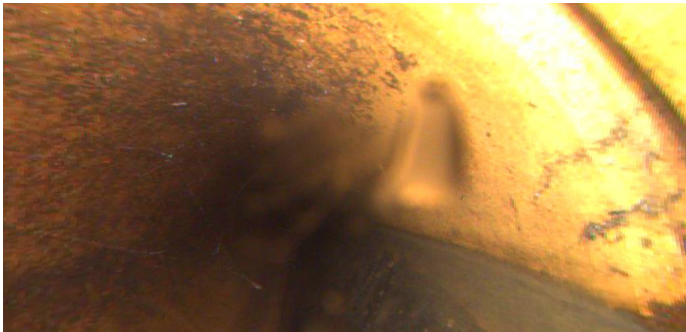
Code: **DSZ**
Description: **Deposits Settled Other**

Distance (ft): **58.5**
Structural Grade: **0**
O&M Grade: **2**
Clock Start/From: **6**
Clock To:
1st Value:
2nd Value:
Value Percent: **5.000**
Continuous Index: **F01**
Within 8" of Joint: **NO**
Remarks: **debris**
