## Profile/Photo Observation Report

Street:	<b>Parking Lot</b>	Flow Control:	<b>Not Controlled</b>
City:	<b>Hobart, IN</b>	Year Renewed:	
Location:	<b>Other</b>	Tape/Media #:	
Purpose:	<b>Not Known</b>	Dia/Height:	<b>12"</b>
Use:	<b>Sanitary</b>	Material:	<b>VCP</b>
Drain Area:	<b>NA</b>	Lining:	
Category:	<b>NA</b>		
Comment:

Location Details:		Direction of Survey:	<b>Upstream</b>
US MH:	<b>M-805-036</b>	DS MH:	<b>M-805-036.1</b>
		Total Length Surveyed (ft):	<b>58.5</b>

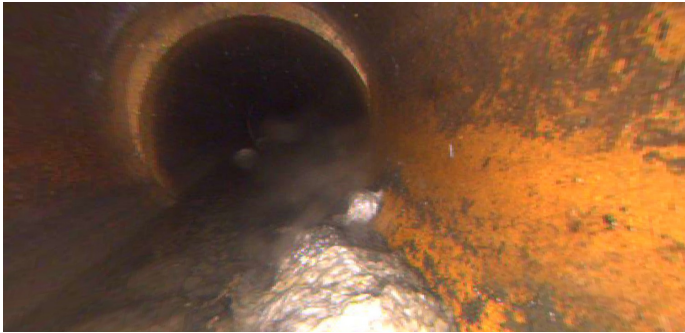
Code:	<b>MWL</b>
Description:	<b>Water Level</b>

Distance (ft):	<b>.0</b>
Structural Grade:	<b>0</b>
O&M Grade:	<b>0</b>
Clock Start/From:	
Clock To:	
1st Value:	
2nd Value:	
Value Percent:	<b>5.000</b>
Continuous Index:	
Within 8" of Joint:	<b>NO</b>
Remarks:

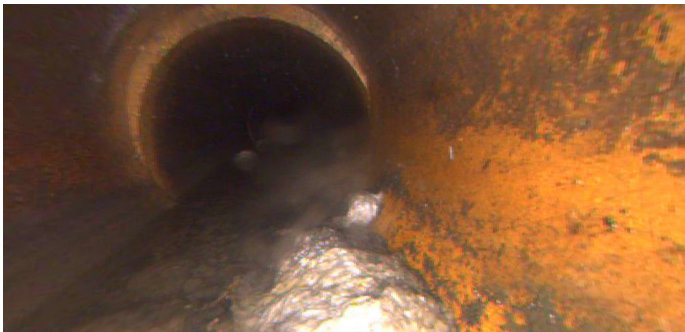
Code:	<b>DSZ</b>
Description:	<b>Deposits Settled Other</b>

Distance (ft):	<b>.0</b>
Structural Grade:	<b>0</b>
O&M Grade:	<b>2</b>
Clock Start/From:	<b>6</b>
Clock To:	
1st Value:	
2nd Value:	
Value Percent:	<b>5.000</b>
Continuous Index:	<b>S01</b>
Within 8" of Joint:	<b>NO</b>
Remarks:	<b>debris</b>

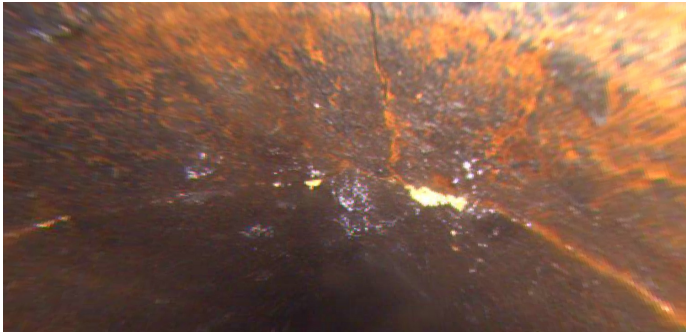
Code: **CM**  
Description: **Crack Multiple**

Distance (ft): **8.5**  
Structural Grade: **3**  
O&M Grade: **0**  
Clock Start/From: **7**  
Clock To: **5**  
1st Value:  
2nd Value:  
Value Percent:  
Continuous Index: **S02**  
Within 8" of Joint: **YES**  
Remarks: **wandering**

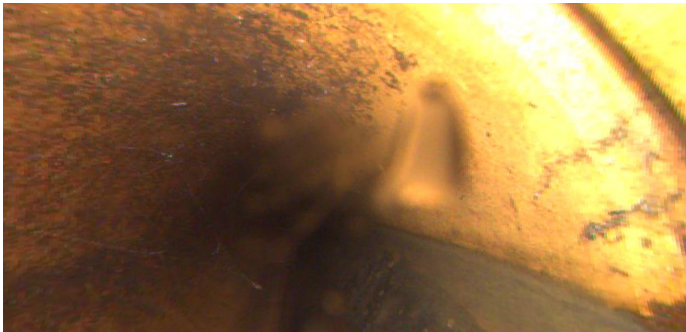
Code: **MSA**  
Description: **Abandoned Survey**

Distance (ft): **58.5**  
Structural Grade: **0**  
O&M Grade: **0**  
Clock Start/From:  
Clock To:  
1st Value:  
2nd Value:  
Value Percent:  
Continuous Index:  
Within 8" of Joint: **NO**  
Remarks: **debris**

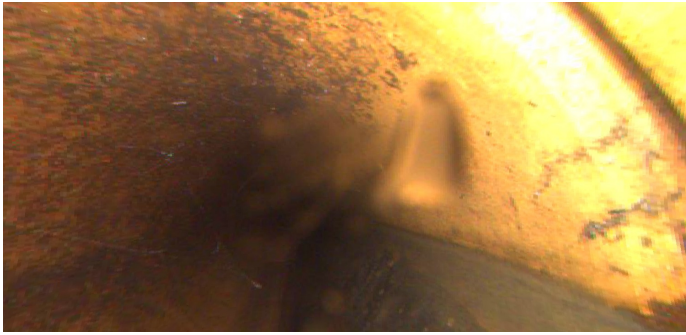
Code: **CM**  
Description: **Crack Multiple**

Distance (ft): **58.5**  
Structural Grade: **3**  
O&M Grade: **0**  
Clock Start/From: **7**  
Clock To: **5**  
1st Value:  
2nd Value:  
Value Percent:  
Continuous Index: **F02**  
Within 8" of Joint: **YES**  
Remarks: **wandering**

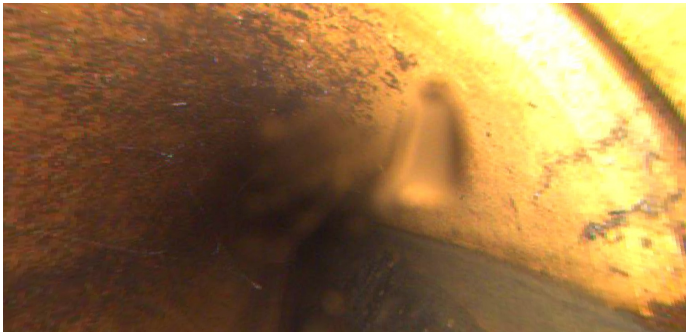
Code: **DSZ**  
Description: **Deposits Settled Other**

Distance (ft): **58.5**  
Structural Grade: **0**  
O&M Grade: **2**  
Clock Start/From: **6**  
Clock To:  
1st Value:  
2nd Value:  
Value Percent: **5.000**  
Continuous Index: **F01**  
Within 8" of Joint: **NO**  
Remarks: **debris**
