Profile/Photo Observation Report

Date:	01/31/2023	Weather:		Coding:	PACP 7.0
Pipe Length (ft):	430.0	Owner:	City of Hobart	Pre Clean:	Heavy Cleaning
P.O.#:	YES502259	Surveyor:	S. Bucklin	PSR:	P-804-002-037
Customer:	City of Hobart	Clean Date:	11/28/2022	Shape:	C

Street:	South Liberty Place	Flow Control:	Not Controlled
City:	Hobart, IN	Year Renewed:	
Location:	Local rural streets with light traffic, t	Tape/Media #:	
Purpose:	Routine Assessment	Dia/Height:	12"
Use:	Sanitary Sewage Pipe	Material:	VCP
Drain Area:		Lining:	None
Category:	NA		
Comment:			
Location Details:		Direction of Survey:	Upstream
US MH:	M-805-037	DS MH:	M-804-002
		Total Length Surveyed (ft):	424.0

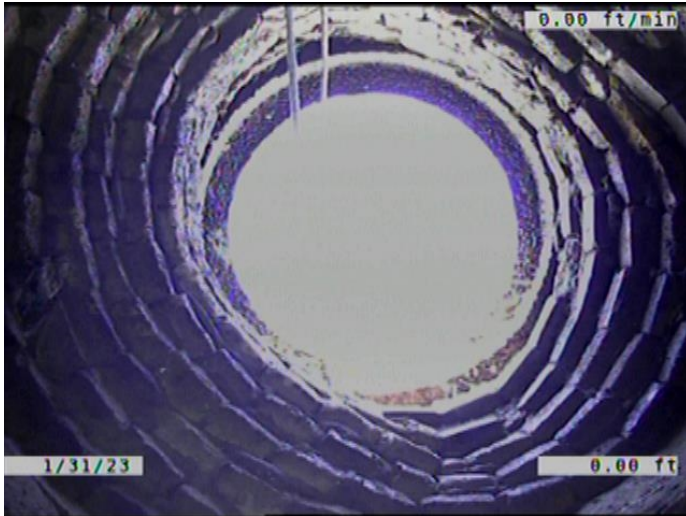
Code: **AMH**
Description: **Manhole**

Distance (ft): **.0**
Structural Grade: **0**
O&M Grade: **0**
Clock Start/From:
Clock To:
1st Value:
2nd Value:
Value Percent:
Continuous Index:
Within 8" of Joint: **NO**
Remarks: **M-804-002**

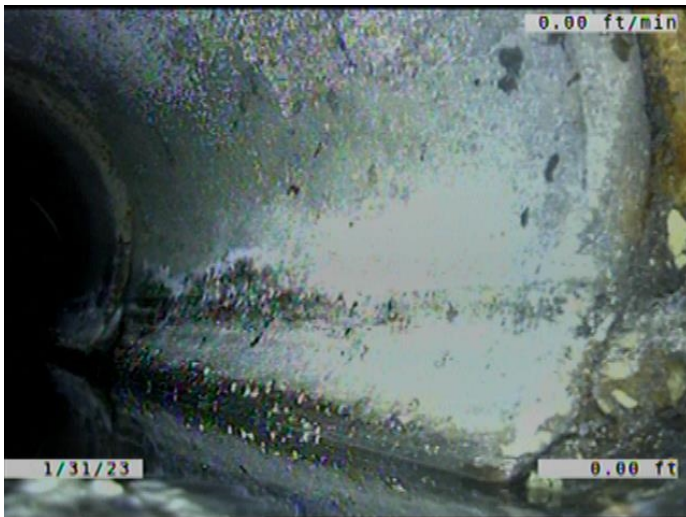
Code: **MWL**
Description: **Miscellaneous Water Level**

Distance (ft): **.0**
Structural Grade: **0**
O&M Grade: **0**
Clock Start/From:
Clock To:
1st Value:
2nd Value:
Value Percent: **10.000**
Continuous Index:
Within 8" of Joint: **NO**
Remarks:

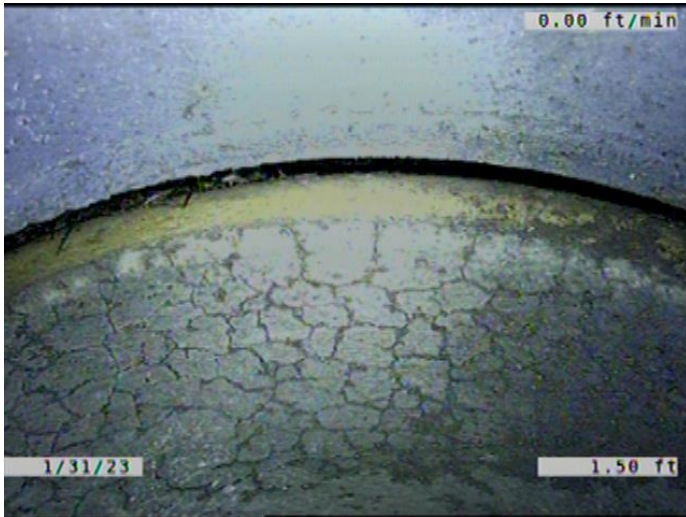
Code: **JOM**
 Description: **Joint Offset Medium**

Distance (ft): **1.5**
 Structural Grade: **3**
 O&M Grade: **0**
 Clock Start/From:
 Clock To:
 1st Value:
 2nd Value:
 Value Percent:
 Continuous Index:
 Within 8" of Joint: **NO**
 Remarks:

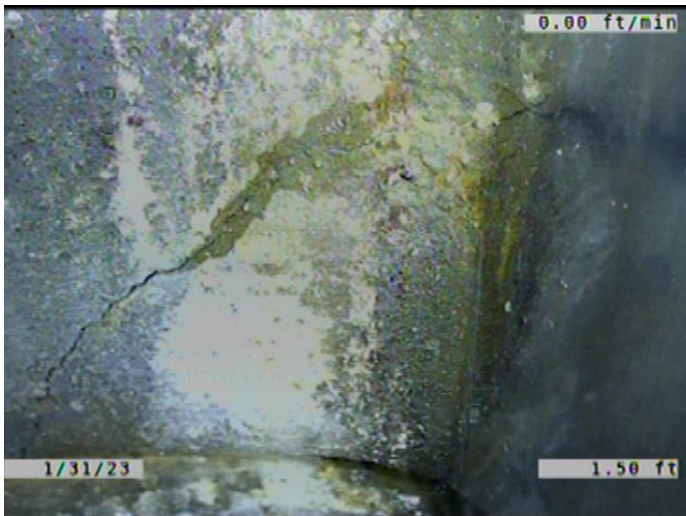
Code: **CM**
 Description: **Crack Multiple**

Distance (ft): **1.5**
 Structural Grade: **3**
 O&M Grade: **0**
 Clock Start/From: **3**
 Clock To: **6**
 1st Value:
 2nd Value:
 Value Percent:
 Continuous Index:
 Within 8" of Joint: **YES**
 Remarks:

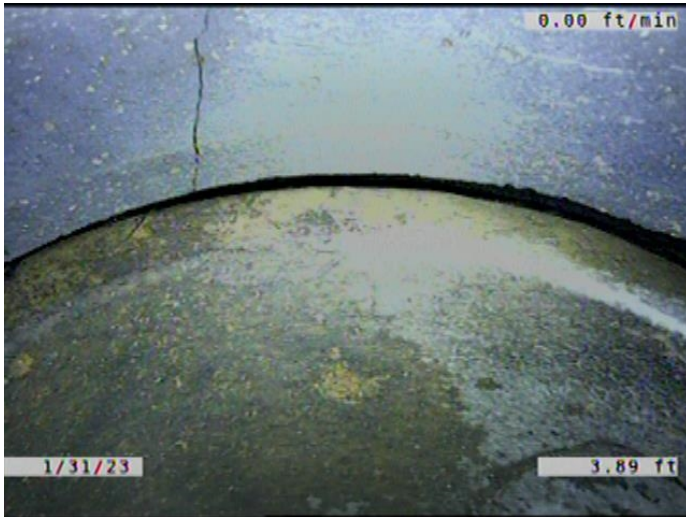
Code: **JOMD**
 Description: **Joint Offset Medium Defective**

Distance (ft): **3.9**
 Structural Grade: **3**
 O&M Grade: **0**
 Clock Start/From:
 Clock To:
 1st Value:
 2nd Value:
 Value Percent:
 Continuous Index: **S01**
 Within 8" of Joint: **NO**
 Remarks:

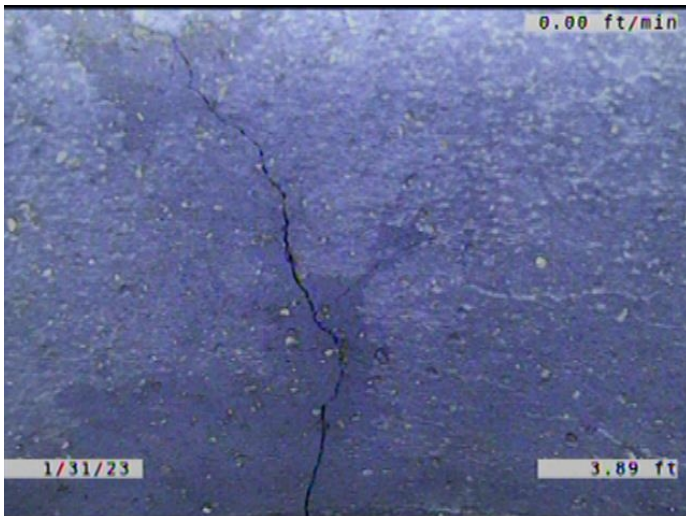
Code: **CM**
 Description: **Crack Multiple**

Distance (ft): **3.9**
 Structural Grade: **3**
 O&M Grade: **0**
 Clock Start/From: **12**
 Clock To: **1**
 1st Value:
 2nd Value:
 Value Percent:
 Continuous Index:
 Within 8" of Joint: **YES**
 Remarks:

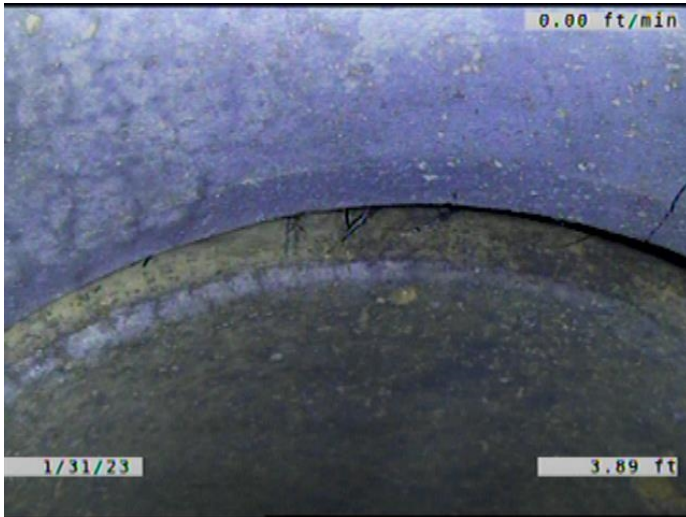
Code: **RFJ**
 Description: **Roots Fine Joint**

Distance (ft): **3.9**
 Structural Grade: **0**
 O&M Grade: **1**
 Clock Start/From: **11**
 Clock To: **12**
 1st Value:
 2nd Value:
 Value Percent:
 Continuous Index:
 Within 8" of Joint: **YES**
 Remarks:

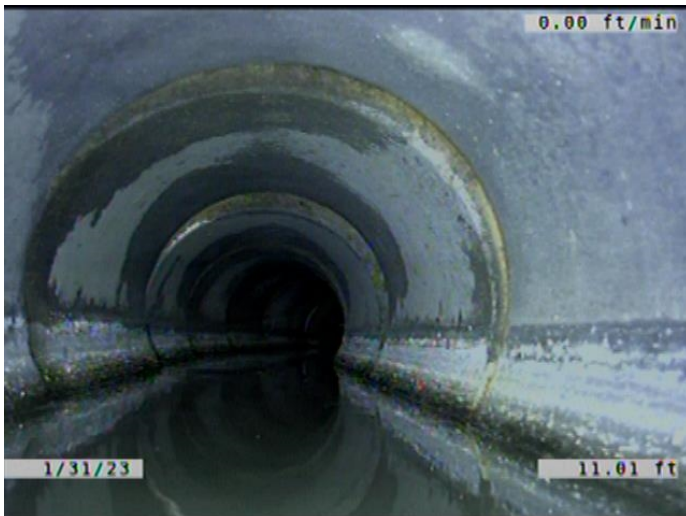
Code: **MWLS**
 Description: **Miscellaneous Water Level Sag**

Distance (ft): **11.0**
 Structural Grade: **2**
 O&M Grade: **0**
 Clock Start/From:
 Clock To:
 1st Value:
 2nd Value:
 Value Percent: **15.000**
 Continuous Index: **S02**
 Within 8" of Joint: **NO**
 Remarks:

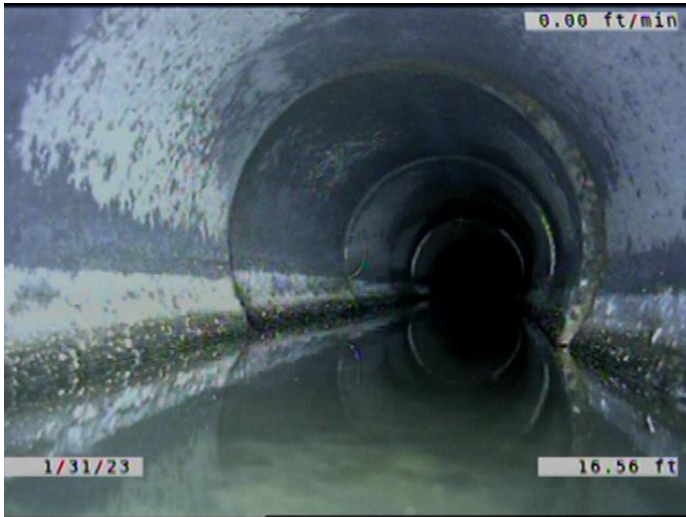
Code: **LR**
 Description: **Line Right**

Distance (ft): **16.6**
 Structural Grade: **0**
 O&M Grade: **2**
 Clock Start/From:
 Clock To:
 1st Value:
 2nd Value:
 Value Percent: **15.000**
 Continuous Index:
 Within 8" of Joint: **NO**
 Remarks:

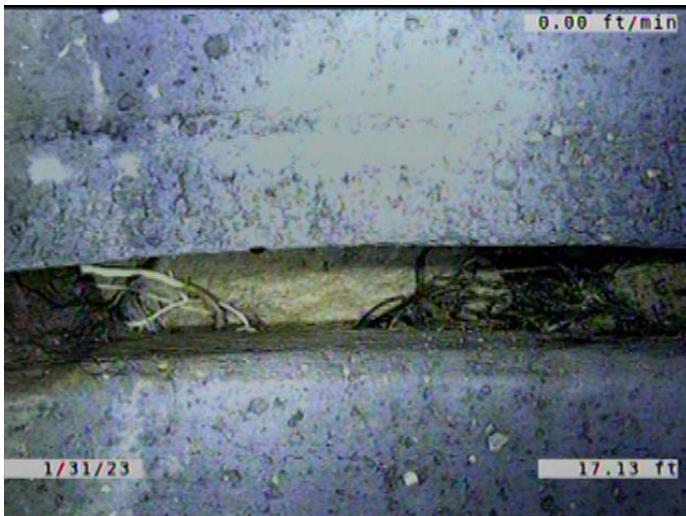
Code: **RFJ**
 Description: **Roots Fine Joint**

Distance (ft): **17.1**
 Structural Grade: **0**
 O&M Grade: **1**
 Clock Start/From: **8**
 Clock To: **4**
 1st Value:
 2nd Value:
 Value Percent:
 Continuous Index: **S03**
 Within 8" of Joint: **YES**
 Remarks:

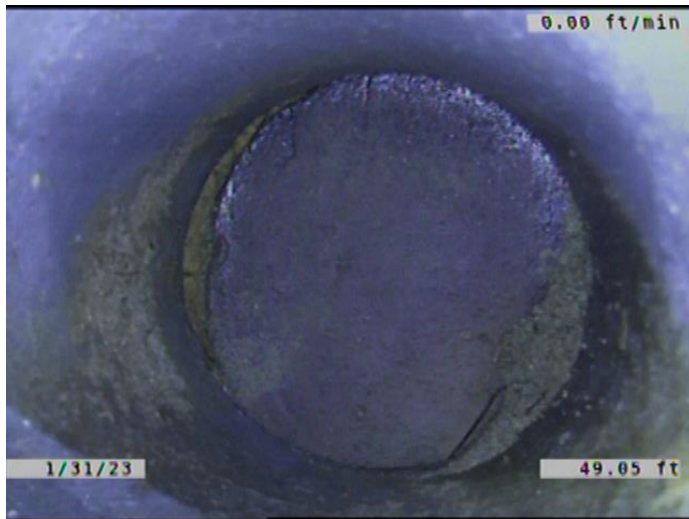
Code: **TFC**
 Description: **Tap Factory Capped**

Distance (ft): **49.0**
 Structural Grade: **0**
 O&M Grade: **0**
 Clock Start/From: **2**
 Clock To:
 1st Value: **6.000**
 2nd Value:
 Value Percent:
 Continuous Index:
 Within 8" of Joint: **YES**
 Remarks:

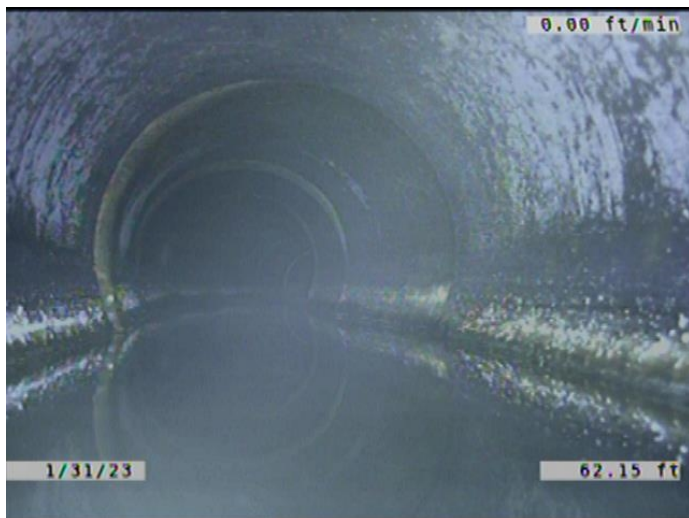
Code: **LL**
 Description: **Line Left**

Distance (ft): **62.2**
 Structural Grade: **0**
 O&M Grade: **1**
 Clock Start/From:
 Clock To:
 1st Value:
 2nd Value:
 Value Percent: **10.000**
 Continuous Index:
 Within 8" of Joint: **NO**
 Remarks:

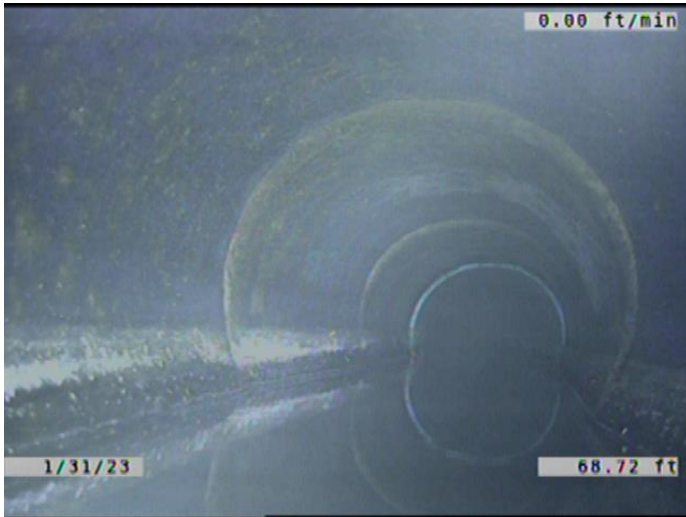
Code: **LR**
Description: **Line Right**

Distance (ft): **68.7**
Structural Grade: **0**
O&M Grade: **1**
Clock Start/From:
Clock To:
1st Value:
2nd Value:
Value Percent: **10.000**
Continuous Index:
Within 8" of Joint: **NO**
Remarks:

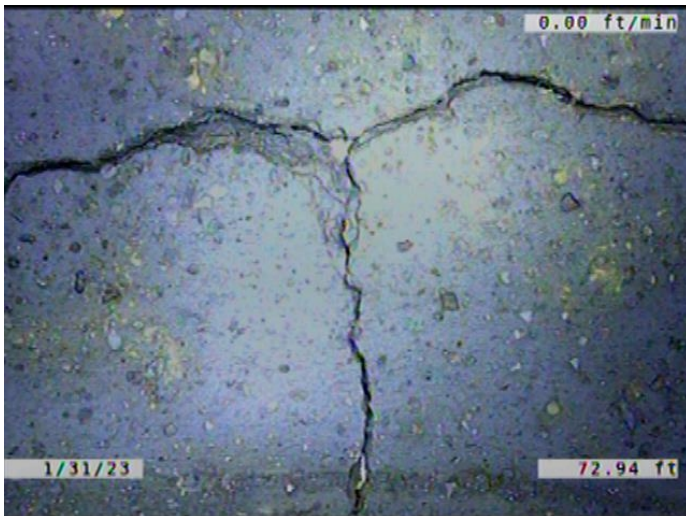
Code: **B**
Description: **Broken**

Distance (ft): **72.9**
Structural Grade: **4**
O&M Grade: **0**
Clock Start/From: **9**
Clock To: **3**
1st Value:
2nd Value:
Value Percent:
Continuous Index:
Within 8" of Joint: **YES**
Remarks:

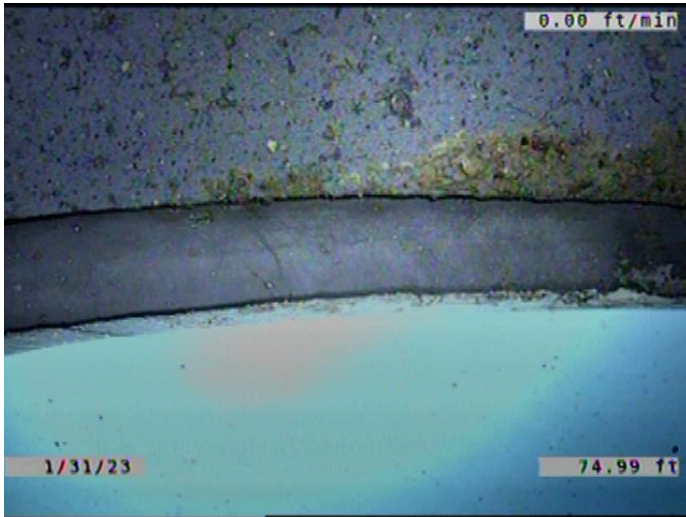
Code: **MMC**
 Description: **Miscellaneous Material Change**

Distance (ft): **75.0**
 Structural Grade: **0**
 O&M Grade: **0**
 Clock Start/From:
 Clock To:
 1st Value:
 2nd Value:
 Value Percent:
 Continuous Index:
 Within 8" of Joint: **NO**
 Remarks: **VCP TO PVC**

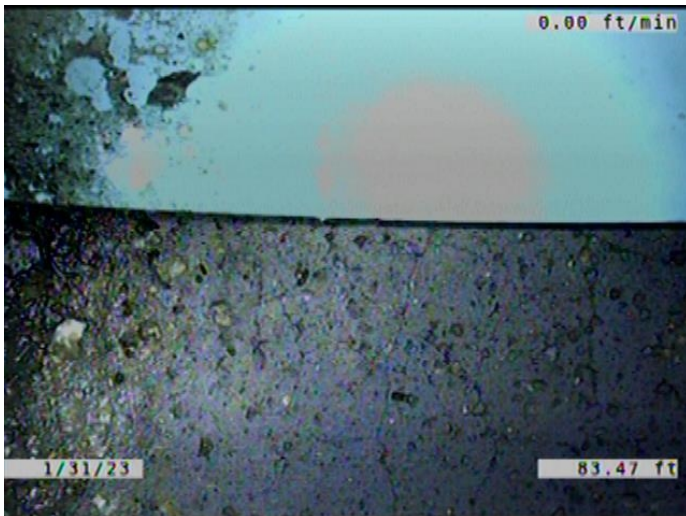
Code: **MMC**
 Description: **Miscellaneous Material Change**

Distance (ft): **83.5**
 Structural Grade: **0**
 O&M Grade: **0**
 Clock Start/From:
 Clock To:
 1st Value:
 2nd Value:
 Value Percent:
 Continuous Index:
 Within 8" of Joint: **NO**
 Remarks: **PVC TO VCP**

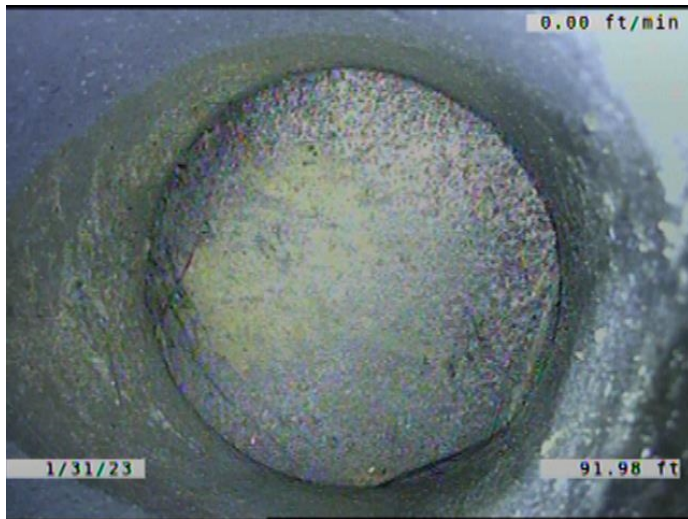
Code: **TFC**
 Description: **Tap Factory Capped**

Distance (ft): **92.0**
 Structural Grade: **0**
 O&M Grade: **0**
 Clock Start/From: **2**
 Clock To:
 1st Value: **6.000**
 2nd Value:
 Value Percent:
 Continuous Index:
 Within 8" of Joint: **YES**
 Remarks:

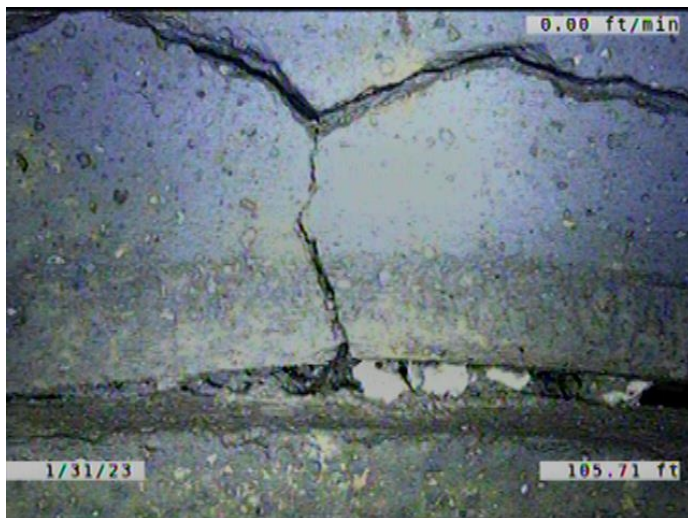
Code: **B**
 Description: **Broken**

Distance (ft): **105.7**
 Structural Grade: **4**
 O&M Grade: **0**
 Clock Start/From: **9**
 Clock To: **3**
 1st Value:
 2nd Value:
 Value Percent:
 Continuous Index:
 Within 8" of Joint: **YES**
 Remarks:

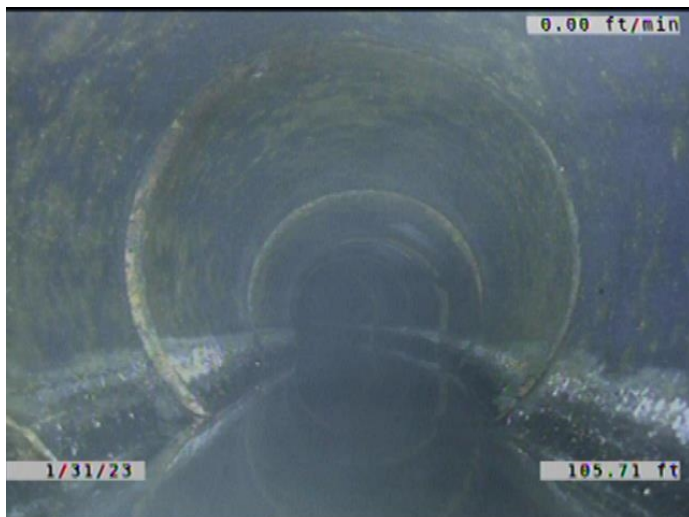
Code: **MWLS**
 Description: **Miscellaneous Water Level Sag**

Distance (ft): **105.7**
 Structural Grade: **2**
 O&M Grade: **0**
 Clock Start/From:
 Clock To:
 1st Value:
 2nd Value:
 Value Percent: **15.000**
 Continuous Index: **F02**
 Within 8" of Joint: **NO**
 Remarks:

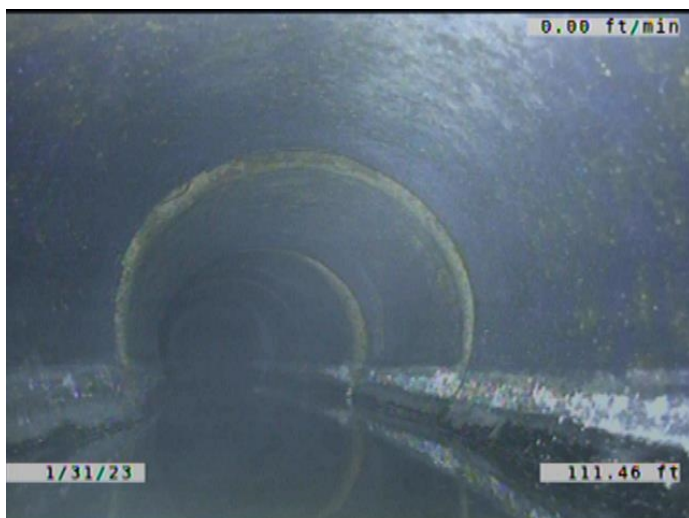
Code: **LL**
 Description: **Line Left**

Distance (ft): **111.5**
 Structural Grade: **0**
 O&M Grade: **1**
 Clock Start/From:
 Clock To:
 1st Value:
 2nd Value:
 Value Percent: **5.000**
 Continuous Index:
 Within 8" of Joint: **NO**
 Remarks:

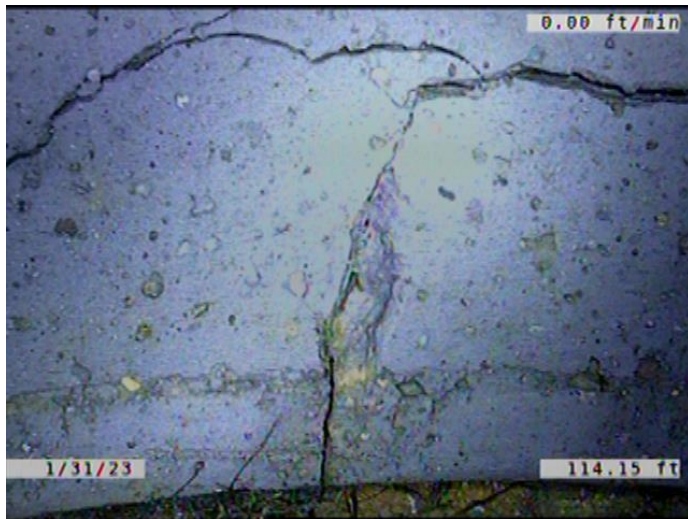
Code: **B**
 Description: **Broken**

Distance (ft): **114.1**
 Structural Grade: **4**
 O&M Grade: **0**
 Clock Start/From: **9**
 Clock To: **11**
 1st Value:
 2nd Value:
 Value Percent:
 Continuous Index:
 Within 8" of Joint: **YES**
 Remarks:

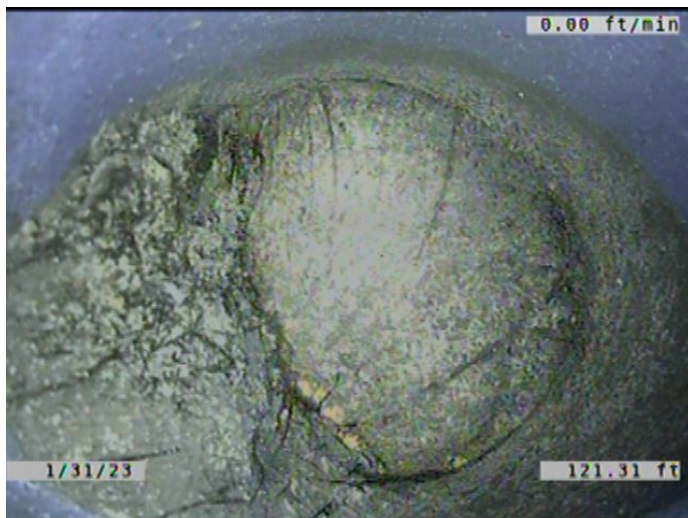
Code: **TFD**
 Description: **Tap Factory Defective**

Distance (ft): **121.3**
 Structural Grade: **0**
 O&M Grade: **3**
 Clock Start/From: **10**
 Clock To:
 1st Value: **6.000**
 2nd Value:
 Value Percent:
 Continuous Index:
 Within 8" of Joint: **YES**
 Remarks: **CAPPED. ROOTS GROWING AROUND THE CAP INTO THE MAIN.**

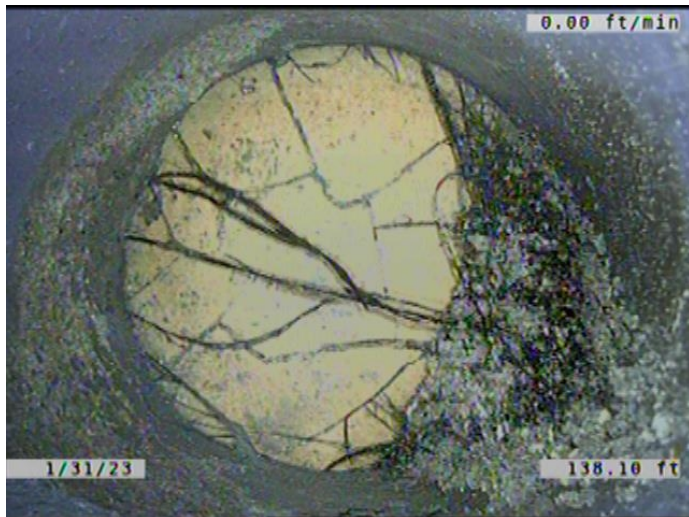
Code:	TFD
Description:	Tap Factory Defective
Distance (ft):	138.1
Structural Grade:	0
O&M Grade:	3
Clock Start/From:	2
Clock To:	
1st Value:	6.000
2nd Value:	
Value Percent:	
Continuous Index:	
Within 8" of Joint:	YES
Remarks:	CAPPED. CAP BROKEN. ROOTS GROWING AROUND THE CAP INTO T

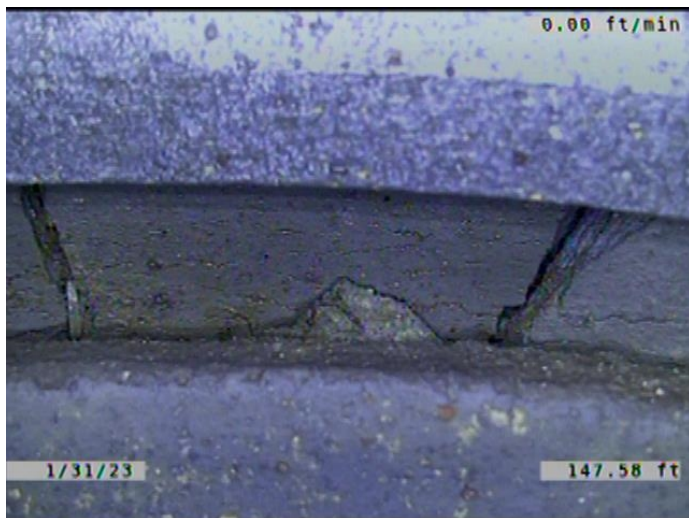
Code:	FM
Description:	Fracture Multiple
Distance (ft):	147.6
Structural Grade:	4
O&M Grade:	0
Clock Start/From:	11
Clock To:	3
1st Value:	
2nd Value:	
Value Percent:	
Continuous Index:	
Within 8" of Joint:	YES
Remarks:

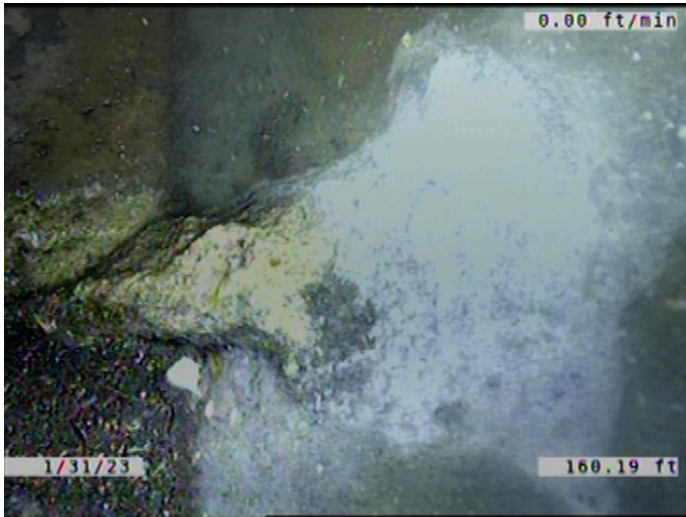
Code:	DAE
Description:	Deposits Attached Encrustation
Distance (ft):	160.2
Structural Grade:	0
O&M Grade:	2
Clock Start/From:	4
Clock To:	8
1st Value:	
2nd Value:	
Value Percent:	5.000
Continuous Index:	
Within 8" of Joint:	YES
Remarks:

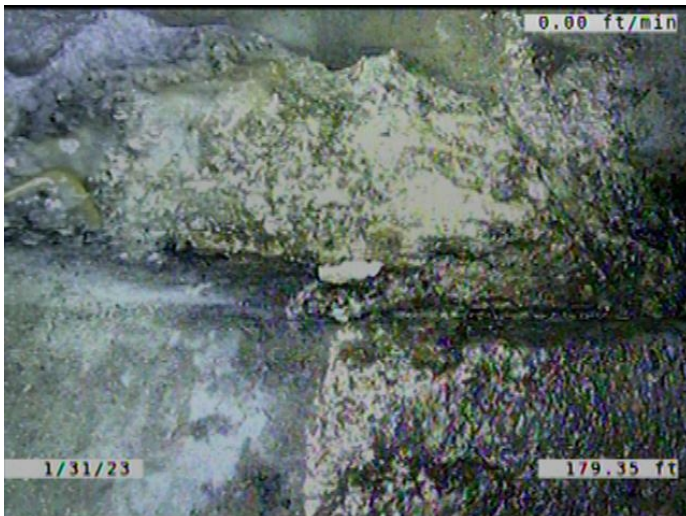
Code:	DAE
Description:	Deposits Attached Encrustation
Distance (ft):	179.4
Structural Grade:	0
O&M Grade:	2
Clock Start/From:	4
Clock To:	8
1st Value:	
2nd Value:	
Value Percent:	5.000
Continuous Index:	S04
Within 8" of Joint:	YES
Remarks:

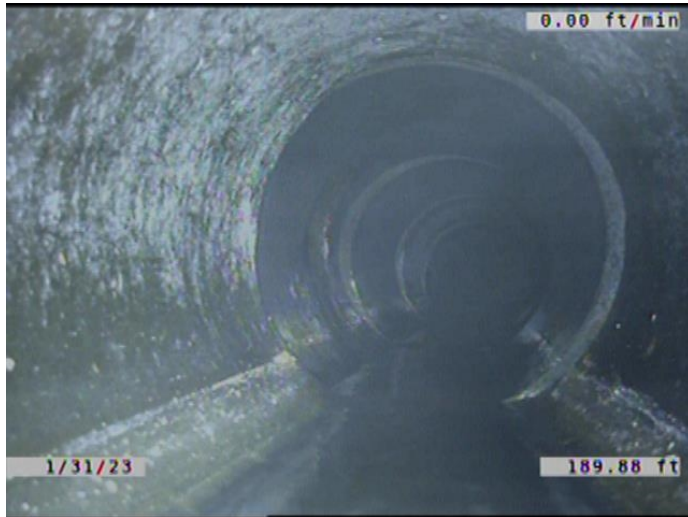
Code: **DAE**
 Description: **Deposits Attached Encrustation**

Distance (ft): **189.9**
 Structural Grade: **0**
 O&M Grade: **2**
 Clock Start/From: **4**
 Clock To: **8**
 1st Value:
 2nd Value:
 Value Percent: **5.000**
 Continuous Index: **F04**
 Within 8" of Joint: **YES**
 Remarks:

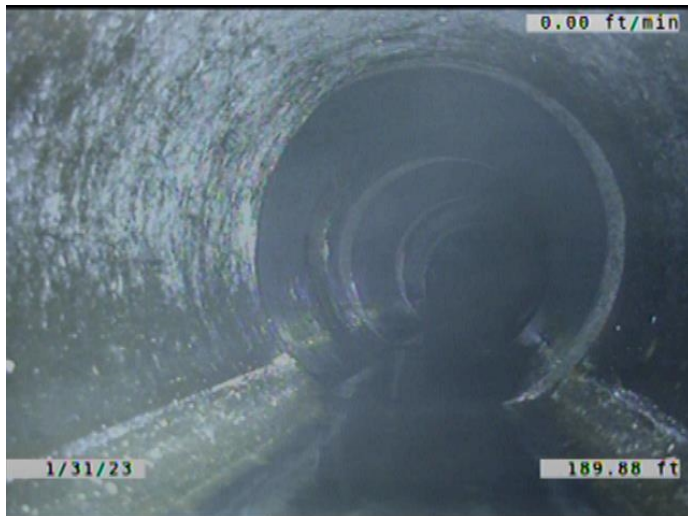
Code: **LR**
 Description: **Line Right**

Distance (ft): **189.9**
 Structural Grade: **0**
 O&M Grade: **1**
 Clock Start/From:
 Clock To:
 1st Value:
 2nd Value:
 Value Percent: **10.000**
 Continuous Index:
 Within 8" of Joint: **NO**
 Remarks:

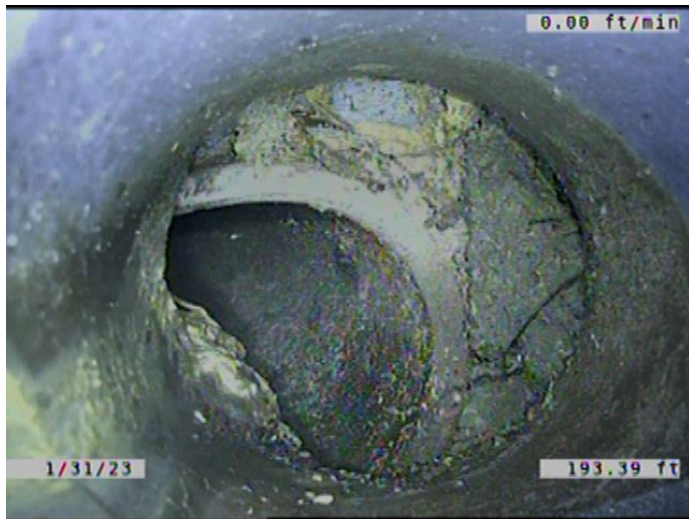
Code:	TFD
Description:	Tap Factory Defective
Distance (ft):	193.4
Structural Grade:	0
O&M Grade:	3
Clock Start/From:	10
Clock To:	
1st Value:	6.000
2nd Value:	
Value Percent:	
Continuous Index:	
Within 8" of Joint:	YES
Remarks:	SERVICE LARGE OFFSET. SOIL VISIBLE. LOOKS LIKE NO SOLIDS AND

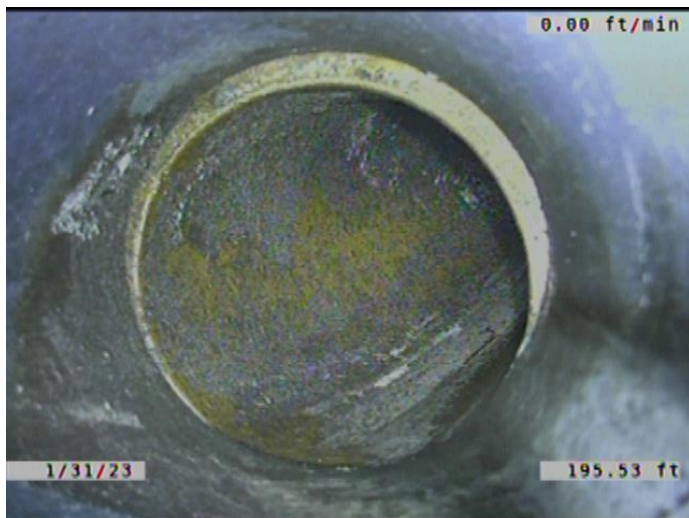
Code:	TF
Description:	Tap Factory
Distance (ft):	195.5
Structural Grade:	0
O&M Grade:	0
Clock Start/From:	2
Clock To:	
1st Value:	6.000
2nd Value:	
Value Percent:	
Continuous Index:	
Within 8" of Joint:	YES
Remarks:

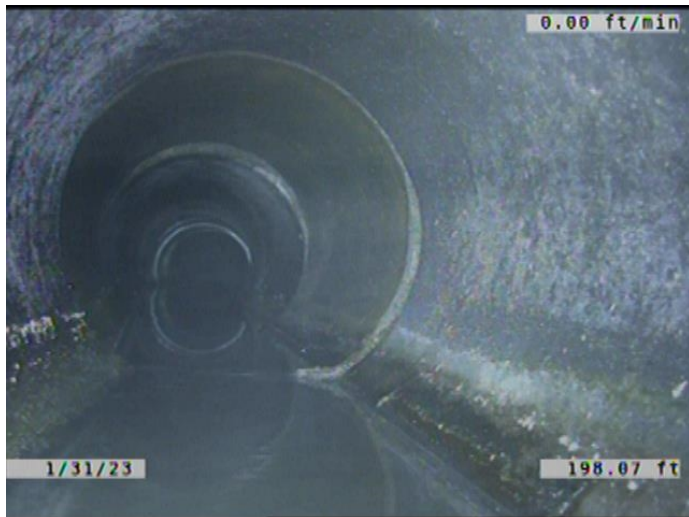
Code: **LL**
 Description: **Line Left**

Distance (ft): **198.1**
 Structural Grade: **0**
 O&M Grade: **1**
 Clock Start/From:
 Clock To:
 1st Value:
 2nd Value:
 Value Percent: **5.000**
 Continuous Index:
 Within 8" of Joint: **NO**
 Remarks:

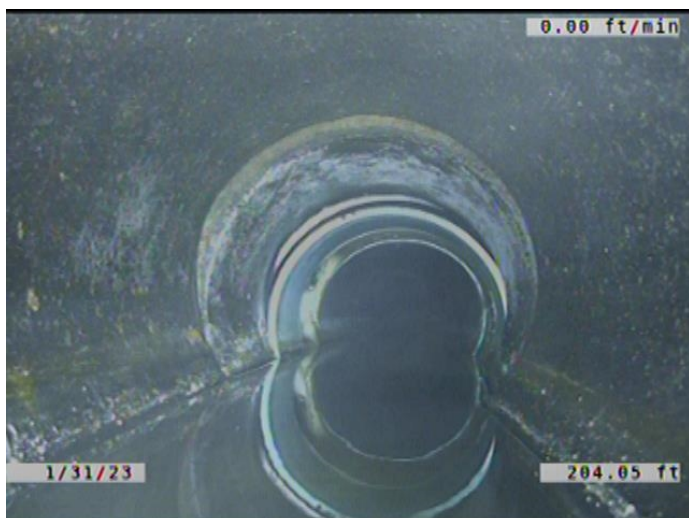
Code: **MWLS**
 Description: **Miscellaneous Water Level Sag**

Distance (ft): **204.0**
 Structural Grade: **2**
 O&M Grade: **0**
 Clock Start/From:
 Clock To:
 1st Value:
 2nd Value:
 Value Percent: **15.000**
 Continuous Index: **S05**
 Within 8" of Joint: **NO**
 Remarks:

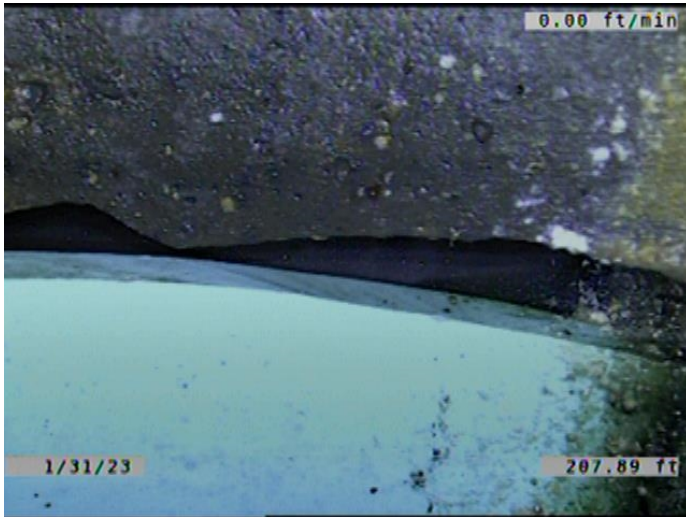
Code: **MMC**
Description: **Miscellaneous Material Change**

Distance (ft): **207.9**
Structural Grade: **0**
O&M Grade: **0**
Clock Start/From:
Clock To:
1st Value:
2nd Value:
Value Percent:
Continuous Index:
Within 8" of Joint: **NO**
Remarks: **VCP TO PVC**

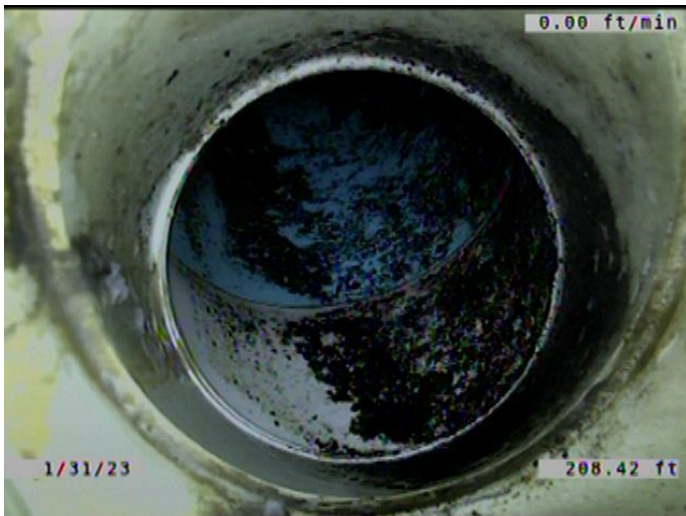
Code: **TF**
Description: **Tap Factory**

Distance (ft): **208.4**
Structural Grade: **0**
O&M Grade: **0**
Clock Start/From: **10**
Clock To:
1st Value: **6.000**
2nd Value:
Value Percent:
Continuous Index:
Within 8" of Joint: **YES**
Remarks:

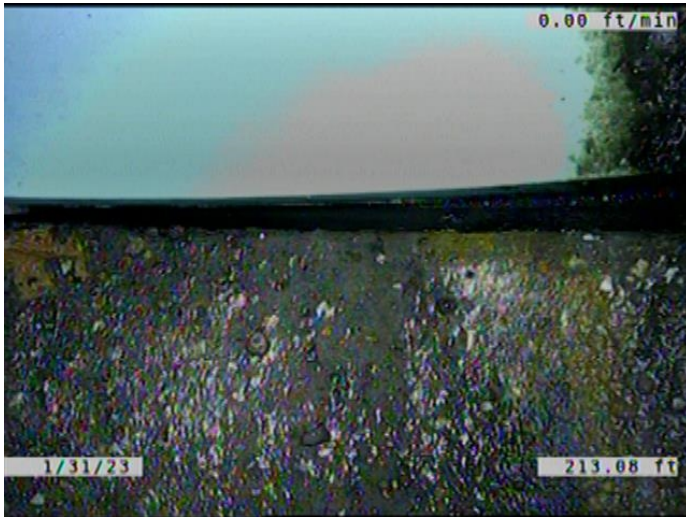
Code: **MMC**
Description: **Miscellaneous Material Change**

Distance (ft): **213.1**
Structural Grade: **0**
O&M Grade: **0**
Clock Start/From:
Clock To:
1st Value:
2nd Value:
Value Percent:
Continuous Index:
Within 8" of Joint: **NO**
Remarks: **PVC TO VCP**

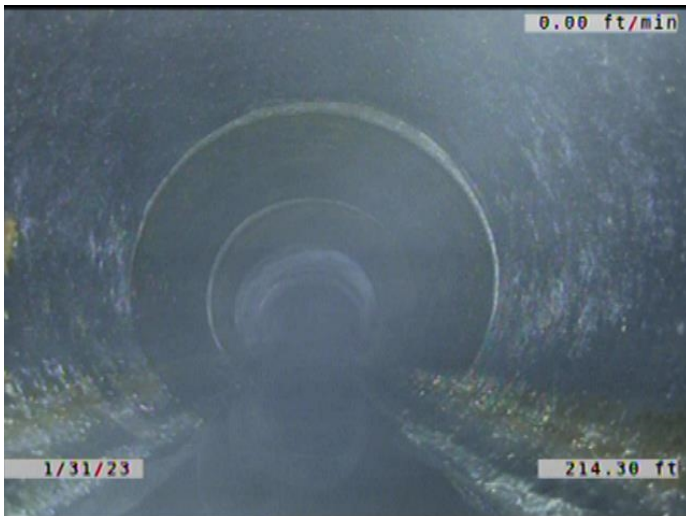
Code: **MWLS**
Description: **Miscellaneous Water Level Sag**

Distance (ft): **214.3**
Structural Grade: **2**
O&M Grade: **0**
Clock Start/From:
Clock To:
1st Value:
2nd Value:
Value Percent: **15.000**
Continuous Index: **F05**
Within 8" of Joint: **NO**
Remarks:

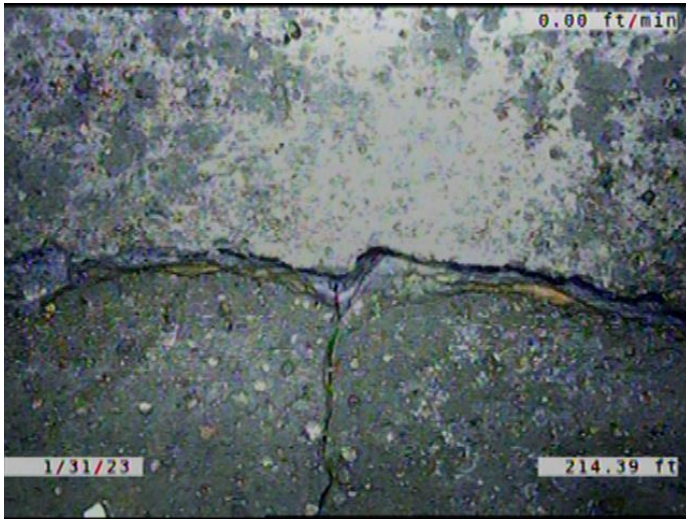
Code: **B**
Description: **Broken**

Distance (ft): **214.4**
Structural Grade: **4**
O&M Grade: **0**
Clock Start/From: **10**
Clock To: **2**
1st Value:
2nd Value:
Value Percent:
Continuous Index:
Within 8" of Joint: **YES**
Remarks:

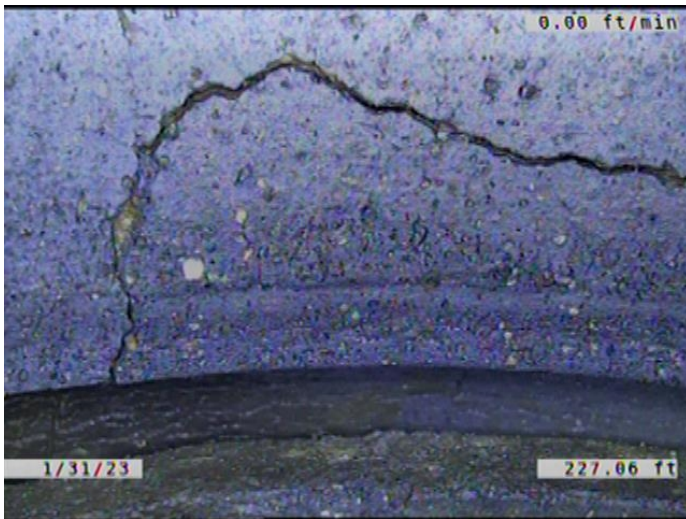
Code: **B**
Description: **Broken**

Distance (ft): **227.1**
Structural Grade: **4**
O&M Grade: **0**
Clock Start/From: **10**
Clock To: **11**
1st Value:
2nd Value:
Value Percent:
Continuous Index:
Within 8" of Joint: **YES**
Remarks:

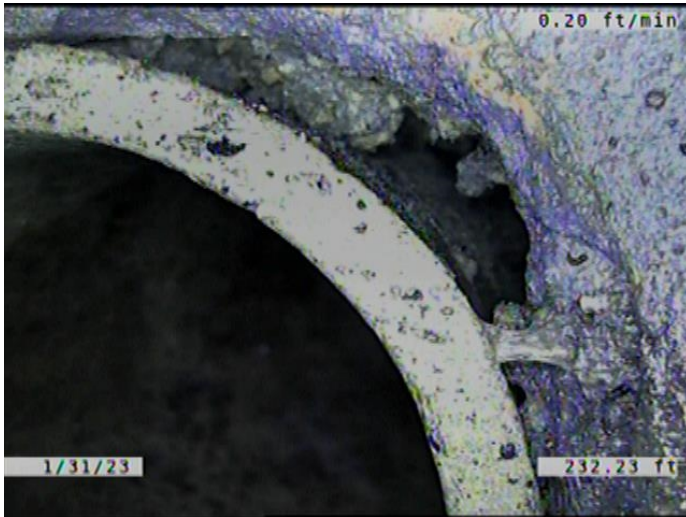
Code: **BSV**
 Description: **Broken Soil Visible**

Distance (ft): **232.2**
 Structural Grade: **5**
 O&M Grade: **0**
 Clock Start/From: **1**
 Clock To: **4**
 1st Value:
 2nd Value:
 Value Percent:
 Continuous Index:
 Within 8" of Joint: **YES**
 Remarks:

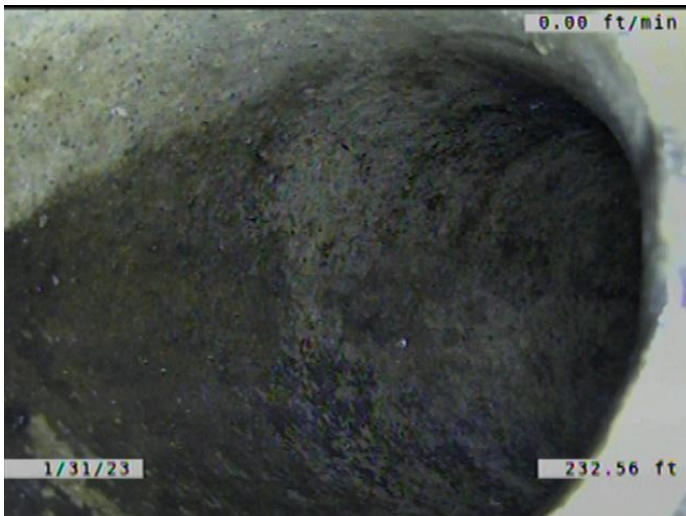
Code: **TB**
 Description: **Tap Break-in/Hammer**

Distance (ft): **232.6**
 Structural Grade: **0**
 O&M Grade: **0**
 Clock Start/From: **2**
 Clock To:
 1st Value: **6.000**
 2nd Value:
 Value Percent:
 Continuous Index:
 Within 8" of Joint: **YES**
 Remarks:

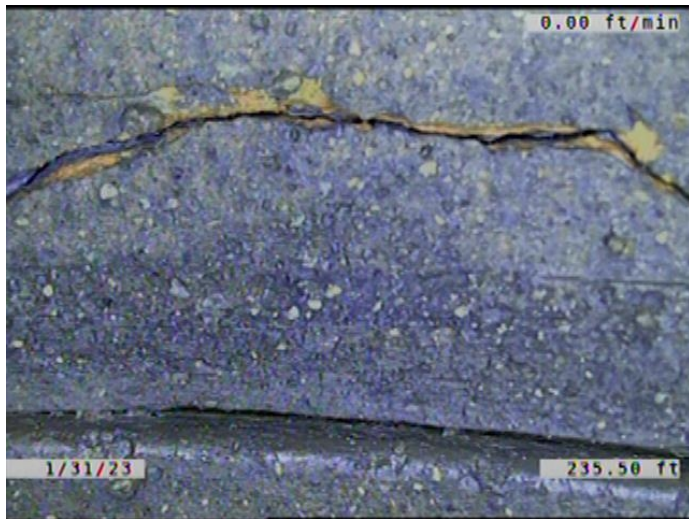
Code: **B**
 Description: **Broken**

Distance (ft): **235.5**
 Structural Grade: **4**
 O&M Grade: **0**
 Clock Start/From: **2**
 Clock To: **4**
 1st Value:
 2nd Value:
 Value Percent:
 Continuous Index:
 Within 8" of Joint: **YES**
 Remarks:

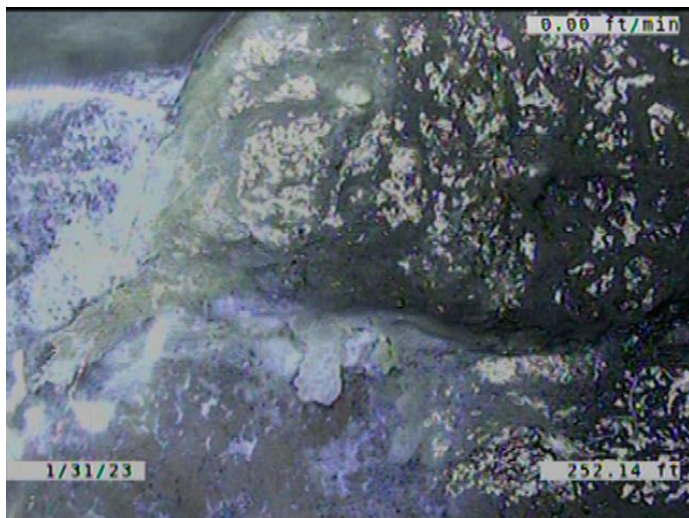
Code: **DAE**
 Description: **Deposits Attached Encrustation**

Distance (ft): **252.1**
 Structural Grade: **0**
 O&M Grade: **2**
 Clock Start/From: **4**
 Clock To: **8**
 1st Value:
 2nd Value:
 Value Percent: **5.000**
 Continuous Index:
 Within 8" of Joint: **YES**
 Remarks:

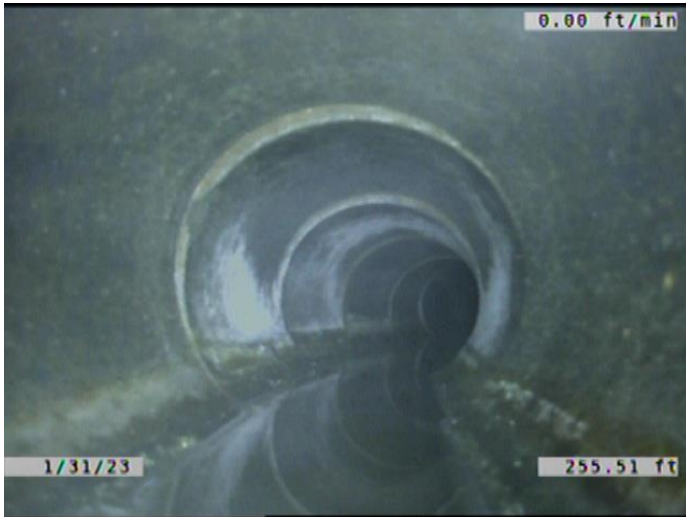
Code: **LR**
Description: **Line Right**

Distance (ft): **255.5**
Structural Grade: **0**
O&M Grade: **1**
Clock Start/From:
Clock To:
1st Value:
2nd Value:
Value Percent: **10.000**
Continuous Index:
Within 8" of Joint: **NO**
Remarks:

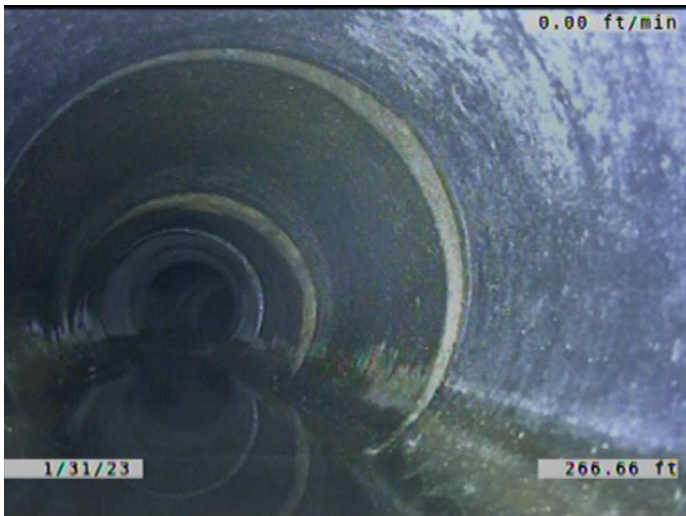
Code: **LL**
Description: **Line Left**

Distance (ft): **266.7**
Structural Grade: **0**
O&M Grade: **1**
Clock Start/From:
Clock To:
1st Value:
2nd Value:
Value Percent: **5.000**
Continuous Index:
Within 8" of Joint: **NO**
Remarks:

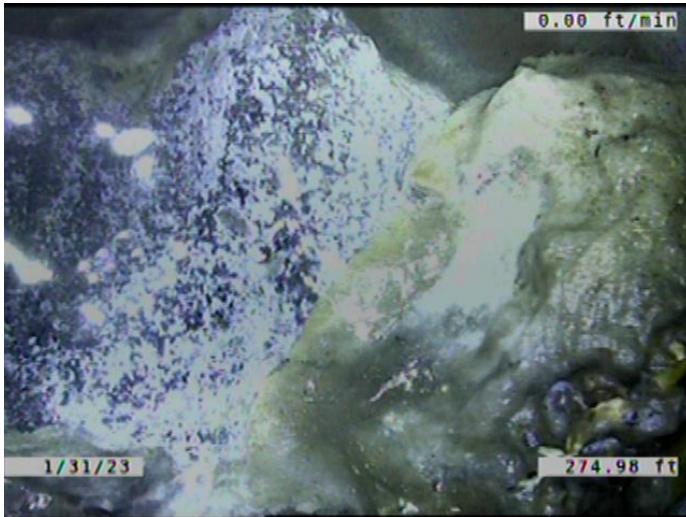
Code:	DAE
Description:	Deposits Attached Encrustation
Distance (ft):	275.0
Structural Grade:	0
O&M Grade:	2
Clock Start/From:	4
Clock To:	8
1st Value:	
2nd Value:	
Value Percent:	5.000
Continuous Index:	
Within 8" of Joint:	YES
Remarks:

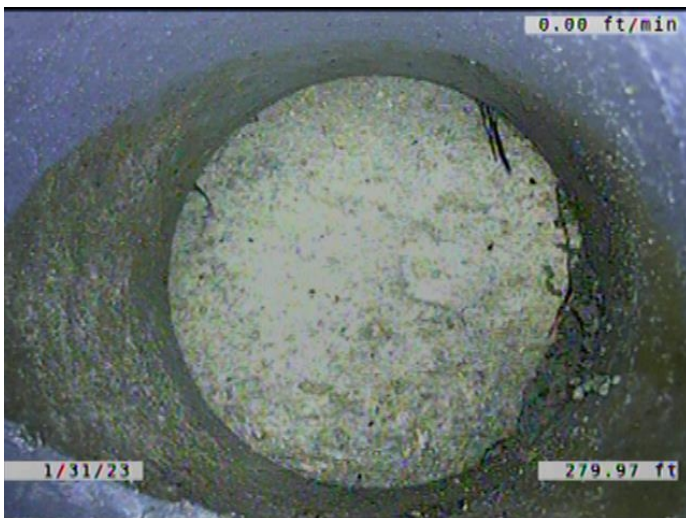
Code:	TFC
Description:	Tap Factory Capped
Distance (ft):	280.0
Structural Grade:	0
O&M Grade:	0
Clock Start/From:	2
Clock To:	
1st Value:	6.000
2nd Value:	
Value Percent:	
Continuous Index:	
Within 8" of Joint:	YES
Remarks:

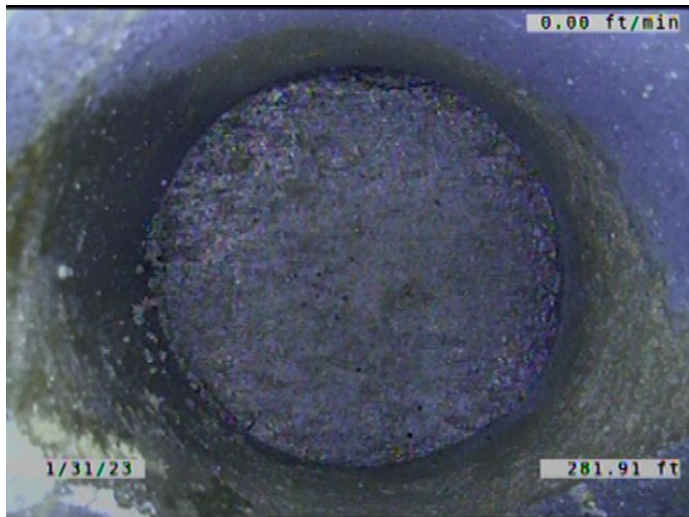
Code: **TFC**
 Description: **Tap Factory Capped**

Distance (ft): **281.9**
 Structural Grade: **0**
 O&M Grade: **0**
 Clock Start/From: **10**
 Clock To:
 1st Value: **6.000**
 2nd Value:
 Value Percent:
 Continuous Index:
 Within 8" of Joint: **YES**
 Remarks:

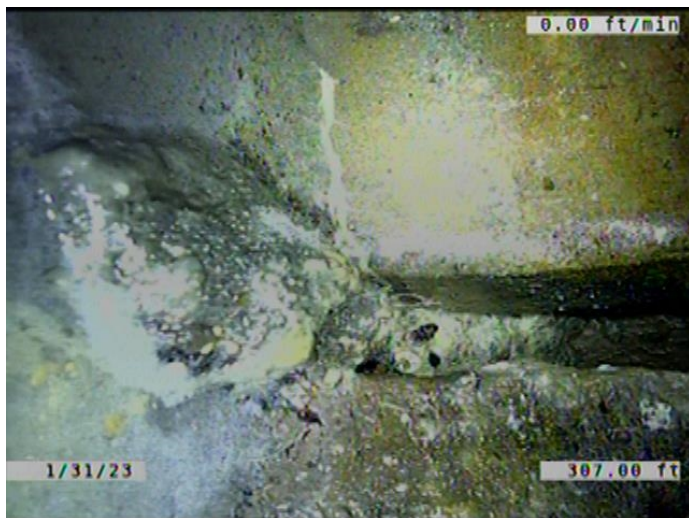
Code: **DAE**
 Description: **Deposits Attached Encrustation**

Distance (ft): **307.0**
 Structural Grade: **0**
 O&M Grade: **2**
 Clock Start/From: **4**
 Clock To: **8**
 1st Value:
 2nd Value:
 Value Percent: **5.000**
 Continuous Index:
 Within 8" of Joint: **YES**
 Remarks:

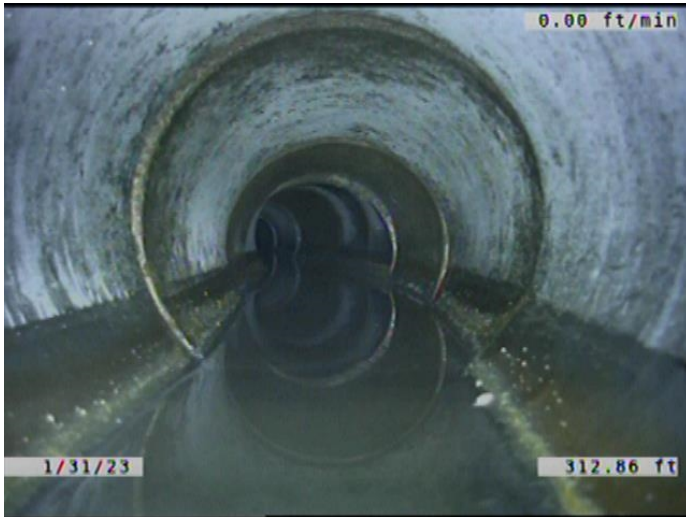
Code: **MWLS**
Description: **Miscellaneous Water Level Sag**

Distance (ft): **312.9**
Structural Grade: **2**
O&M Grade: **0**
Clock Start/From:
Clock To:
1st Value:
2nd Value:
Value Percent: **20.000**
Continuous Index: **S06**
Within 8" of Joint: **NO**
Remarks:

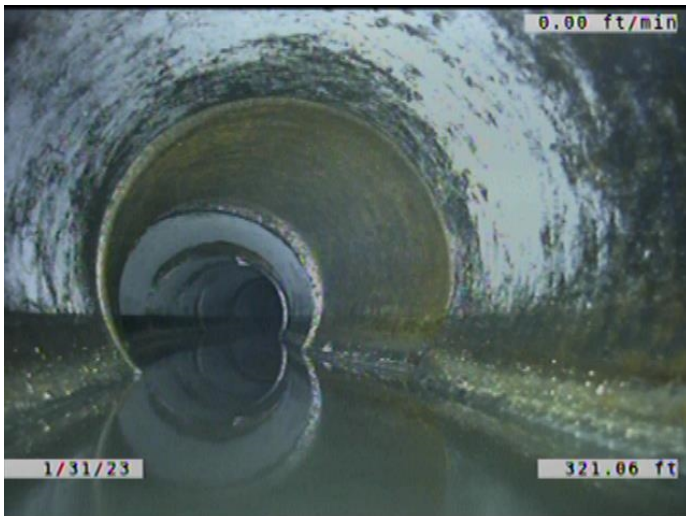
Code: **LL**
Description: **Line Left**

Distance (ft): **321.1**
Structural Grade: **0**
O&M Grade: **1**
Clock Start/From:
Clock To:
1st Value:
2nd Value:
Value Percent: **5.000**
Continuous Index:
Within 8" of Joint: **NO**
Remarks:

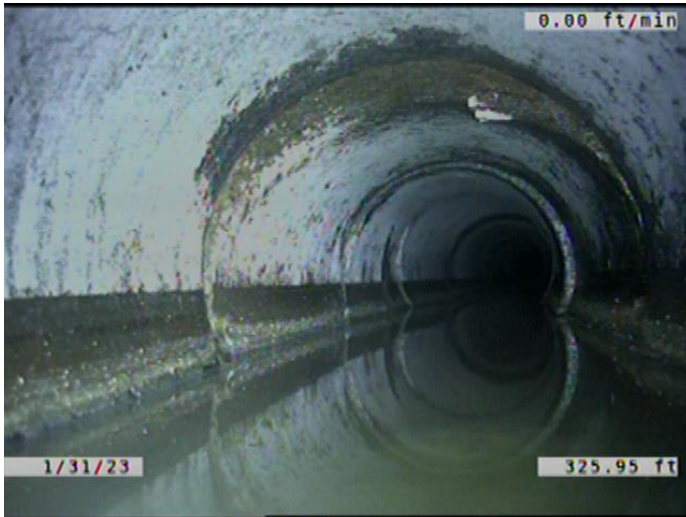
Code: **LR**
Description: **Line Right**

Distance (ft): **325.9**
Structural Grade: **0**
O&M Grade: **1**
Clock Start/From:
Clock To:
1st Value:
2nd Value:
Value Percent: **10.000**
Continuous Index:
Within 8" of Joint: **NO**
Remarks:

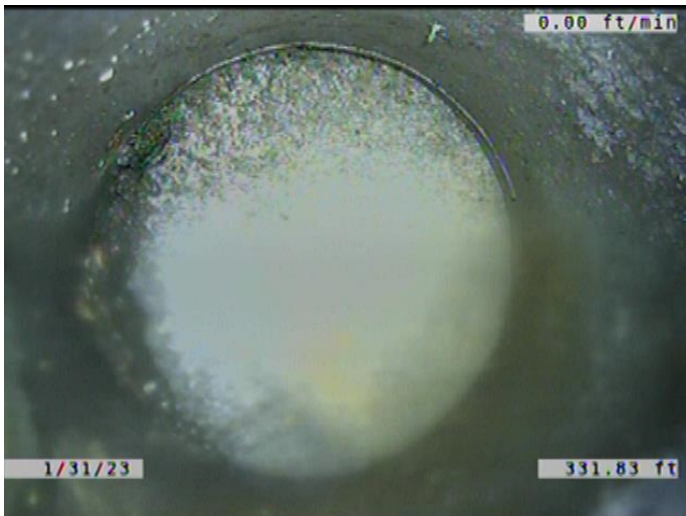
Code: **TFC**
Description: **Tap Factory Capped**

Distance (ft): **331.8**
Structural Grade: **0**
O&M Grade: **0**
Clock Start/From: **10**
Clock To:
1st Value: **6.000**
2nd Value:
Value Percent:
Continuous Index:
Within 8" of Joint: **YES**
Remarks:

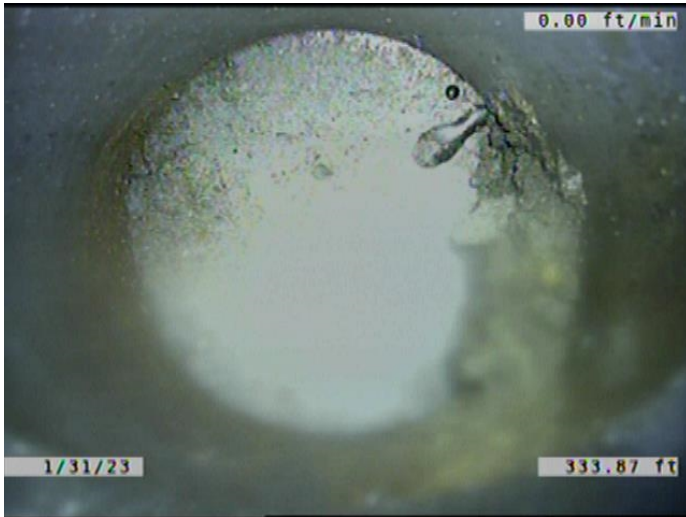
Code: **TFC**
 Description: **Tap Factory Capped**

Distance (ft): **333.9**
 Structural Grade: **0**
 O&M Grade: **0**
 Clock Start/From: **2**
 Clock To:
 1st Value: **6.000**
 2nd Value:
 Value Percent:
 Continuous Index:
 Within 8" of Joint: **YES**
 Remarks:
