Profile/Photo Observation Report

Date:	01/31/2023	Weather:		Coding:	PACP 7.0
Pipe Length (ft):	430.0	Owner:	City of Hobart	Pre Clean:	Heavy Cleaning
P.O.#:	YES502259	Surveyor:	S. Bucklin	PSR:	P-804-002-037
Customer:	City of Hobart	Clean Date:	11/28/2022	Shape:	C

Street:	South Liberty Place	Flow Control:	Not Controlled
City:	Hobart, IN	Year Renewed:	
Location:	Local rural streets with light traffic, t	Tape/Media #:	
Purpose:	Routine Assessment	Dia/Height:	12"
Use:	Sanitary Sewage Pipe	Material:	VCP
Drain Area:		Lining:	None
Category:	NA		
Comment:			
Location Details:		Direction of Survey:	Upstream
US MH:	M-805-037	DS MH:	M-804-002
		Total Length Surveyed (ft):	424.0

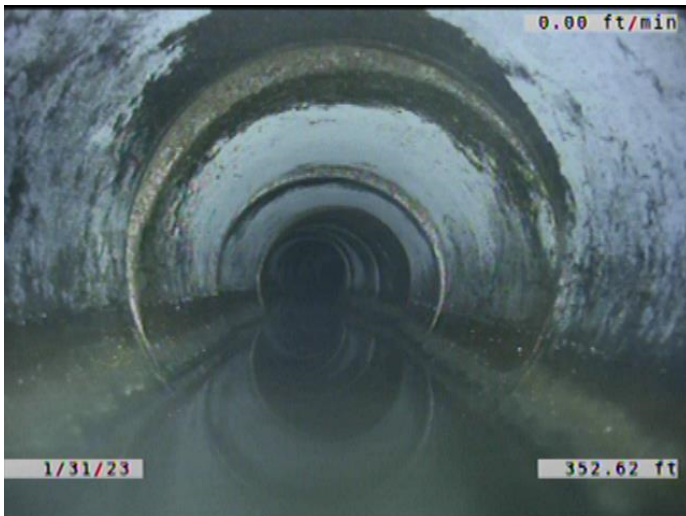
Code: **MWLS**
 Description: **Miscellaneous Water Level Sag**

Distance (ft): **352.6**
 Structural Grade: **2**
 O&M Grade: **0**
 Clock Start/From:
 Clock To:
 1st Value:
 2nd Value:
 Value Percent: **20.000**
 Continuous Index: **F06**
 Within 8" of Joint: **NO**
 Remarks:

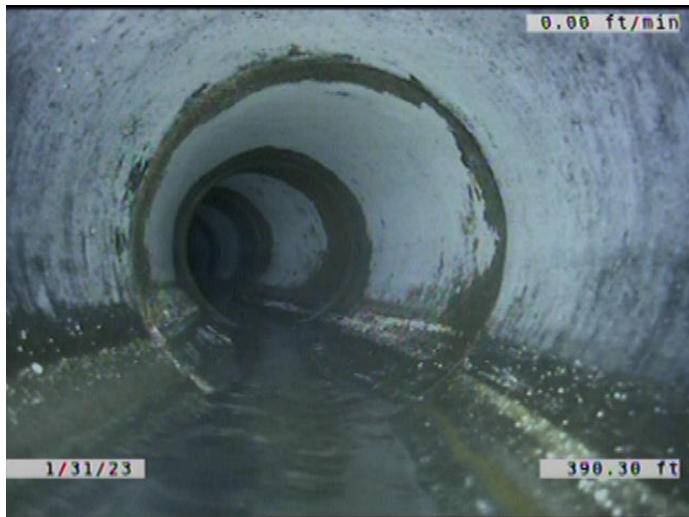
Code: **LL**
 Description: **Line Left**

Distance (ft): **390.3**
 Structural Grade: **0**
 O&M Grade: **2**
 Clock Start/From:
 Clock To:
 1st Value:
 2nd Value:
 Value Percent: **20.000**
 Continuous Index:
 Within 8" of Joint: **NO**
 Remarks:

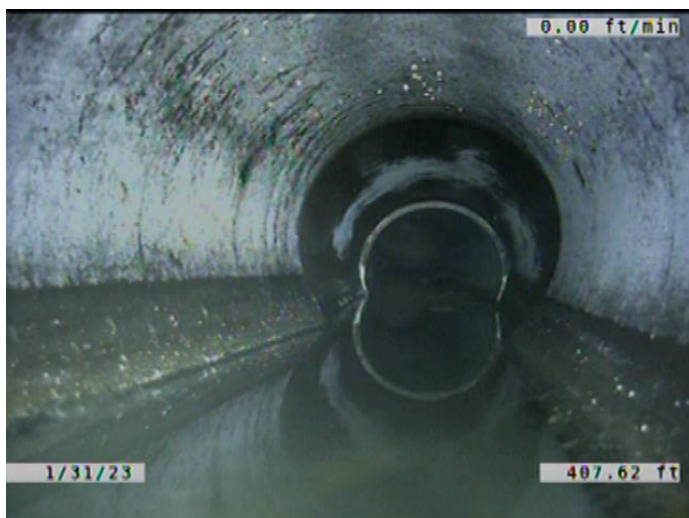
Code: **LR**
 Description: **Line Right**

Distance (ft): **407.6**
 Structural Grade: **0**
 O&M Grade: **1**
 Clock Start/From:
 Clock To:
 1st Value:
 2nd Value:
 Value Percent: **10.000**
 Continuous Index:
 Within 8" of Joint: **NO**
 Remarks:

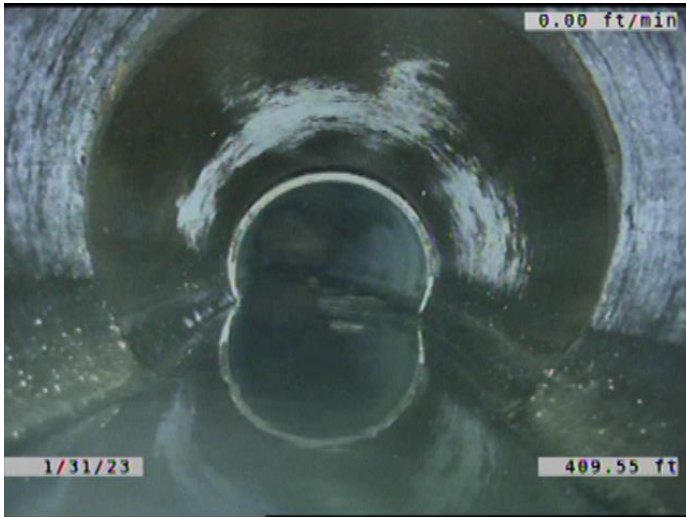
Code: **MWLS**
 Description: **Miscellaneous Water Level Sag**

Distance (ft): **409.5**
 Structural Grade: **2**
 O&M Grade: **0**
 Clock Start/From:
 Clock To:
 1st Value:
 2nd Value:
 Value Percent: **20.000**
 Continuous Index: **S07**
 Within 8" of Joint: **NO**
 Remarks:

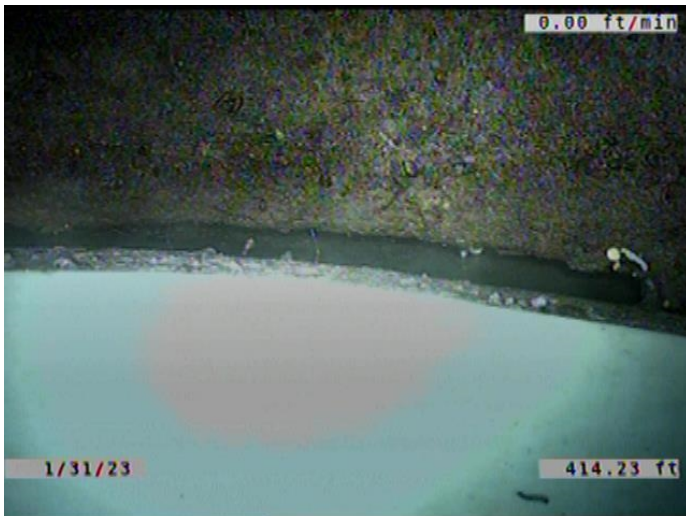
Code: **MMC**
 Description: **Miscellaneous Material Change**

Distance (ft): **414.2**
 Structural Grade: **0**
 O&M Grade: **0**
 Clock Start/From:
 Clock To:
 1st Value:
 2nd Value:
 Value Percent:
 Continuous Index:
 Within 8" of Joint: **NO**
 Remarks: **VCP TO PVC**

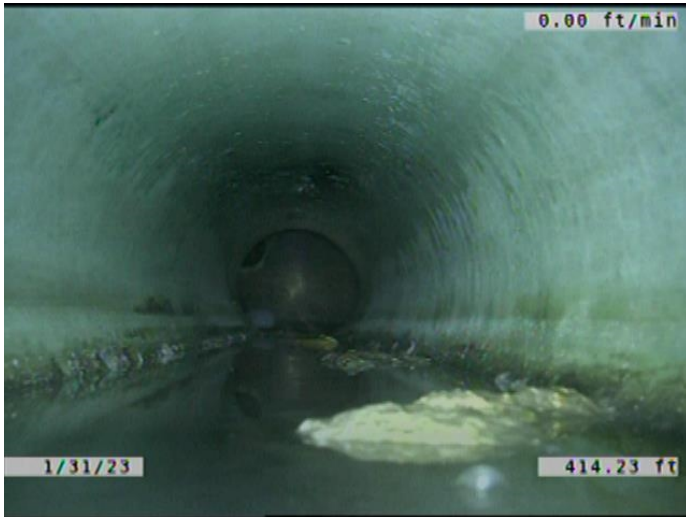
Code: **JOMD**
 Description: **Joint Offset Medium Defective**

Distance (ft): **414.2**
 Structural Grade: **3**
 O&M Grade: **0**
 Clock Start/From:
 Clock To:
 1st Value:
 2nd Value:
 Value Percent:
 Continuous Index: **F01**
 Within 8" of Joint: **NO**
 Remarks:

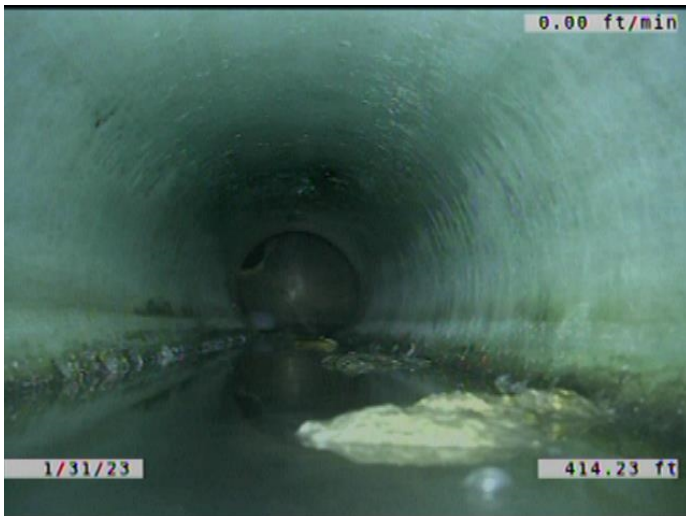
Code: **RFJ**
 Description: **Roots Fine Joint**

Distance (ft): **414.2**
 Structural Grade: **0**
 O&M Grade: **1**
 Clock Start/From: **8**
 Clock To: **4**
 1st Value:
 2nd Value:
 Value Percent:
 Continuous Index: **F03**
 Within 8" of Joint: **YES**
 Remarks:

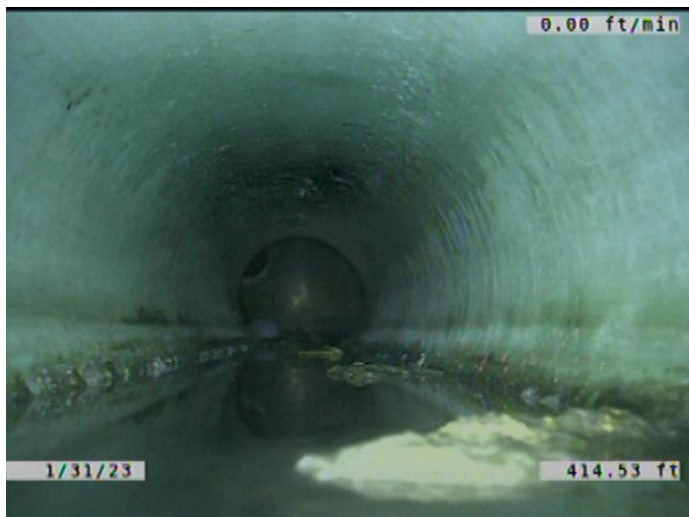
Code: **DSF**
 Description: **Deposits Settled Fine**

Distance (ft): **414.5**
 Structural Grade: **0**
 O&M Grade: **2**
 Clock Start/From: **5**
 Clock To: **7**
 1st Value:
 2nd Value:
 Value Percent: **5.000**
 Continuous Index:
 Within 8" of Joint: **YES**
 Remarks: **ALSO RAGS AND TP**

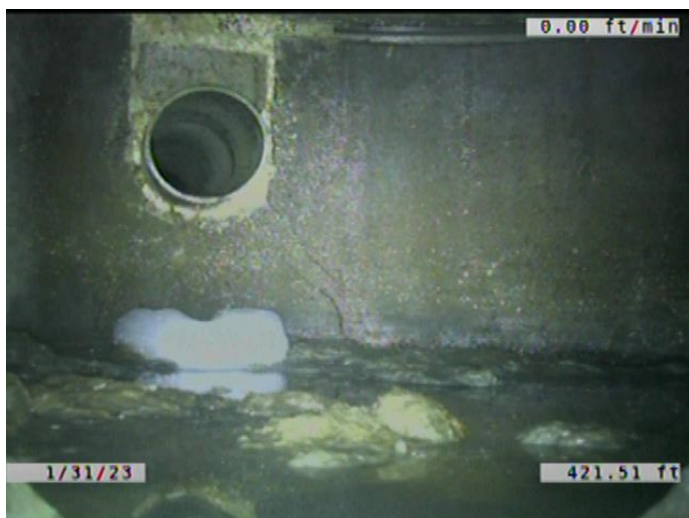
Code: **MWLS**
 Description: **Miscellaneous Water Level Sag**

Distance (ft): **421.5**
 Structural Grade: **2**
 O&M Grade: **0**
 Clock Start/From:
 Clock To:
 1st Value:
 2nd Value:
 Value Percent: **20.000**
 Continuous Index: **F07**
 Within 8" of Joint: **NO**
 Remarks:

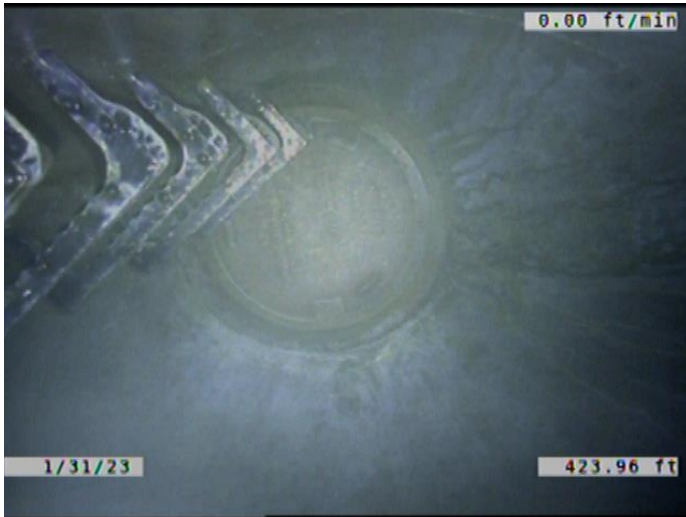
Code:	AMH
Description:	Manhole
Distance (ft):	424.0
Structural Grade:	0
O&M Grade:	0
Clock Start/From:	
Clock To:	
1st Value:	
2nd Value:	
Value Percent:	
Continuous Index:	
Within 8" of Joint:	NO
Remarks:	M-805-037
