Profile/Photo Observation Report

| Pipe Length (ft): | 120.0 | Owner: | City of Hobart | Pre Clean: | Heavy Cleaning |
| P.O.#: | YES502259 | Surveyor: | S. Bucklin | PSR: | M-805-036-M-805-037.1 |

| Street: | South Liberty Place | Flow Control: | Not Controlled |

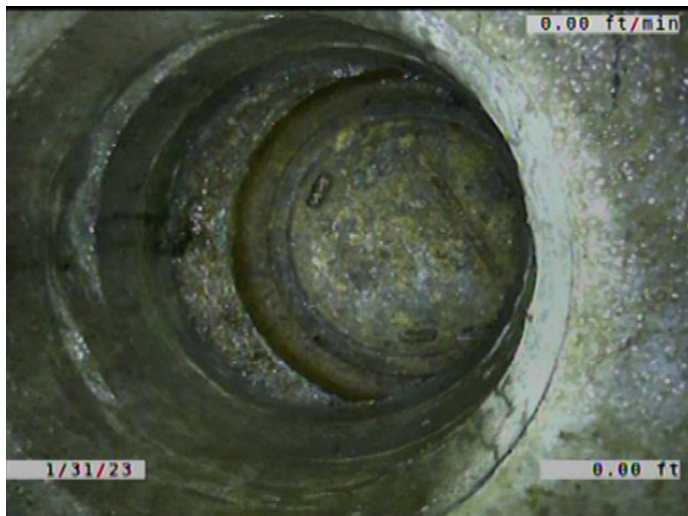
Code: **AMH**
Description: **Manhole**

Distance (ft): **.0**
Structural Grade: **0**
O&M Grade: **0**
Clock Start/From:
Clock To:
1st Value:
2nd Value:
Value Percent:
Continuous Index:
Within 8" of Joint: **NO**
Remarks: **M-805-037.1**

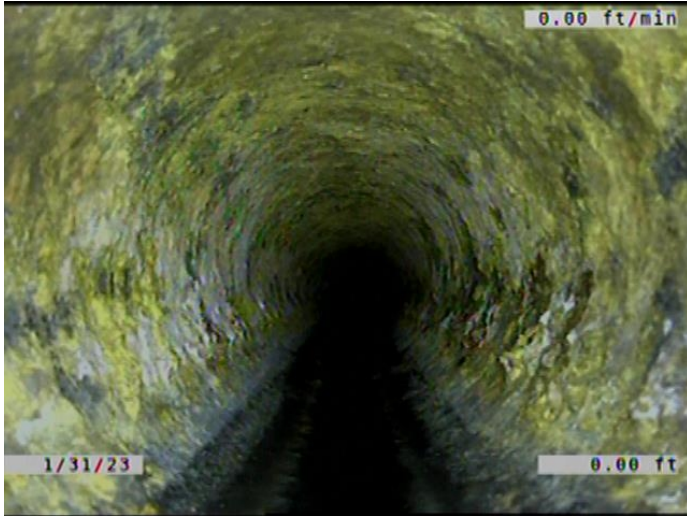
| Description: | Miscellaneous Water Level |
| Value Percent: | 5.000 |

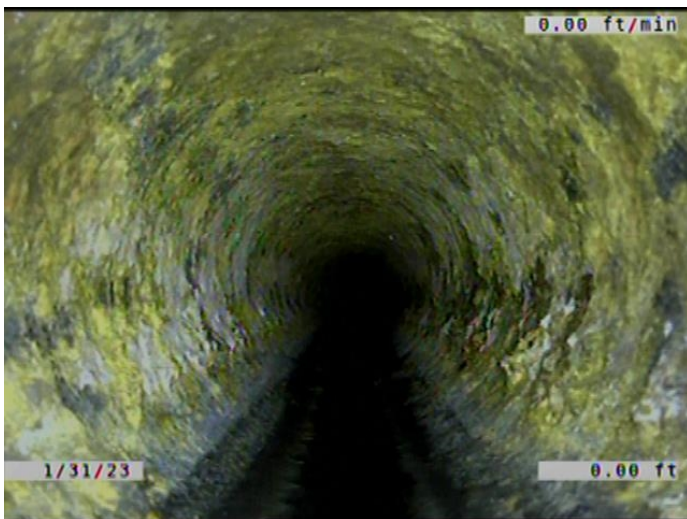
| Description: | Surface Damage Surface Spalling |
| Distance (ft): | .0 |
| Structural Grade: | 2 |
| Clock Start/From: | 7 |
| Clock To: | 5 |

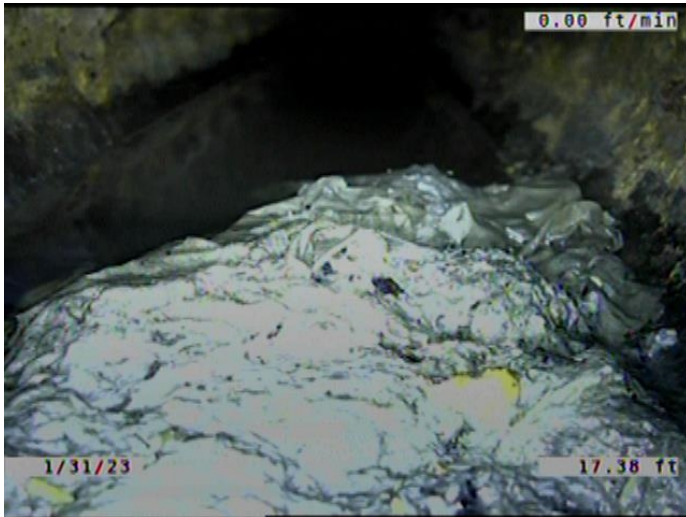
Code: **DAR**
 Description: **Deposits Attached Ragging**

Distance (ft): **17.4**
 Structural Grade: **0**
 O&M Grade: **2**
 Clock Start/From: **5**
 Clock To: **7**
 1st Value:
 2nd Value:
 Value Percent: **5.000**
 Continuous Index:
 Within 8" of Joint: **NO**
 Remarks:

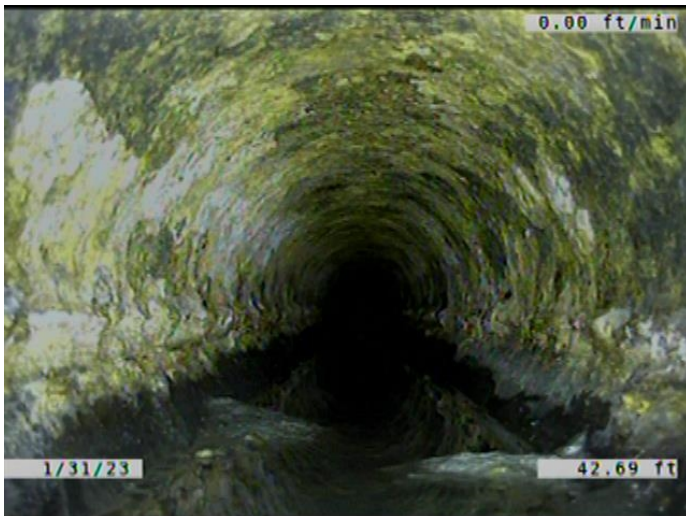
Code: **DAE**
 Description: **Deposits Attached Encrustation**

Distance (ft): **42.7**
 Structural Grade: **0**
 O&M Grade: **2**
 Clock Start/From: **8**
 Clock To: **4**
 1st Value:
 2nd Value:
 Value Percent: **5.000**
 Continuous Index: **S02**
 Within 8" of Joint: **YES**
 Remarks:

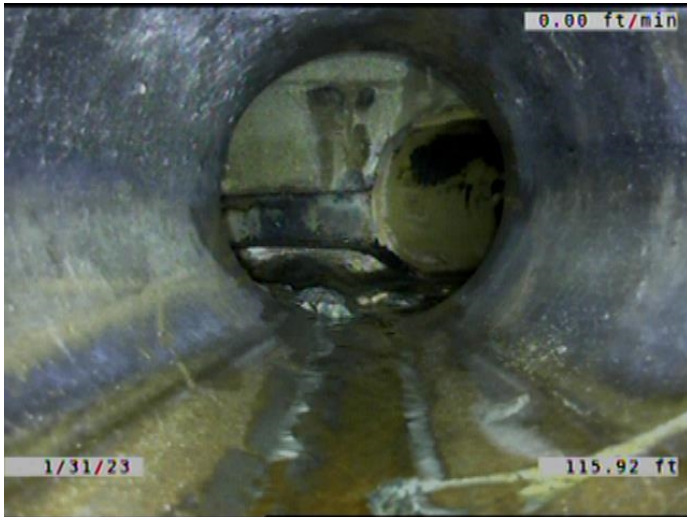
Code: **SSS**
Description: **Surface Damage Surface Spalling**

Distance (ft): **115.9**
Structural Grade: **2**
O&M Grade: **0**
Clock Start/From: **7**
Clock To: **5**
1st Value:
2nd Value:
Value Percent:
Continuous Index: **F01**
Within 8" of Joint: **YES**
Remarks:

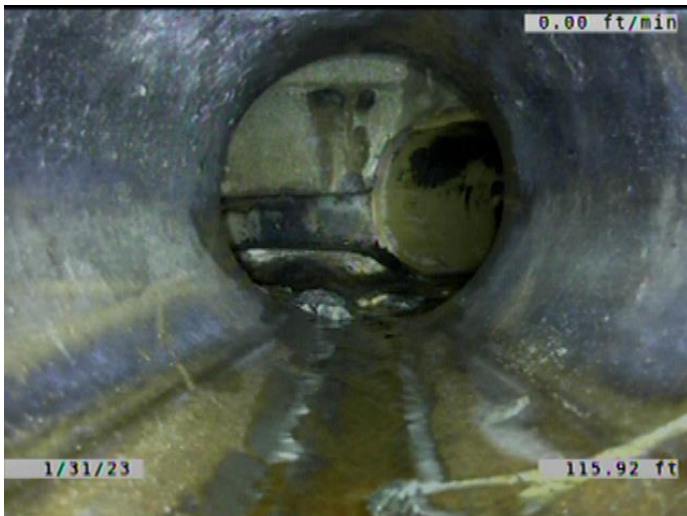
Code: **DAE**
Description: **Deposits Attached Encrustation**

Distance (ft): **115.9**
Structural Grade: **0**
O&M Grade: **2**
Clock Start/From: **8**
Clock To: **4**
1st Value:
2nd Value:
Value Percent: **5.000**
Continuous Index: **F02**
Within 8" of Joint: **YES**
Remarks:

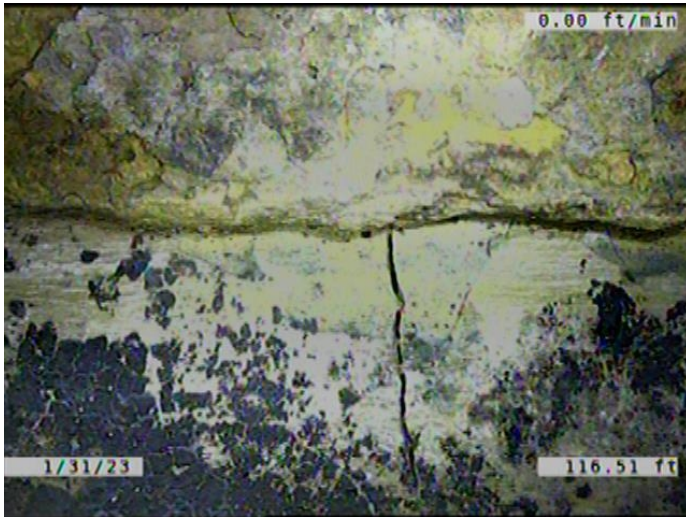
Code: **MMC**
 Description: **Miscellaneous Material Change**

Distance (ft): **116.5**
 Structural Grade: **0**
 O&M Grade: **0**
 Clock Start/From:
 Clock To:
 1st Value:
 2nd Value:
 Value Percent:
 Continuous Index:
 Within 8" of Joint: **NO**
 Remarks: **DIP TO VCP**

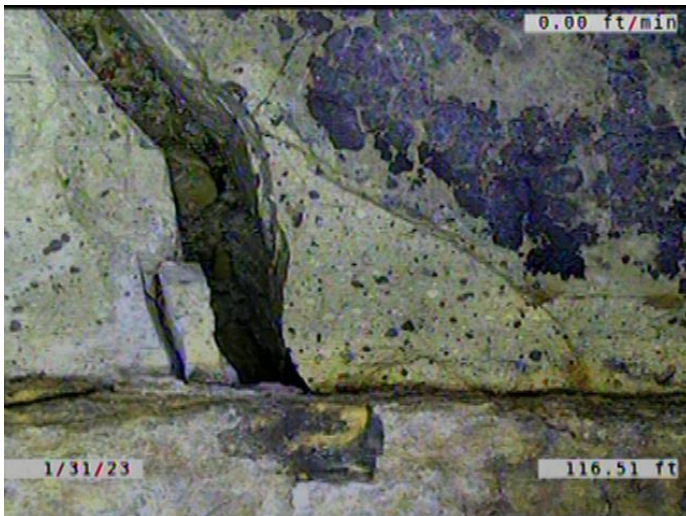
Code: **BVV**
 Description: **Broken Void Visible**

Distance (ft): **116.5**
 Structural Grade: **5**
 O&M Grade: **0**
 Clock Start/From: **12**
 Clock To: **8**
 1st Value:
 2nd Value:
 Value Percent:
 Continuous Index:
 Within 8" of Joint: **YES**
 Remarks:

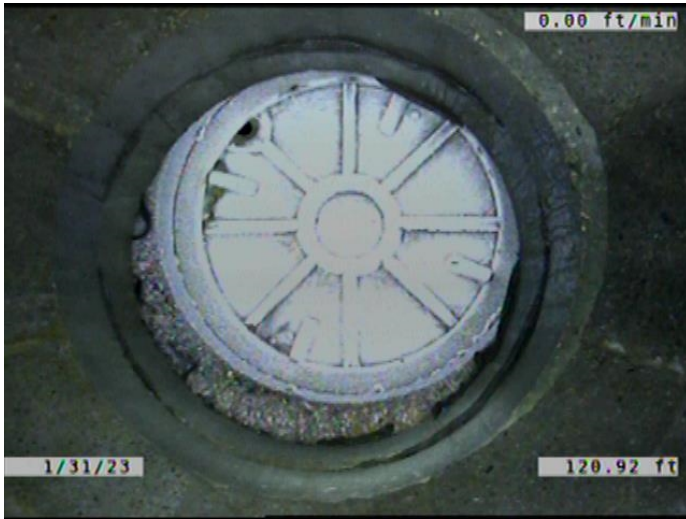
| Description: | Manhole |
| Distance (ft): | 120.9 |
| Remarks: | M-805-036 |
