## Profile/Photo Observation Report

Date:	<b>04/20/2018</b>	Weather:		Coding:	<b>PACP 6.0</b>
Pipe Length (ft):	<b>165.6</b>	Owner:	<b>NA</b>	Pre Clean:	<b>Not Known</b>
P.O.#:		Surveyor:	<b>Byrd Fitzgerald</b>	PSR:	<b>P-805-036-037</b>
Customer:		Clean Date:	<b>01/01/1900</b>	Shape:	<b>C</b>

Location Details:		Direction of Survey:	<b>Upstream</b>
US MH:	<b>M-805-037</b>	DS MH:	<b>M-805-036</b>
		Total Length Surveyed (ft):	<b>120.0</b>

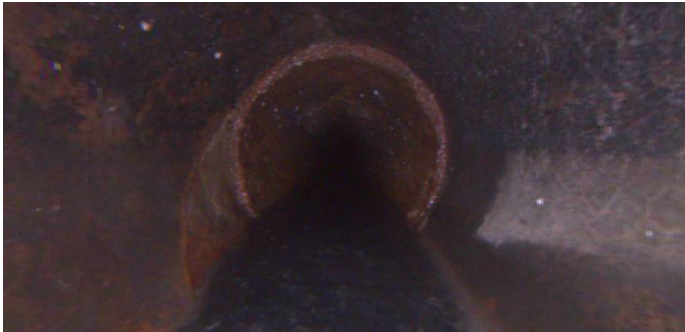
Code:	<b>MWL</b>
Description:	<b>Water Level</b>

Distance (ft):	<b>.0</b>
Structural Grade:	<b>0</b>
O&M Grade:	<b>0</b>
Clock Start/From:	
Clock To:	
1st Value:	
2nd Value:	
Value Percent:	<b>5.000</b>
Continuous Index:	
Within 8" of Joint:	<b>NO</b>
Remarks:

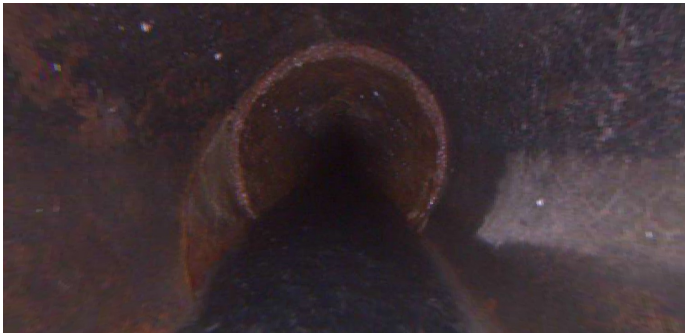
Code:	<b>CC</b>
Description:	<b>Crack Circumferential</b>

Distance (ft):	<b>.0</b>
Structural Grade:	<b>1</b>
O&M Grade:	<b>0</b>
Clock Start/From:	<b>7</b>
Clock To:	<b>11</b>
1st Value:	
2nd Value:	
Value Percent:	
Continuous Index:	
Within 8" of Joint:	<b>YES</b>
Remarks:

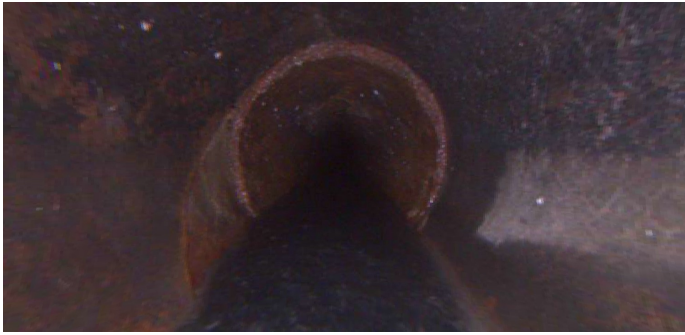
Code: **SCP**  
Description: **Surface Corrosion Metal Pipe**

Distance (ft): **.0**  
Structural Grade: **3**  
O&M Grade: **0**  
Clock Start/From: **7**  
Clock To: **5**  
1st Value:  
2nd Value:  
Value Percent:  
Continuous Index: **S01**  
Within 8" of Joint:  
Remarks:

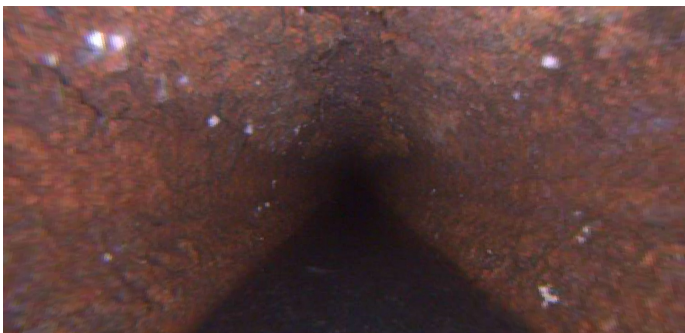
Code: **SSS**  
Description: **Surface Spalling**

Distance (ft): **4.5**  
Structural Grade: **2**  
O&M Grade: **0**  
Clock Start/From: **11**  
Clock To: **1**  
1st Value:  
2nd Value:  
Value Percent:  
Continuous Index: **S02**  
Within 8" of Joint:  
Remarks: **wandering**

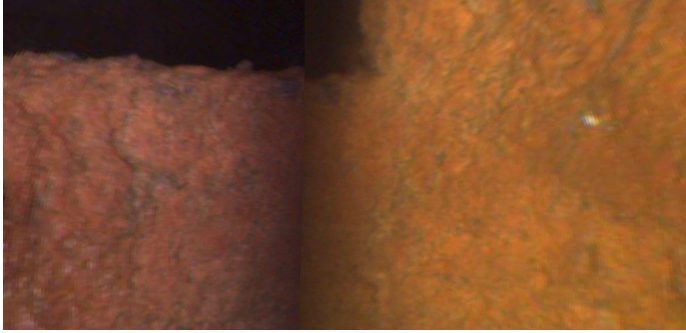
Code: **SCP**  
Description: **Surface Corrosion Metal Pipe**

Distance (ft): **118.1**  
Structural Grade: **3**  
O&M Grade: **0**  
Clock Start/From: **7**  
Clock To: **5**  
1st Value:  
2nd Value:  
Value Percent:  
Continuous Index: **F01**  
Within 8" of Joint:  
Remarks:

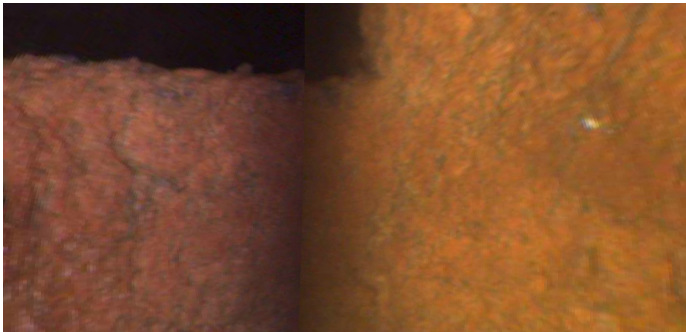
Code: **SSS**  
Description: **Surface Spalling**

Distance (ft): **118.1**  
Structural Grade: **2**  
O&M Grade: **0**  
Clock Start/From: **11**  
Clock To: **1**  
1st Value:  
2nd Value:  
Value Percent:  
Continuous Index: **F02**  
Within 8" of Joint:  
Remarks: **wandering**
