Profile/Photo Observation Report

Date:	04/20/2018	Weather:		Coding:	PACP 6.0
Pipe Length (ft):	156.1	Owner:	NA	Pre Clean:	Not Known
P.O.#:		Surveyor:	Jen Costello	PSR:	P-805-037-038
Customer:		Clean Date:	01/01/1900	Shape:	C

Street:	DEVONSHIRE ST	Flow Control:	Not Controlled
City:	Hobart, IN	Year Renewed:	
Location:	Other	Tape/Media #:	
Purpose:	Not Known	Dia/Height:	12"
Use:	Sanitary	Material:	VCP
Drain Area:	NA	Lining:	
Category:	NA		
Comment:

Location Details:		Direction of Survey:	Downstream
US MH:	M-805-038	DS MH:	M-805-037
		Total Length Surveyed (ft):	12.6

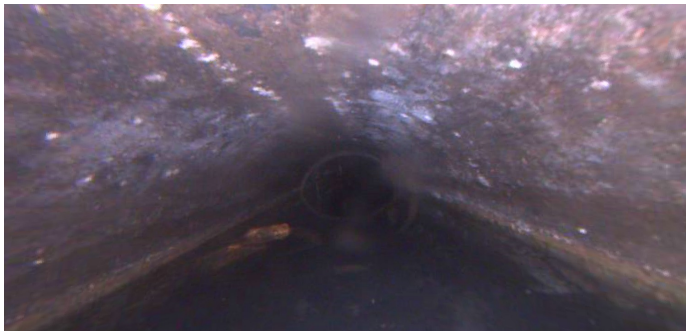
Code: **AMH**
Description: **Manhole**

Distance (ft): **.0**
Structural Grade: **0**
O&M Grade: **0**
Clock Start/From:
Clock To:
1st Value:
2nd Value:
Value Percent:
Continuous Index:
Within 8" of Joint: **NO**
Remarks: **M-805-038**

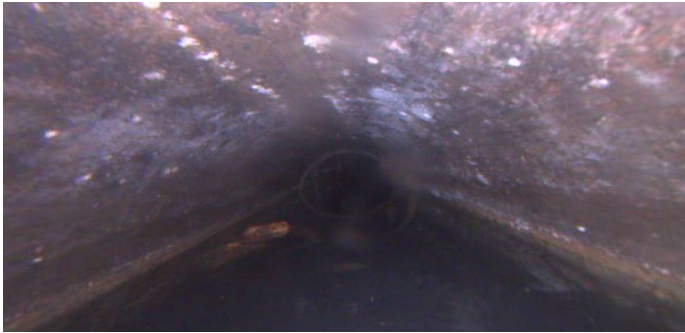
Code:	MWL
Description:	Water Level

Distance (ft):	.0
Structural Grade:	0
O&M Grade:	0
Clock Start/From:	
Clock To:	
1st Value:	
2nd Value:	
Value Percent:	30.000
Continuous Index:	
Within 8" of Joint:	NO
Remarks:

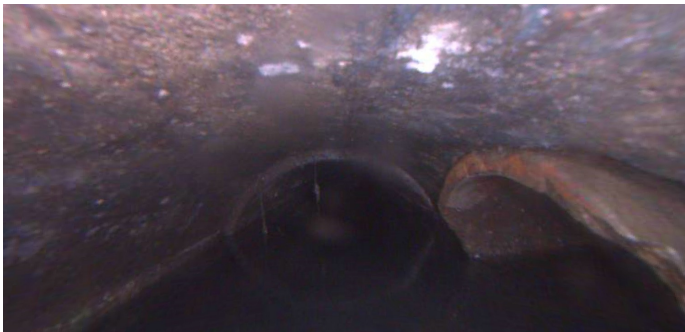
Code:	TBI
Description:	Tap Break-in Intruding

Distance (ft):	2.9
Structural Grade:	0
O&M Grade:	2
Clock Start/From:	3
Clock To:	
1st Value:	4.000
2nd Value:	1.000
Value Percent:	
Continuous Index:	
Within 8" of Joint:	NO
Remarks:

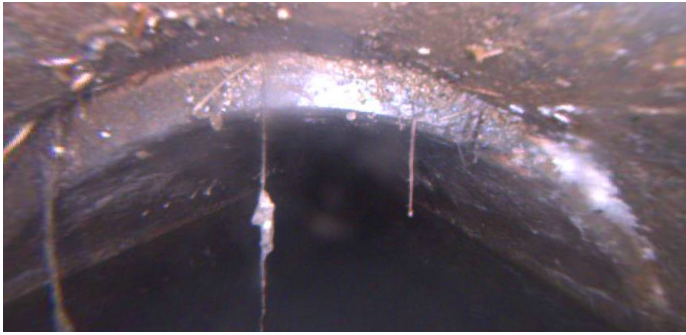
Code: **RFJ**
Description: **Roots Fine Joint**

Distance (ft): **3.8**
Structural Grade: **0**
O&M Grade: **1**
Clock Start/From: **10**
Clock To: **2**
1st Value:
2nd Value:
Value Percent:
Continuous Index:
Within 8" of Joint: **YES**
Remarks:

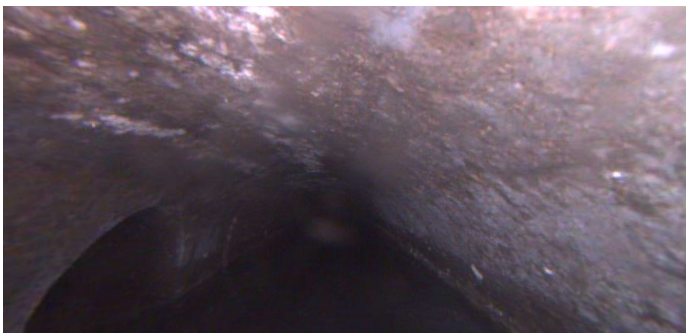
Code: **TFA**
Description: **Tap Factory Active**

Distance (ft): **7.4**
Structural Grade: **0**
O&M Grade: **0**
Clock Start/From: **9**
Clock To:
1st Value: **4.000**
2nd Value:
Value Percent:
Continuous Index:
Within 8" of Joint:
Remarks:

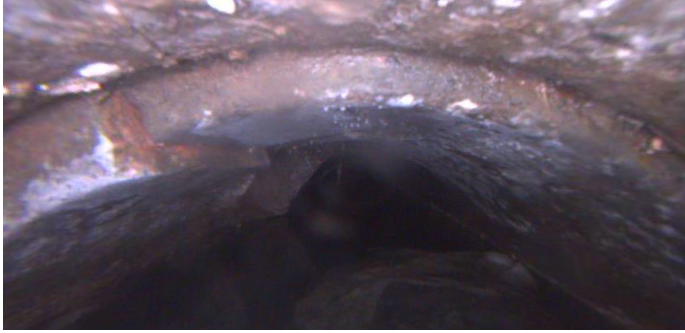
Code: **B**
Description: **Broken**

Distance (ft): **12.1**
Structural Grade: **3**
O&M Grade: **0**
Clock Start/From: **11**
Clock To:
1st Value:
2nd Value:
Value Percent:
Continuous Index:
Within 8" of Joint: **YES**
Remarks:

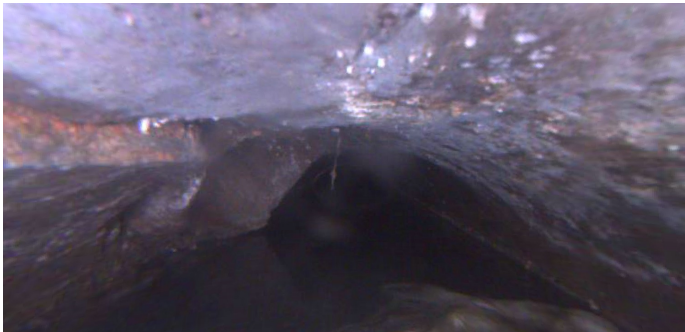
Code: **MSA**
Description: **Abandoned Survey**

Distance (ft): **12.6**
Structural Grade: **0**
O&M Grade: **0**
Clock Start/From:
Clock To:
1st Value:
2nd Value:
Value Percent:
Continuous Index:
Within 8" of Joint: **NO**
Remarks: **broken**
