Profile/Photo Observation Report

Street:	DEVONSHIRE ST	Flow Control:	Not Controlled
City:	Hobart, IN	Year Renewed:	
Location:	Other	Tape/Media #:	
Purpose:	Not Known	Dia/Height:	12"
Use:	Sanitary	Material:	VCP
Drain Area:	NA	Lining:	
Category:	NA		
Comment:

Location Details:		Direction of Survey:	Upstream
US MH:	M-805-038	DS MH:	M-805-037
		Total Length Surveyed (ft):	49.6

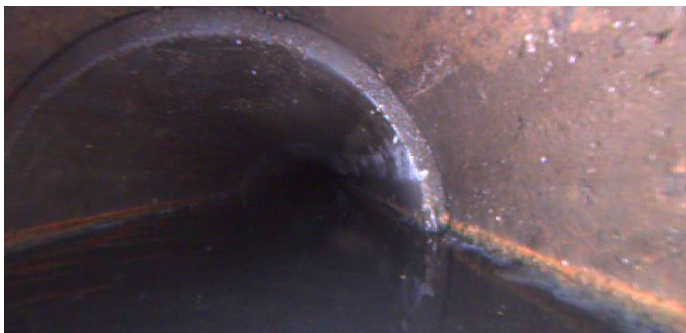
Code: **AMH**
Description: **Manhole**

Distance (ft): **.0**
Structural Grade: **0**
O&M Grade: **0**
Clock Start/From:
Clock To:
1st Value:
2nd Value:
Value Percent:
Continuous Index:
Within 8" of Joint: **NO**
Remarks: **M-805-037**

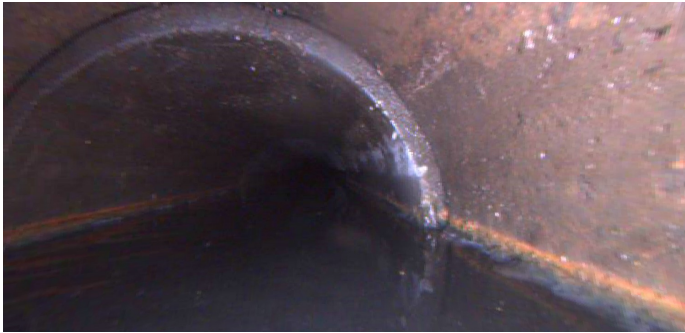
Code:	MWL
Description:	Water Level

Distance (ft):	.0
Structural Grade:	0
O&M Grade:	0
Clock Start/From:	
Clock To:	
1st Value:	
2nd Value:	
Value Percent:	25.000
Continuous Index:	
Within 8" of Joint:	NO
Remarks:

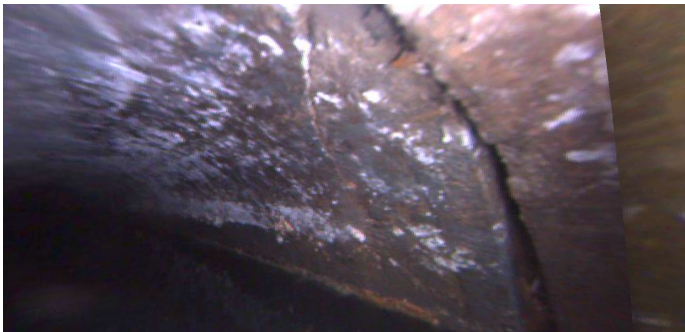
Code:	CS
Description:	Crack Spiral

Distance (ft):	30.8
Structural Grade:	2
O&M Grade:	0
Clock Start/From:	1
Clock To:	4
1st Value:	
2nd Value:	
Value Percent:	
Continuous Index:	
Within 8" of Joint:	YES
Remarks:

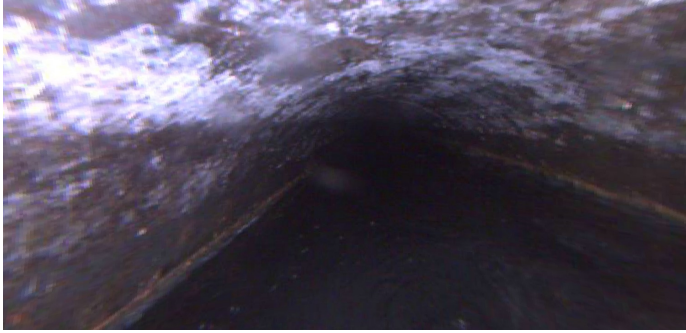
Code: **MWL**
Description: **Water Level**

Distance (ft): **46.0**
Structural Grade: **0**
O&M Grade: **0**
Clock Start/From:
Clock To:
1st Value:
2nd Value:
Value Percent: **50.000**
Continuous Index:
Within 8" of Joint: **NO**
Remarks:

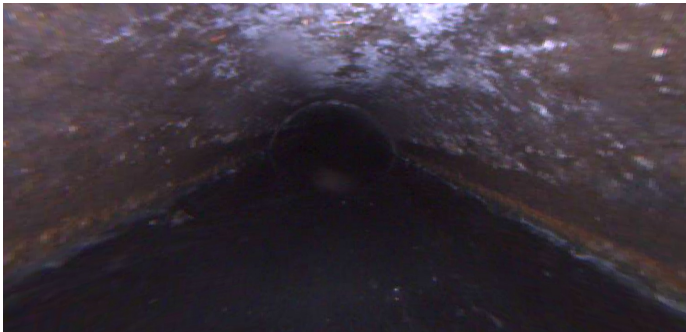
Code: **MSA**
Description: **Abandoned Survey**

Distance (ft): **49.6**
Structural Grade: **0**
O&M Grade: **0**
Clock Start/From:
Clock To:
1st Value:
2nd Value:
Value Percent:
Continuous Index:
Within 8" of Joint: **NO**
Remarks: **debris under water**
