Profile/Photo Observation Report

Date:	04/20/2018	Weather:		Coding:	PACP 6.0
Pipe Length (ft):	156.1	Owner:	NA	Pre Clean:	Not Known
P.O.#:		Surveyor:	Byrd Fitzgerald	PSR:	P-805-037-038
Customer:		Clean Date:	01/01/1900	Shape:	C

Street:	Devonshire St.	Flow Control:	Not Controlled
City:	Hobart, IN	Year Renewed:	
Location:	Other	Tape/Media #:	
Purpose:	Not Known	Dia/Height:	12"
Use:	Sanitary	Material:	VCP
Drain Area:	NA	Lining:	
Category:	NA		
Comment:

Location Details:		Direction of Survey:	Upstream
US MH:	M-805-038	DS MH:	M-805-037
		Total Length Surveyed (ft):	49.6

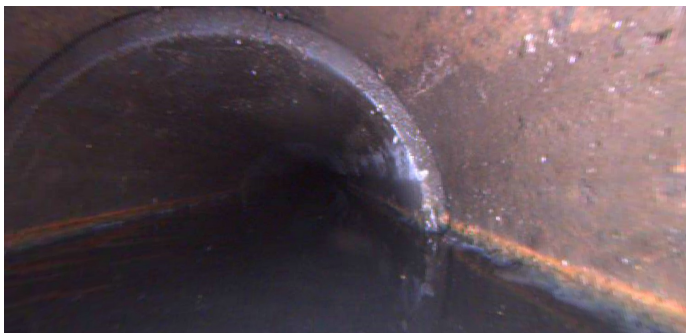
Code: **AMH**
Description: **Manhole**

Distance (ft): **.0**
Structural Grade: **0**
O&M Grade: **0**
Clock Start/From:
Clock To:
1st Value:
2nd Value:
Value Percent:
Continuous Index:
Within 8" of Joint: **NO**
Remarks: **M-805-037**

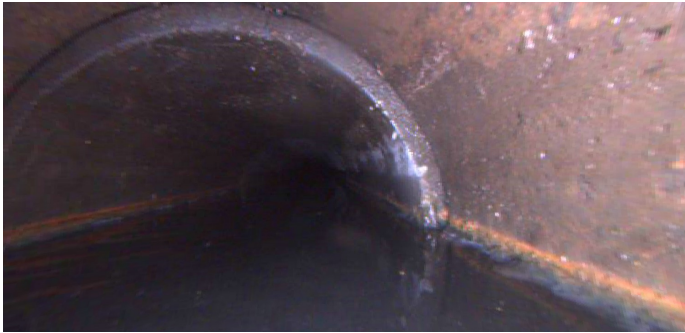
Code:	MWL
Description:	Water Level

Distance (ft):	.0
Structural Grade:	0
O&M Grade:	0
Clock Start/From:	
Clock To:	
1st Value:	
2nd Value:	
Value Percent:	25.000
Continuous Index:	
Within 8" of Joint:	NO
Remarks:

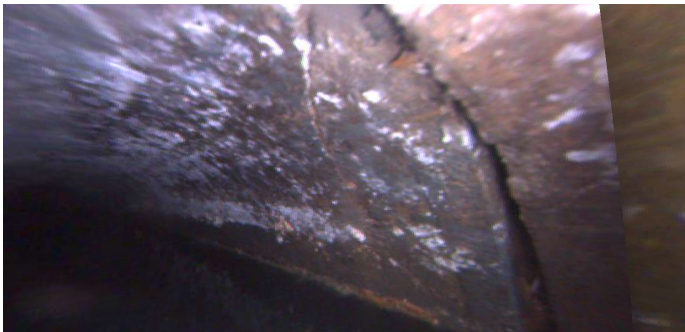
Code:	CS
Description:	Crack Spiral

Distance (ft):	30.8
Structural Grade:	2
O&M Grade:	0
Clock Start/From:	1
Clock To:	4
1st Value:	
2nd Value:	
Value Percent:	
Continuous Index:	
Within 8" of Joint:	YES
Remarks:

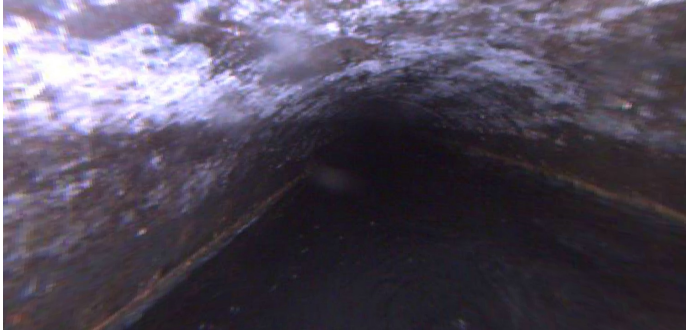
Code: **MWL**
Description: **Water Level**

Distance (ft): **46.0**
Structural Grade: **0**
O&M Grade: **0**
Clock Start/From:
Clock To:
1st Value:
2nd Value:
Value Percent: **50.000**
Continuous Index:
Within 8" of Joint: **NO**
Remarks:

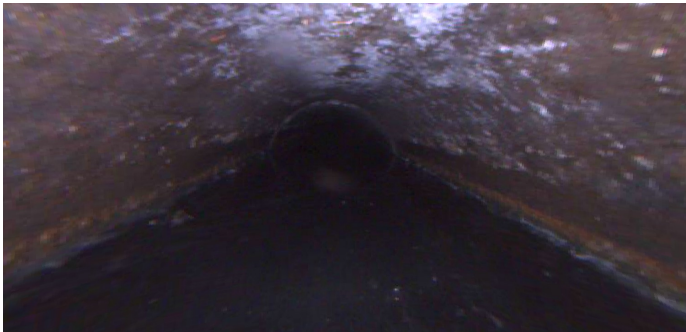
Code: **MSA**
Description: **Abandoned Survey**

Distance (ft): **49.6**
Structural Grade: **0**
O&M Grade: **0**
Clock Start/From:
Clock To:
1st Value:
2nd Value:
Value Percent:
Continuous Index:
Within 8" of Joint: **NO**
Remarks: **debris under water**
