Street:	Devanshire Street		Flow Control:	Not Controlled	
City:	Hobart, IN		Year Renewed:		
Location:	Local rural streets with light traffic, t		Tape/Media #:		
Purpose:	Routine Assessment		Dia/Height:	12"	
Use:	Sanitary Sewage Pipe		Material:	VCP	
Drain Area:			Lining:	None	
Category:	NA				
Comment:					
Location Details:			Direction of Survey:	Downstream	
US MH:	M-805-038	DS MH:	M-805-037	Total Length Surveyed (ft):	161.9

**Tuesday, April 25, 2023**

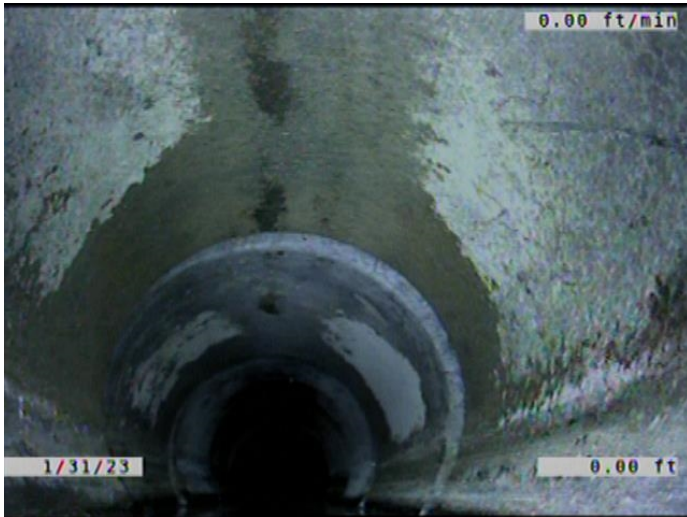
Code: **MWL**  
 Description: **Miscellaneous Water Level**

Distance (ft): **.0**  
 Structural Grade: **0**  
 O&M Grade: **0**  
 Clock Start/From:  
 Clock To:  
 1st Value:  
 2nd Value:  
 Value Percent: **10.000**  
 Continuous Index:  
 Within 8" of Joint: **NO**  
 Remarks:

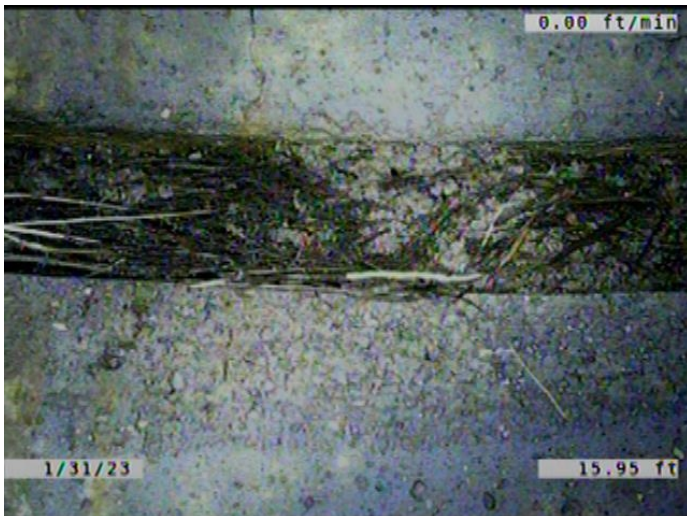
Code: **RFJ**  
 Description: **Roots Fine Joint**

Distance (ft): **15.9**  
 Structural Grade: **0**  
 O&M Grade: **1**  
 Clock Start/From: **8**  
 Clock To: **4**  
 1st Value:  
 2nd Value:  
 Value Percent:  
 Continuous Index:  
 Within 8" of Joint: **YES**  
 Remarks:

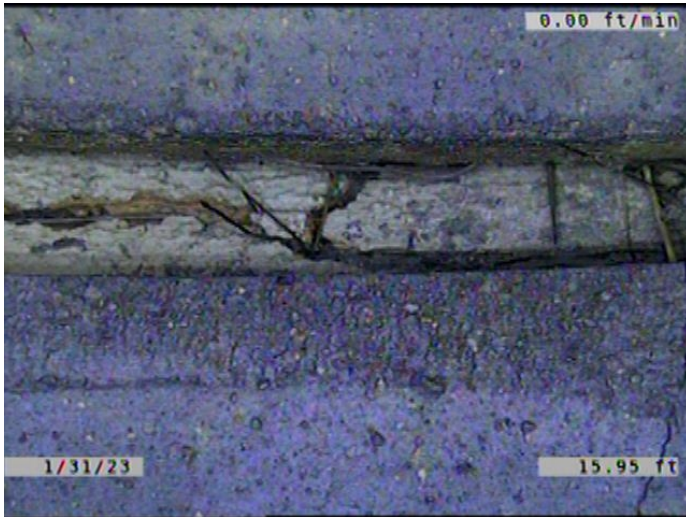
Code: **BSV**  
Description: **Broken Soil Visible**

Distance (ft): **16.0**  
Structural Grade: **5**  
O&M Grade: **0**  
Clock Start/From: **9**  
Clock To: **3**  
1st Value:  
2nd Value:  
Value Percent:  
Continuous Index:  
Within 8" of Joint: **YES**  
Remarks:

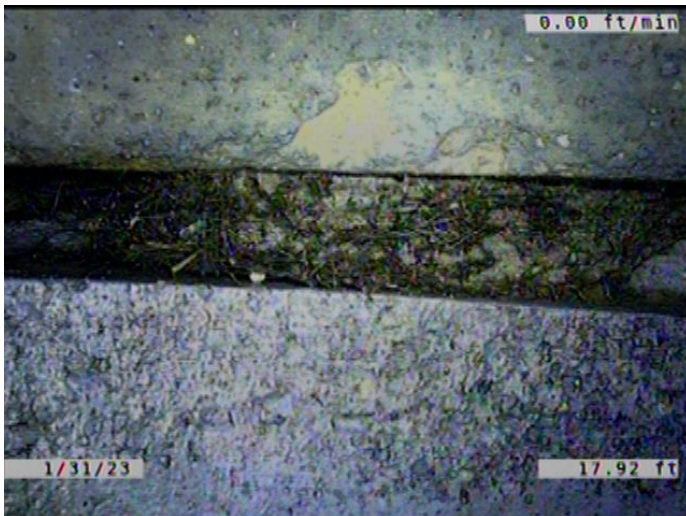
Code: **RFJ**  
Description: **Roots Fine Joint**

Distance (ft): **17.9**  
Structural Grade: **0**  
O&M Grade: **1**  
Clock Start/From: **8**  
Clock To: **10**  
1st Value:  
2nd Value:  
Value Percent:  
Continuous Index:  
Within 8" of Joint: **YES**  
Remarks:

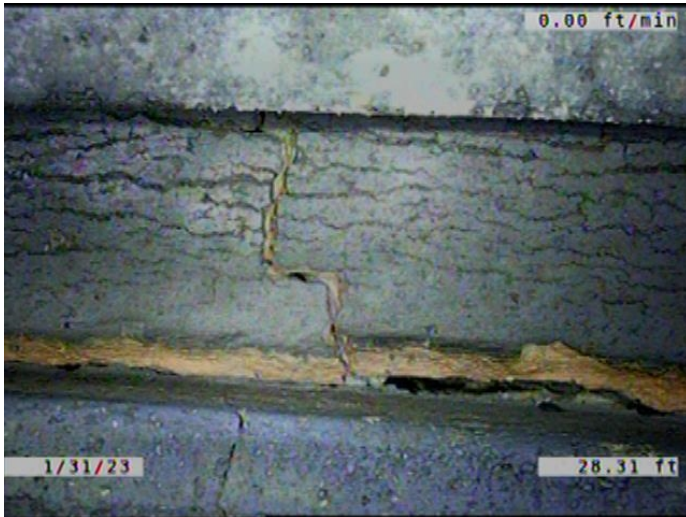
Code: **BSV**  
Description: **Broken Soil Visible**

Distance (ft): **28.3**  
Structural Grade: **5**  
O&M Grade: **0**  
Clock Start/From: **9**  
Clock To: **3**  
1st Value:  
2nd Value:  
Value Percent:  
Continuous Index:  
Within 8" of Joint: **YES**  
Remarks:

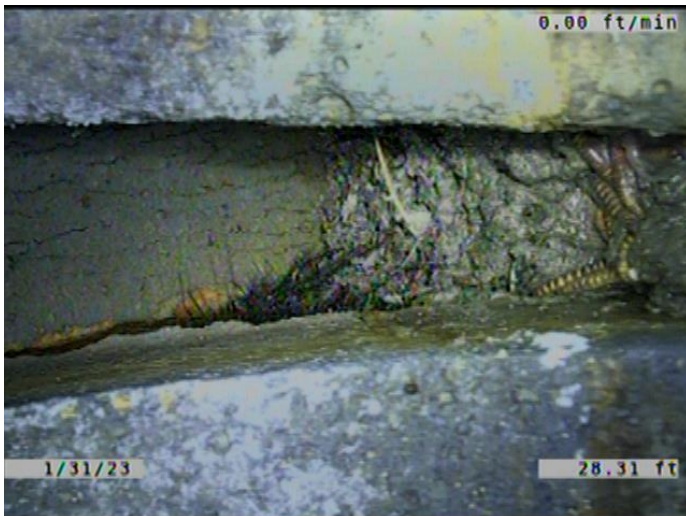
Code: **RFJ**  
Description: **Roots Fine Joint**

Distance (ft): **28.3**  
Structural Grade: **0**  
O&M Grade: **1**  
Clock Start/From: **3**  
Clock To: **4**  
1st Value:  
2nd Value:  
Value Percent:  
Continuous Index:  
Within 8" of Joint: **YES**  
Remarks:

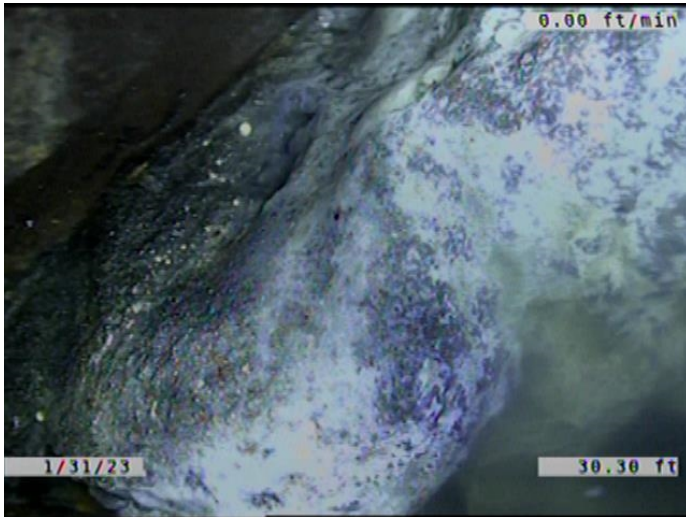
Code: **DAE**  
 Description: **Deposits Attached Encrustation**

Distance (ft): **30.3**  
 Structural Grade: **0**  
 O&M Grade: **2**  
 Clock Start/From: **4**  
 Clock To: **8**  
 1st Value:  
 2nd Value:  
 Value Percent: **5.000**  
 Continuous Index:  
 Within 8" of Joint: **YES**  
 Remarks:

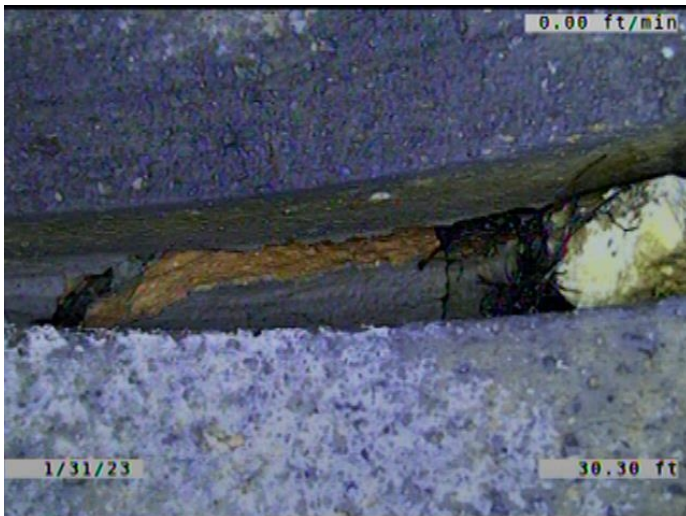
Code: **BSV**  
 Description: **Broken Soil Visible**

Distance (ft): **30.3**  
 Structural Grade: **5**  
 O&M Grade: **0**  
 Clock Start/From: **8**  
 Clock To: **12**  
 1st Value:  
 2nd Value:  
 Value Percent:  
 Continuous Index:  
 Within 8" of Joint: **YES**  
 Remarks:

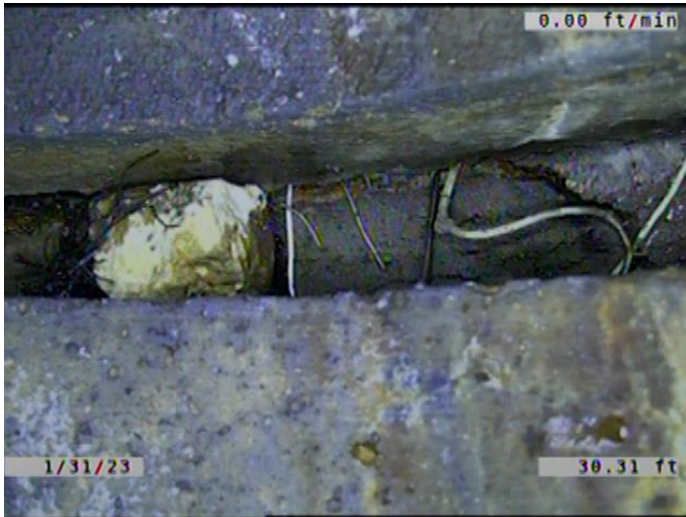
Code: **RFJ**  
Description: **Roots Fine Joint**

Distance (ft): **30.3**  
Structural Grade: **0**  
O&M Grade: **1**  
Clock Start/From: **8**  
Clock To: **9**  
1st Value:  
2nd Value:  
Value Percent:  
Continuous Index:  
Within 8" of Joint: **YES**  
Remarks:

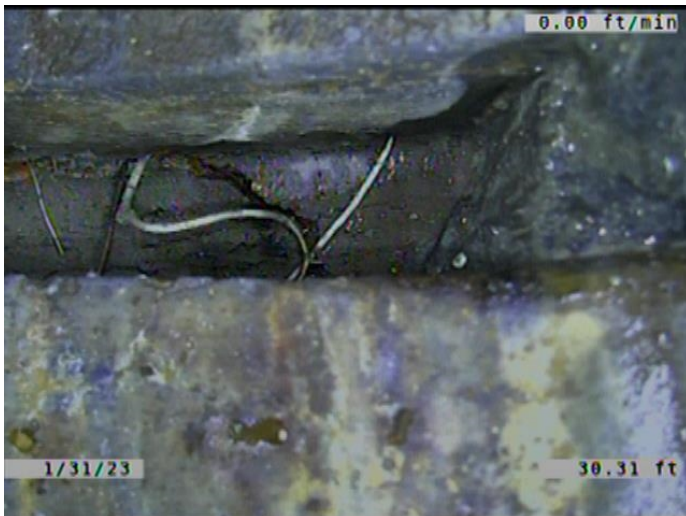
Code: **JAM**  
Description: **Joint Angular Medium**

Distance (ft): **30.3**  
Structural Grade: **3**  
O&M Grade: **0**  
Clock Start/From:  
Clock To:  
1st Value:  
2nd Value:  
Value Percent:  
Continuous Index:  
Within 8" of Joint: **NO**  
Remarks:

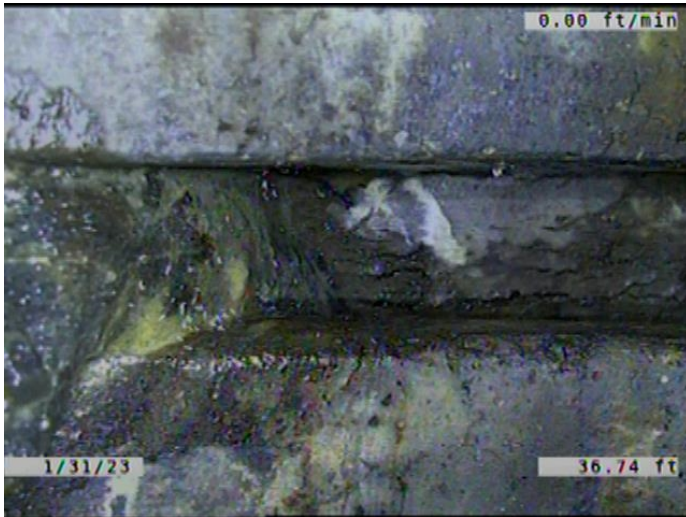
Code: **JAM**  
Description: **Joint Angular Medium**

Distance (ft): **36.7**  
Structural Grade: **3**  
O&M Grade: **0**  
Clock Start/From:  
Clock To:  
1st Value:  
2nd Value:  
Value Percent:  
Continuous Index: **S01**  
Within 8" of Joint: **NO**  
Remarks:

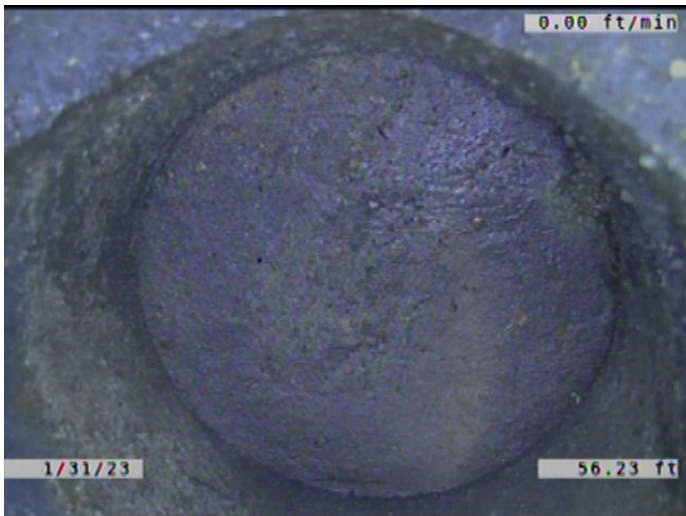
Code: **TFD**  
Description: **Tap Factory Defective**

Distance (ft): **56.2**  
Structural Grade: **0**  
O&M Grade: **3**  
Clock Start/From: **2**  
Clock To:  
1st Value: **6.000**  
2nd Value:  
Value Percent:  
Continuous Index:  
Within 8" of Joint: **YES**  
Remarks: **CAPPED. TAP BROKEN.**

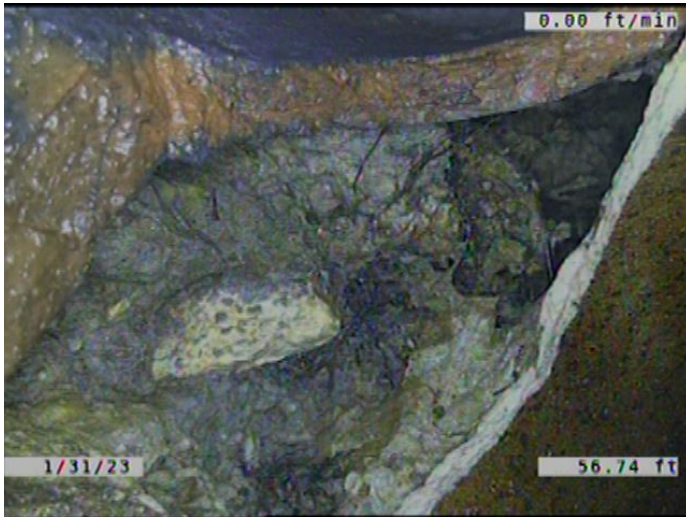
Code: **BVV**  
 Description: **Broken Void Visible**

Distance (ft): **56.7**  
 Structural Grade: **5**  
 O&M Grade: **0**  
 Clock Start/From: **1**  
 Clock To: **4**  
 1st Value:  
 2nd Value:  
 Value Percent:  
 Continuous Index:  
 Within 8" of Joint: **YES**  
 Remarks: **SOIL VISIBLE ALSO.**

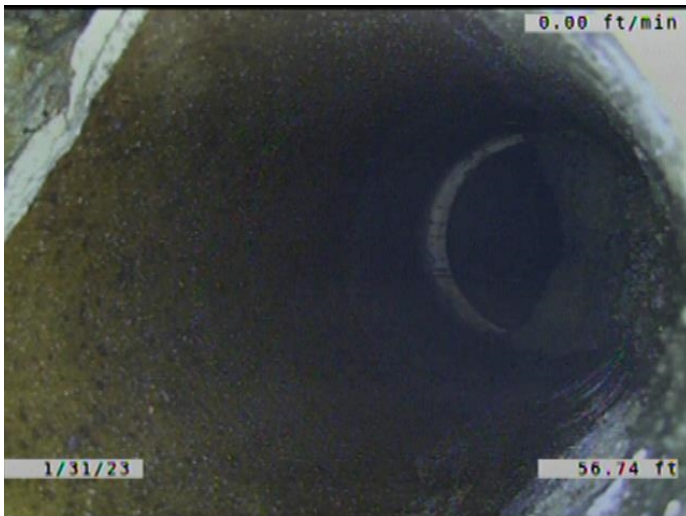
Code: **TBI**  
 Description: **Tap Break-in Intruding**

Distance (ft): **56.7**  
 Structural Grade: **0**  
 O&M Grade: **2**  
 Clock Start/From: **3**  
 Clock To:  
 1st Value: **6.000**  
 2nd Value: **2.000**  
 Value Percent:  
 Continuous Index:  
 Within 8" of Joint: **YES**  
 Remarks: **50% PLUGGED WITH DIRT.**

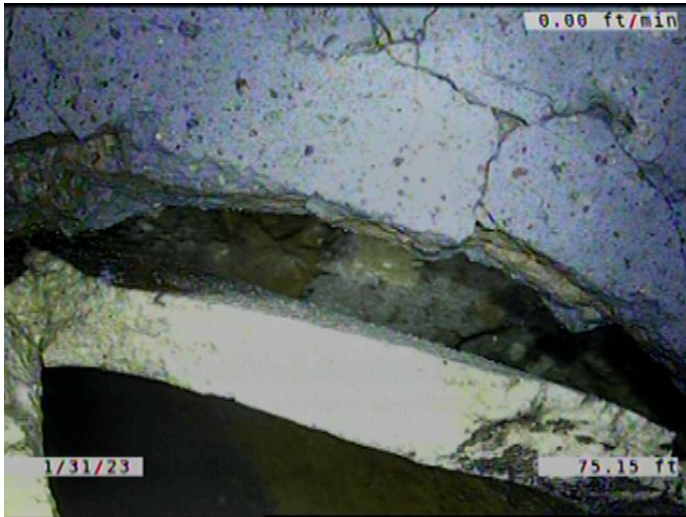
Code: **BSV**  
 Description: **Broken Soil Visible**

Distance (ft): **75.1**  
 Structural Grade: **5**  
 O&M Grade: **0**  
 Clock Start/From: **8**  
 Clock To: **1**  
 1st Value:  
 2nd Value:  
 Value Percent:  
 Continuous Index:  
 Within 8" of Joint: **YES**  
 Remarks:

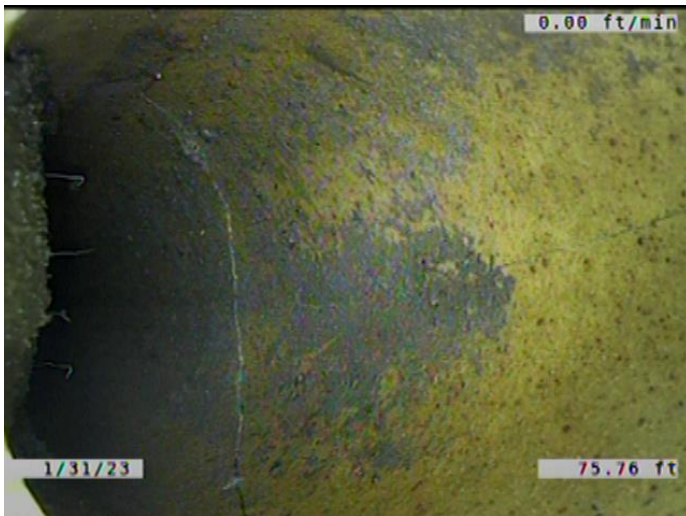
Code: **TBI**  
 Description: **Tap Break-in Intruding**

Distance (ft): **75.8**  
 Structural Grade: **0**  
 O&M Grade: **2**  
 Clock Start/From: **9**  
 Clock To:  
 1st Value: **6.000**  
 2nd Value: **3.000**  
 Value Percent:  
 Continuous Index:  
 Within 8" of Joint: **YES**  
 Remarks: **SERVICE CRACKED.**

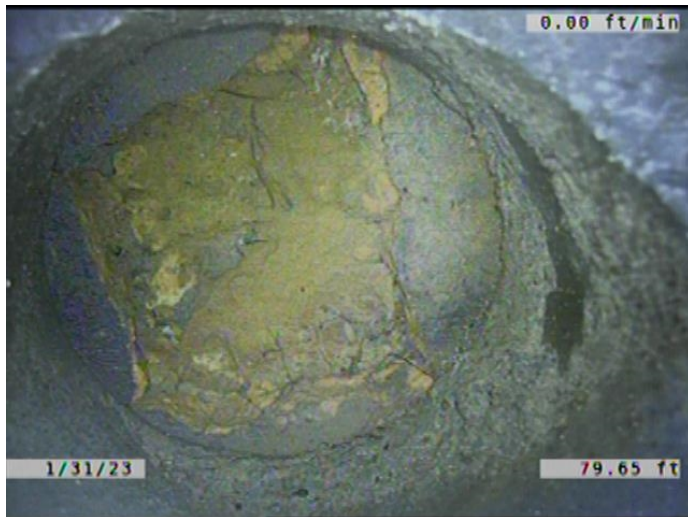
Code: **TFD**  
 Description: **Tap Factory Defective**

Distance (ft): **79.6**  
 Structural Grade: **0**  
 O&M Grade: **3**  
 Clock Start/From: **11**  
 Clock To:  
 1st Value: **6.000**  
 2nd Value:  
 Value Percent:  
 Continuous Index:  
 Within 8" of Joint: **YES**  
 Remarks: **CAPPED. CAP BROKEN.**

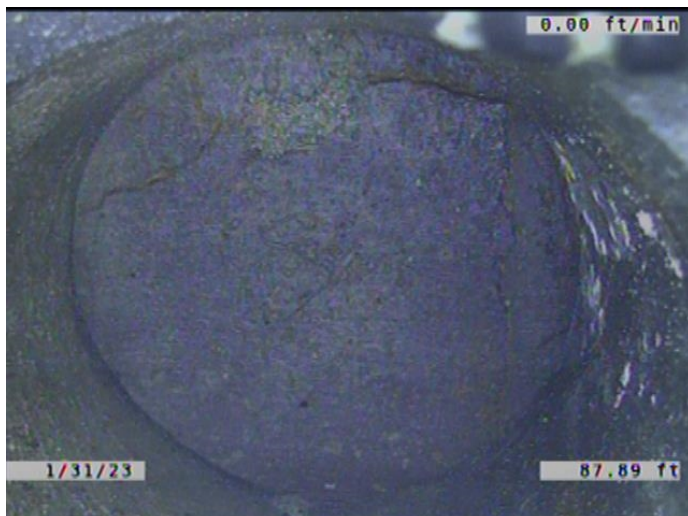
Code: **TFD**  
 Description: **Tap Factory Defective**

Distance (ft): **87.9**  
 Structural Grade: **0**  
 O&M Grade: **3**  
 Clock Start/From: **2**  
 Clock To:  
 1st Value: **6.000**  
 2nd Value:  
 Value Percent:  
 Continuous Index:  
 Within 8" of Joint: **YES**  
 Remarks: **CAPPED. CAP BROKEN. SOIL VISIBLE.**

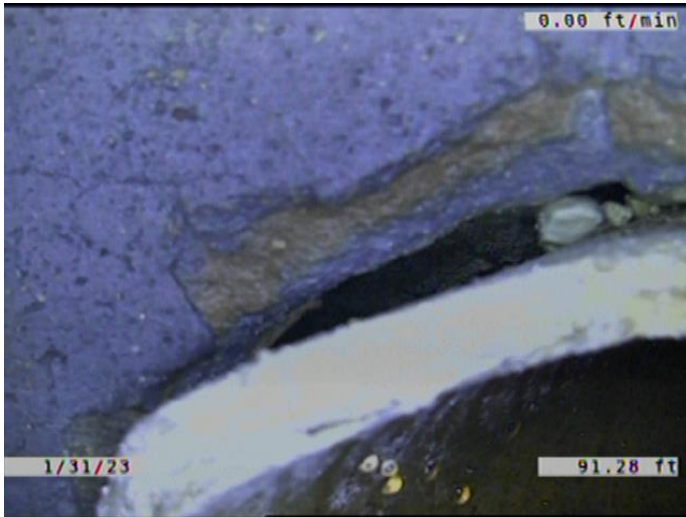
91.3	BSV	Broken Soil Visible	1051	S 5
91.7	TBI	Tap Break-in Intruding	1086	M 2
94.4	MWLS(S02)	Miscellaneous Water Level Sag	1116	S 3
98.8	FM	Fracture Multiple	1183	S 4

Code: **BSV**  
 Description: **Broken Soil Visible**

Distance (ft): **91.3**  
 Structural Grade: **5**  
 O&M Grade: **0**  
 Clock Start/From: **1**  
 Clock To: **4**  
 1st Value:  
 2nd Value:  
 Value Percent:  
 Continuous Index:  
 Within 8" of Joint: **YES**  
 Remarks:

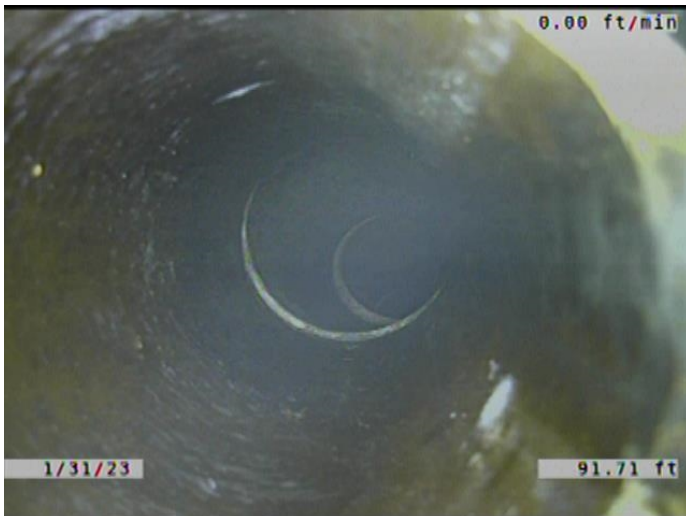
Code: **TBI**  
 Description: **Tap Break-in Intruding**

Distance (ft): **91.7**  
 Structural Grade: **0**  
 O&M Grade: **2**  
 Clock Start/From: **3**  
 Clock To:  
 1st Value: **6.000**  
 2nd Value: **2.000**  
 Value Percent:  
 Continuous Index:  
 Within 8" of Joint: **YES**  
 Remarks:

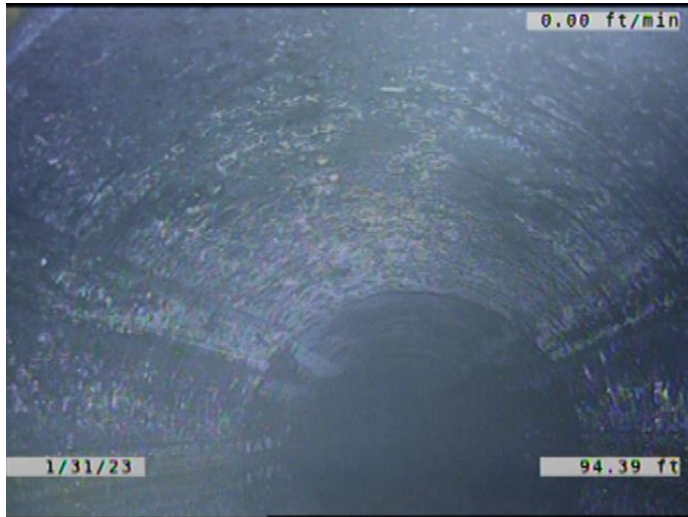
Code: **MWLS**  
Description: **Miscellaneous Water Level Sag**

Distance (ft): **94.4**  
Structural Grade: **3**  
O&M Grade: **0**  
Clock Start/From:  
Clock To:  
1st Value:  
2nd Value:  
Value Percent: **35.000**  
Continuous Index: **S02**  
Within 8" of Joint: **NO**  
Remarks:

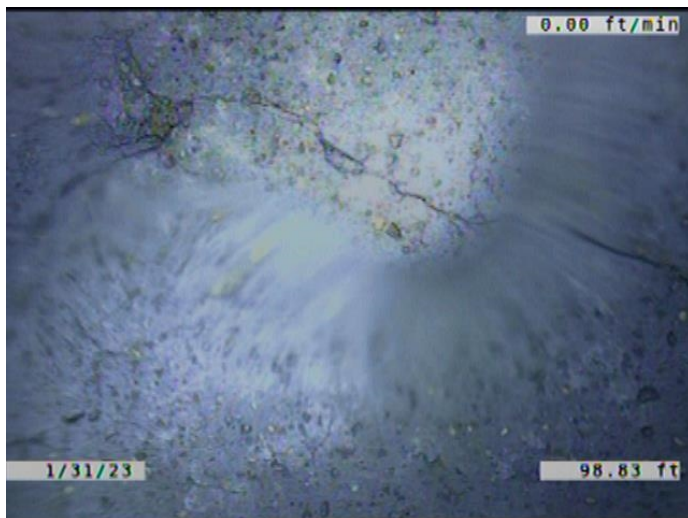
Code: **FM**  
Description: **Fracture Multiple**

Distance (ft): **98.8**  
Structural Grade: **4**  
O&M Grade: **0**  
Clock Start/From: **11**  
Clock To: **1**  
1st Value:  
2nd Value:  
Value Percent:  
Continuous Index:  
Within 8" of Joint: **YES**  
Remarks:

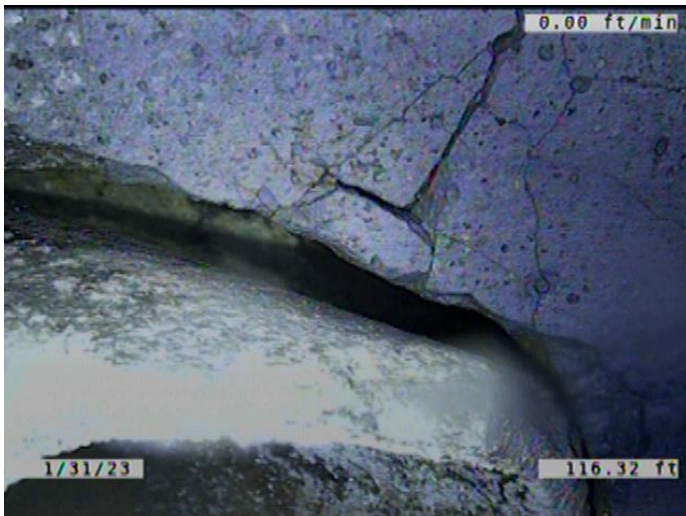
Code:	<b>BVV</b>
Description:	<b>Broken Void Visible</b>
Distance (ft):	<b>116.3</b>
Structural Grade:	<b>5</b>
O&M Grade:	<b>0</b>
Clock Start/From:	<b>8</b>
Clock To:	<b>12</b>
1st Value:	
2nd Value:	
Value Percent:	
Continuous Index:	
Within 8" of Joint:	<b>YES</b>
Remarks:

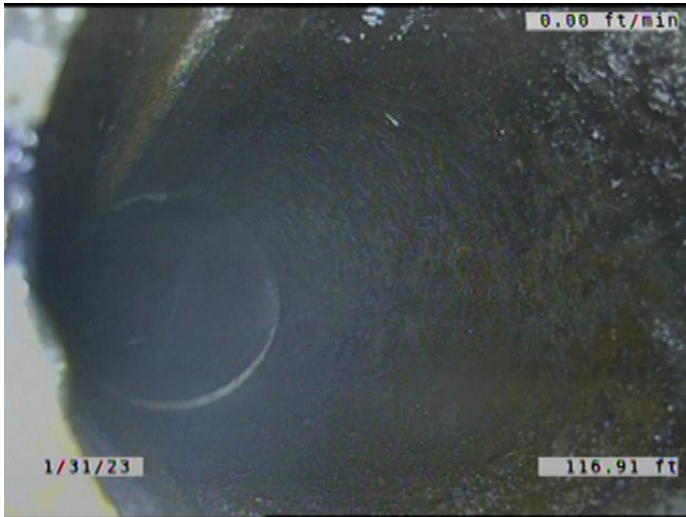
Code: **TBI**  
Description: **Tap Break-in Intruding**

Distance (ft): **116.9**  
Structural Grade: **0**  
O&M Grade: **2**  
Clock Start/From: **9**  
Clock To:  
1st Value: **6.000**  
2nd Value: **3.000**  
Value Percent:  
Continuous Index:  
Within 8" of Joint: **YES**  
Remarks:

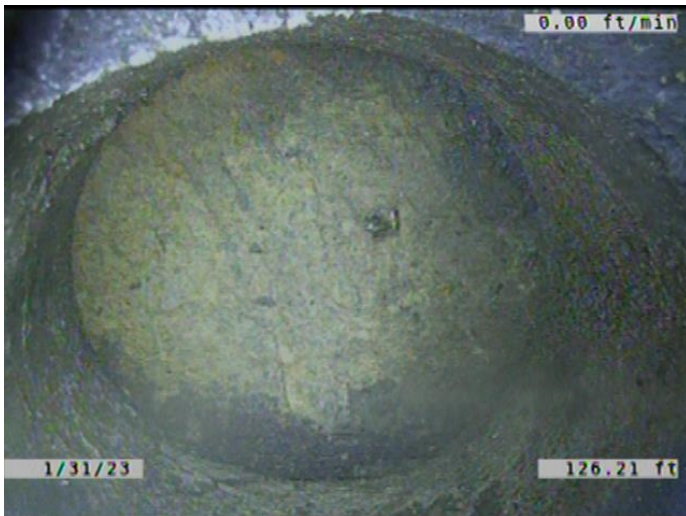
Code: **TFC**  
Description: **Tap Factory Capped**

Distance (ft): **126.2**  
Structural Grade: **0**  
O&M Grade: **0**  
Clock Start/From: **11**  
Clock To:  
1st Value: **6.000**  
2nd Value:  
Value Percent:  
Continuous Index:  
Within 8" of Joint: **YES**  
Remarks:

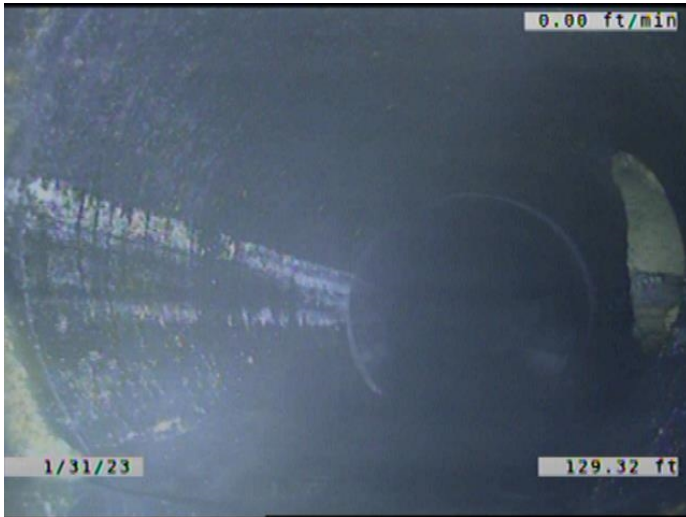
Code: **MWLS**  
Description: **Miscellaneous Water Level Sag**

Distance (ft): **129.3**  
Structural Grade: **3**  
O&M Grade: **0**  
Clock Start/From:  
Clock To:  
1st Value:  
2nd Value:  
Value Percent: **35.000**  
Continuous Index: **F02**  
Within 8" of Joint: **NO**  
Remarks:

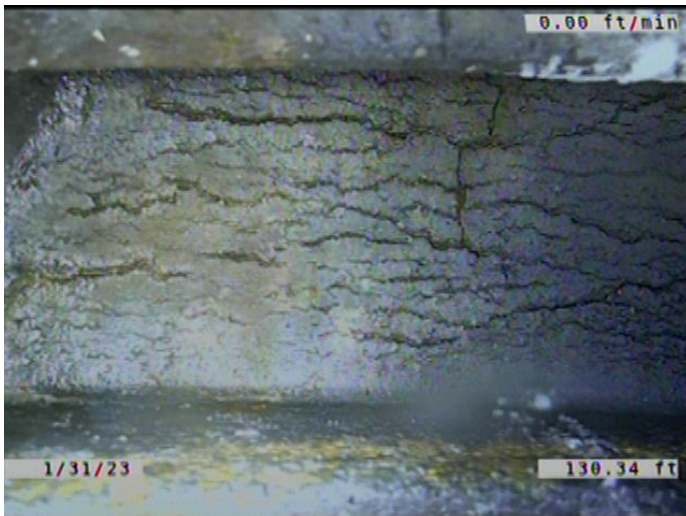
Code: **JAL**  
Description: **Joint Angular Large**

Distance (ft): **130.3**  
Structural Grade: **4**  
O&M Grade: **0**  
Clock Start/From:  
Clock To:  
1st Value:  
2nd Value:  
Value Percent:  
Continuous Index:  
Within 8" of Joint: **NO**  
Remarks:

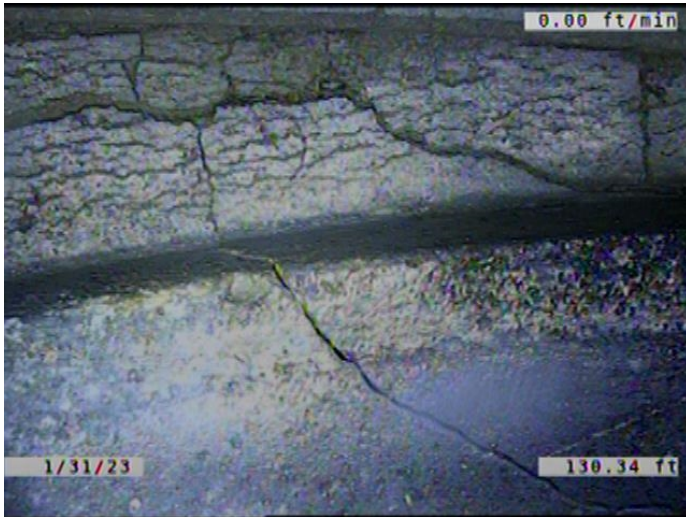
Code: **FM**  
 Description: **Fracture Multiple**

Distance (ft): **130.3**  
 Structural Grade: **4**  
 O&M Grade: **0**  
 Clock Start/From: **8**  
 Clock To: **4**  
 1st Value:  
 2nd Value:  
 Value Percent:  
 Continuous Index:  
 Within 8" of Joint: **YES**  
 Remarks:

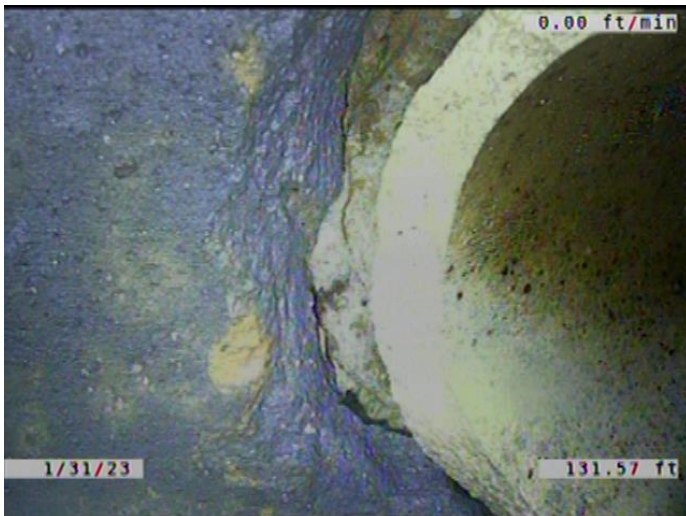
Code: **B**  
 Description: **Broken**

Distance (ft): **131.6**  
 Structural Grade: **4**  
 O&M Grade: **0**  
 Clock Start/From: **1**  
 Clock To: **4**  
 1st Value:  
 2nd Value:  
 Value Percent:  
 Continuous Index:  
 Within 8" of Joint: **YES**  
 Remarks:

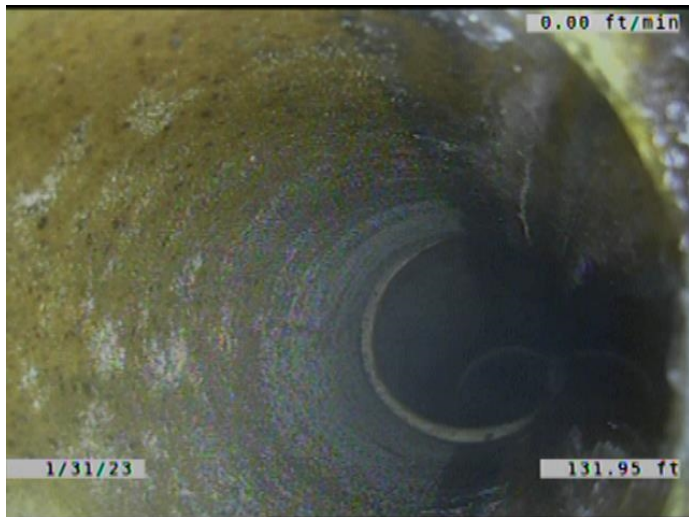
Code:	<b>TBD</b>
Description:	<b>Tap Break-in/Hammer Defective</b>
Distance (ft):	<b>131.9</b>
Structural Grade:	<b>0</b>
O&M Grade:	<b>3</b>
Clock Start/From:	<b>3</b>
Clock To:	
1st Value:	<b>6.000</b>
2nd Value:	
Value Percent:	
Continuous Index:	
Within 8" of Joint:	<b>YES</b>
Remarks:	<b>Defective</b>

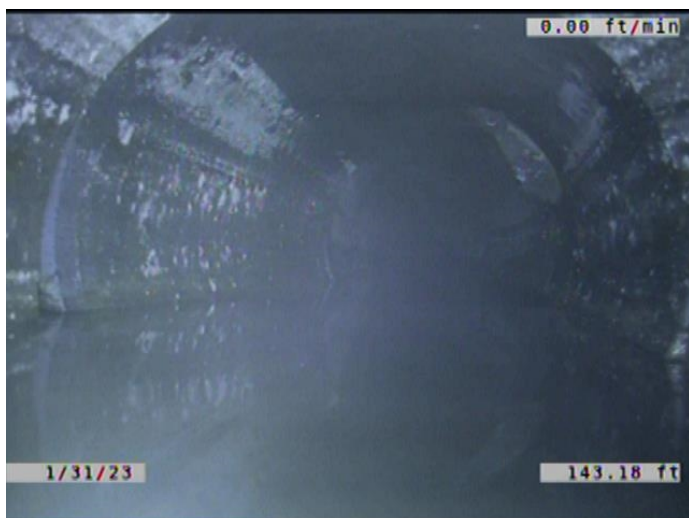
Code:	<b>MWLS</b>
Description:	<b>Miscellaneous Water Level Sag</b>
Distance (ft):	<b>143.2</b>
Structural Grade:	<b>2</b>
O&M Grade:	<b>0</b>
Clock Start/From:	
Clock To:	
1st Value:	
2nd Value:	
Value Percent:	<b>20.000</b>
Continuous Index:	<b>S03</b>
Within 8" of Joint:	<b>NO</b>
Remarks:

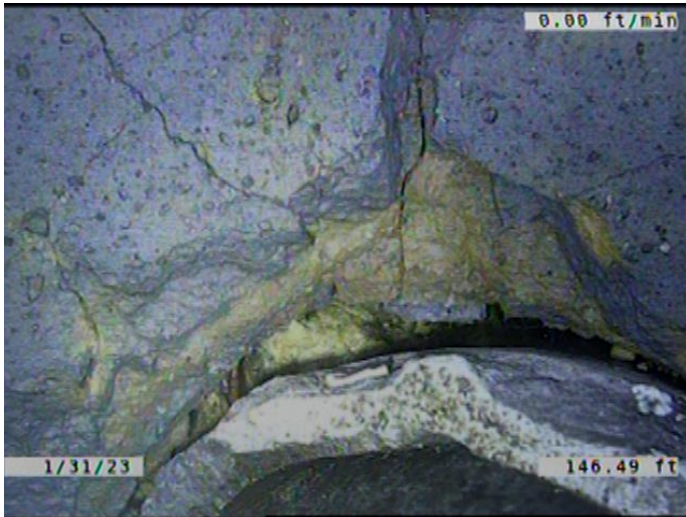
Code: **FM**  
Description: **Fracture Multiple**

Distance (ft): **145.3**  
Structural Grade: **4**  
O&M Grade: **0**  
Clock Start/From: **8**  
Clock To: **4**  
1st Value:  
2nd Value:  
Value Percent:  
Continuous Index:  
Within 8" of Joint: **YES**  
Remarks:

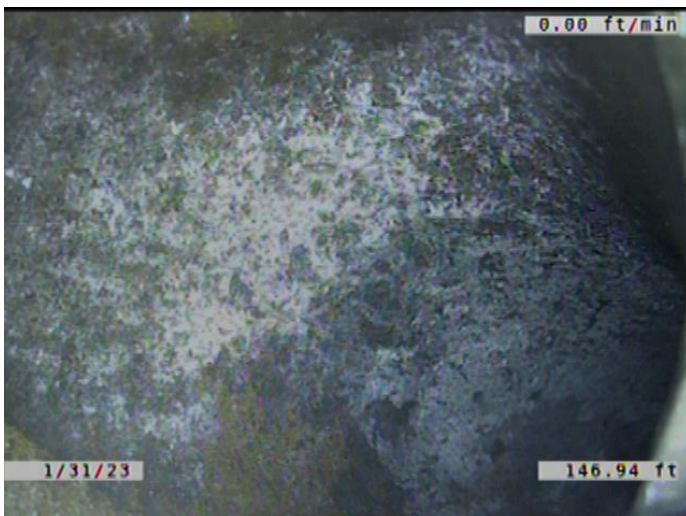
Code: **TBI**  
Description: **Tap Break-in Intruding**

Distance (ft): **146.9**  
Structural Grade: **0**  
O&M Grade: **2**  
Clock Start/From: **2**  
Clock To:  
1st Value: **6.000**  
2nd Value: **2.000**  
Value Percent:  
Continuous Index:  
Within 8" of Joint: **YES**  
Remarks: **CONSTANTLY RUNNING WATER.**

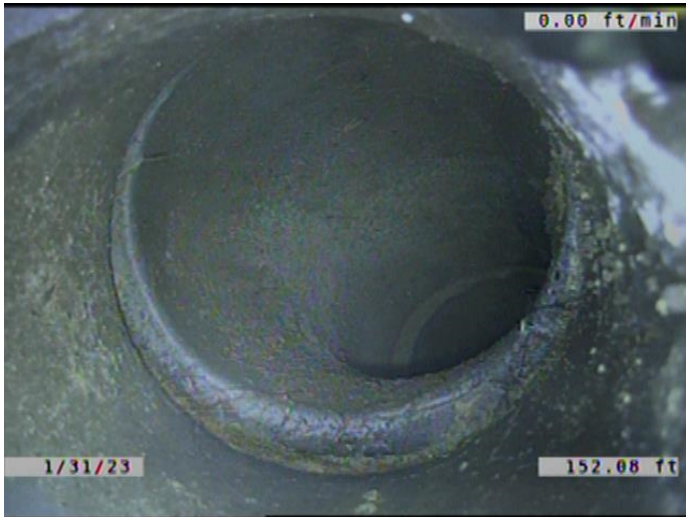
Code:	<b>TFD</b>
Description:	<b>Tap Factory Defective</b>
Distance (ft):	<b>152.1</b>
Structural Grade:	<b>0</b>
O&M Grade:	<b>3</b>
Clock Start/From:	<b>2</b>
Clock To:	
1st Value:	<b>6.000</b>
2nd Value:	
Value Percent:	
Continuous Index:	
Within 8" of Joint:	<b>YES</b>
Remarks:	<b>TAP CRACKED. SERVICE OFFSET. SOIL VISIBLE. ROOTS GROWING IN THE SE</b>

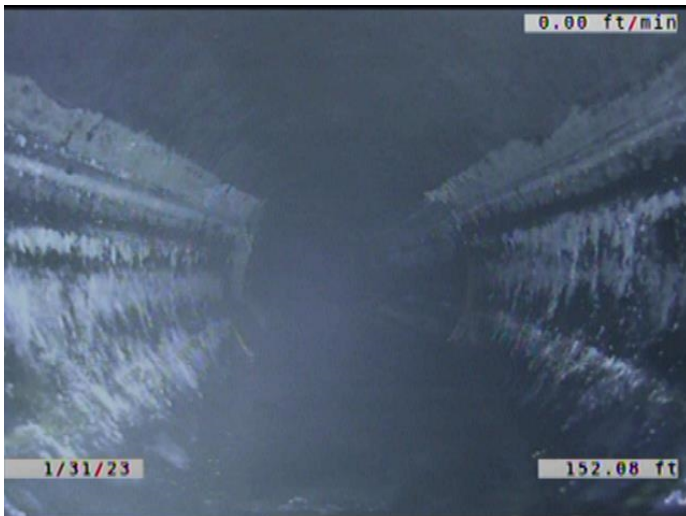
Code:	<b>MWLS</b>
Description:	<b>Miscellaneous Water Level Sag</b>
Distance (ft):	<b>152.1</b>
Structural Grade:	<b>2</b>
O&M Grade:	<b>0</b>
Clock Start/From:	
Clock To:	
1st Value:	
2nd Value:	
Value Percent:	<b>20.000</b>
Continuous Index:	<b>F03</b>
Within 8" of Joint:	<b>NO</b>
Remarks:

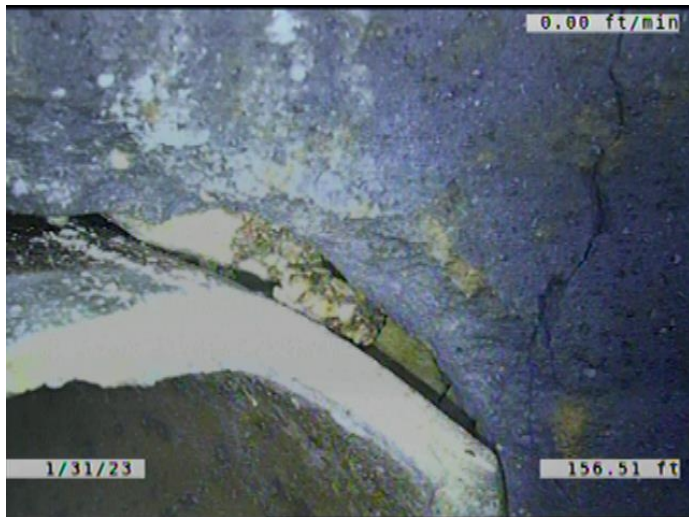
Code: **BSV**  
 Description: **Broken Soil Visible**

Distance (ft): **156.5**  
 Structural Grade: **5**  
 O&M Grade: **0**  
 Clock Start/From: **8**  
 Clock To: **12**  
 1st Value:  
 2nd Value:  
 Value Percent:  
 Continuous Index:  
 Within 8" of Joint: **YES**  
 Remarks:

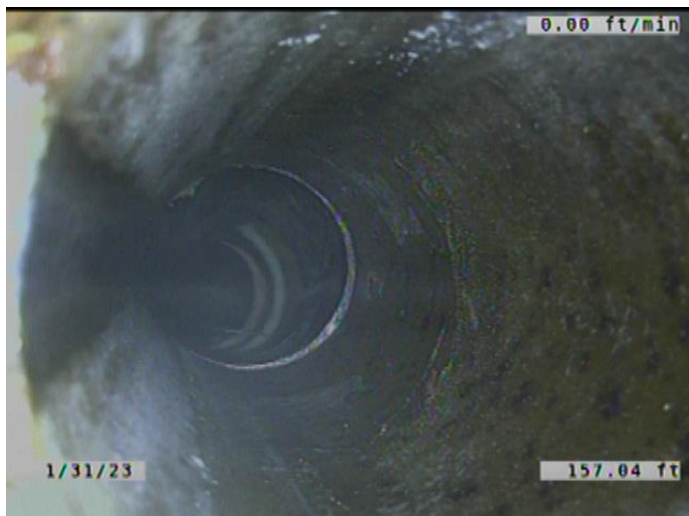
Code: **TBI**  
 Description: **Tap Break-in Intruding**

Distance (ft): **157.0**  
 Structural Grade: **0**  
 O&M Grade: **2**  
 Clock Start/From: **9**  
 Clock To:  
 1st Value: **6.000**  
 2nd Value: **1.000**  
 Value Percent:  
 Continuous Index:  
 Within 8" of Joint: **YES**  
 Remarks:

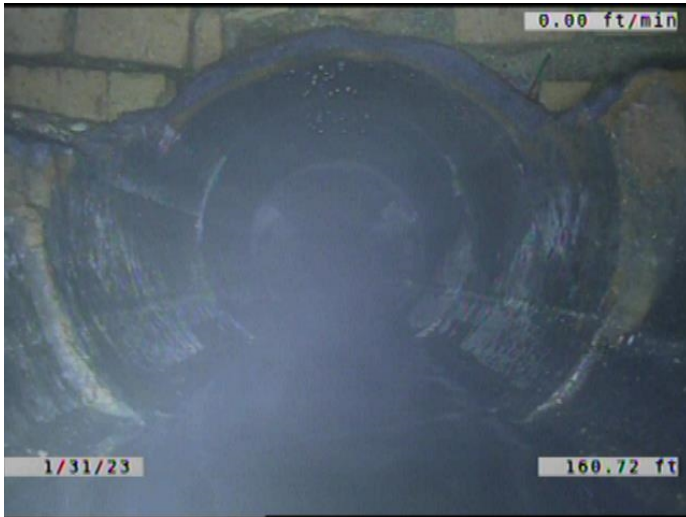
Code: **JAM**  
 Description: **Joint Angular Medium**

Distance (ft): **160.7**  
 Structural Grade: **3**  
 O&M Grade: **0**  
 Clock Start/From:  
 Clock To:  
 1st Value:  
 2nd Value:  
 Value Percent:  
 Continuous Index: **F01**  
 Within 8" of Joint: **NO**  
 Remarks:
