Profile/Photo Observation Report

Date:	01/31/2023	Weather:		Coding:	PACP 7.0
Pipe Length (ft):	156.0	Owner:	City of Hobart	Pre Clean:	Heavy Cleaning
P.O.#:	YES502259	Surveyor:	S. Bucklin	PSR:	P-805-038-039
Customer:	City of Hobart	Clean Date:	12/06/2022	Shape:	C

Street:	Devanshire Street	Flow Control:	Not Controlled
City:	Hobart, IN	Year Renewed:	
Location:	Local rural streets with light traffic, t	Tape/Media #:	
Purpose:	Routine Assessment	Dia/Height:	12"
Use:	Sanitary Sewage Pipe	Material:	VCP
Drain Area:		Lining:	None
Category:	NA		
Comment:			
Location Details:		Direction of Survey:	Downstream
US MH:	M-805-039	DS MH:	M-805-038
		Total Length Surveyed (ft):	155.8

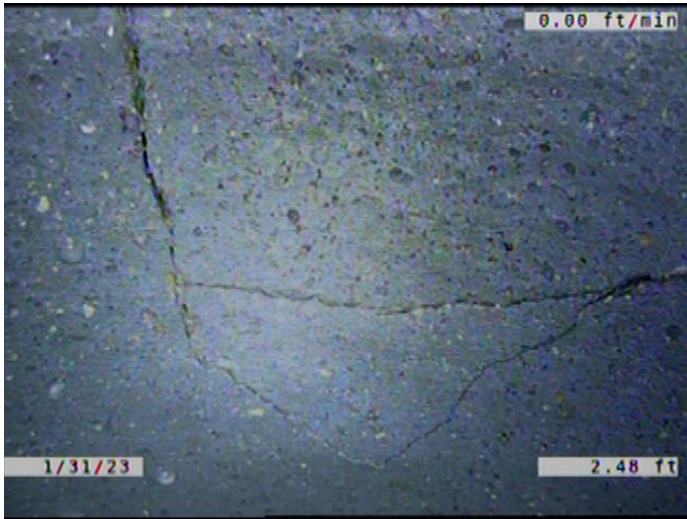
Code: **B**
Description: **Broken**

Distance (ft): **2.5**
Structural Grade: **4**
O&M Grade: **0**
Clock Start/From: **1**
Clock To: **4**
1st Value:
2nd Value:
Value Percent:
Continuous Index:
Within 8" of Joint: **YES**
Remarks:

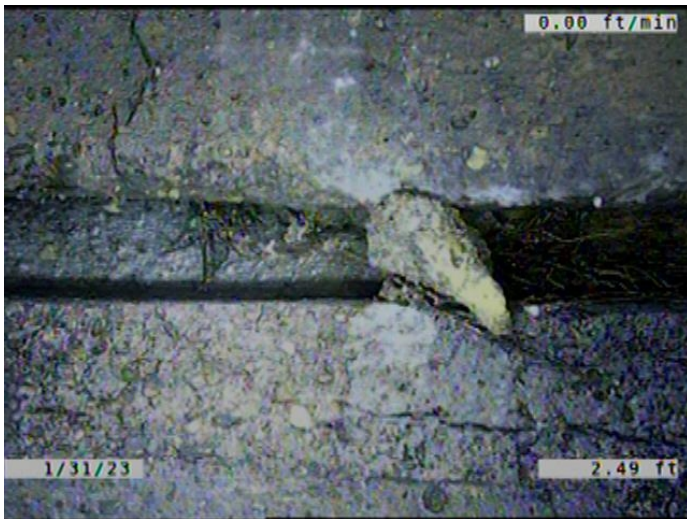
Code: **RFJ**
Description: **Roots Fine Joint**

Distance (ft): **2.5**
Structural Grade: **0**
O&M Grade: **1**
Clock Start/From: **3**
Clock To:
1st Value:
2nd Value:
Value Percent:
Continuous Index:
Within 8" of Joint: **YES**
Remarks:

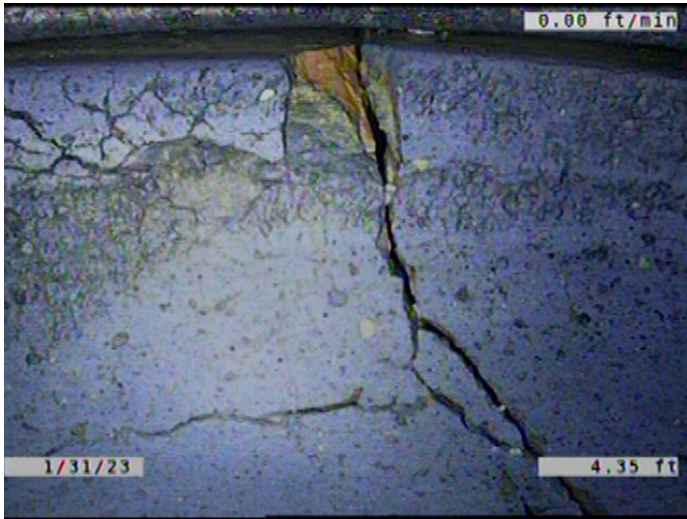
Code: **B**
 Description: **Broken**

Distance (ft): **4.4**
 Structural Grade: **4**
 O&M Grade: **0**
 Clock Start/From: **10**
 Clock To: **4**
 1st Value:
 2nd Value:
 Value Percent:
 Continuous Index:
 Within 8" of Joint: **YES**
 Remarks:

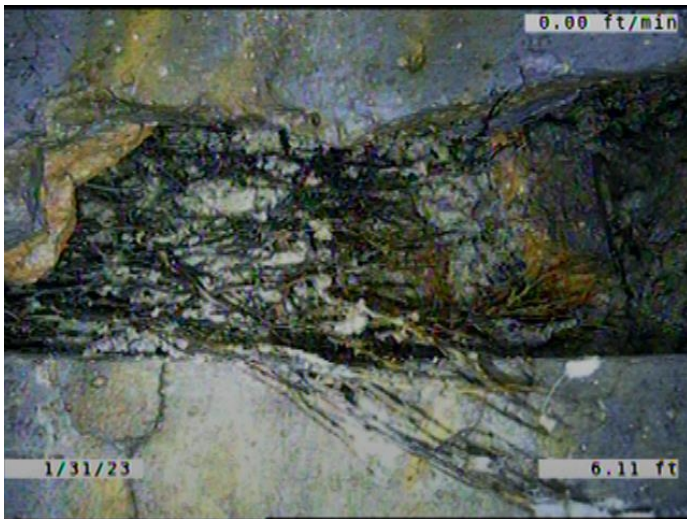
Code: **RFJ**
 Description: **Roots Fine Joint**

Distance (ft): **6.1**
 Structural Grade: **0**
 O&M Grade: **1**
 Clock Start/From: **12**
 Clock To: **4**
 1st Value:
 2nd Value:
 Value Percent:
 Continuous Index:
 Within 8" of Joint: **YES**
 Remarks:

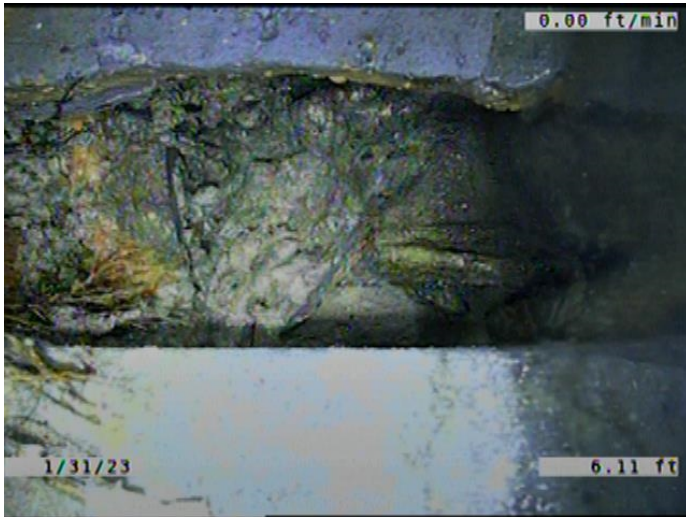
Code: **BSV**
 Description: **Broken Soil Visible**

Distance (ft): **6.1**
 Structural Grade: **5**
 O&M Grade: **0**
 Clock Start/From: **8**
 Clock To: **4**
 1st Value:
 2nd Value:
 Value Percent:
 Continuous Index:
 Within 8" of Joint: **YES**
 Remarks:

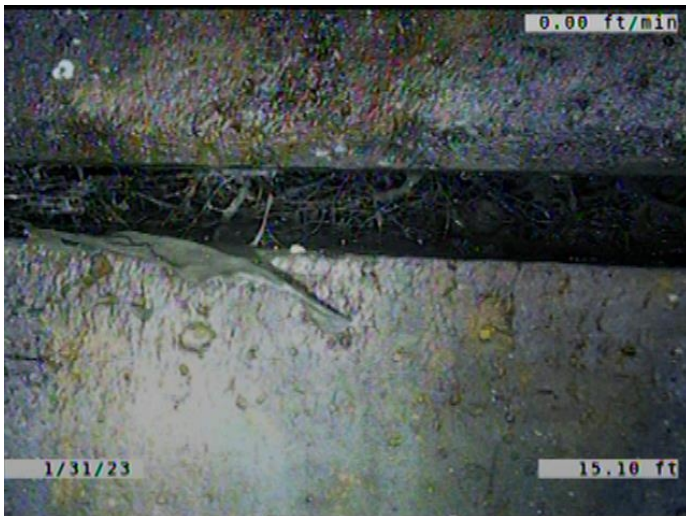
Code: **RFJ**
 Description: **Roots Fine Joint**

Distance (ft): **15.1**
 Structural Grade: **0**
 O&M Grade: **1**
 Clock Start/From: **8**
 Clock To: **4**
 1st Value:
 2nd Value:
 Value Percent:
 Continuous Index:
 Within 8" of Joint: **YES**
 Remarks:

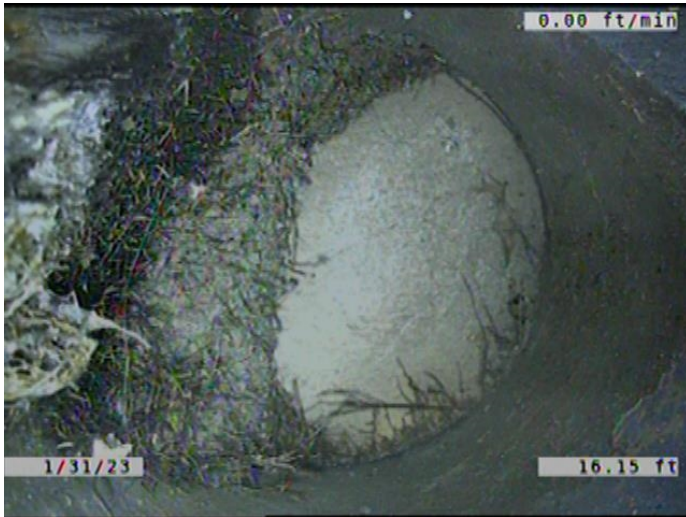
Code:	TFD
Description:	Tap Factory Defective
Distance (ft):	16.1
Structural Grade:	0
O&M Grade:	3
Clock Start/From:	10
Clock To:	
1st Value:	6.000
2nd Value:	
Value Percent:	
Continuous Index:	
Within 8" of Joint:	YES
Remarks:	CAPPED. ROOTS GROWING AROUND THE CAP INTO THE MAIN.

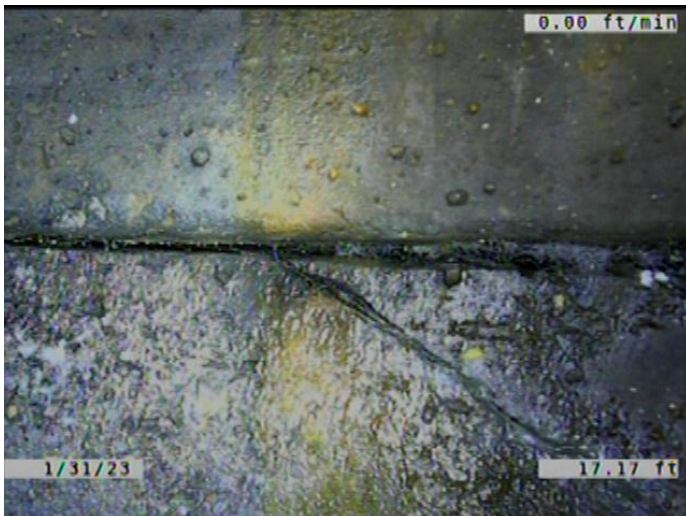
Code:	RFJ
Description:	Roots Fine Joint
Distance (ft):	17.2
Structural Grade:	0
O&M Grade:	1
Clock Start/From:	8
Clock To:	4
1st Value:	
2nd Value:	
Value Percent:	
Continuous Index:	
Within 8" of Joint:	YES
Remarks:

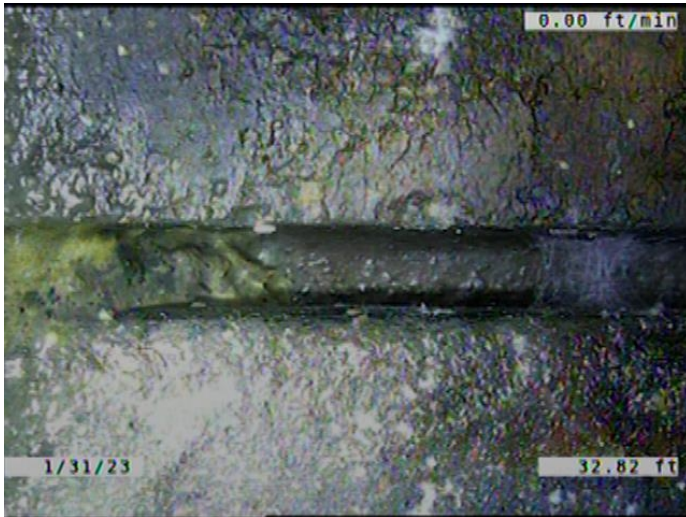
Code: **JAM**
 Description: **Joint Angular Medium**

Distance (ft): **32.8**
 Structural Grade: **3**
 O&M Grade: **0**
 Clock Start/From:
 Clock To:
 1st Value:
 2nd Value:
 Value Percent:
 Continuous Index: **S01**
 Within 8" of Joint: **NO**
 Remarks:

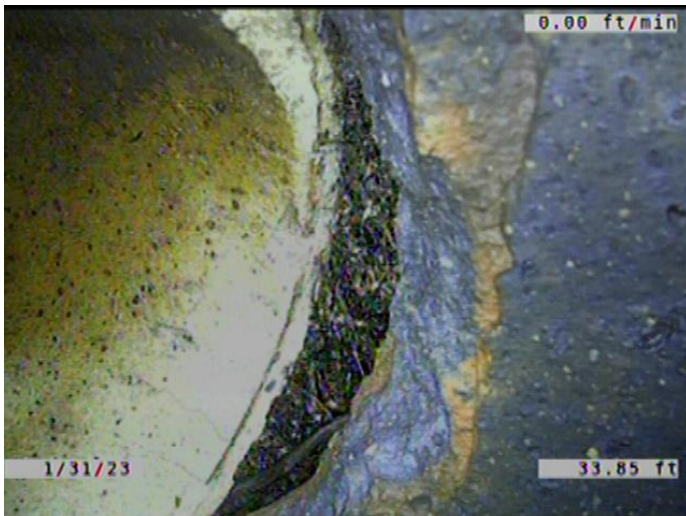
Code: **SSS**
 Description: **Surface Damage Surface Spalling**

Distance (ft): **33.8**
 Structural Grade: **2**
 O&M Grade: **0**
 Clock Start/From: **9**
 Clock To: **12**
 1st Value:
 2nd Value:
 Value Percent:
 Continuous Index:
 Within 8" of Joint: **YES**
 Remarks:

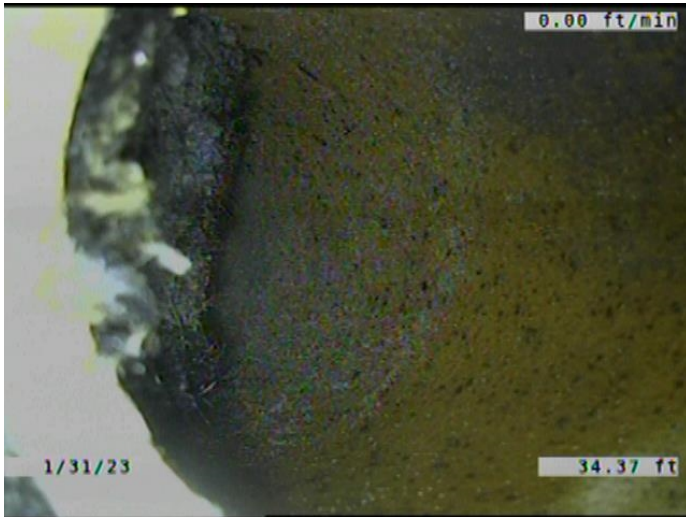
Code:	TBI
Description:	Tap Break-in Intruding
Distance (ft):	34.4
Structural Grade:	0
O&M Grade:	2
Clock Start/From:	10
Clock To:	
1st Value:	6.000
2nd Value:	1.000
Value Percent:	
Continuous Index:	
Within 8" of Joint:	YES
Remarks:	ROOTS GROWING AROUND THE SERVICE INTO THE MAIN. ROOTS GR

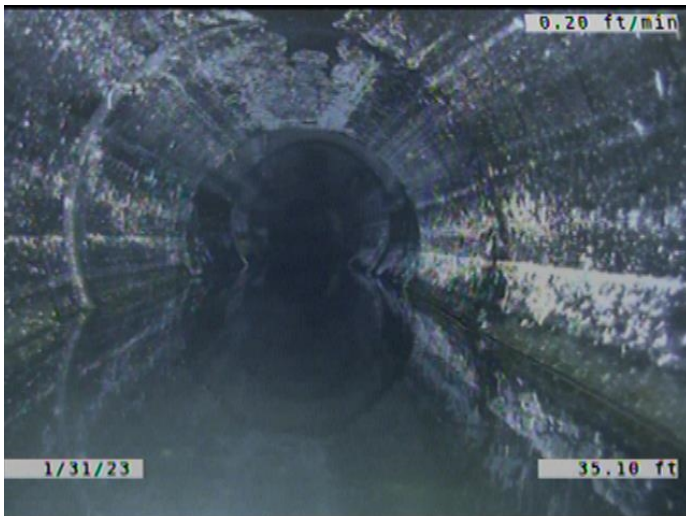
Code:	MWLS
Description:	Miscellaneous Water Level Sag
Distance (ft):	35.1
Structural Grade:	2
O&M Grade:	0
Clock Start/From:	
Clock To:	
1st Value:	
2nd Value:	
Value Percent:	15.000
Continuous Index:	S02
Within 8" of Joint:	NO
Remarks:

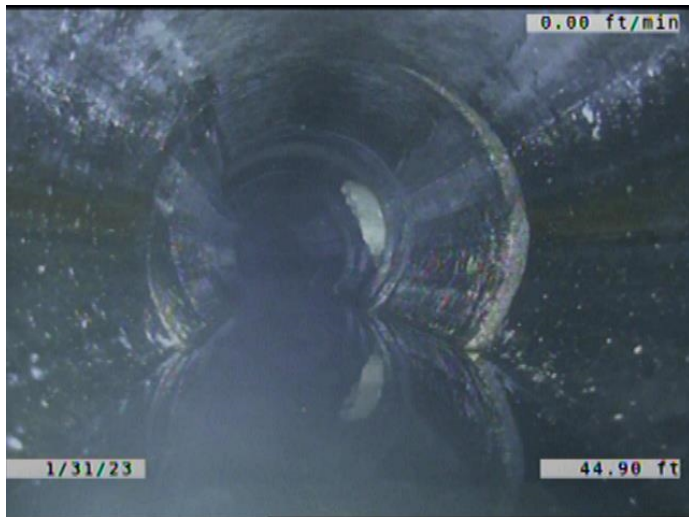
Code: **MWLS**
 Description: **Miscellaneous Water Level Sag**

Distance (ft): **44.9**
 Structural Grade: **2**
 O&M Grade: **0**
 Clock Start/From:
 Clock To:
 1st Value:
 2nd Value:
 Value Percent: **15.000**
 Continuous Index: **F02**
 Within 8" of Joint: **NO**
 Remarks:

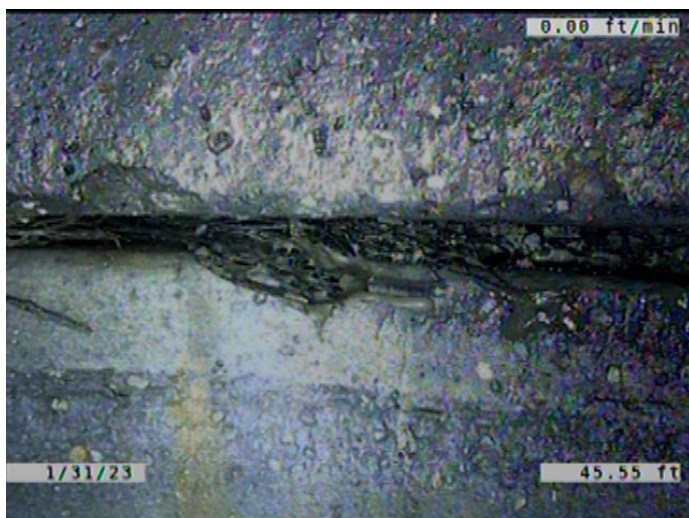
Code: **RFJ**
 Description: **Roots Fine Joint**

Distance (ft): **45.5**
 Structural Grade: **0**
 O&M Grade: **1**
 Clock Start/From: **8**
 Clock To: **4**
 1st Value:
 2nd Value:
 Value Percent:
 Continuous Index: **S03**
 Within 8" of Joint: **YES**
 Remarks:

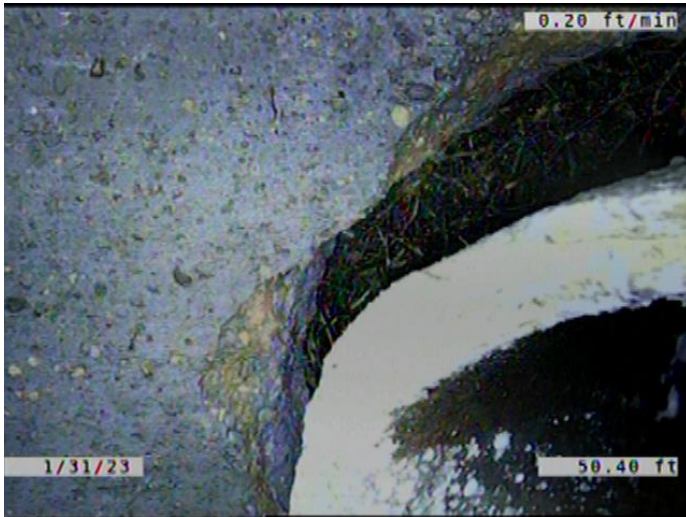
Code: **SSS**
Description: **Surface Damage Surface Spalling**

Distance (ft): **50.4**
Structural Grade: **2**
O&M Grade: **0**
Clock Start/From: **12**
Clock To: **4**
1st Value:
2nd Value:
Value Percent:
Continuous Index:
Within 8" of Joint: **YES**
Remarks:

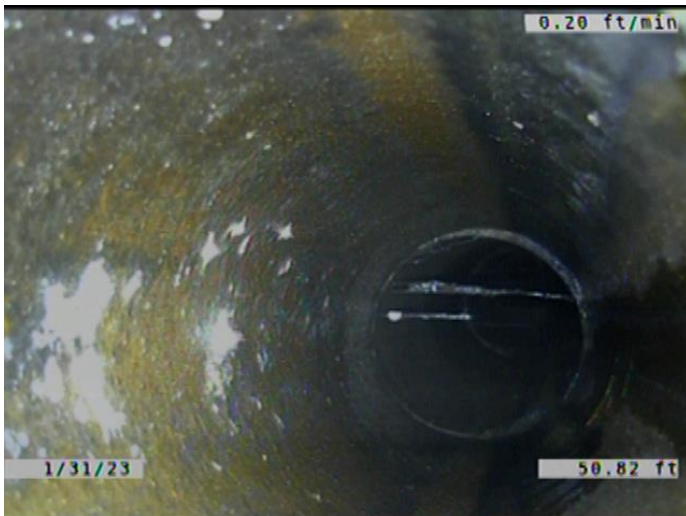
Code: **TBI**
Description: **Tap Break-in Intruding**

Distance (ft): **50.8**
Structural Grade: **0**
O&M Grade: **2**
Clock Start/From: **3**
Clock To:
1st Value: **6.000**
2nd Value: **2.000**
Value Percent:
Continuous Index:
Within 8" of Joint: **YES**
Remarks: **ROOTS GROWING AROUND THE SERVICE AND IN THE SERVICE JOINTS**

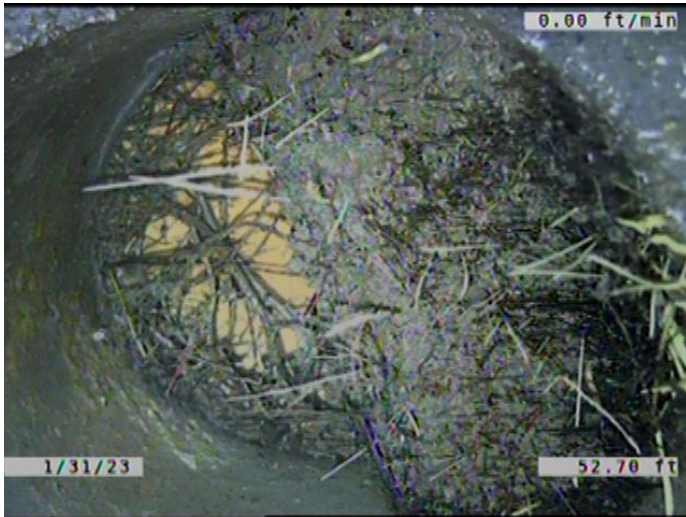
Code:	TFD
Description:	Tap Factory Defective
Distance (ft):	52.7
Structural Grade:	0
O&M Grade:	3
Clock Start/From:	2
Clock To:	
1st Value:	6.000
2nd Value:	
Value Percent:	
Continuous Index:	
Within 8" of Joint:	YES
Remarks:	CAPPED. ROOTS GROWING AROUND THE CAP INTO THE MAIN.

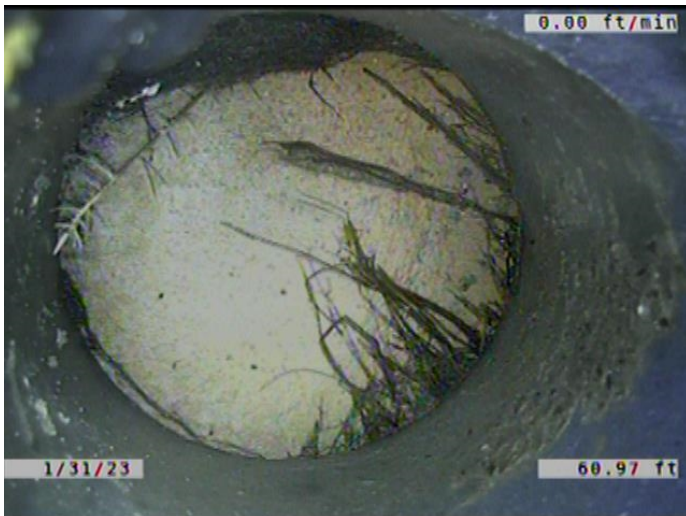
Code:	TFD
Description:	Tap Factory Defective
Distance (ft):	61.0
Structural Grade:	0
O&M Grade:	3
Clock Start/From:	10
Clock To:	
1st Value:	6.000
2nd Value:	
Value Percent:	
Continuous Index:	
Within 8" of Joint:	YES
Remarks:	CAPPED. ROOTS GROWING AROUND THE CAP.

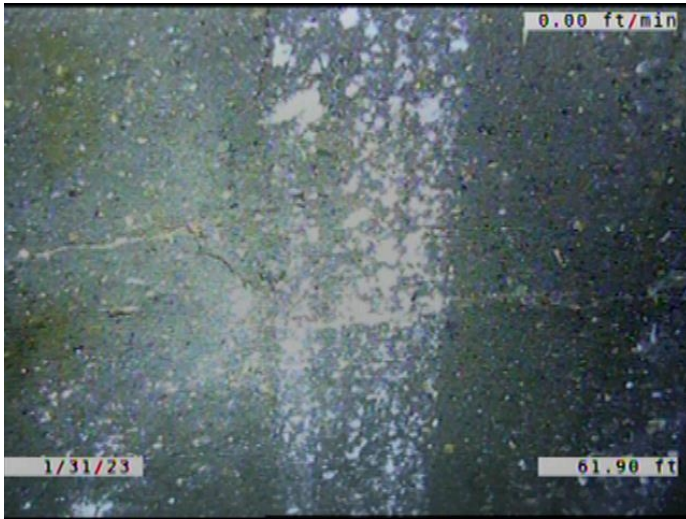
Code: **FM**
 Description: **Fracture Multiple**

Distance (ft): **61.9**
 Structural Grade: **4**
 O&M Grade: **0**
 Clock Start/From: **8**
 Clock To: **12**
 1st Value:
 2nd Value:
 Value Percent:
 Continuous Index:
 Within 8" of Joint: **YES**
 Remarks:

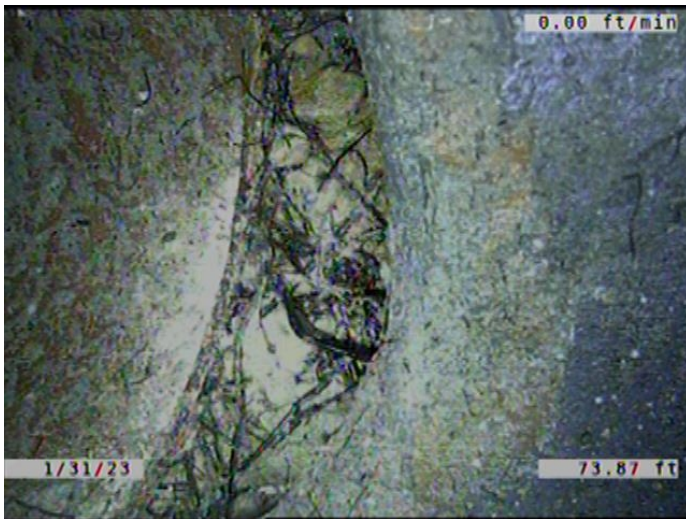
Code: **BSV**
 Description: **Broken Soil Visible**

Distance (ft): **73.9**
 Structural Grade: **5**
 O&M Grade: **0**
 Clock Start/From: **9**
 Clock To: **12**
 1st Value:
 2nd Value:
 Value Percent:
 Continuous Index:
 Within 8" of Joint: **YES**
 Remarks:

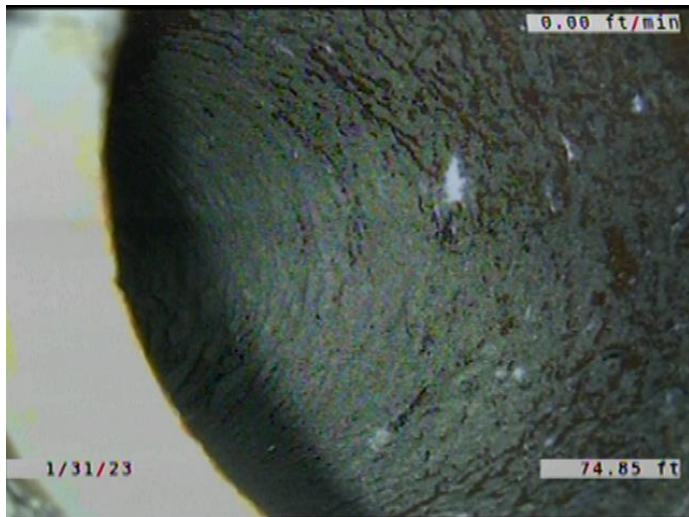
Code: **TBI**
 Description: **Tap Break-in Intruding**

Distance (ft): **74.8**
 Structural Grade: **0**
 O&M Grade: **2**
 Clock Start/From: **10**
 Clock To:
 1st Value: **6.000**
 2nd Value: **3.000**
 Value Percent:
 Continuous Index:
 Within 8" of Joint: **YES**
 Remarks: **ROOTS GROWING AROUND THE SERVICE.**

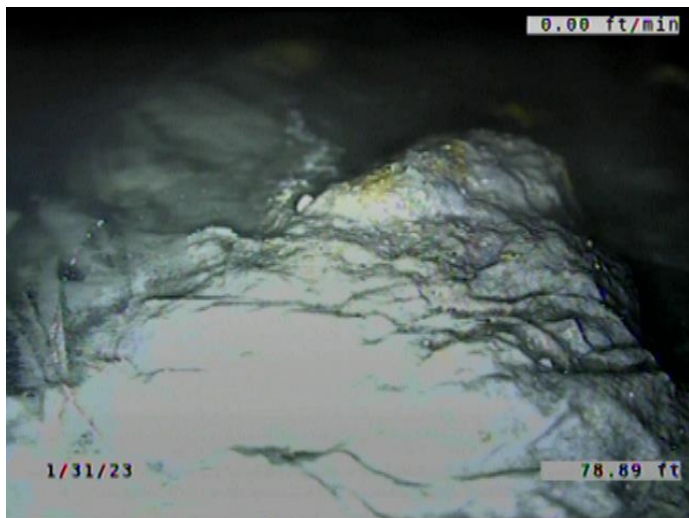
Code: **DAR**
 Description: **Deposits Attached Ragging**

Distance (ft): **78.9**
 Structural Grade: **0**
 O&M Grade: **2**
 Clock Start/From: **5**
 Clock To: **7**
 1st Value:
 2nd Value:
 Value Percent: **5.000**
 Continuous Index:
 Within 8" of Joint: **YES**
 Remarks:

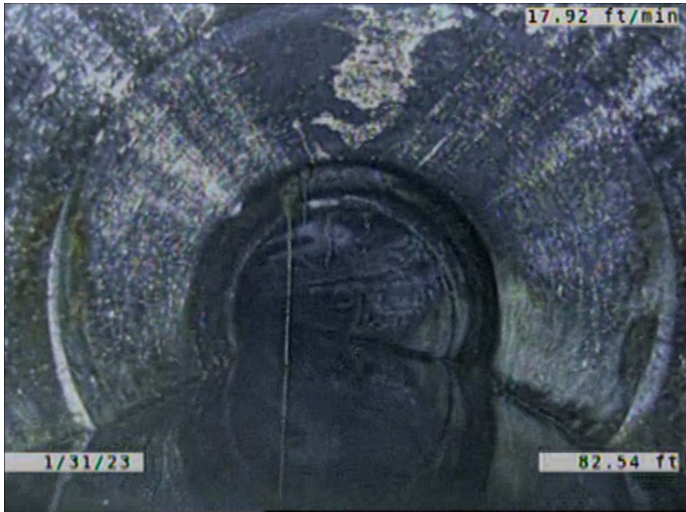
Code: **FM**
Description: **Fracture Multiple**

Distance (ft): **82.5**
Structural Grade: **4**
O&M Grade: **0**
Clock Start/From: **3**
Clock To: **4**
1st Value:
2nd Value:
Value Percent:
Continuous Index:
Within 8" of Joint: **YES**
Remarks:

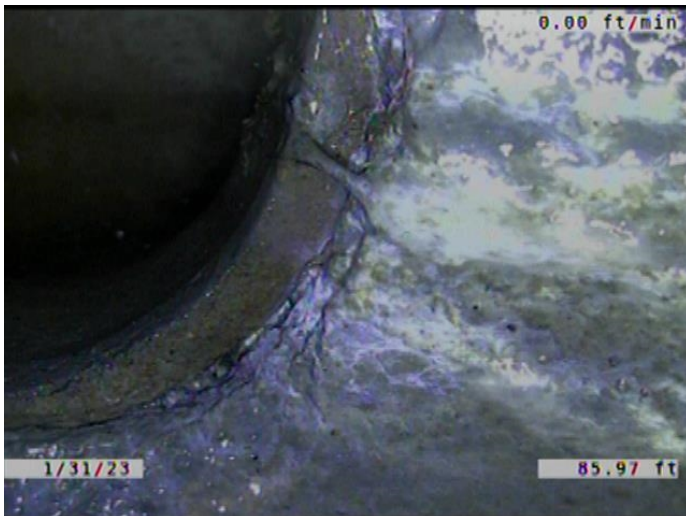
Code: **SSS**
Description: **Surface Damage Surface Spalling**

Distance (ft): **86.0**
Structural Grade: **2**
O&M Grade: **0**
Clock Start/From: **11**
Clock To: **1**
1st Value:
2nd Value:
Value Percent:
Continuous Index:
Within 8" of Joint: **YES**
Remarks:

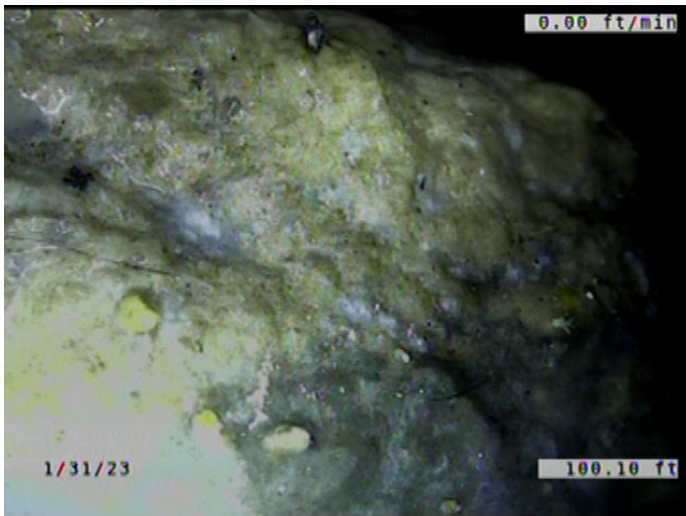
Code: **DAR**
 Description: **Deposits Attached Ragging**

Distance (ft): **100.1**
 Structural Grade: **0**
 O&M Grade: **2**
 Clock Start/From: **5**
 Clock To: **7**
 1st Value:
 2nd Value:
 Value Percent: **5.000**
 Continuous Index:
 Within 8" of Joint: **YES**
 Remarks:

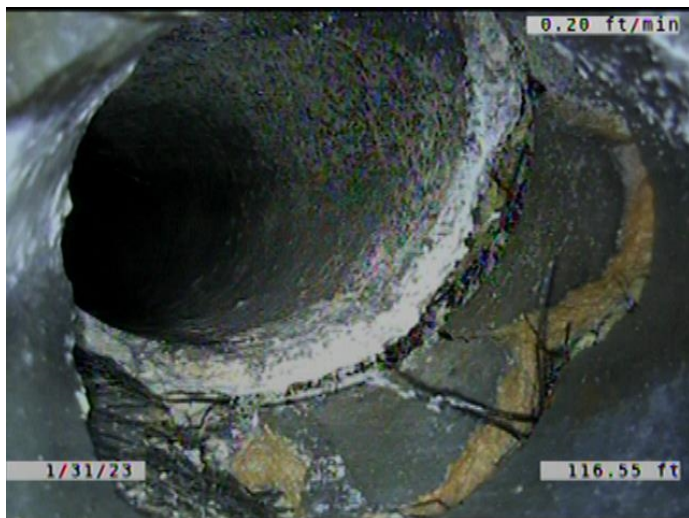
Code: **TFD**
 Description: **Tap Factory Defective**

Distance (ft): **116.5**
 Structural Grade: **0**
 O&M Grade: **3**
 Clock Start/From: **10**
 Clock To:
 1st Value: **6.000**
 2nd Value:
 Value Percent:
 Continuous Index:
 Within 8" of Joint: **YES**
 Remarks: **TAP BROKEN. SERVICE OFFSET. ROOTS GROWING IN THE BROKEN T**

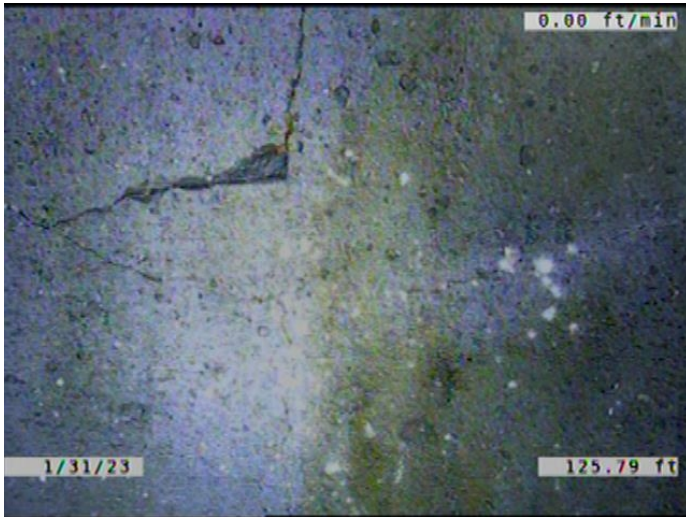
Code: **FM**
 Description: **Fracture Multiple**

Distance (ft): **125.8**
 Structural Grade: **4**
 O&M Grade: **0**
 Clock Start/From: **1**
 Clock To: **4**
 1st Value:
 2nd Value:
 Value Percent:
 Continuous Index:
 Within 8" of Joint: **YES**
 Remarks:

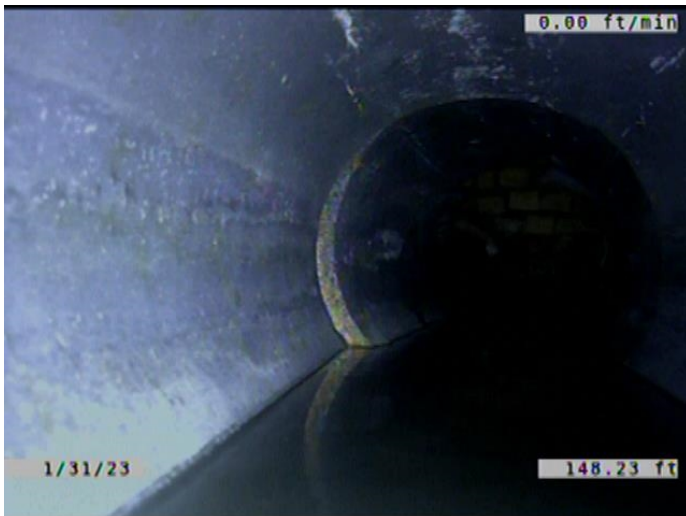
Code: **LR**
 Description: **Line Right**

Distance (ft): **148.2**
 Structural Grade: **0**
 O&M Grade: **1**
 Clock Start/From:
 Clock To:
 1st Value:
 2nd Value:
 Value Percent: **10.000**
 Continuous Index:
 Within 8" of Joint: **NO**
 Remarks:

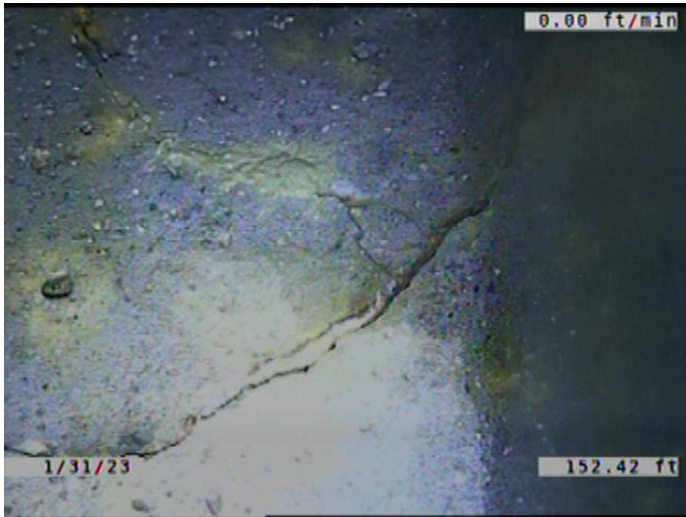
Code: **B**
Description: **Broken**

Distance (ft): **152.4**
Structural Grade: **4**
O&M Grade: **0**
Clock Start/From: **7**
Clock To: **5**
1st Value:
2nd Value:
Value Percent:
Continuous Index:
Within 8" of Joint: **YES**
Remarks:

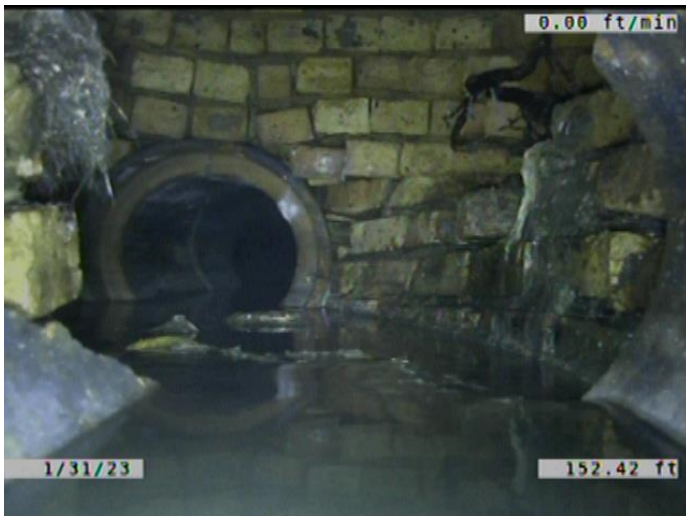
Code: **RFJ**
Description: **Roots Fine Joint**

Distance (ft): **152.4**
Structural Grade: **0**
O&M Grade: **1**
Clock Start/From: **8**
Clock To: **4**
1st Value:
2nd Value:
Value Percent:
Continuous Index: **F03**
Within 8" of Joint: **YES**
Remarks:

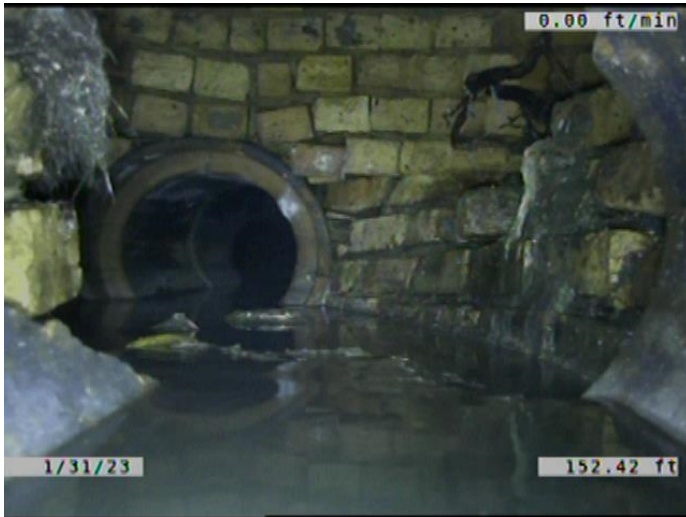
Code: **JAM**
 Description: **Joint Angular Medium**

Distance (ft): **152.4**
 Structural Grade: **3**
 O&M Grade: **0**
 Clock Start/From:
 Clock To:
 1st Value:
 2nd Value:
 Value Percent:
 Continuous Index: **F01**
 Within 8" of Joint: **NO**
 Remarks:
