# Profile/Photo Observation Report

Date:	<b>04/19/2018</b>	Weather:		Coding:	<b>PACP 6.0</b>
Pipe Length (ft):	<b>221.3</b>	Owner:	<b>NA</b>	Pre Clean:	<b>Not Known</b>
P.O.#:		Surveyor:	<b>Byrd Fitzgerald</b>	PSR:	<b>P-805-044-039</b>
Customer:		Clean Date:	<b>01/01/1900</b>	Shape:	<b>C</b>

Street:	<b>S JOLIET ST</b>	Flow Control:	<b>Not Controlled</b>
City:	<b>Hobart, IN</b>	Year Renewed:	
Location:	<b>Other</b>	Tape/Media #:	
Purpose:	<b>Not Known</b>	Dia/Height:	<b>8"</b>
Use:	<b>Sanitary</b>	Material:	<b>VCP</b>
Drain Area:	<b>NA</b>	Lining:	
Category:	<b>NA</b>		
Comment:			
Location Details:		Direction of Survey:	<b>Downstream</b>
US MH:	<b>M-805-039</b>	DS MH:	<b>M-805-044</b>
		Total Length Surveyed (ft):	<b>29.3</b>

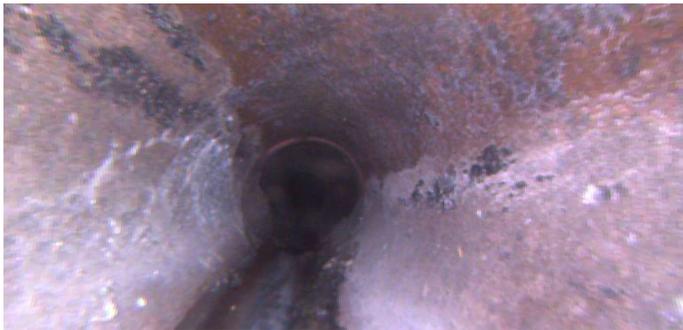
Code: **AMH**  
Description: **Manhole**

Distance (ft): **.0**  
Structural Grade: **0**  
O&M Grade: **0**  
Clock Start/From:  
Clock To:  
1st Value:  
2nd Value:  
Value Percent:  
Continuous Index:  
Within 8" of Joint: **NO**  
Remarks: **M-805-039**

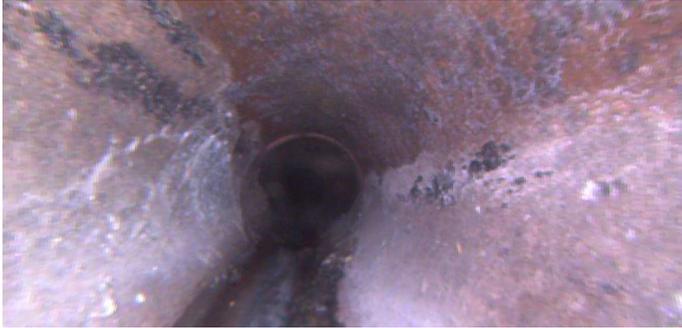
Code: **MWL**  
Description: **Water Level**

Distance (ft): **.0**  
Structural Grade: **0**  
O&M Grade: **0**  
Clock Start/From:  
Clock To:  
1st Value:  
2nd Value:  
Value Percent: **5.000**  
Continuous Index:  
Within 8" of Joint: **NO**  
Remarks:

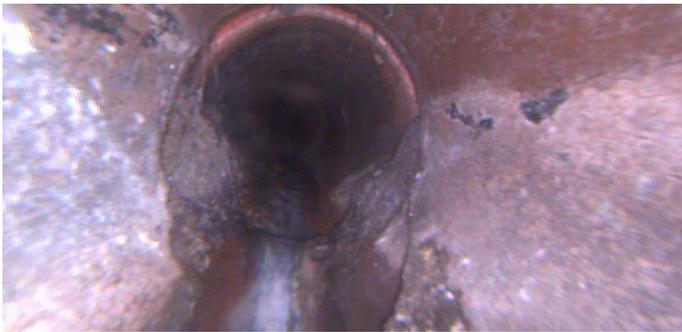
Code: **RMJ**  
Description: **Roots Medium Joint**

Distance (ft): **1.8**  
Structural Grade: **0**  
O&M Grade: **3**  
Clock Start/From: **7**  
Clock To: **5**  
1st Value:  
2nd Value:  
Value Percent: **5.000**  
Continuous Index: **S01**  
Within 8" of Joint: **YES**  
Remarks: **wandering**

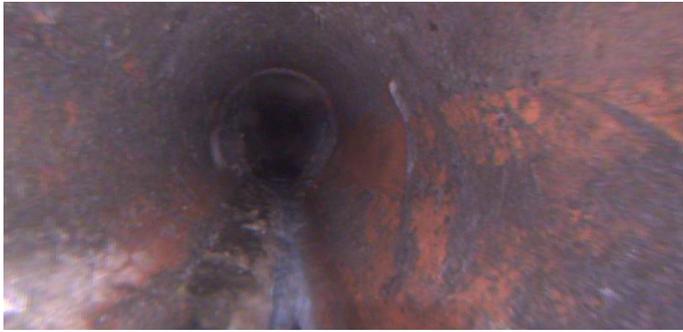
Code: **DSZ**  
Description: **Deposits Settled Other**

Distance (ft): **3.0**  
Structural Grade: **0**  
O&M Grade: **2**  
Clock Start/From: **6**  
Clock To:  
1st Value:  
2nd Value:  
Value Percent: **5.000**  
Continuous Index: **S02**  
Within 8" of Joint: **NO**  
Remarks: **debris**

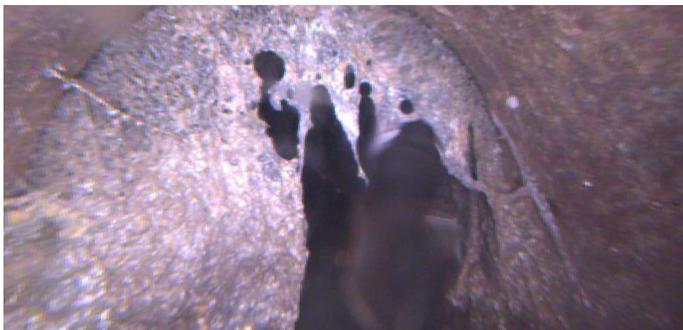
Code: **RBJ**  
Description: **Roots Ball Joint**

Distance (ft): **22.6**  
Structural Grade: **0**  
O&M Grade: **4**  
Clock Start/From: **7**  
Clock To: **5**  
1st Value:  
2nd Value:  
Value Percent: **55.000**  
Continuous Index:  
Within 8" of Joint: **YES**  
Remarks:

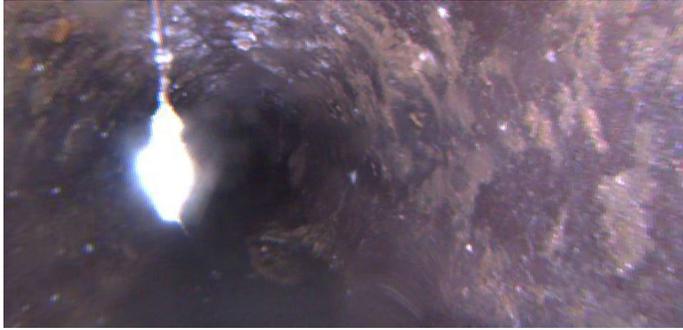
Code: **MSA**  
Description: **Abandoned Survey**

Distance (ft): **29.3**  
Structural Grade: **0**  
O&M Grade: **0**  
Clock Start/From:  
Clock To:  
1st Value:  
2nd Value:  
Value Percent:  
Continuous Index:  
Within 8" of Joint: **NO**  
Remarks: **rmj**

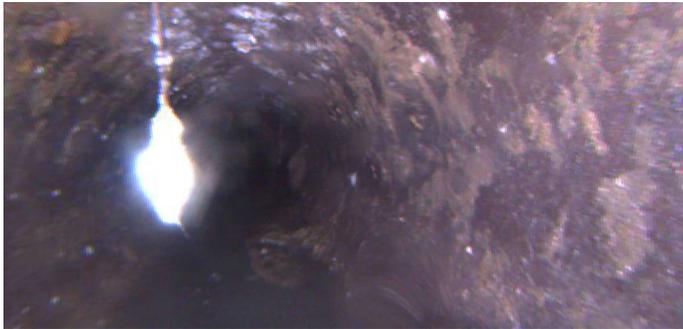
Code: **RMJ**  
Description: **Roots Medium Joint**

Distance (ft): **29.3**  
Structural Grade: **0**  
O&M Grade: **3**  
Clock Start/From: **7**  
Clock To: **5**  
1st Value:  
2nd Value:  
Value Percent: **5.000**  
Continuous Index: **F01**  
Within 8" of Joint: **YES**  
Remarks: **wandering**

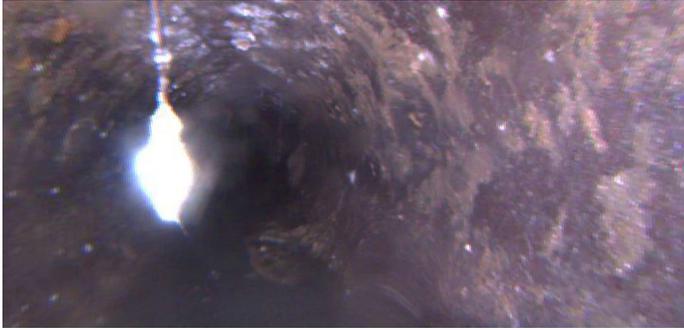
Code: **DSZ**  
Description: **Deposits Settled Other**

Distance (ft): **29.3**  
Structural Grade: **0**  
O&M Grade: **2**  
Clock Start/From: **6**  
Clock To:  
1st Value:  
2nd Value:  
Value Percent: **5.000**  
Continuous Index: **F02**  
Within 8" of Joint: **NO**  
Remarks: **debris**
