## Profile/Photo Observation Report

Street:	<b>Joliet St.</b>	Flow Control:	<b>Not Controlled</b>
City:	<b>Hobart, IN</b>	Year Renewed:	
Location:	<b>Other</b>	Tape/Media #:	
Purpose:	<b>Not Known</b>	Dia/Height:	<b>8"</b>
Use:	<b>Sanitary</b>	Material:	<b>VCP</b>
Drain Area:	<b>NA</b>	Lining:	
Category:	<b>NA</b>		
Comment:

Location Details:		Direction of Survey:	<b>Downstream</b>
US MH:	<b>M-805-039</b>	DS MH:	<b>M-805-044</b>
		Total Length Surveyed (ft):	<b>29.3</b>

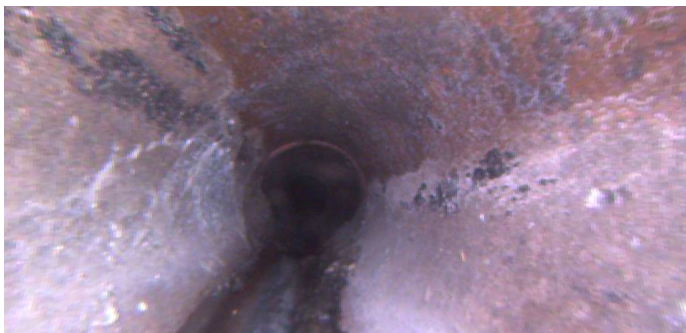
Code: **AMH**  
Description: **Manhole**

Distance (ft): **.0**  
Structural Grade: **0**  
O&M Grade: **0**  
Clock Start/From:  
Clock To:  
1st Value:  
2nd Value:  
Value Percent:  
Continuous Index:  
Within 8" of Joint: **NO**  
Remarks: **M-805-039**

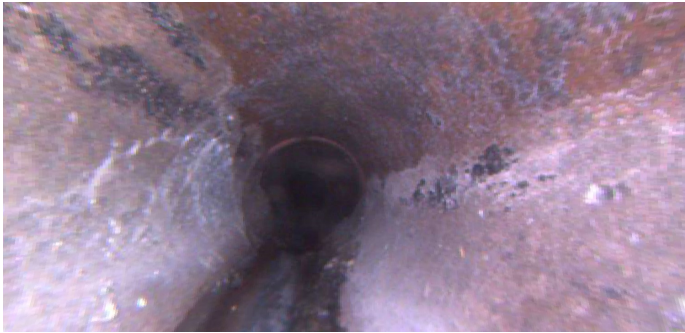
Code:	<b>MWL</b>
Description:	<b>Water Level</b>

Distance (ft):	<b>.0</b>
Structural Grade:	<b>0</b>
O&M Grade:	<b>0</b>
Clock Start/From:	
Clock To:	
1st Value:	
2nd Value:	
Value Percent:	<b>5.000</b>
Continuous Index:	
Within 8" of Joint:	<b>NO</b>
Remarks:

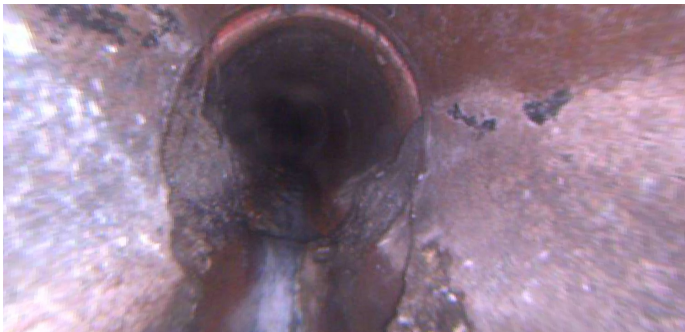
Code:	<b>RMJ</b>
Description:	<b>Roots Medium Joint</b>

Distance (ft):	<b>1.8</b>
Structural Grade:	<b>0</b>
O&M Grade:	<b>3</b>
Clock Start/From:	<b>7</b>
Clock To:	<b>5</b>
1st Value:	
2nd Value:	
Value Percent:	<b>5.000</b>
Continuous Index:	<b>S01</b>
Within 8" of Joint:	<b>YES</b>
Remarks:	<b>wandering</b>

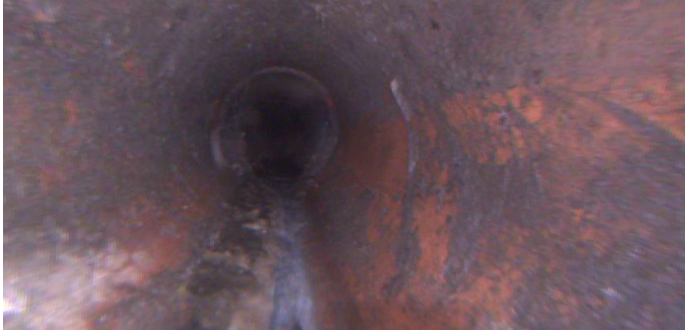
Code: **DSZ**  
Description: **Deposits Settled Other**

Distance (ft): **3.0**  
Structural Grade: **0**  
O&M Grade: **2**  
Clock Start/From: **6**  
Clock To:  
1st Value:  
2nd Value:  
Value Percent: **5.000**  
Continuous Index: **S02**  
Within 8" of Joint: **NO**  
Remarks: **debris**

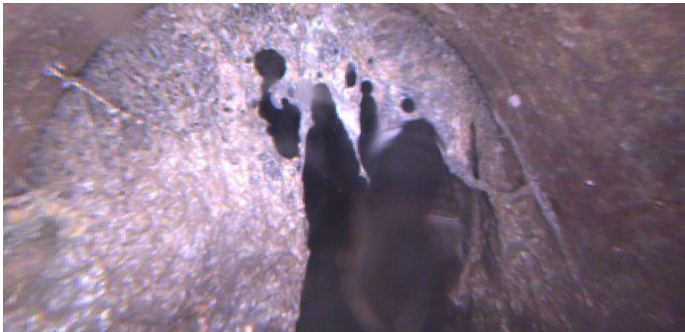
Code: **RBJ**  
Description: **Roots Ball Joint**

Distance (ft): **22.6**  
Structural Grade: **0**  
O&M Grade: **4**  
Clock Start/From: **7**  
Clock To: **5**  
1st Value:  
2nd Value:  
Value Percent: **55.000**  
Continuous Index:  
Within 8" of Joint: **YES**  
Remarks:

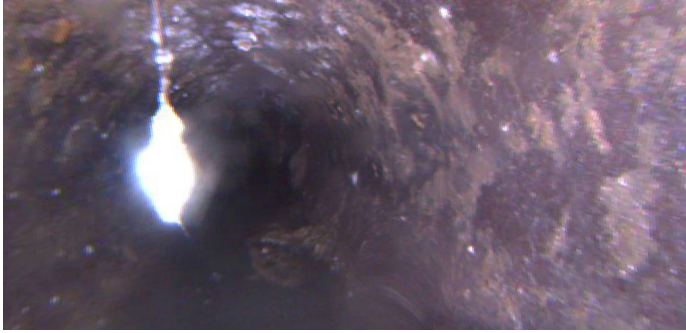
Code: **MSA**  
Description: **Abandoned Survey**

Distance (ft): **29.3**  
Structural Grade: **0**  
O&M Grade: **0**  
Clock Start/From:  
Clock To:  
1st Value:  
2nd Value:  
Value Percent:  
Continuous Index:  
Within 8" of Joint: **NO**  
Remarks: **rmj**

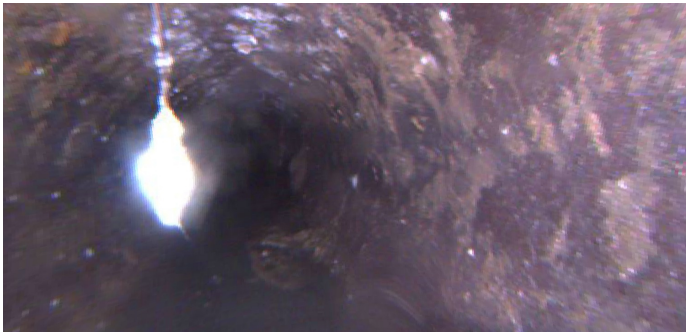
Code: **RMJ**  
Description: **Roots Medium Joint**

Distance (ft): **29.3**  
Structural Grade: **0**  
O&M Grade: **3**  
Clock Start/From: **7**  
Clock To: **5**  
1st Value:  
2nd Value:  
Value Percent: **5.000**  
Continuous Index: **F01**  
Within 8" of Joint: **YES**  
Remarks: **wandering**

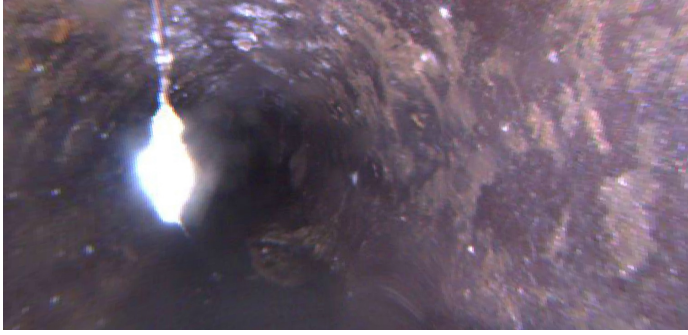
Code:	<b>DSZ</b>
Description:	<b>Deposits Settled Other</b>
Distance (ft):	<b>29.3</b>
Structural Grade:	<b>0</b>
O&M Grade:	<b>2</b>
Clock Start/From:	<b>6</b>
Clock To:	
1st Value:	
2nd Value:	
Value Percent:	<b>5.000</b>
Continuous Index:	<b>F02</b>
Within 8" of Joint:	<b>NO</b>
Remarks:	<b>debris</b>
