Profile/Photo Observation Report

Date:	04/21/2018	Weather:		Coding:	PACP 6.0
Pipe Length (ft):	202.2	Owner:	NA	Pre Clean:	Not Known
P.O.#:		Surveyor:	Mark Ruby	PSR:	P-805-046-047
Customer:		Clean Date:	01/01/1900	Shape:	C

Street:	S ILLINOIS ST	Flow Control:	Not Controlled
City:	Hobart, IN	Year Renewed:	
Location:	Light Highway	Tape/Media #:	
Purpose:	Maintenance Related	Dia/Height:	8"
Use:	Sanitary	Material:	VCP
Drain Area:	NA	Lining:	Cured in Place
Category:	NA		
Comment:	heavy sludge at 93'.

Location Details:		Direction of Survey:	Downstream
US MH:	M-805-046	DS MH:	M-805-047
		Total Length Surveyed (ft):	94.7

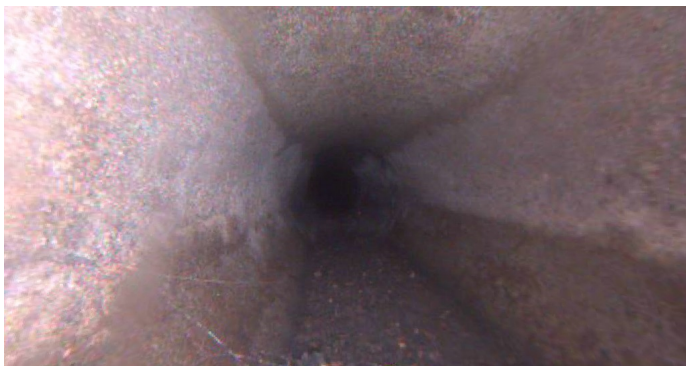
Code: **AMH**
Description: **Manhole**

Distance (ft): **.0**
Structural Grade: **0**
O&M Grade: **0**
Clock Start/From:
Clock To:
1st Value:
2nd Value:
Value Percent:
Continuous Index:
Within 8" of Joint: **NO**
Remarks: **M-805-046**

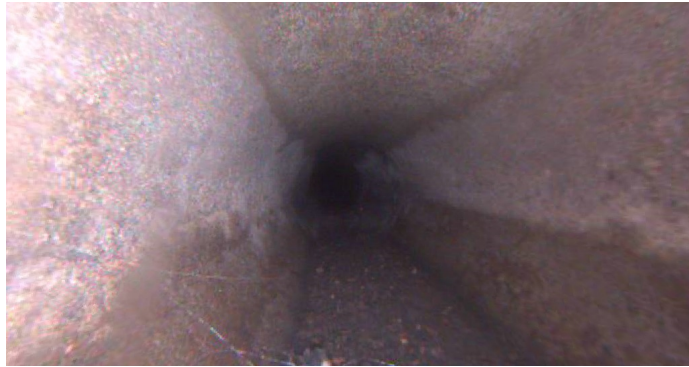
Code: **MWL**
Description: **Water Level**

Distance (ft): **.0**
Structural Grade: **0**
O&M Grade: **0**
Clock Start/From:
Clock To:
1st Value:
2nd Value:
Value Percent: **10.000**
Continuous Index:
Within 8" of Joint: **NO**
Remarks:

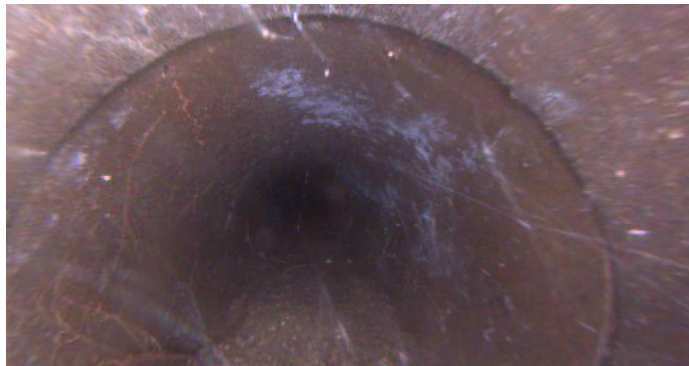
Code: **CL**
Description: **Crack Longitudinal**

Distance (ft): **23.2**
Structural Grade: **2**
O&M Grade: **0**
Clock Start/From: **10**
Clock To:
1st Value:
2nd Value:
Value Percent:
Continuous Index:
Within 8" of Joint: **YES**
Remarks:

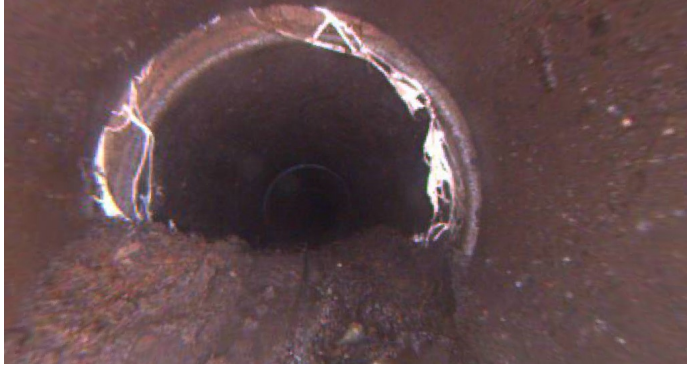
Code:	DAZ
Description:	Deposits Attached Other
Distance (ft):	30.3
Structural Grade:	0
O&M Grade:	2
Clock Start/From:	5
Clock To:	7
1st Value:	
2nd Value:	
Value Percent:	5.000
Continuous Index:	
Within 8" of Joint:	YES
Remarks:

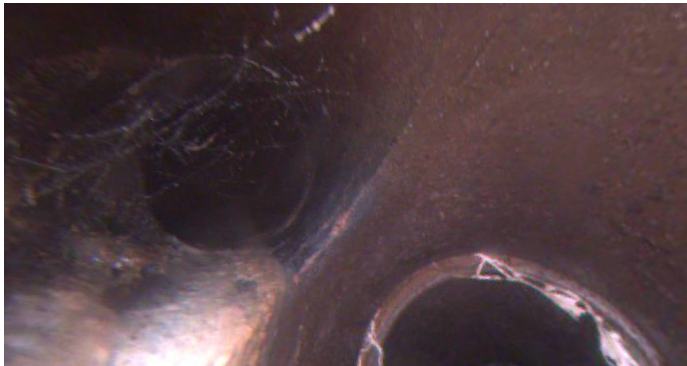
Code:	TF
Description:	Tap Factory
Distance (ft):	30.7
Structural Grade:	0
O&M Grade:	0
Clock Start/From:	2
Clock To:	
1st Value:	4.000
2nd Value:	
Value Percent:	
Continuous Index:	
Within 8" of Joint:	
Remarks:

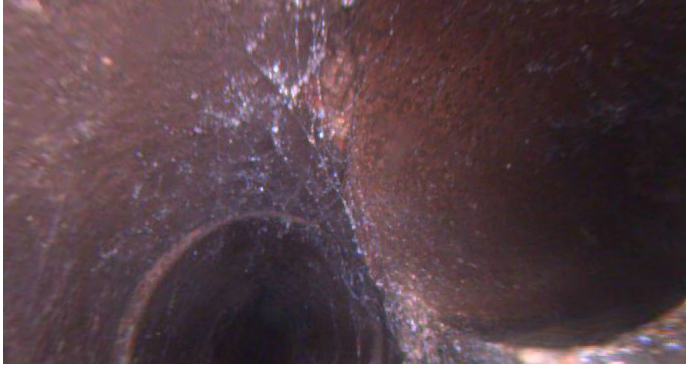
Code: **TB**
Description: **Tap Break-in**

Distance (ft): **40.9**
Structural Grade: **0**
O&M Grade: **0**
Clock Start/From: **9**
Clock To:
1st Value: **4.000**
2nd Value:
Value Percent:
Continuous Index:
Within 8" of Joint:
Remarks:

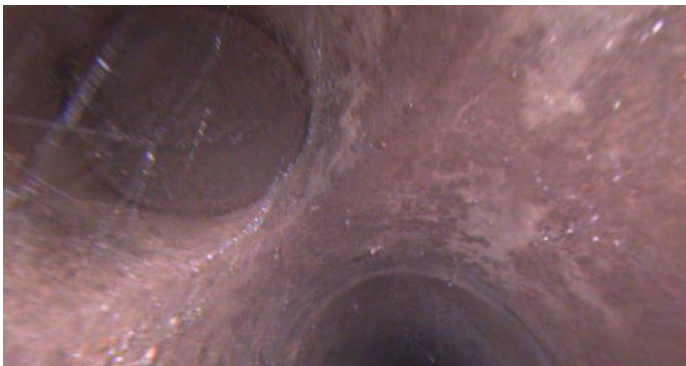
Code: **TFC**
Description: **Tap Factory Capped**

Distance (ft): **51.0**
Structural Grade: **0**
O&M Grade: **0**
Clock Start/From: **2**
Clock To:
1st Value: **4.000**
2nd Value:
Value Percent:
Continuous Index:
Within 8" of Joint:
Remarks:

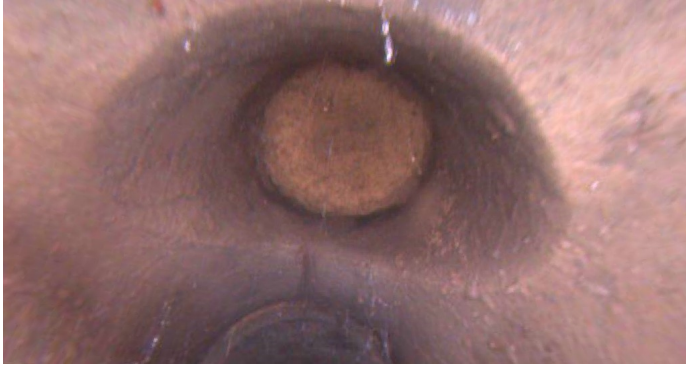
Code: **TFC**
Description: **Tap Factory Capped**

Distance (ft): **57.5**
Structural Grade: **0**
O&M Grade: **0**
Clock Start/From: **11**
Clock To:
1st Value: **4.000**
2nd Value:
Value Percent:
Continuous Index:
Within 8" of Joint:
Remarks:

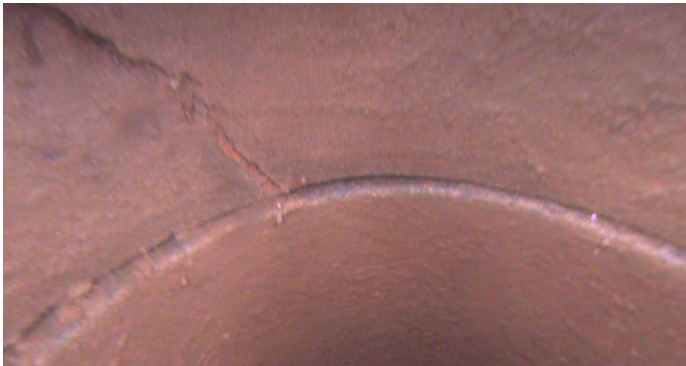
Code: **FL**
Description: **Fracture Longitudinal**

Distance (ft): **62.5**
Structural Grade: **3**
O&M Grade: **0**
Clock Start/From: **2**
Clock To:
1st Value:
2nd Value:
Value Percent:
Continuous Index:
Within 8" of Joint:
Remarks:

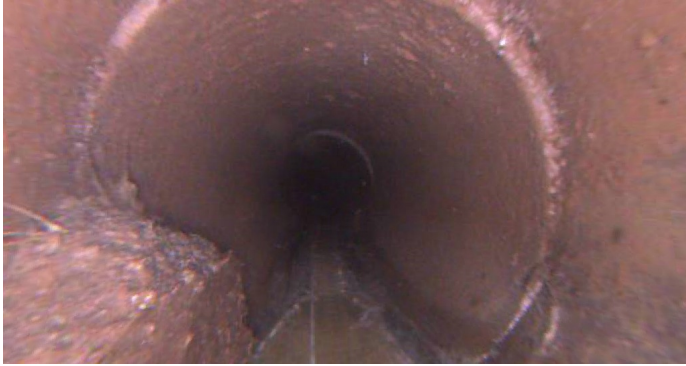
Code: **RFJ**
Description: **Roots Fine Joint**

Distance (ft): **68.9**
Structural Grade: **0**
O&M Grade: **1**
Clock Start/From: **5**
Clock To:
1st Value:
2nd Value:
Value Percent:
Continuous Index:
Within 8" of Joint: **YES**
Remarks:

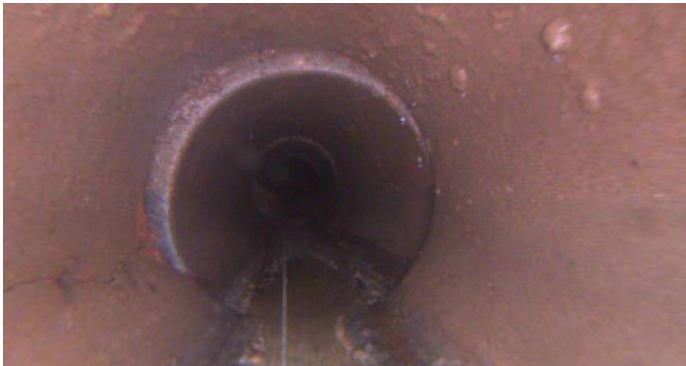
Code: **CS**
Description: **Crack Spiral**

Distance (ft): **71.4**
Structural Grade: **2**
O&M Grade: **0**
Clock Start/From: **8**
Clock To: **4**
1st Value:
2nd Value:
Value Percent:
Continuous Index:
Within 8" of Joint:
Remarks:

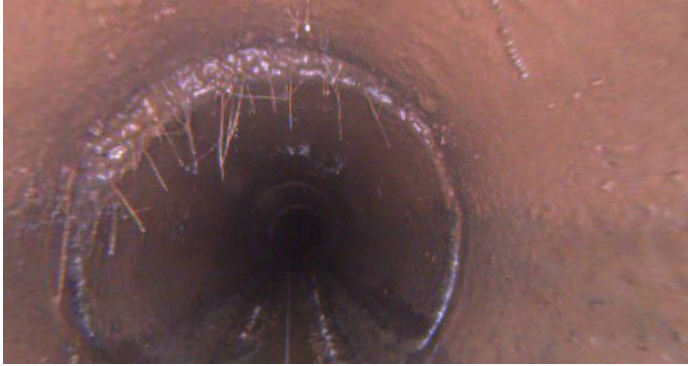
Code: **RFJ**
Description: **Roots Fine Joint**

Distance (ft): **75.2**
Structural Grade: **0**
O&M Grade: **1**
Clock Start/From: **4**
Clock To: **10**
1st Value:
2nd Value:
Value Percent:
Continuous Index:
Within 8" of Joint: **YES**
Remarks:

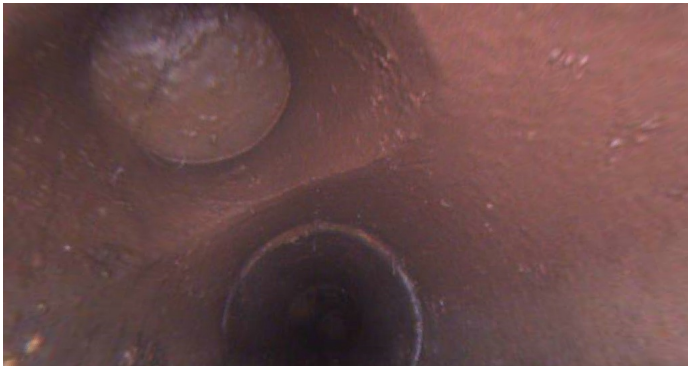
Code: **TFC**
Description: **Tap Factory Capped**

Distance (ft): **78.0**
Structural Grade: **0**
O&M Grade: **0**
Clock Start/From: **1**
Clock To:
1st Value: **4.000**
2nd Value:
Value Percent:
Continuous Index:
Within 8" of Joint:
Remarks:

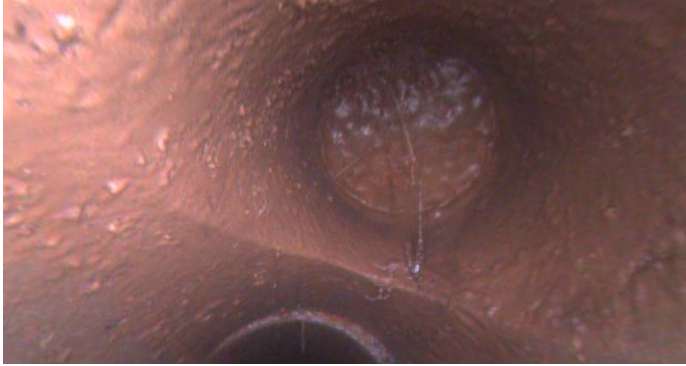
Code: **TFC**
Description: **Tap Factory Capped**

Distance (ft): **79.9**
Structural Grade: **0**
O&M Grade: **0**
Clock Start/From: **10**
Clock To:
1st Value: **4.000**
2nd Value:
Value Percent:
Continuous Index:
Within 8" of Joint:
Remarks:

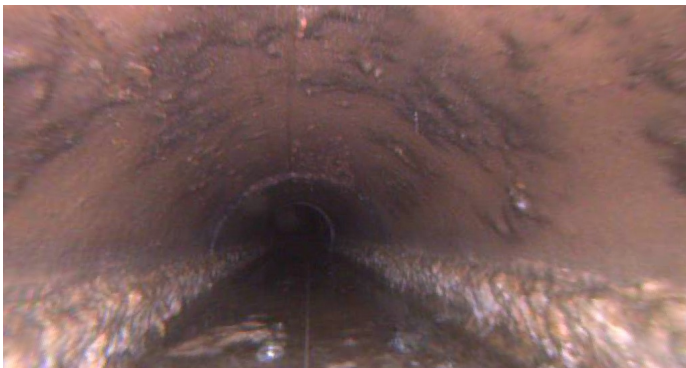
Code: **DAGS**
Description: **Deposits Attached Grease**

Distance (ft): **82.2**
Structural Grade: **0**
O&M Grade: **2**
Clock Start/From: **5**
Clock To: **7**
1st Value:
2nd Value:
Value Percent: **5.000**
Continuous Index: **S01**
Within 8" of Joint: **NO**
Remarks:
