## Profile/Photo Observation Report

Date:	<b>04/21/2018</b>	Weather:		Coding:	<b>PACP 6.0</b>
Pipe Length (ft):	<b>202.2</b>	Owner:	<b>NA</b>	Pre Clean:	<b>Not Known</b>
P.O.#:		Surveyor:	<b>Mark Ruby</b>	PSR:	<b>P-805-046-047</b>
Customer:		Clean Date:	<b>01/01/1900</b>	Shape:	<b>C</b>

Street:	<b>Capitol</b>	Flow Control:	<b>Not Controlled</b>
City:	<b>Hobart, IN</b>	Year Renewed:	
Location:	<b>Light Highway</b>	Tape/Media #:	
Purpose:	<b>Maintenance Related</b>	Dia/Height:	<b>8"</b>
Use:	<b>Sanitary</b>	Material:	<b>VCP</b>
Drain Area:	<b>NA</b>	Lining:	<b>Cured in Place</b>
Category:	<b>NA</b>		
Comment:	<b>heavy sludge at 93'.</b>

Location Details:		Direction of Survey:	<b>Downstream</b>
US MH:	<b>M-805-046</b>	DS MH:	<b>M-805-047</b>
		Total Length Surveyed (ft):	<b>94.7</b>

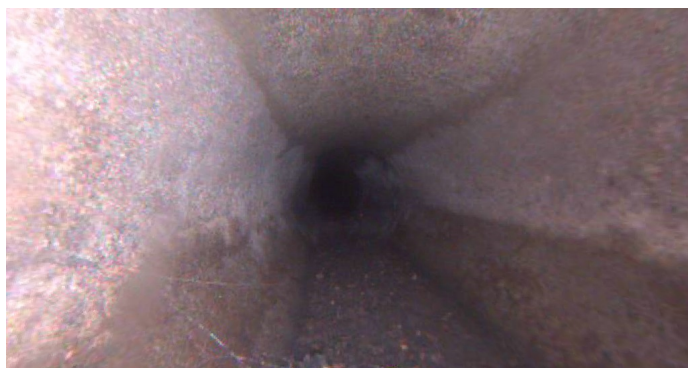
Code: **AMH**  
 Description: **Manhole**

Distance (ft): **.0**  
 Structural Grade: **0**  
 O&M Grade: **0**  
 Clock Start/From:  
 Clock To:  
 1st Value:  
 2nd Value:  
 Value Percent:  
 Continuous Index:  
 Within 8" of Joint: **NO**  
 Remarks: **M-805-046**

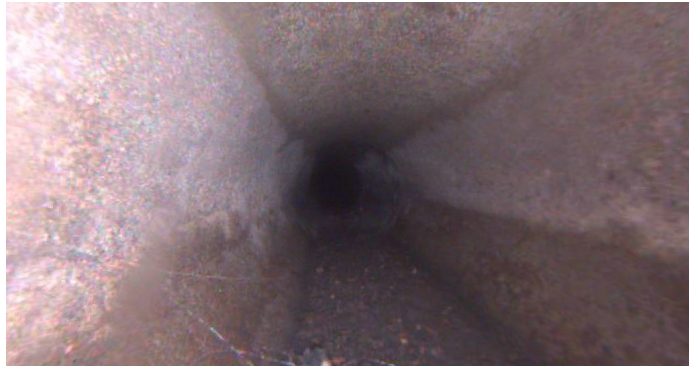
Code: **MWL**  
Description: **Water Level**

Distance (ft): **.0**  
Structural Grade: **0**  
O&M Grade: **0**  
Clock Start/From:  
Clock To:  
1st Value:  
2nd Value:  
Value Percent: **10.000**  
Continuous Index:  
Within 8" of Joint: **NO**  
Remarks:

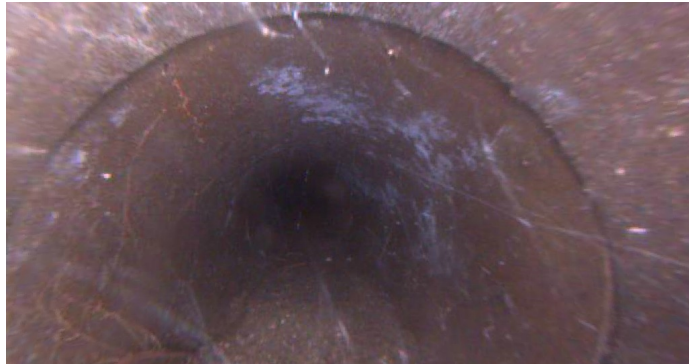
Code: **CL**  
Description: **Crack Longitudinal**

Distance (ft): **23.2**  
Structural Grade: **2**  
O&M Grade: **0**  
Clock Start/From: **10**  
Clock To:  
1st Value:  
2nd Value:  
Value Percent:  
Continuous Index:  
Within 8" of Joint: **YES**  
Remarks:

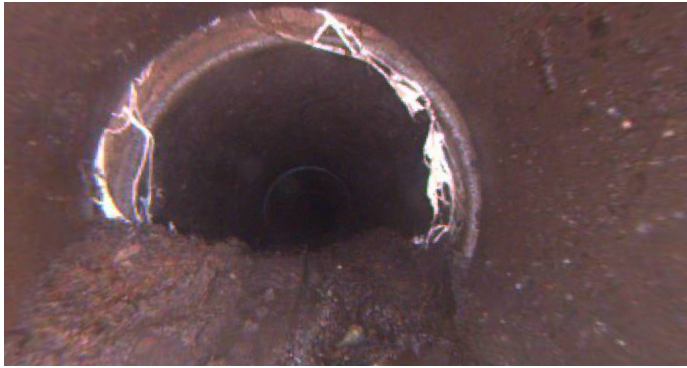
Code:	<b>DAZ</b>
Description:	<b>Deposits Attached Other</b>
Distance (ft):	<b>30.3</b>
Structural Grade:	<b>0</b>
O&M Grade:	<b>2</b>
Clock Start/From:	<b>5</b>
Clock To:	<b>7</b>
1st Value:	
2nd Value:	
Value Percent:	<b>5.000</b>
Continuous Index:	
Within 8" of Joint:	<b>YES</b>
Remarks:

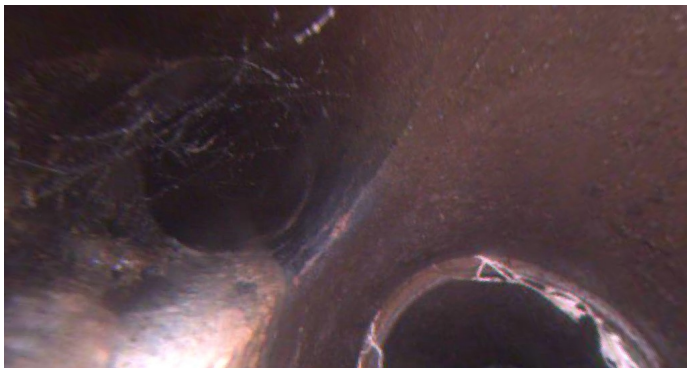
Code:	<b>TF</b>
Description:	<b>Tap Factory</b>
Distance (ft):	<b>30.7</b>
Structural Grade:	<b>0</b>
O&M Grade:	<b>0</b>
Clock Start/From:	<b>2</b>
Clock To:	
1st Value:	<b>4.000</b>
2nd Value:	
Value Percent:	
Continuous Index:	
Within 8" of Joint:	
Remarks:

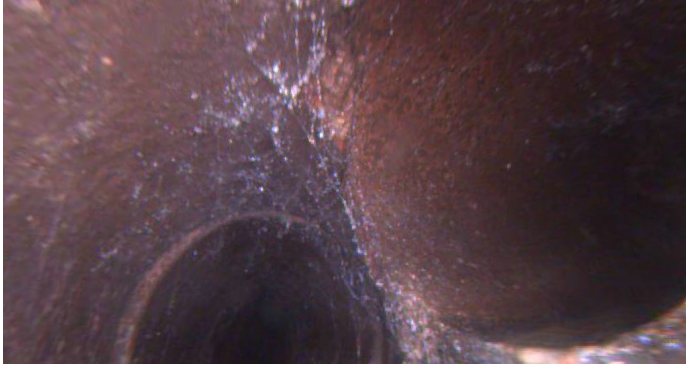
Code: **TB**  
Description: **Tap Break-in**

Distance (ft): **40.9**  
Structural Grade: **0**  
O&M Grade: **0**  
Clock Start/From: **9**  
Clock To:  
1st Value: **4.000**  
2nd Value:  
Value Percent:  
Continuous Index:  
Within 8" of Joint:  
Remarks:

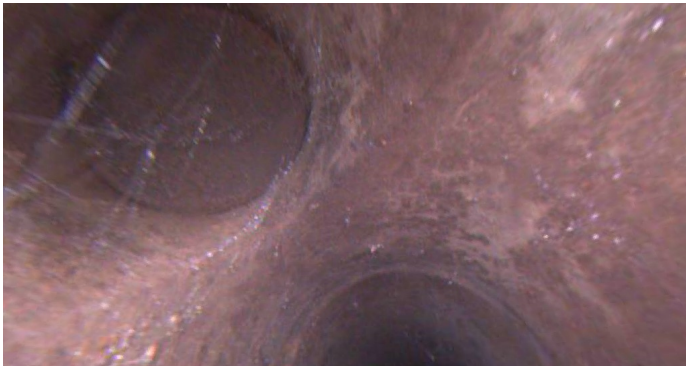
Code: **TFC**  
Description: **Tap Factory Capped**

Distance (ft): **51.0**  
Structural Grade: **0**  
O&M Grade: **0**  
Clock Start/From: **2**  
Clock To:  
1st Value: **4.000**  
2nd Value:  
Value Percent:  
Continuous Index:  
Within 8" of Joint:  
Remarks:

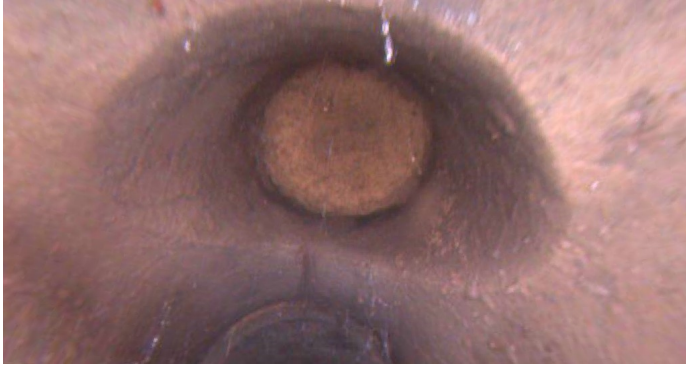
Code: **TFC**  
Description: **Tap Factory Capped**

Distance (ft): **57.5**  
Structural Grade: **0**  
O&M Grade: **0**  
Clock Start/From: **11**  
Clock To:  
1st Value: **4.000**  
2nd Value:  
Value Percent:  
Continuous Index:  
Within 8" of Joint:  
Remarks:

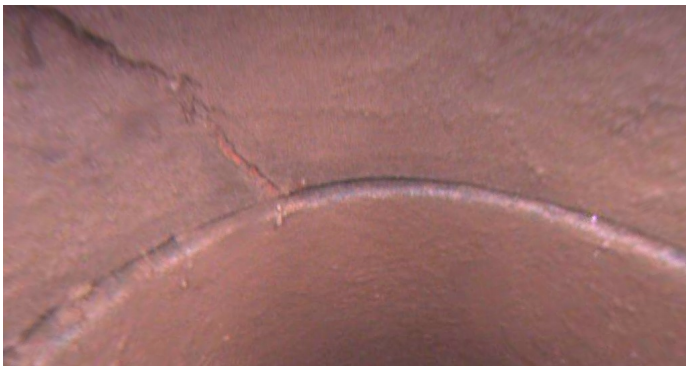
Code: **FL**  
Description: **Fracture Longitudinal**

Distance (ft): **62.5**  
Structural Grade: **3**  
O&M Grade: **0**  
Clock Start/From: **2**  
Clock To:  
1st Value:  
2nd Value:  
Value Percent:  
Continuous Index:  
Within 8" of Joint:  
Remarks:

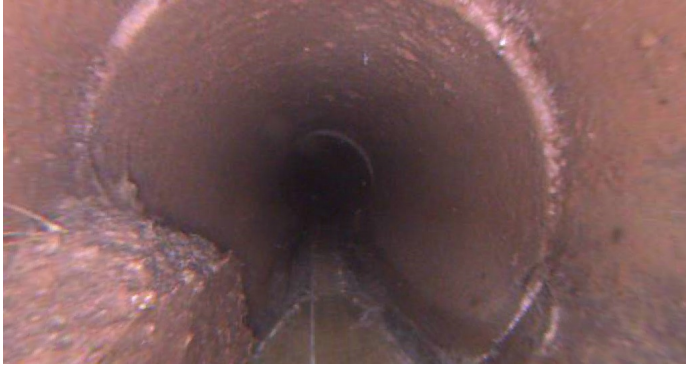
Code: **RFJ**  
Description: **Roots Fine Joint**

Distance (ft): **68.9**  
Structural Grade: **0**  
O&M Grade: **1**  
Clock Start/From: **5**  
Clock To:  
1st Value:  
2nd Value:  
Value Percent:  
Continuous Index:  
Within 8" of Joint: **YES**  
Remarks:

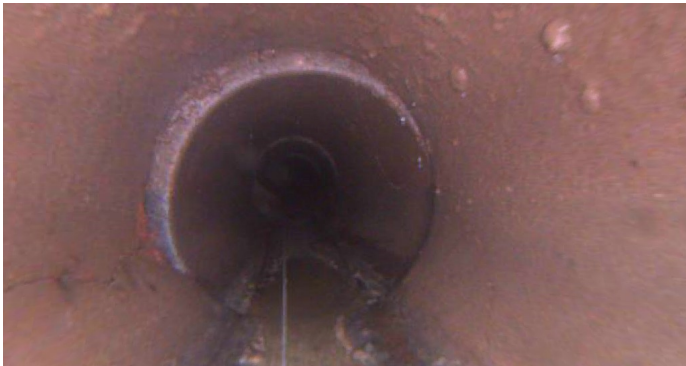
Code: **CS**  
Description: **Crack Spiral**

Distance (ft): **71.4**  
Structural Grade: **2**  
O&M Grade: **0**  
Clock Start/From: **8**  
Clock To: **4**  
1st Value:  
2nd Value:  
Value Percent:  
Continuous Index:  
Within 8" of Joint:  
Remarks:

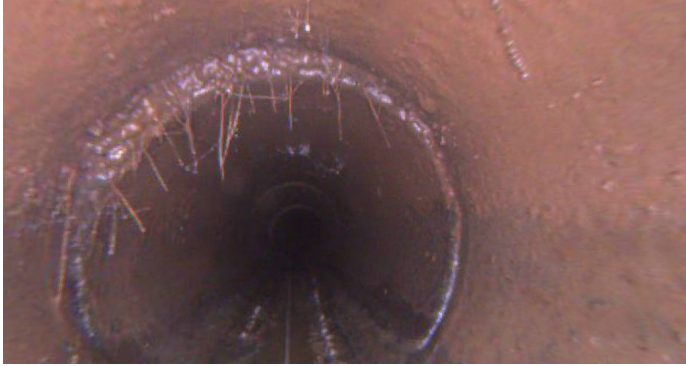
Code: **RFJ**  
Description: **Roots Fine Joint**

Distance (ft): **75.2**  
Structural Grade: **0**  
O&M Grade: **1**  
Clock Start/From: **4**  
Clock To: **10**  
1st Value:  
2nd Value:  
Value Percent:  
Continuous Index:  
Within 8" of Joint: **YES**  
Remarks:

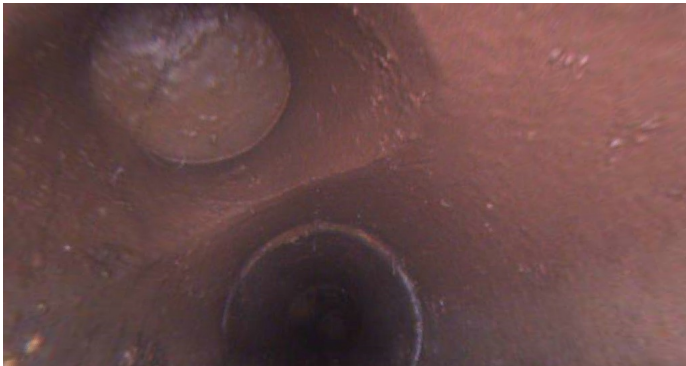
Code: **TFC**  
Description: **Tap Factory Capped**

Distance (ft): **78.0**  
Structural Grade: **0**  
O&M Grade: **0**  
Clock Start/From: **1**  
Clock To:  
1st Value: **4.000**  
2nd Value:  
Value Percent:  
Continuous Index:  
Within 8" of Joint:  
Remarks:

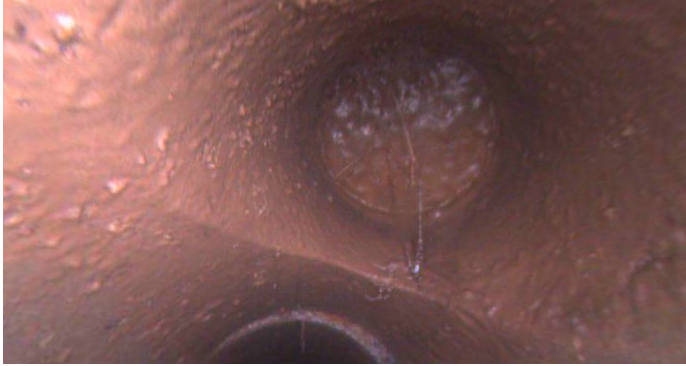
Code: **TFC**  
Description: **Tap Factory Capped**

Distance (ft): **79.9**  
Structural Grade: **0**  
O&M Grade: **0**  
Clock Start/From: **10**  
Clock To:  
1st Value: **4.000**  
2nd Value:  
Value Percent:  
Continuous Index:  
Within 8" of Joint:  
Remarks:

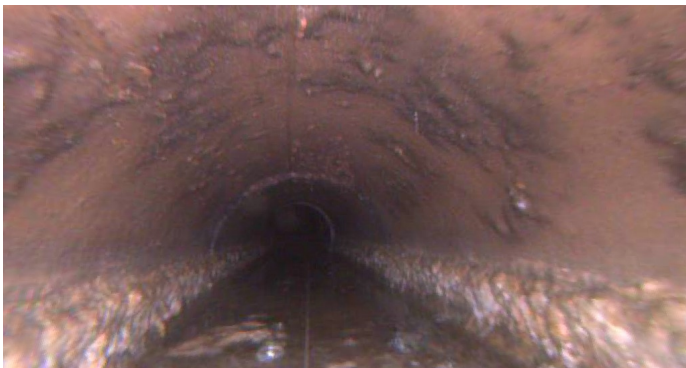
Code: **DAGS**  
Description: **Deposits Attached Grease**

Distance (ft): **82.2**  
Structural Grade: **0**  
O&M Grade: **2**  
Clock Start/From: **5**  
Clock To: **7**  
1st Value:  
2nd Value:  
Value Percent: **5.000**  
Continuous Index: **S01**  
Within 8" of Joint: **NO**  
Remarks:
