Profile/Photo Observation Report

Street:	3rd Street	Flow Control:	Not Controlled
City:	Hobart, IN	Year Renewed:	
Location:	Light Highway	Tape/Media #:	973
Purpose:	Routine Assessment	Dia/Height:	8"
Use:	Sanitary	Material:	VCP
Drain Area:		Lining:	
Category:	NA		
Comment:			
Location Details:		Direction of Survey:	Upstream
US MH:	M-805-47	DS MH:	M-805-49
		Total Length Surveyed (ft):	.1

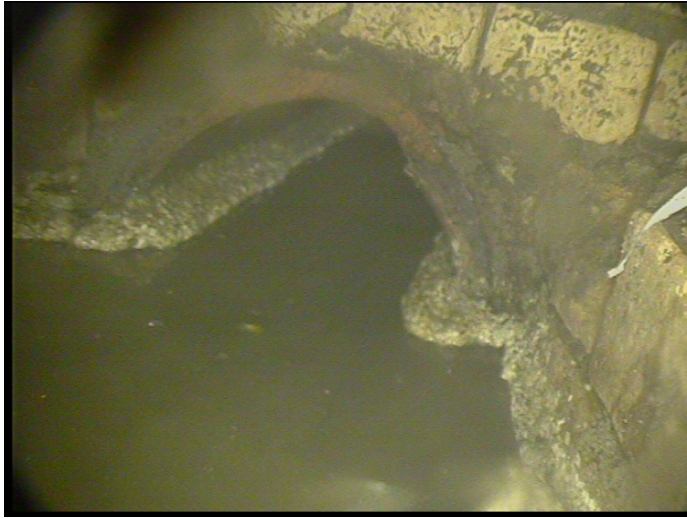
Code: **MWL**
Description: **Water Level**

Distance (ft): **.0**
Structural Grade: **0**
O&M Grade: **0**
Clock Start/From:
Clock To:
1st Value:
2nd Value:
Value Percent: **30.000**
Continuous Index:
Within 8" of Joint: **NO**
Remarks:

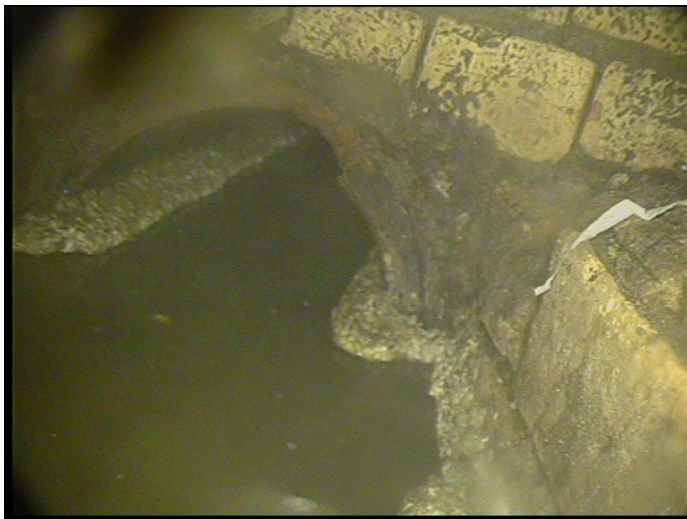
Code: **DAGS**
Description: **Deposits Attached Grease**

Distance (ft): **.0**
Structural Grade: **0**
O&M Grade: **3**
Clock Start/From: **9**
Clock To: **3**
1st Value:
2nd Value:
Value Percent: **15.000**
Continuous Index:
Within 8" of Joint: **NO**
Remarks:

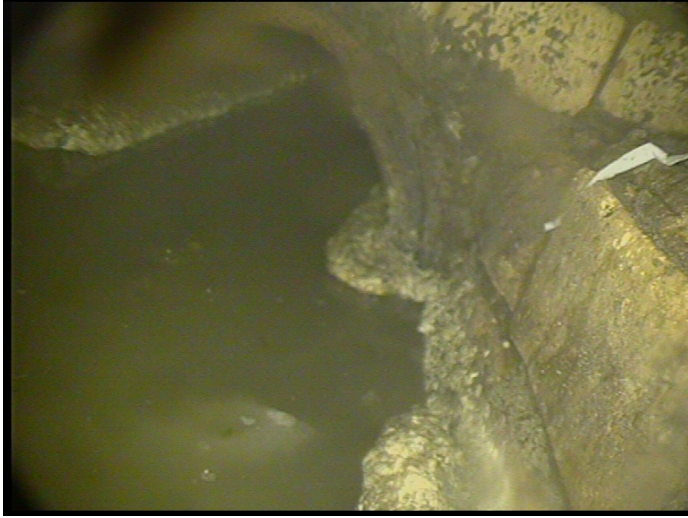
Code:	MSA
Description:	Abandoned Survey
Distance (ft):	.0
Structural Grade:	0
O&M Grade:	0
Clock Start/From:	
Clock To:	
1st Value:	
2nd Value:	
Value Percent:	
Continuous Index:	
Within 8" of Joint:	NO
Remarks:	high water level and grease
