Profile/Photo Observation Report

Street:	GEORGIANNA ST & S ILLINOIS ST	Flow Control:	Not Controlled
City:	Hobart, IN	Year Renewed:	
Location:	Other	Tape/Media #:	
Purpose:	Not Known	Dia/Height:	8"
Use:	Sanitary	Material:	VCP
Drain Area:	NA	Lining:	
Category:	NA		
Comment:

Location Details:		Direction of Survey:	Downstream
US MH:	M-805-050	DS MH:	M-805-049
		Total Length Surveyed (ft):	59.4

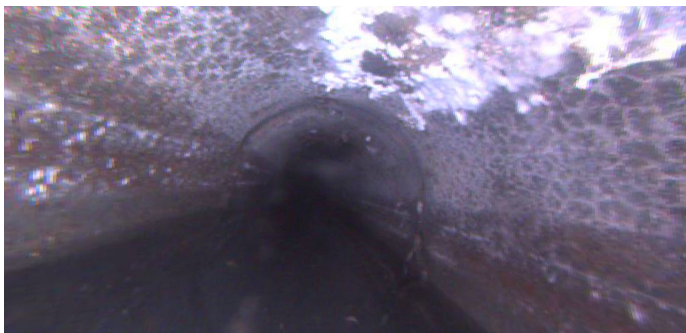
Code: **AMH**
Description: **Manhole**

Distance (ft): **.0**
Structural Grade: **0**
O&M Grade: **0**
Clock Start/From:
Clock To:
1st Value:
2nd Value:
Value Percent:
Continuous Index:
Within 8" of Joint: **NO**
Remarks: **M-805-050**

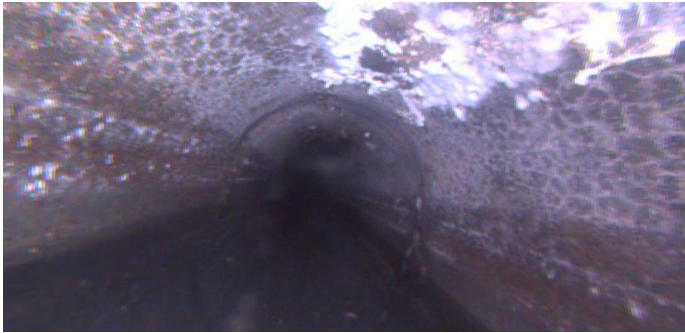
Code:	MWL
Description:	Water Level

Distance (ft):	.0
Structural Grade:	0
O&M Grade:	0
Clock Start/From:	
Clock To:	
1st Value:	
2nd Value:	
Value Percent:	5.000
Continuous Index:	
Within 8" of Joint:	NO
Remarks:

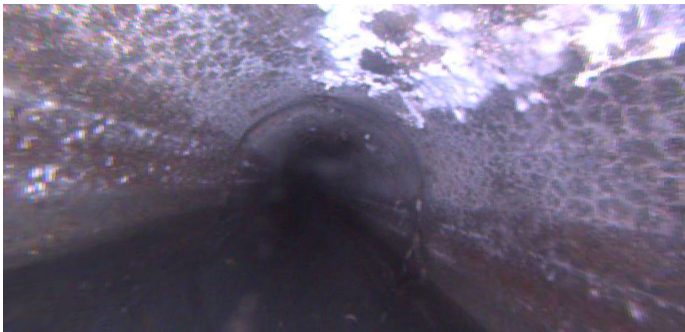
Code:	CM
Description:	Crack Multiple

Distance (ft):	.0
Structural Grade:	3
O&M Grade:	0
Clock Start/From:	7
Clock To:	5
1st Value:	
2nd Value:	
Value Percent:	
Continuous Index:	S01
Within 8" of Joint:	
Remarks:

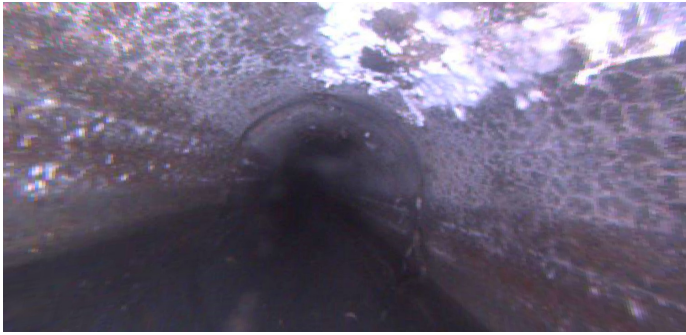
Code: **DAGS**
Description: **Deposits Attached Grease**

Distance (ft): **.0**
Structural Grade: **0**
O&M Grade: **2**
Clock Start/From: **12**
Clock To: **1**
1st Value:
2nd Value:
Value Percent: **5.000**
Continuous Index:
Within 8" of Joint: **NO**
Remarks:

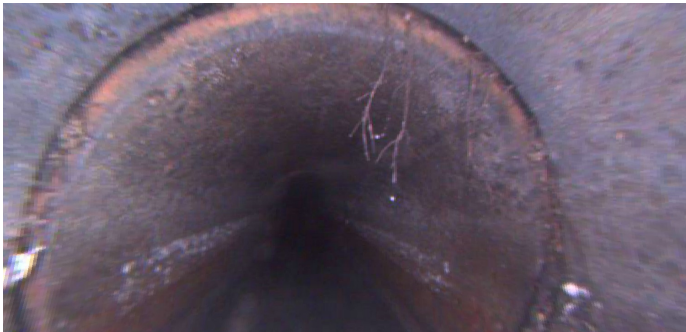
Code: **RFJ**
Description: **Roots Fine Joint**

Distance (ft): **6.1**
Structural Grade: **0**
O&M Grade: **1**
Clock Start/From: **7**
Clock To: **5**
1st Value:
2nd Value:
Value Percent:
Continuous Index: **S02**
Within 8" of Joint: **YES**
Remarks: **wandering**

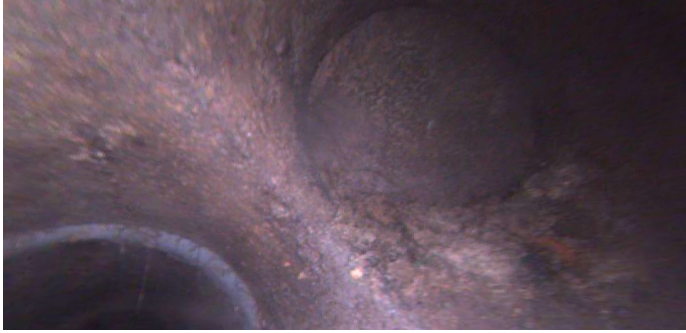
Code: **TFC**
Description: **Tap Factory Capped**

Distance (ft): **9.7**
Structural Grade: **0**
O&M Grade: **0**
Clock Start/From: **1**
Clock To:
1st Value: **4.000**
2nd Value:
Value Percent:
Continuous Index:
Within 8" of Joint: **YES**
Remarks:

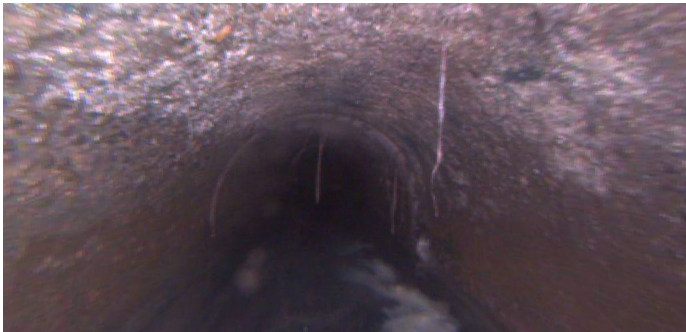
Code: **DSZ**
Description: **Deposits Settled Other**

Distance (ft): **27.8**
Structural Grade: **0**
O&M Grade: **2**
Clock Start/From: **6**
Clock To:
1st Value:
2nd Value:
Value Percent: **5.000**
Continuous Index: **S03**
Within 8" of Joint: **NO**
Remarks: **tissue/debris**

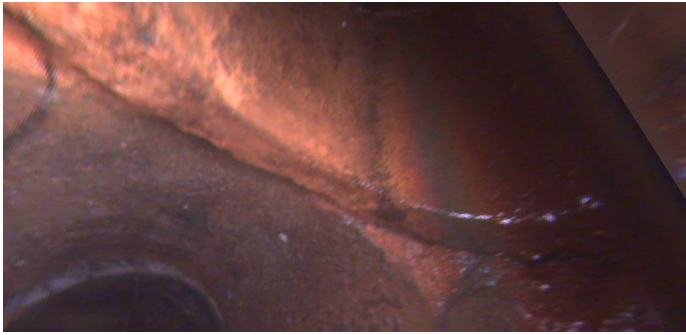
Code: **TB**
Description: **Tap Break-in**

Distance (ft): **35.7**
Structural Grade: **0**
O&M Grade: **0**
Clock Start/From: **1**
Clock To:
1st Value: **8.000**
2nd Value:
Value Percent:
Continuous Index:
Within 8" of Joint:
Remarks:

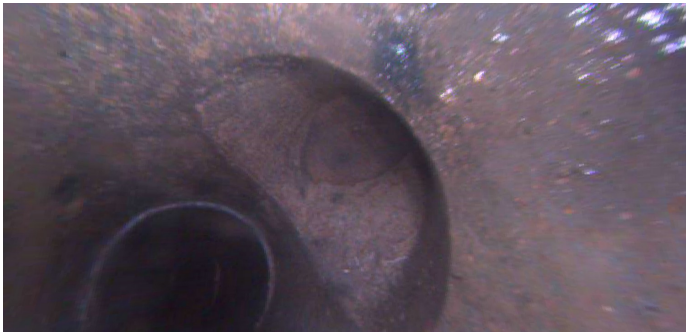
Code: **TFC**
Description: **Tap Factory Capped**

Distance (ft): **47.9**
Structural Grade: **0**
O&M Grade: **0**
Clock Start/From: **2**
Clock To:
1st Value: **4.000**
2nd Value:
Value Percent:
Continuous Index:
Within 8" of Joint: **YES**
Remarks:

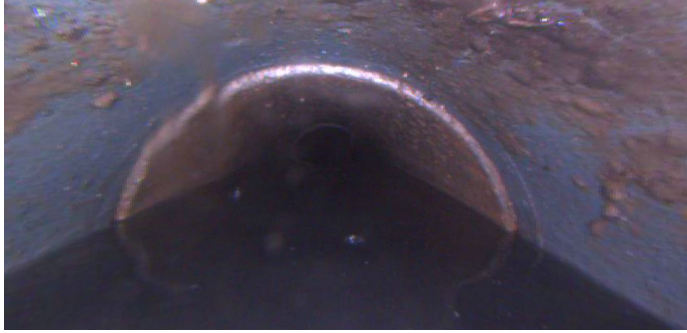
Code: **MWL**
Description: **Water Level**

Distance (ft): **59.2**
Structural Grade: **0**
O&M Grade: **0**
Clock Start/From:
Clock To:
1st Value:
2nd Value:
Value Percent: **50.000**
Continuous Index:
Within 8" of Joint: **NO**
Remarks:

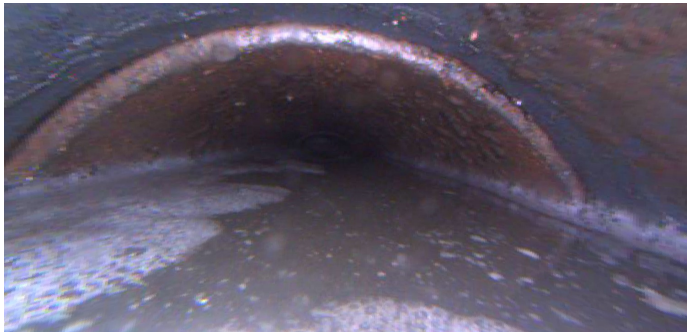
Code: **MSA**
Description: **Abandoned Survey**

Distance (ft): **59.4**
Structural Grade: **0**
O&M Grade: **0**
Clock Start/From:
Clock To:
1st Value:
2nd Value:
Value Percent:
Continuous Index:
Within 8" of Joint: **NO**
Remarks: **debris under water**

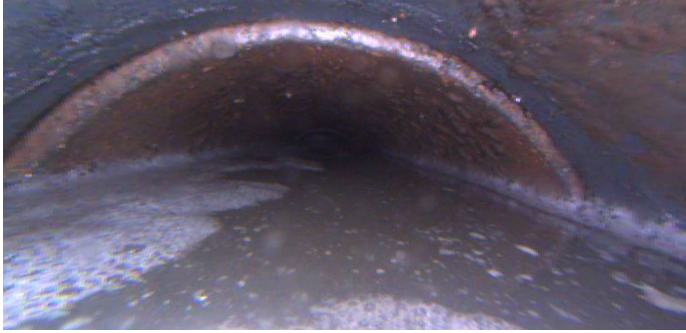
Code: **CM**
Description: **Crack Multiple**

Distance (ft): **59.4**
Structural Grade: **3**
O&M Grade: **0**
Clock Start/From: **7**
Clock To: **5**
1st Value:
2nd Value:
Value Percent:
Continuous Index: **F01**
Within 8" of Joint:
Remarks:

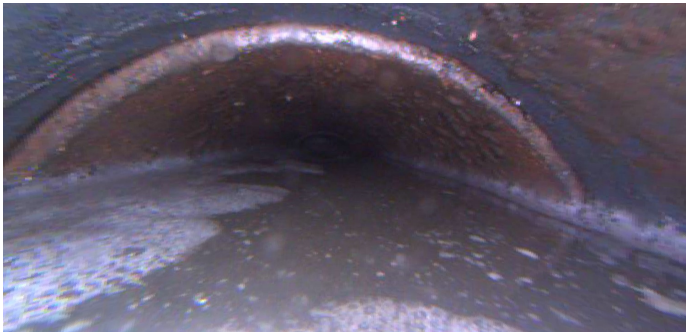
Code: **RFJ**
Description: **Roots Fine Joint**

Distance (ft): **59.4**
Structural Grade: **0**
O&M Grade: **1**
Clock Start/From: **7**
Clock To: **5**
1st Value:
2nd Value:
Value Percent:
Continuous Index: **F02**
Within 8" of Joint: **YES**
Remarks: **wandering**

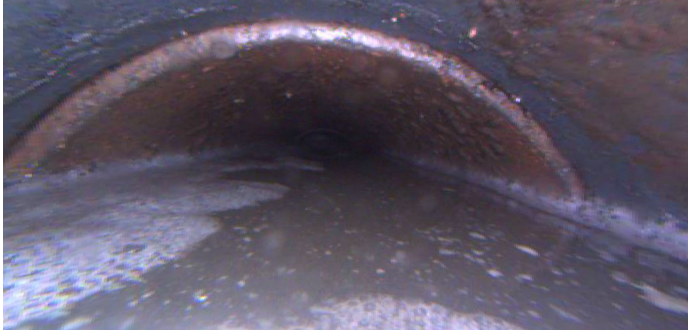
Code:	DSZ
Description:	Deposits Settled Other
Distance (ft):	59.4
Structural Grade:	0
O&M Grade:	2
Clock Start/From:	6
Clock To:	
1st Value:	
2nd Value:	
Value Percent:	5.000
Continuous Index:	F03
Within 8" of Joint:	NO
Remarks:	tissue/debris
