Profile/Photo Observation Report

Date:	04/19/2018	Weather:		Coding:	PACP 6.0
Pipe Length (ft):	275.2	Owner:	NA	Pre Clean:	Not Known
P.O.#:		Surveyor:	Byrd Fitzgerald	PSR:	P-805-049-050
Customer:		Clean Date:	01/01/1900	Shape:	C

Street:	Georgianna St.	Flow Control:	Not Controlled
City:	Hobart, IN	Year Renewed:	
Location:	Other	Tape/Media #:	
Purpose:	Not Known	Dia/Height:	8"
Use:	Sanitary	Material:	VCP
Drain Area:	NA	Lining:	
Category:	NA		
Comment:

Location Details:		Direction of Survey:	Downstream
US MH:	M-805-050	DS MH:	M-805-049
		Total Length Surveyed (ft):	59.4

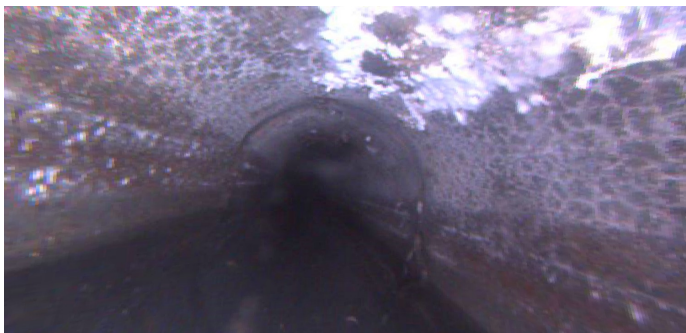
Code: **AMH**
Description: **Manhole**

Distance (ft): **.0**
Structural Grade: **0**
O&M Grade: **0**
Clock Start/From:
Clock To:
1st Value:
2nd Value:
Value Percent:
Continuous Index:
Within 8" of Joint: **NO**
Remarks: **M-805-050**

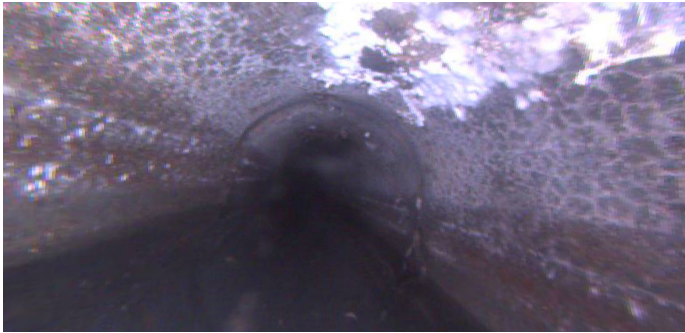
Code:	MWL
Description:	Water Level

Distance (ft):	.0
Structural Grade:	0
O&M Grade:	0
Clock Start/From:	
Clock To:	
1st Value:	
2nd Value:	
Value Percent:	5.000
Continuous Index:	
Within 8" of Joint:	NO
Remarks:

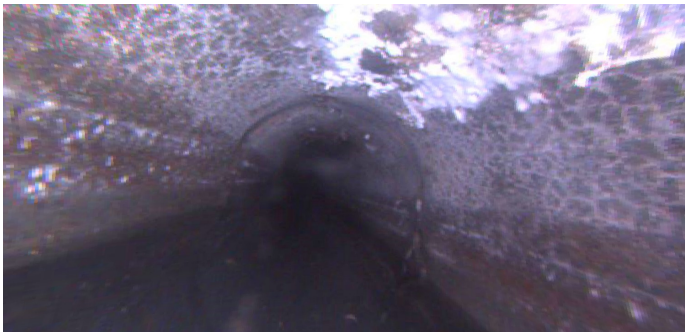
Code:	CM
Description:	Crack Multiple

Distance (ft):	.0
Structural Grade:	3
O&M Grade:	0
Clock Start/From:	7
Clock To:	5
1st Value:	
2nd Value:	
Value Percent:	
Continuous Index:	S01
Within 8" of Joint:	
Remarks:

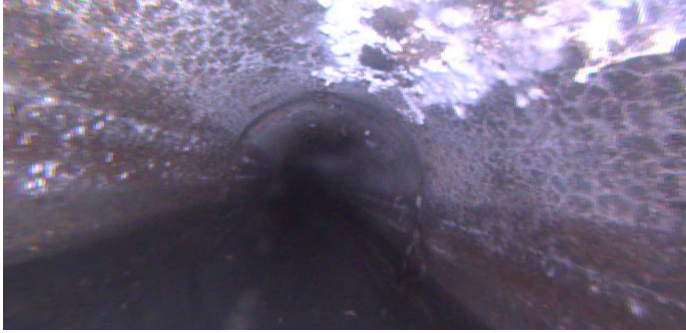
Code: **DAGS**
Description: **Deposits Attached Grease**

Distance (ft): **.0**
Structural Grade: **0**
O&M Grade: **2**
Clock Start/From: **12**
Clock To: **1**
1st Value:
2nd Value:
Value Percent: **5.000**
Continuous Index:
Within 8" of Joint: **NO**
Remarks:

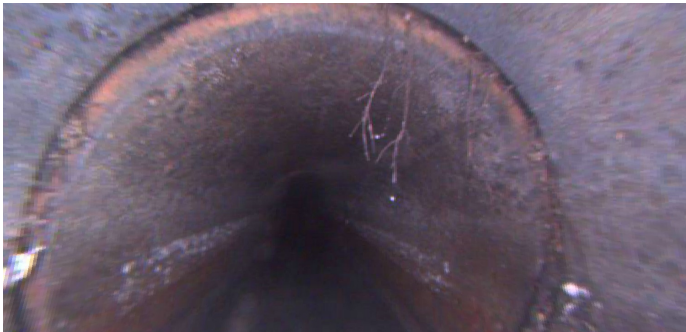
Code: **RFJ**
Description: **Roots Fine Joint**

Distance (ft): **6.1**
Structural Grade: **0**
O&M Grade: **1**
Clock Start/From: **7**
Clock To: **5**
1st Value:
2nd Value:
Value Percent:
Continuous Index: **S02**
Within 8" of Joint: **YES**
Remarks: **wandering**

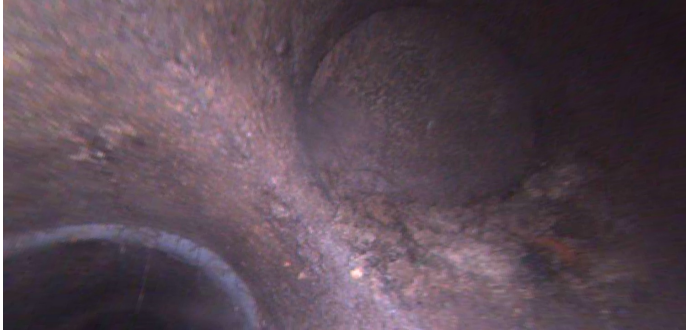
Code: **TFC**
Description: **Tap Factory Capped**

Distance (ft): **9.7**
Structural Grade: **0**
O&M Grade: **0**
Clock Start/From: **1**
Clock To:
1st Value: **4.000**
2nd Value:
Value Percent:
Continuous Index:
Within 8" of Joint: **YES**
Remarks:

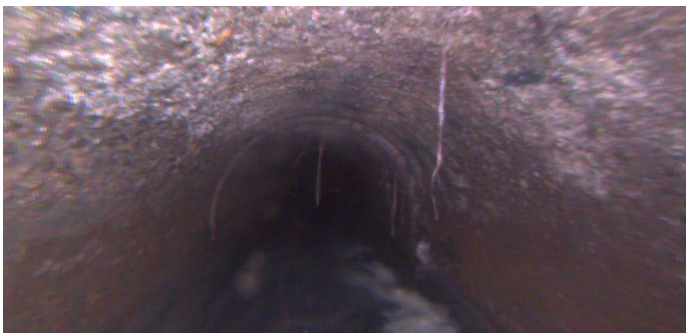
Code: **DSZ**
Description: **Deposits Settled Other**

Distance (ft): **27.8**
Structural Grade: **0**
O&M Grade: **2**
Clock Start/From: **6**
Clock To:
1st Value:
2nd Value:
Value Percent: **5.000**
Continuous Index: **S03**
Within 8" of Joint: **NO**
Remarks: **tissue/debris**

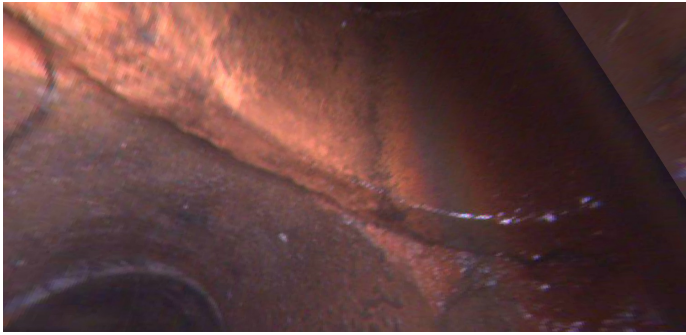
Code: **TB**
Description: **Tap Break-in**

Distance (ft): **35.7**
Structural Grade: **0**
O&M Grade: **0**
Clock Start/From: **1**
Clock To:
1st Value: **8.000**
2nd Value:
Value Percent:
Continuous Index:
Within 8" of Joint:
Remarks:

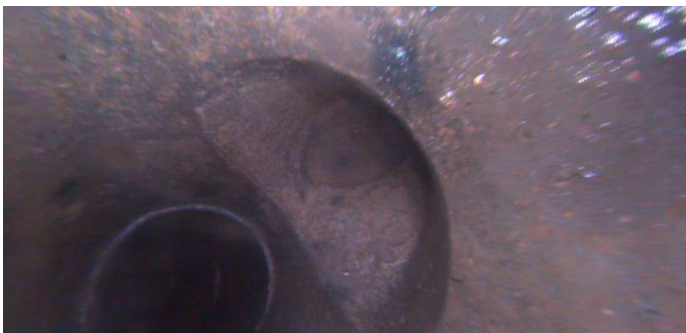
Code: **TFC**
Description: **Tap Factory Capped**

Distance (ft): **47.9**
Structural Grade: **0**
O&M Grade: **0**
Clock Start/From: **2**
Clock To:
1st Value: **4.000**
2nd Value:
Value Percent:
Continuous Index:
Within 8" of Joint: **YES**
Remarks:

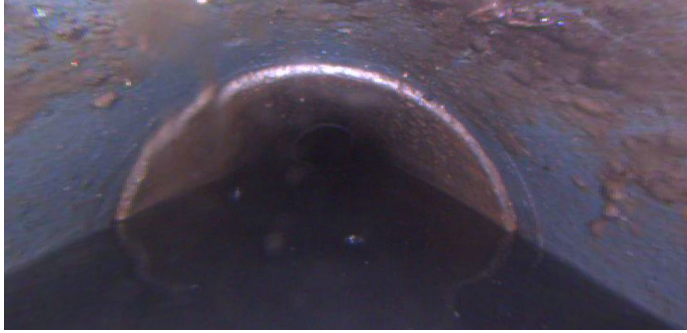
Code: **MWL**
Description: **Water Level**

Distance (ft): **59.2**
Structural Grade: **0**
O&M Grade: **0**
Clock Start/From:
Clock To:
1st Value:
2nd Value:
Value Percent: **50.000**
Continuous Index:
Within 8" of Joint: **NO**
Remarks:

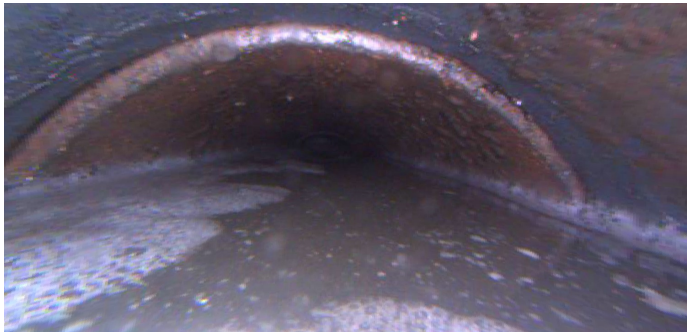
Code: **MSA**
Description: **Abandoned Survey**

Distance (ft): **59.4**
Structural Grade: **0**
O&M Grade: **0**
Clock Start/From:
Clock To:
1st Value:
2nd Value:
Value Percent:
Continuous Index:
Within 8" of Joint: **NO**
Remarks: **debris under water**

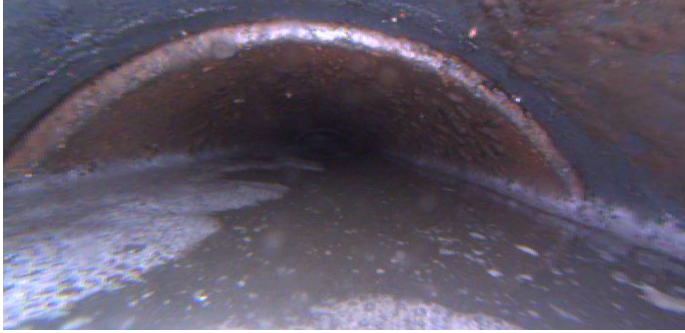
Code: **CM**
Description: **Crack Multiple**

Distance (ft): **59.4**
Structural Grade: **3**
O&M Grade: **0**
Clock Start/From: **7**
Clock To: **5**
1st Value:
2nd Value:
Value Percent:
Continuous Index: **F01**
Within 8" of Joint:
Remarks:

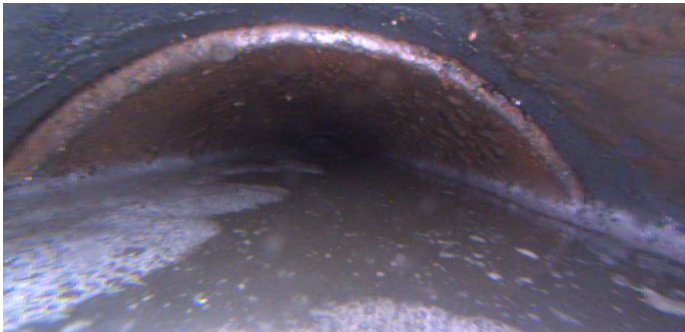
Code: **RFJ**
Description: **Roots Fine Joint**

Distance (ft): **59.4**
Structural Grade: **0**
O&M Grade: **1**
Clock Start/From: **7**
Clock To: **5**
1st Value:
2nd Value:
Value Percent:
Continuous Index: **F02**
Within 8" of Joint: **YES**
Remarks: **wandering**

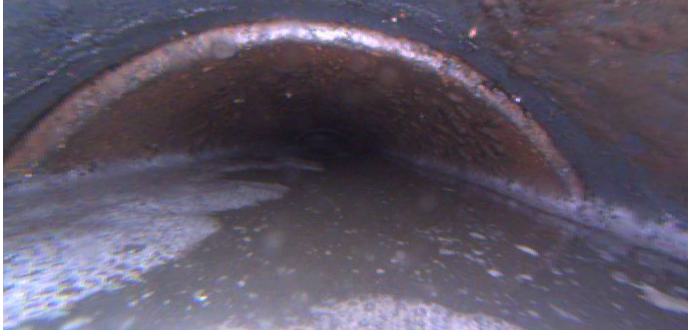
Code:	DSZ
Description:	Deposits Settled Other
Distance (ft):	59.4
Structural Grade:	0
O&M Grade:	2
Clock Start/From:	6
Clock To:	
1st Value:	
2nd Value:	
Value Percent:	5.000
Continuous Index:	F03
Within 8" of Joint:	NO
Remarks:	tissue/debris
