## Profile/Photo Observation Report

Street:	<b>GEORGIANNA ST &amp; S ILLINOIS ST</b>	Flow Control:	<b>Not Controlled</b>
City:	<b>Hobart, IN</b>	Year Renewed:	
Location:	<b>Other</b>	Tape/Media #:	
Purpose:	<b>Not Known</b>	Dia/Height:	<b>8"</b>
Use:	<b>Sanitary</b>	Material:	<b>PVC</b>
Drain Area:	<b>NA</b>	Lining:	
Category:	<b>NA</b>		
Comment:

Location Details:		Direction of Survey:	<b>Upstream</b>
US MH:	<b>M-805-050</b>	DS MH:	<b>M-805-049</b>
		Total Length Surveyed (ft):	<b>50.2</b>

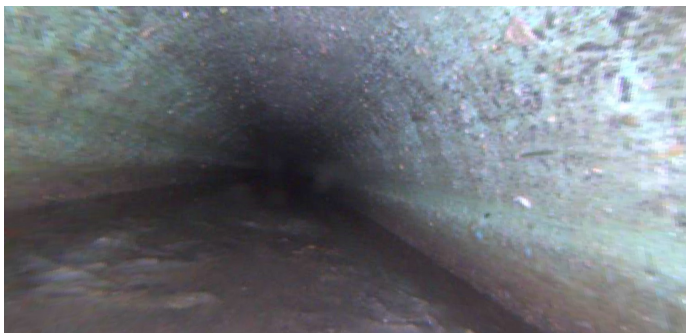
Code: **AMH**  
Description: **Manhole**

Distance (ft): **.0**  
Structural Grade: **0**  
O&M Grade: **0**  
Clock Start/From:  
Clock To:  
1st Value:  
2nd Value:  
Value Percent:  
Continuous Index:  
Within 8" of Joint: **NO**  
Remarks: **M-805-049**

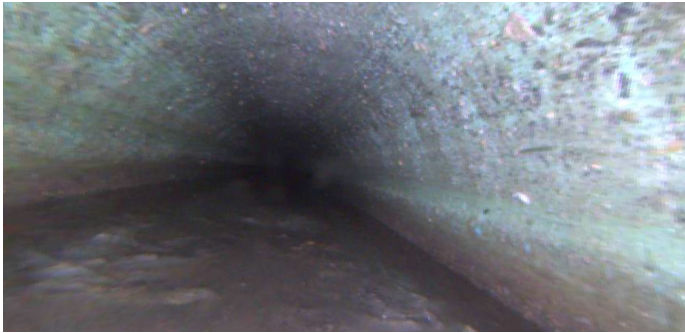
Code:	<b>MWL</b>
Description:	<b>Water Level</b>

Distance (ft):	<b>.0</b>
Structural Grade:	<b>0</b>
O&M Grade:	<b>0</b>
Clock Start/From:	
Clock To:	
1st Value:	
2nd Value:	
Value Percent:	<b>10.000</b>
Continuous Index:	
Within 8" of Joint:	<b>NO</b>
Remarks:

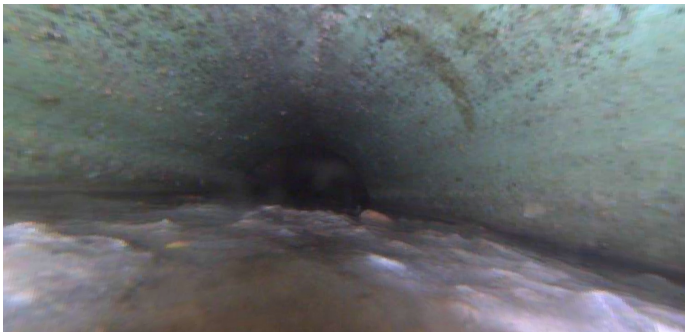
Code:	<b>MWL</b>
Description:	<b>Water Level</b>

Distance (ft):	<b>3.4</b>
Structural Grade:	<b>0</b>
O&M Grade:	<b>0</b>
Clock Start/From:	
Clock To:	
1st Value:	
2nd Value:	
Value Percent:	<b>50.000</b>
Continuous Index:	
Within 8" of Joint:	<b>NO</b>
Remarks:	<b>heavy debris</b>

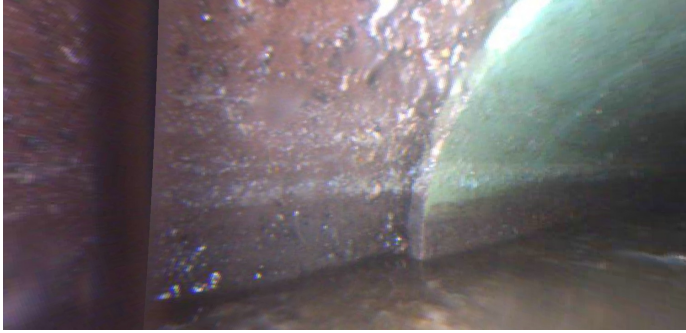
Code: **MMC**  
Description: **Material Change**

Distance (ft): **5.1**  
Structural Grade: **0**  
O&M Grade: **0**  
Clock Start/From:  
Clock To:  
1st Value:  
2nd Value:  
Value Percent:  
Continuous Index:  
Within 8" of Joint: **NO**  
Remarks: **vcp**

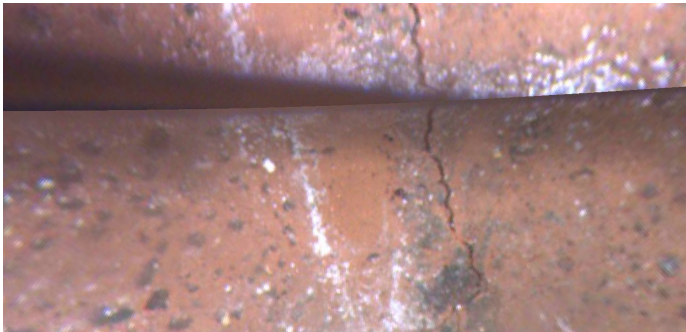
Code: **CL**  
Description: **Crack Longitudinal**

Distance (ft): **5.1**  
Structural Grade: **2**  
O&M Grade: **0**  
Clock Start/From: **12**  
Clock To:  
1st Value:  
2nd Value:  
Value Percent:  
Continuous Index:  
Within 8" of Joint: **YES**  
Remarks:

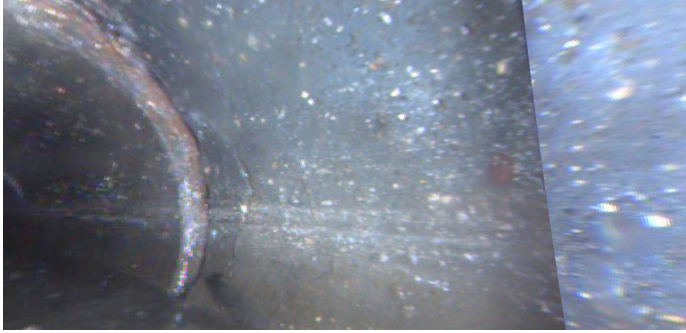
Code: **CM**  
Description: **Crack Multiple**

Distance (ft): **15.0**  
Structural Grade: **3**  
O&M Grade: **0**  
Clock Start/From: **7**  
Clock To: **5**  
1st Value:  
2nd Value:  
Value Percent:  
Continuous Index: **S01**  
Within 8" of Joint: **YES**  
Remarks: **wandering**

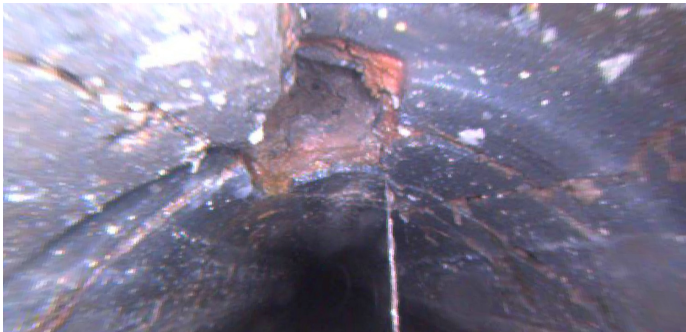
Code: **TB**  
Description: **Tap Break-in**

Distance (ft): **16.2**  
Structural Grade: **0**  
O&M Grade: **0**  
Clock Start/From: **12**  
Clock To:  
1st Value: **4.000**  
2nd Value:  
Value Percent:  
Continuous Index:  
Within 8" of Joint:  
Remarks:

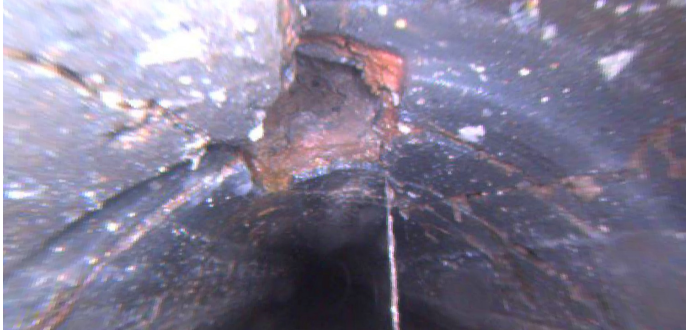
Code: **FM**  
Description: **Fracture Multiple**

Distance (ft): **16.2**  
Structural Grade: **4**  
O&M Grade: **0**  
Clock Start/From: **8**  
Clock To: **4**  
1st Value:  
2nd Value:  
Value Percent:  
Continuous Index:  
Within 8" of Joint:  
Remarks:

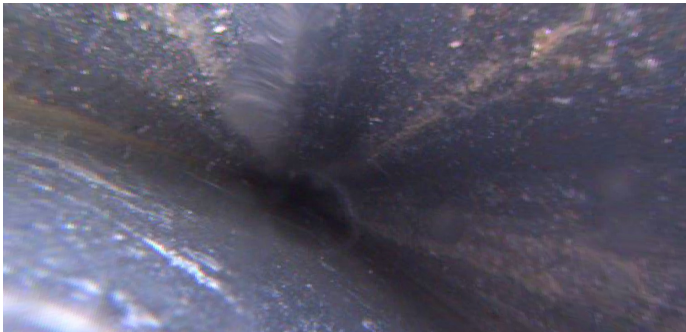
Code: **MWL**  
Description: **Water Level**

Distance (ft): **50.2**  
Structural Grade: **0**  
O&M Grade: **0**  
Clock Start/From:  
Clock To:  
1st Value:  
2nd Value:  
Value Percent: **75.000**  
Continuous Index:  
Within 8" of Joint: **NO**  
Remarks:

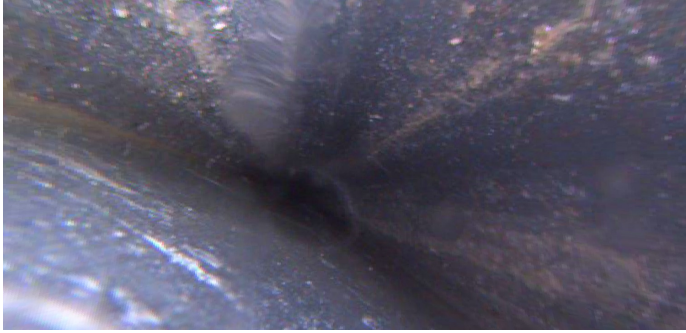
Code: **MSA**  
Description: **Abandoned Survey**

Distance (ft): **50.2**  
Structural Grade: **0**  
O&M Grade: **0**  
Clock Start/From:  
Clock To:  
1st Value:  
2nd Value:  
Value Percent:  
Continuous Index:  
Within 8" of Joint: **NO**  
Remarks: **debris under water**

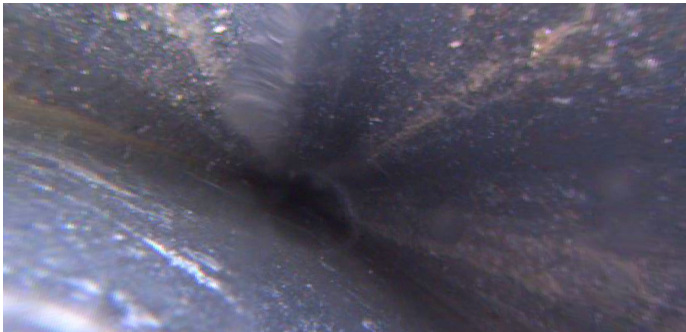
Code: **CM**  
Description: **Crack Multiple**

Distance (ft): **50.2**  
Structural Grade: **3**  
O&M Grade: **0**  
Clock Start/From: **7**  
Clock To: **5**  
1st Value:  
2nd Value:  
Value Percent:  
Continuous Index: **F01**  
Within 8" of Joint: **YES**  
Remarks: **wandering**
