## Profile/Photo Observation Report

Street:	<b>Georgianna St.</b>	Flow Control:	<b>Not Controlled</b>
City:	<b>Hobart, IN</b>	Year Renewed:	
Location:	<b>Other</b>	Tape/Media #:	
Purpose:	<b>Not Known</b>	Dia/Height:	<b>8"</b>
Use:	<b>Sanitary</b>	Material:	<b>PVC</b>
Drain Area:	<b>NA</b>	Lining:	
Category:	<b>NA</b>		
Comment:

Location Details:		Direction of Survey:	<b>Upstream</b>
US MH:	<b>M-805-050</b>	DS MH:	<b>M-805-049</b>
		Total Length Surveyed (ft):	<b>50.2</b>

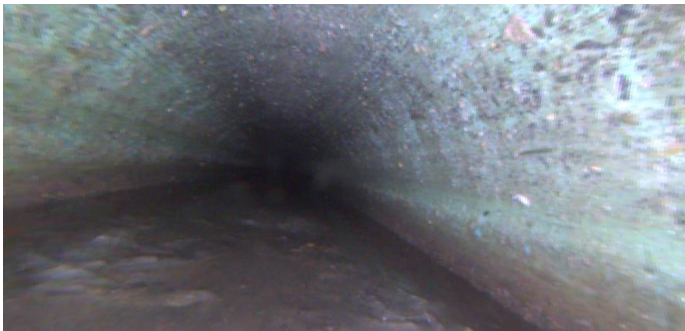
Code: **AMH**  
Description: **Manhole**

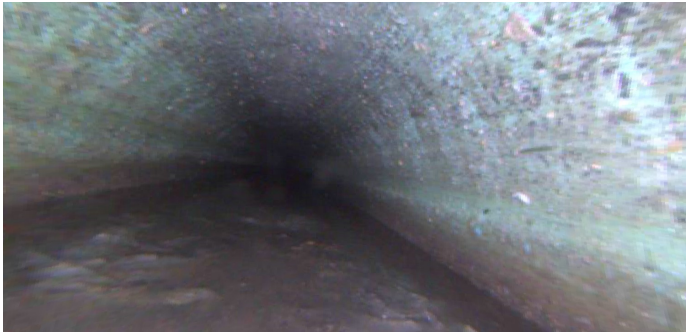
Code:	<b>MWL</b>
Description:	<b>Water Level</b>

Distance (ft):	<b>.0</b>
Structural Grade:	<b>0</b>
O&M Grade:	<b>0</b>
Clock Start/From:	
Clock To:	
1st Value:	
2nd Value:	
Value Percent:	<b>10.000</b>
Continuous Index:	
Within 8" of Joint:	<b>NO</b>
Remarks:

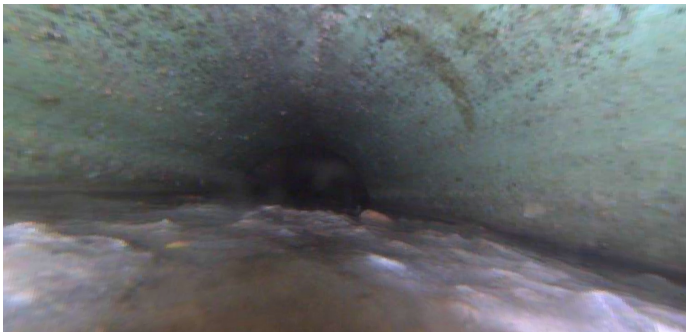
Code:	<b>MWL</b>
Description:	<b>Water Level</b>

Distance (ft):	<b>3.4</b>
Structural Grade:	<b>0</b>
O&M Grade:	<b>0</b>
Clock Start/From:	
Clock To:	
1st Value:	
2nd Value:	
Value Percent:	<b>50.000</b>
Continuous Index:	
Within 8" of Joint:	<b>NO</b>
Remarks:	<b>heavy debris</b>

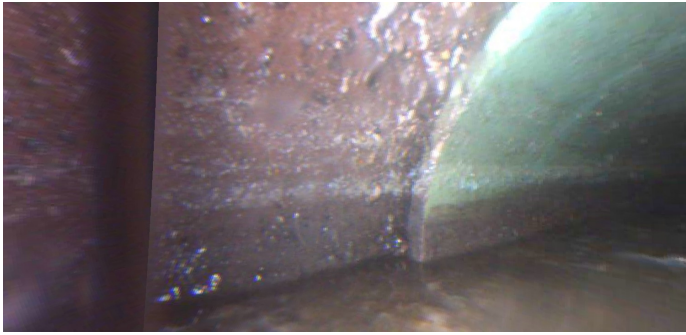
Code: **MMC**  
Description: **Material Change**

Distance (ft): **5.1**  
Structural Grade: **0**  
O&M Grade: **0**  
Clock Start/From:  
Clock To:  
1st Value:  
2nd Value:  
Value Percent:  
Continuous Index:  
Within 8" of Joint: **NO**  
Remarks: **vcp**

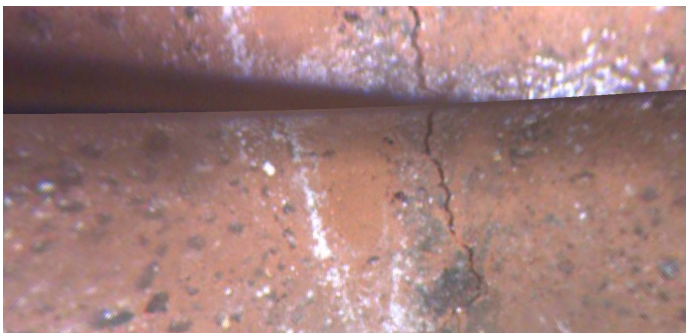
Code: **CL**  
Description: **Crack Longitudinal**

Distance (ft): **5.1**  
Structural Grade: **2**  
O&M Grade: **0**  
Clock Start/From: **12**  
Clock To:  
1st Value:  
2nd Value:  
Value Percent:  
Continuous Index:  
Within 8" of Joint: **YES**  
Remarks:

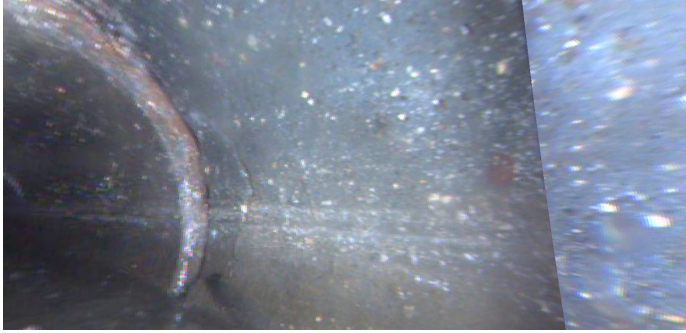
Code: **CM**  
Description: **Crack Multiple**

Distance (ft): **15.0**  
Structural Grade: **3**  
O&M Grade: **0**  
Clock Start/From: **7**  
Clock To: **5**  
1st Value:  
2nd Value:  
Value Percent:  
Continuous Index: **S01**  
Within 8" of Joint: **YES**  
Remarks: **wandering**

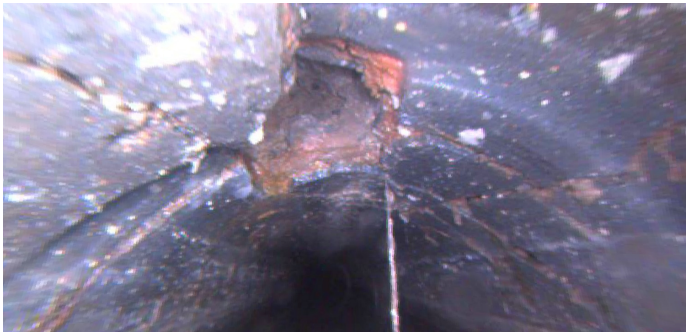
Code: **TB**  
Description: **Tap Break-in**

Distance (ft): **16.2**  
Structural Grade: **0**  
O&M Grade: **0**  
Clock Start/From: **12**  
Clock To:  
1st Value: **4.000**  
2nd Value:  
Value Percent:  
Continuous Index:  
Within 8" of Joint:  
Remarks:

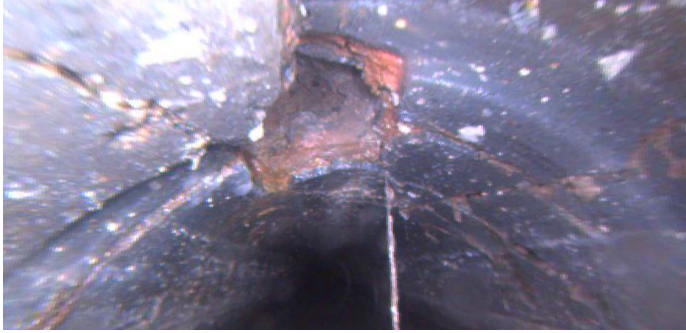
Code: **FM**  
Description: **Fracture Multiple**

Distance (ft): **16.2**  
Structural Grade: **4**  
O&M Grade: **0**  
Clock Start/From: **8**  
Clock To: **4**  
1st Value:  
2nd Value:  
Value Percent:  
Continuous Index:  
Within 8" of Joint:  
Remarks:

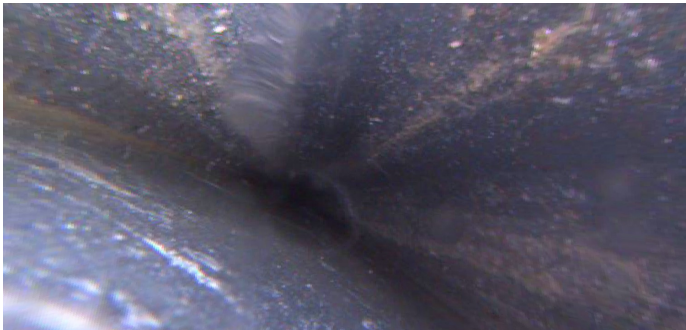
Code: **MWL**  
Description: **Water Level**

Distance (ft): **50.2**  
Structural Grade: **0**  
O&M Grade: **0**  
Clock Start/From:  
Clock To:  
1st Value:  
2nd Value:  
Value Percent: **75.000**  
Continuous Index:  
Within 8" of Joint: **NO**  
Remarks:

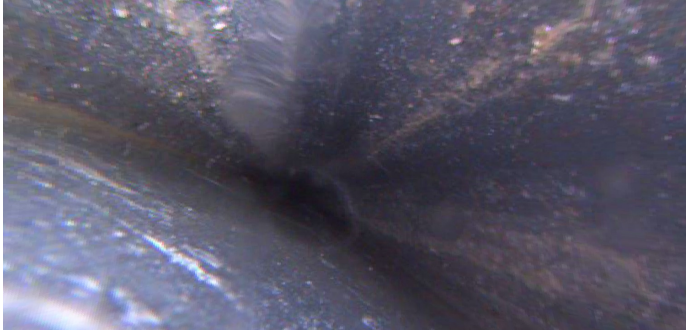
Code: **MSA**  
Description: **Abandoned Survey**

Distance (ft): **50.2**  
Structural Grade: **0**  
O&M Grade: **0**  
Clock Start/From:  
Clock To:  
1st Value:  
2nd Value:  
Value Percent:  
Continuous Index:  
Within 8" of Joint: **NO**  
Remarks: **debris under water**

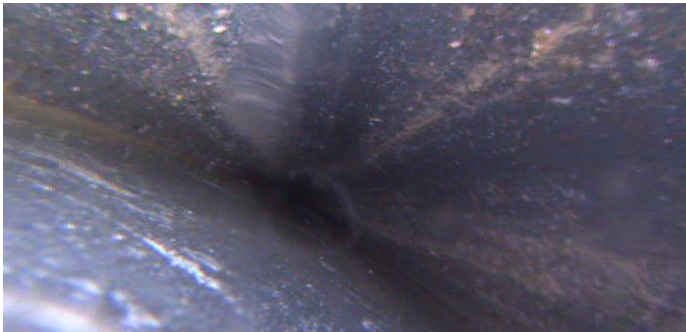
Code: **CM**  
Description: **Crack Multiple**

Distance (ft): **50.2**  
Structural Grade: **3**  
O&M Grade: **0**  
Clock Start/From: **7**  
Clock To: **5**  
1st Value:  
2nd Value:  
Value Percent:  
Continuous Index: **F01**  
Within 8" of Joint: **YES**  
Remarks: **wandering**
