Profile/Photo Observation Report

Date:	04/19/2018	Weather:		Coding:	PACP 6.0
Pipe Length (ft):	267.0	Owner:	NA	Pre Clean:	Not Known
P.O.#:		Surveyor:	Byrd Fitzgerald	PSR:	P-805-050-051
Customer:		Clean Date:	01/01/1900	Shape:	C

Street:	GEORGIANNA ST & S LINDA ST	Flow Control:	Not Controlled
City:	Hobart, IN	Year Renewed:	
Location:	Other	Tape/Media #:	
Purpose:	Not Known	Dia/Height:	8"
Use:	Sanitary	Material:	VCP
Drain Area:	NA	Lining:	
Category:	NA		
Comment:

Location Details:		Direction of Survey:	Upstream
US MH:	M-805-051	DS MH:	M-805-050
		Total Length Surveyed (ft):	47.7

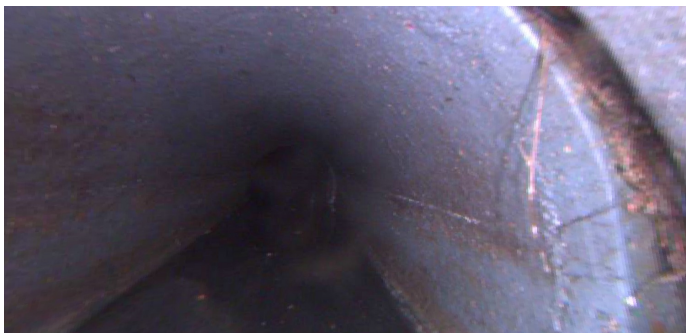
Code: **AMH**
Description: **Manhole**

Distance (ft): **.0**
Structural Grade: **0**
O&M Grade: **0**
Clock Start/From:
Clock To:
1st Value:
2nd Value:
Value Percent:
Continuous Index:
Within 8" of Joint: **NO**
Remarks: **M-805-050**

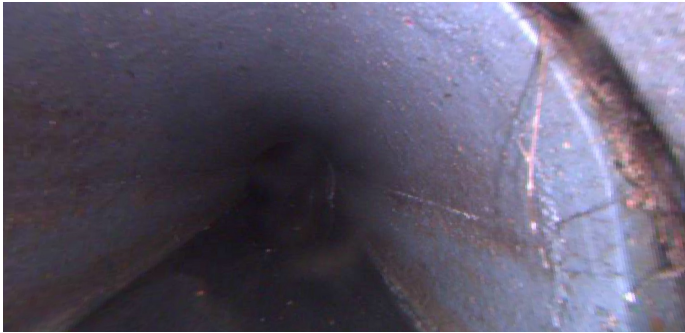
Code:	MWL
Description:	Water Level

Distance (ft):	.0
Structural Grade:	0
O&M Grade:	0
Clock Start/From:	
Clock To:	
1st Value:	
2nd Value:	
Value Percent:	5.000
Continuous Index:	
Within 8" of Joint:	NO
Remarks:

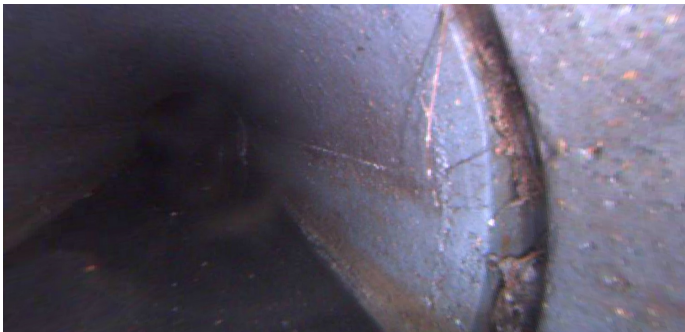
Code:	RFJ
Description:	Roots Fine Joint

Distance (ft):	.0
Structural Grade:	0
O&M Grade:	1
Clock Start/From:	2
Clock To:	5
1st Value:	
2nd Value:	
Value Percent:	
Continuous Index:	
Within 8" of Joint:	YES
Remarks:	wandering

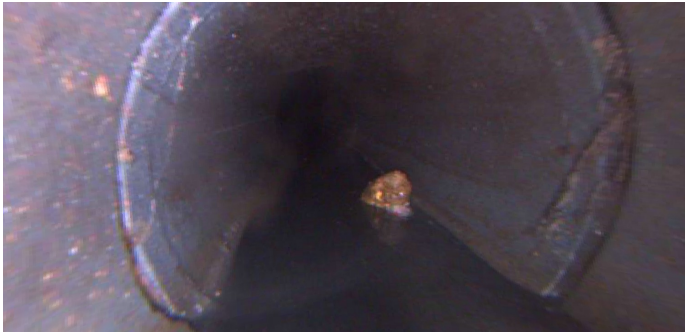
Code: **CM**
Description: **Crack Multiple**

Distance (ft): **7.9**
Structural Grade: **3**
O&M Grade: **0**
Clock Start/From: **7**
Clock To: **11**
1st Value:
2nd Value:
Value Percent:
Continuous Index: **S01**
Within 8" of Joint: **YES**
Remarks: **wandering**

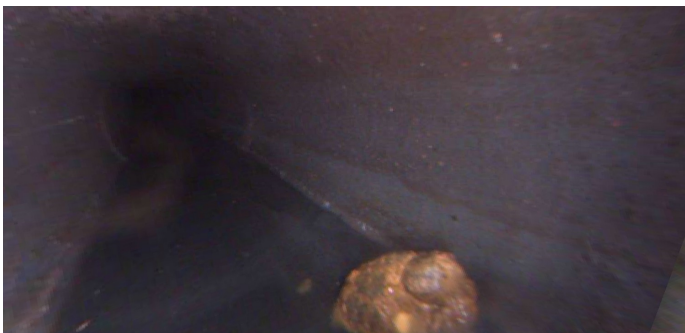
Code: **DSZ**
Description: **Deposits Settled Other**

Distance (ft): **8.5**
Structural Grade: **0**
O&M Grade: **2**
Clock Start/From: **6**
Clock To:
1st Value:
2nd Value:
Value Percent: **5.000**
Continuous Index:
Within 8" of Joint: **NO**
Remarks: **debris**

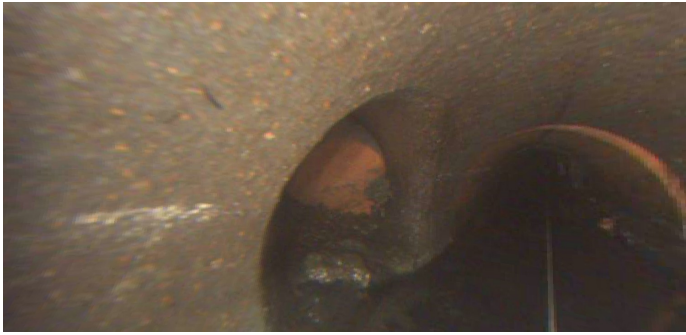
Code: **TFC**
Description: **Tap Factory Capped**

Distance (ft): **19.9**
Structural Grade: **0**
O&M Grade: **0**
Clock Start/From: **3**
Clock To:
1st Value: **4.000**
2nd Value:
Value Percent:
Continuous Index:
Within 8" of Joint: **YES**
Remarks:

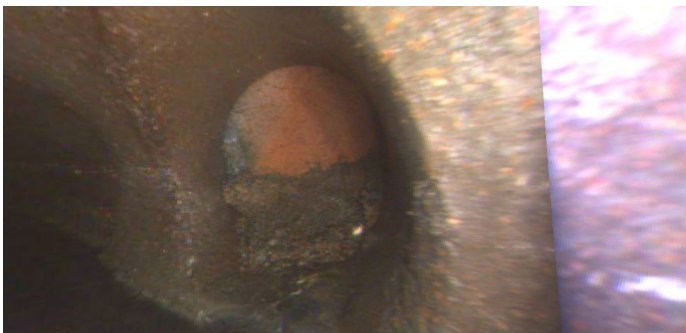
Code: **TFC**
Description: **Tap Factory Capped**

Distance (ft): **21.7**
Structural Grade: **0**
O&M Grade: **0**
Clock Start/From: **9**
Clock To:
1st Value: **4.000**
2nd Value:
Value Percent:
Continuous Index:
Within 8" of Joint: **YES**
Remarks:

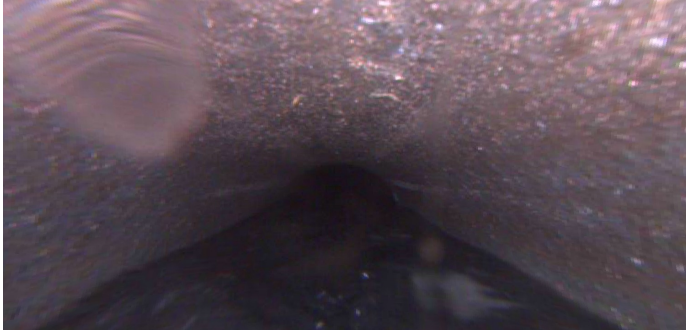
Code: **MWL**
Description: **Water Level**

Distance (ft): **47.7**
Structural Grade: **0**
O&M Grade: **0**
Clock Start/From:
Clock To:
1st Value:
2nd Value:
Value Percent: **75.000**
Continuous Index:
Within 8" of Joint: **NO**
Remarks:

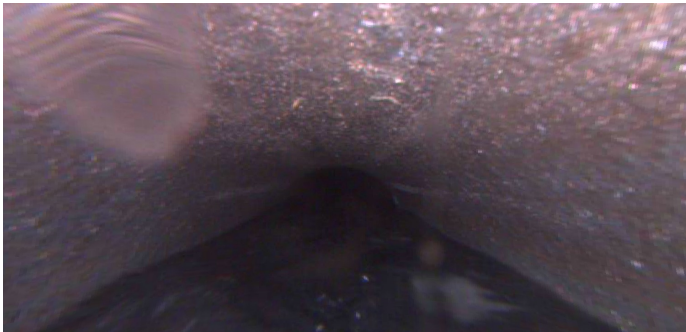
Code: **MSA**
Description: **Abandoned Survey**

Distance (ft): **47.7**
Structural Grade: **0**
O&M Grade: **0**
Clock Start/From:
Clock To:
1st Value:
2nd Value:
Value Percent:
Continuous Index:
Within 8" of Joint: **NO**
Remarks: **debris under water**

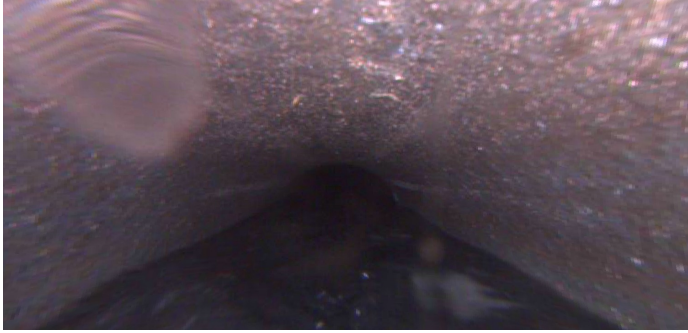
Code:	CM
Description:	Crack Multiple
Distance (ft):	47.7
Structural Grade:	3
O&M Grade:	0
Clock Start/From:	7
Clock To:	11
1st Value:	
2nd Value:	
Value Percent:	
Continuous Index:	F01
Within 8" of Joint:	YES
Remarks:	wandering
