Profile/Photo Observation Report

Street:	GEORGIANNA ST & S LINDA ST	Flow Control:	Not Controlled
City:	Hobart, IN	Year Renewed:	
Location:	Other	Tape/Media #:	
Purpose:	Not Known	Dia/Height:	8"
Use:	Sanitary	Material:	VCP
Drain Area:	NA	Lining:	
Category:	NA		
Comment:

Location Details:		Direction of Survey:	Downstream
US MH:	M-805-051	DS MH:	M-805-050
		Total Length Surveyed (ft):	163.1

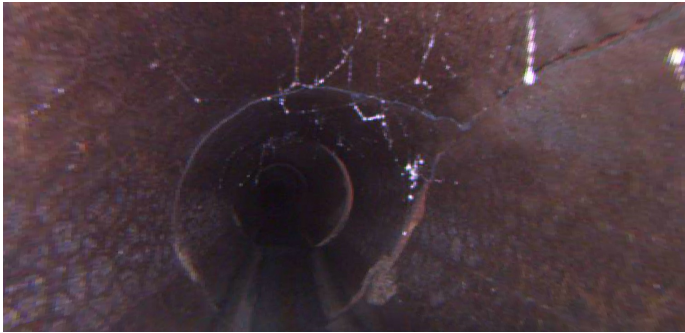
Code:	MWL
Description:	Water Level

Distance (ft):	.0
Structural Grade:	0
O&M Grade:	0
Clock Start/From:	
Clock To:	
1st Value:	
2nd Value:	
Value Percent:	5.000
Continuous Index:	
Within 8" of Joint:	NO
Remarks:

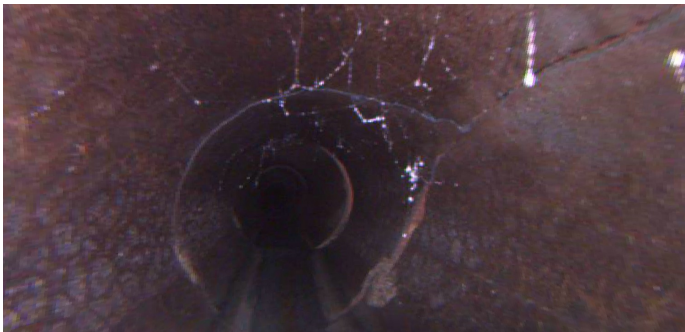
Code:	FM
Description:	Fracture Multiple

Distance (ft):	.0
Structural Grade:	4
O&M Grade:	0
Clock Start/From:	12
Clock To:	12
1st Value:	
2nd Value:	
Value Percent:	
Continuous Index:	
Within 8" of Joint:	
Remarks:

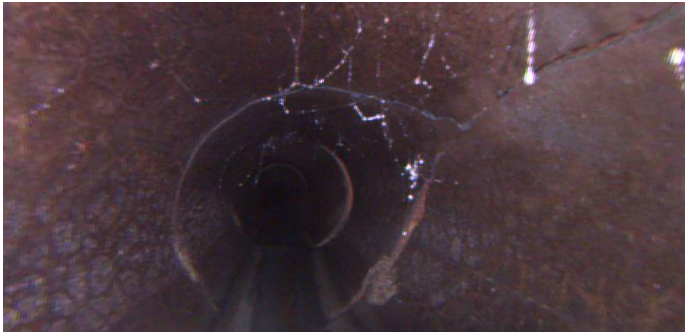
Code: **CM**
Description: **Crack Multiple**

Distance (ft): **.0**
Structural Grade: **3**
O&M Grade: **0**
Clock Start/From: **7**
Clock To: **5**
1st Value:
2nd Value:
Value Percent:
Continuous Index: **S01**
Within 8" of Joint:
Remarks:

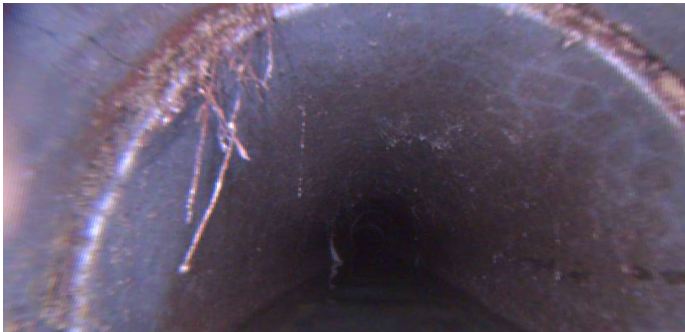
Code: **RFJ**
Description: **Roots Fine Joint**

Distance (ft): **25.7**
Structural Grade: **0**
O&M Grade: **1**
Clock Start/From: **11**
Clock To:
1st Value:
2nd Value:
Value Percent:
Continuous Index: **S02**
Within 8" of Joint: **YES**
Remarks: **wandering**

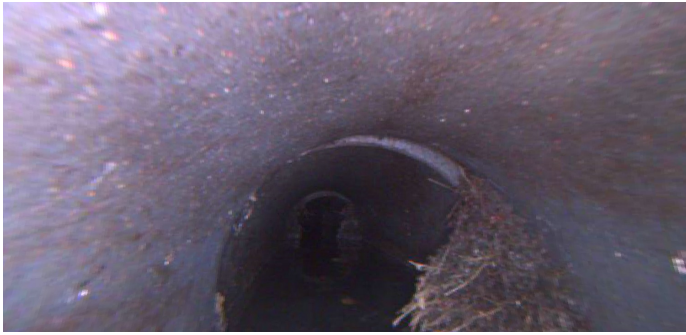
Code: **RMJ**
Description: **Roots Medium Joint**

Distance (ft): **52.0**
Structural Grade: **0**
O&M Grade: **3**
Clock Start/From: **2**
Clock To: **5**
1st Value:
2nd Value:
Value Percent: **10.000**
Continuous Index: **S03**
Within 8" of Joint: **YES**
Remarks: **wandering**

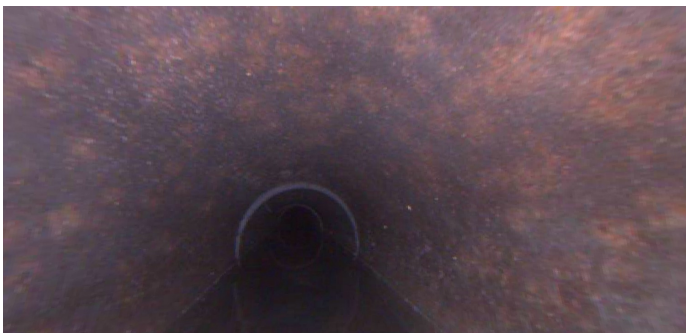
Code: **RMJ**
Description: **Roots Medium Joint**

Distance (ft): **69.5**
Structural Grade: **0**
O&M Grade: **3**
Clock Start/From: **2**
Clock To: **5**
1st Value:
2nd Value:
Value Percent: **10.000**
Continuous Index: **F03**
Within 8" of Joint: **YES**
Remarks: **wandering**

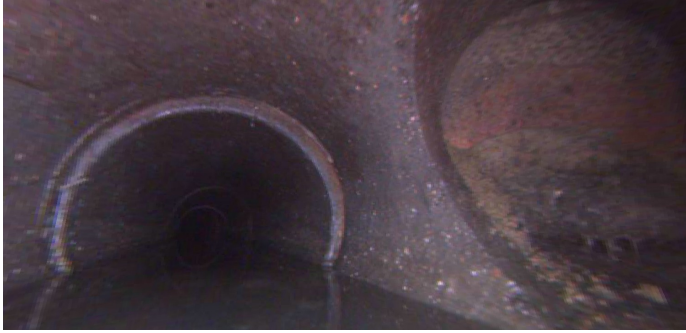
Code: **TFC**
Description: **Tap Factory Capped**

Distance (ft): **76.5**
Structural Grade: **0**
O&M Grade: **0**
Clock Start/From: **2**
Clock To:
1st Value: **6.000**
2nd Value:
Value Percent:
Continuous Index:
Within 8" of Joint: **YES**
Remarks:

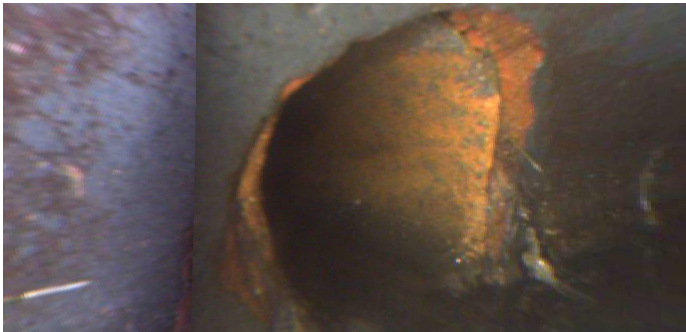
Code: **TB**
Description: **Tap Break-in**

Distance (ft): **83.1**
Structural Grade: **0**
O&M Grade: **0**
Clock Start/From: **3**
Clock To:
1st Value: **6.000**
2nd Value:
Value Percent:
Continuous Index:
Within 8" of Joint:
Remarks:

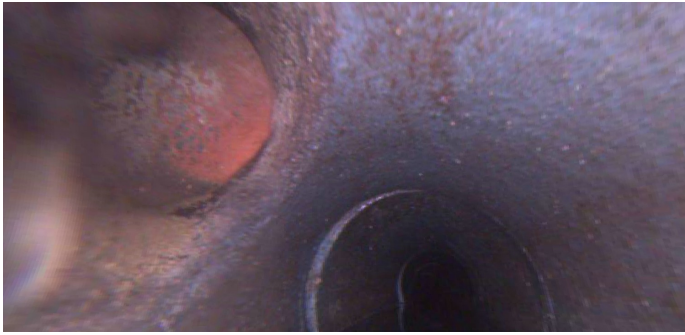
Code: **TFC**
Description: **Tap Factory Capped**

Distance (ft): **101.1**
Structural Grade: **0**
O&M Grade: **0**
Clock Start/From: **11**
Clock To:
1st Value: **4.000**
2nd Value:
Value Percent:
Continuous Index:
Within 8" of Joint: **YES**
Remarks:

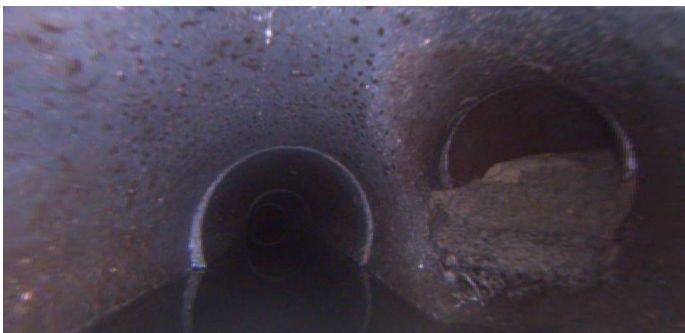
Code: **TFD**
Description: **Tap Factory Defective**

Distance (ft): **102.9**
Structural Grade: **0**
O&M Grade: **2**
Clock Start/From: **2**
Clock To:
1st Value: **4.000**
2nd Value:
Value Percent:
Continuous Index:
Within 8" of Joint:
Remarks: **blocked**

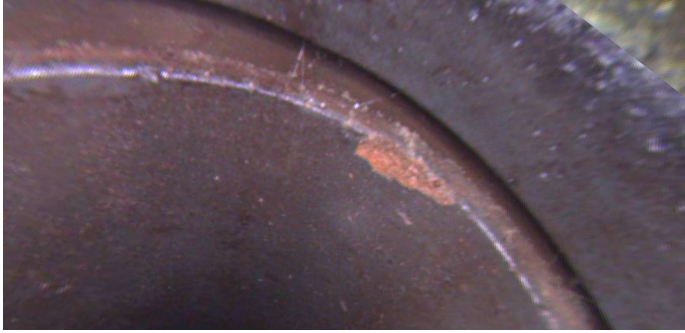
Code: **MGO**
Description: **General Observation**

Distance (ft): **114.2**
Structural Grade: **0**
O&M Grade: **0**
Clock Start/From:
Clock To:
1st Value:
2nd Value:
Value Percent:
Continuous Index:
Within 8" of Joint: **NO**
Remarks: **chipped at joint**

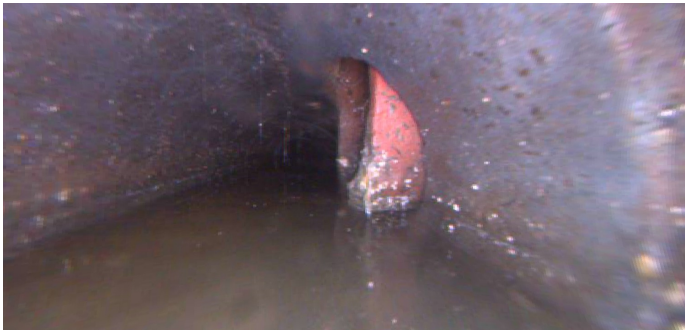
Code: **TBI**
Description: **Tap Break-in Intruding**

Distance (ft): **142.4**
Structural Grade: **0**
O&M Grade: **2**
Clock Start/From: **3**
Clock To:
1st Value: **6.000**
2nd Value: **2.000**
Value Percent:
Continuous Index:
Within 8" of Joint:
Remarks:

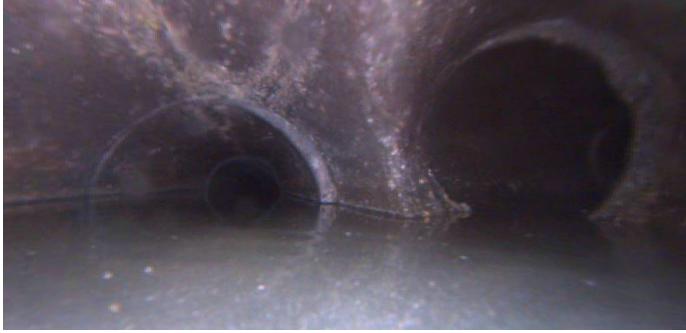
Code: **TF**
Description: **Tap Factory**

Distance (ft): **153.4**
Structural Grade: **0**
O&M Grade: **0**
Clock Start/From: **2**
Clock To:
1st Value: **4.000**
2nd Value:
Value Percent:
Continuous Index:
Within 8" of Joint: **YES**
Remarks:

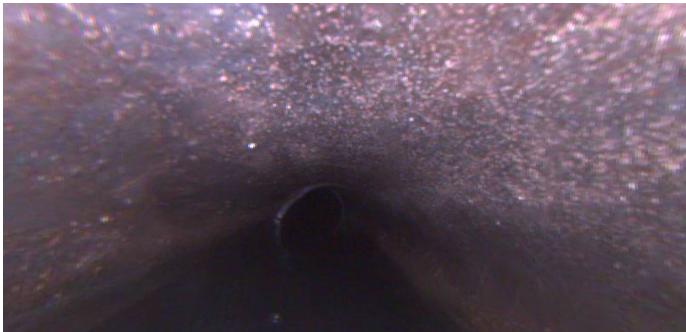
Code: **MSA**
Description: **Abandoned Survey**

Distance (ft): **163.1**
Structural Grade: **0**
O&M Grade: **0**
Clock Start/From:
Clock To:
1st Value:
2nd Value:
Value Percent:
Continuous Index:
Within 8" of Joint: **NO**
Remarks: **debris under water**

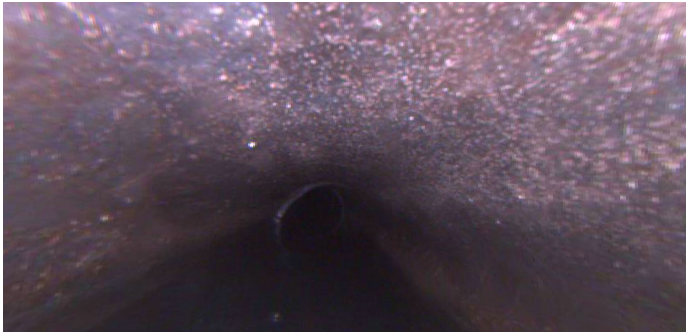
Code: **CM**
Description: **Crack Multiple**

Distance (ft): **163.1**
Structural Grade: **3**
O&M Grade: **0**
Clock Start/From: **7**
Clock To: **5**
1st Value:
2nd Value:
Value Percent:
Continuous Index: **F01**
Within 8" of Joint:
Remarks:

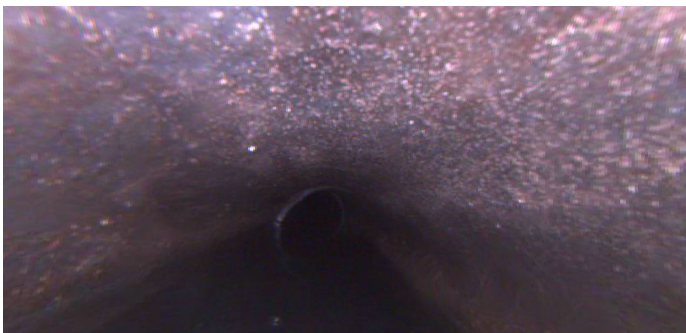
Code: **RFJ**
Description: **Roots Fine Joint**

Distance (ft): **163.1**
Structural Grade: **0**
O&M Grade: **1**
Clock Start/From: **11**
Clock To:
1st Value:
2nd Value:
Value Percent:
Continuous Index: **F02**
Within 8" of Joint: **YES**
Remarks: **wandering**
