Profile/Photo Observation Report

Date:	04/30/2018	Weather:		Coding:	PACP 6.0
Pipe Length (ft):		Owner:	City of Hobart	Pre Clean:	No Pre-Cleaning
P.O.#:	141	Surveyor:	M. Pielacha	PSR:	P-805-054-051
Customer:	City of Hobart	Clean Date:		Shape:	C

Street:	Linda Street	Flow Control:	Not Controlled
City:	Hobart, IN	Year Renewed:	
Location:	Light Highway	Tape/Media #:	DEP 141
Purpose:	Routine Assessment	Dia/Height:	15"
Use:	Sanitary	Material:	VCP
Drain Area:		Lining:	
Category:	NA		
Comment:	5-21-2018		
Location Details:		Direction of Survey:	Downstream
US MH:	M-805-051	DS MH:	M-805-054
		Total Length Surveyed (ft):	81.8

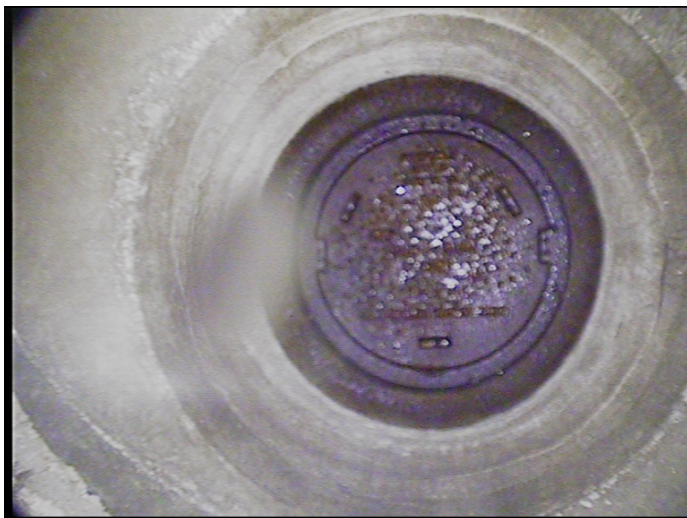
Code: **AMH**
 Description: **Manhole**

Distance (ft): **.0**
 Structural Grade: **0**
 O&M Grade: **0**
 Clock Start/From:
 Clock To:
 1st Value:
 2nd Value:
 Value Percent:
 Continuous Index:
 Within 8" of Joint: **NO**
 Remarks: **M-805-054**

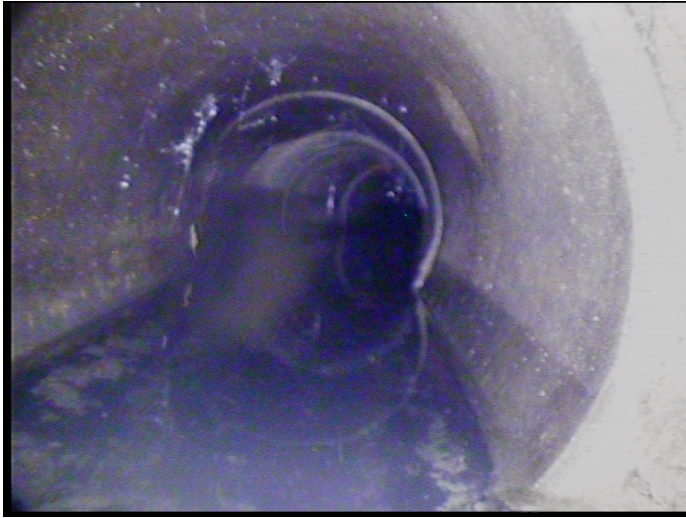
Code:	MWL
Description:	Water Level
Distance (ft):	.0
Structural Grade:	0
O&M Grade:	0
Clock Start/From:	
Clock To:	
1st Value:	
2nd Value:	
Value Percent:	10.000
Continuous Index:	
Within 8" of Joint:	NO
Remarks:

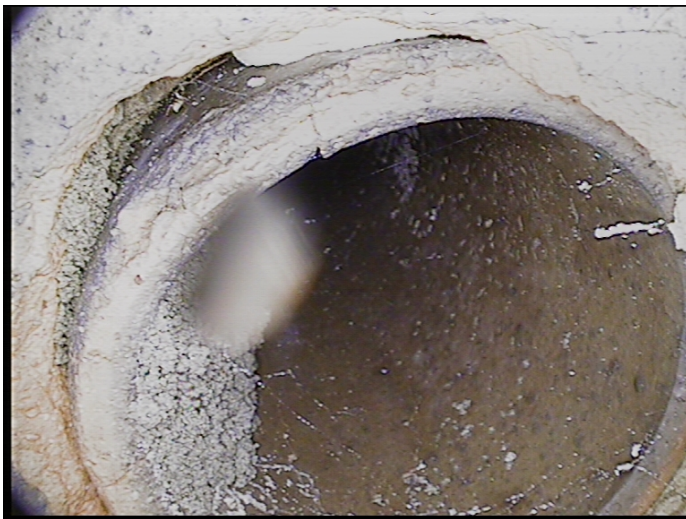
Code:	TB
Description:	Tap Break-in
Distance (ft):	15.0
Structural Grade:	0
O&M Grade:	0
Clock Start/From:	9
Clock To:	
1st Value:	4.000
2nd Value:	
Value Percent:	
Continuous Index:	
Within 8" of Joint:	NO
Remarks:

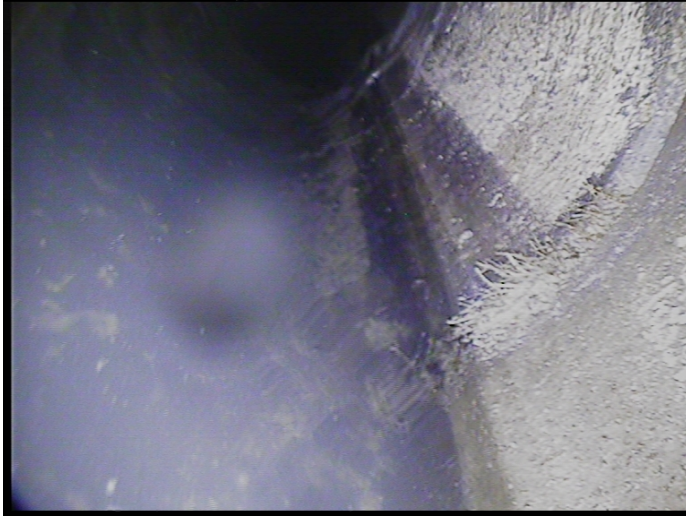
Code: **RFJ**
Description: **Roots Fine Joint**

Distance (ft): **46.3**
Structural Grade: **0**
O&M Grade: **1**
Clock Start/From: **8**
Clock To: **4**
1st Value:
2nd Value:
Value Percent:
Continuous Index: **S01**
Within 8" of Joint: **YES**
Remarks:

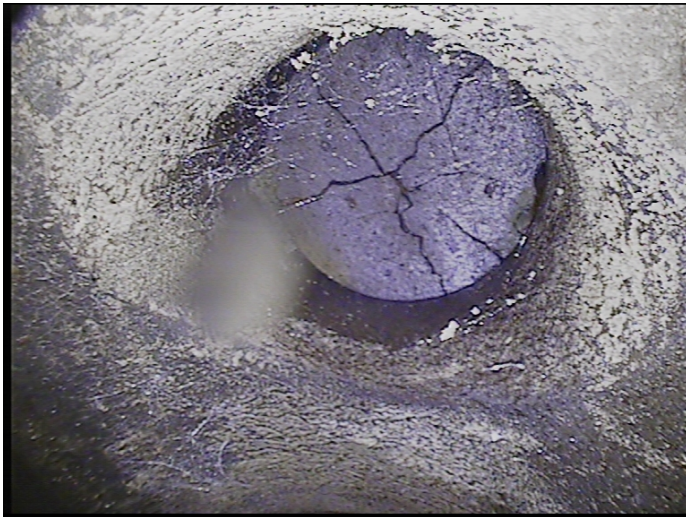
Code: **TFC**
Description: **Tap Factory Capped**

Distance (ft): **49.0**
Structural Grade: **0**
O&M Grade: **0**
Clock Start/From: **9**
Clock To:
1st Value: **4.000**
2nd Value:
Value Percent:
Continuous Index:
Within 8" of Joint: **NO**
Remarks:

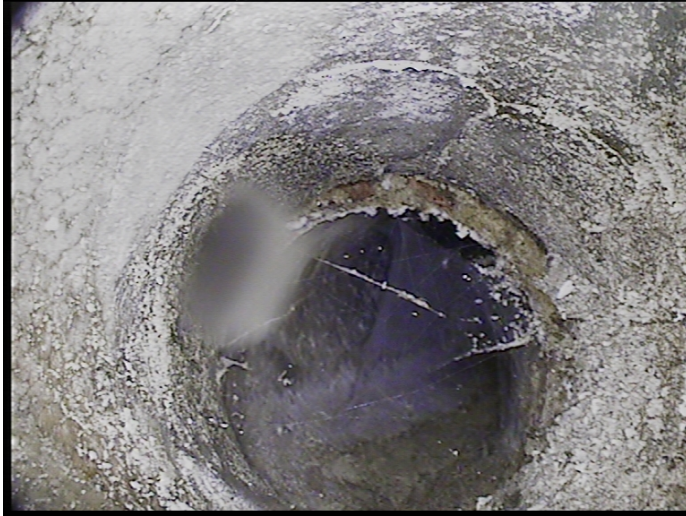
Code: **TF**
Description: **Tap Factory**

Distance (ft): **52.4**
Structural Grade: **0**
O&M Grade: **0**
Clock Start/From: **3**
Clock To:
1st Value: **4.000**
2nd Value:
Value Percent:
Continuous Index:
Within 8" of Joint: **NO**
Remarks:

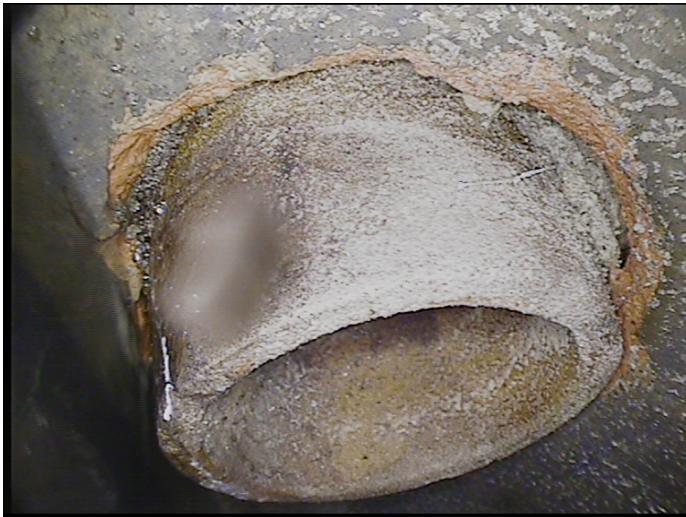
Code: **TBI**
Description: **Tap Break-in Intruding**

Distance (ft): **54.7**
Structural Grade: **0**
O&M Grade: **2**
Clock Start/From: **9**
Clock To:
1st Value: **4.000**
2nd Value: **2.000**
Value Percent:
Continuous Index:
Within 8" of Joint: **NO**
Remarks:

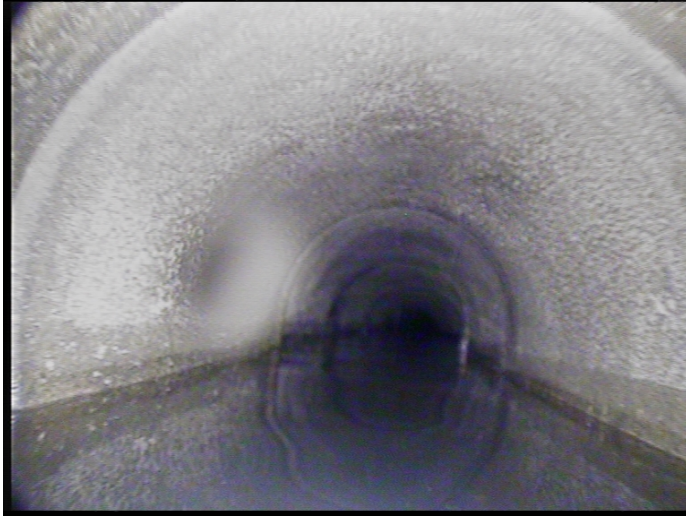
Code: **RFJ**
Description: **Roots Fine Joint**

Distance (ft): **64.8**
Structural Grade: **0**
O&M Grade: **1**
Clock Start/From: **8**
Clock To: **4**
1st Value:
2nd Value:
Value Percent:
Continuous Index: **F01**
Within 8" of Joint: **YES**
Remarks:

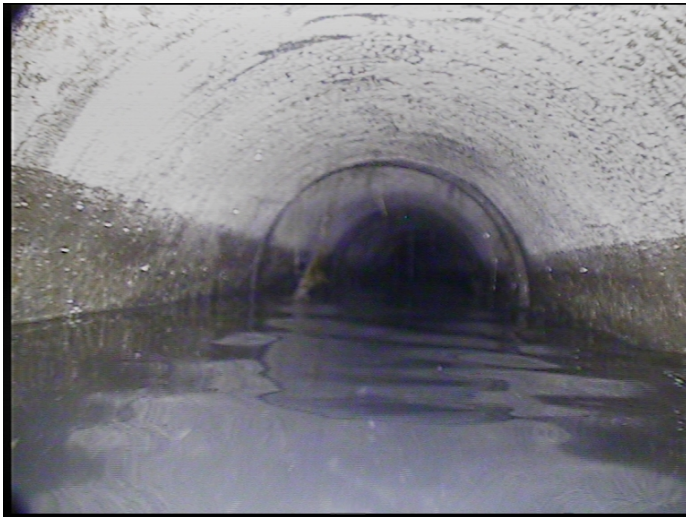
Code: **MSA**
Description: **Abandoned Survey**

Distance (ft): **80.9**
Structural Grade: **0**
O&M Grade: **0**
Clock Start/From:
Clock To:
1st Value:
2nd Value:
Value Percent:
Continuous Index:
Within 8" of Joint: **NO**
Remarks: **sediment**
