## Profile/Photo Observation Report

Date:	<b>04/30/2018</b>	Weather:		Coding:	<b>PACP 6.0</b>
Pipe Length (ft):		Owner:	<b>City of Hobart</b>	Pre Clean:	<b>No Pre-Cleaning</b>
P.O.#:	<b>143</b>	Surveyor:	<b>M. Pielacha</b>	PSR:	<b>P-805-054-051</b>
Customer:	<b>City of Hobart</b>	Clean Date:		Shape:	<b>C</b>

Street:	<b>Lillian Street</b>	Flow Control:	<b>Not Controlled</b>
City:	<b>Hobart, IN</b>	Year Renewed:	
Location:	<b>Light Highway</b>	Tape/Media #:	<b>DEP 143</b>
Purpose:	<b>Routine Assessment</b>	Dia/Height:	<b>15"</b>
Use:	<b>Sanitary</b>	Material:	<b>VCP</b>
Drain Area:		Lining:	
Category:	<b>NA</b>		
Comment:	<b>5-21-2018</b>		
Location Details:		Direction of Survey:	<b>Downstream</b>
US MH:	<b>M-805-051</b>	DS MH:	<b>M-805-054</b>
		Total Length Surveyed (ft):	<b>177.0</b>

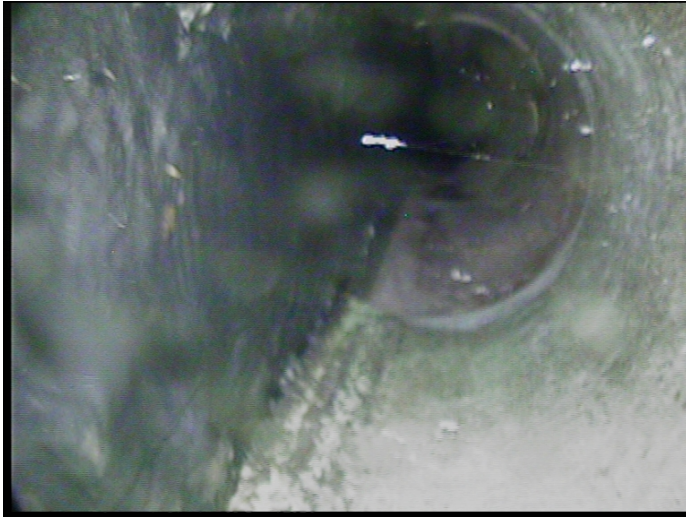
Code: **MWL**  
Description: **Water Level**

Distance (ft): **.0**  
Structural Grade: **0**  
O&M Grade: **0**  
Clock Start/From:  
Clock To:  
1st Value:  
2nd Value:  
Value Percent: **10.000**  
Continuous Index:  
Within 8" of Joint: **NO**  
Remarks:

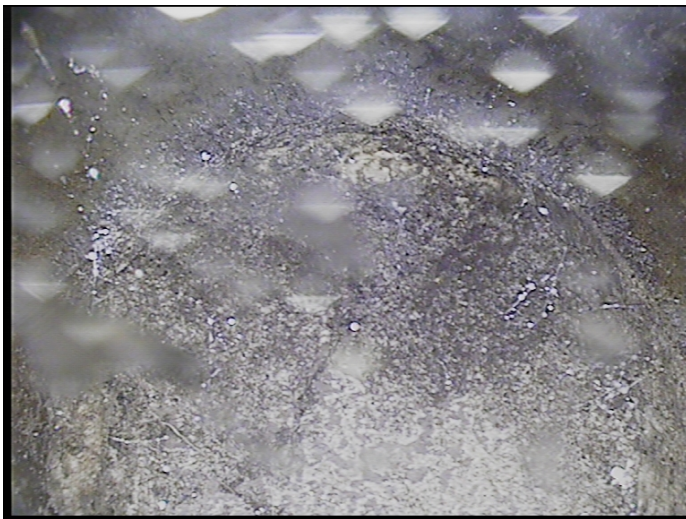
Code: **TFC**  
Description: **Tap Factory Capped**

Distance (ft): **8.0**  
Structural Grade: **0**  
O&M Grade: **0**  
Clock Start/From: **12**  
Clock To:  
1st Value: **4.000**  
2nd Value:  
Value Percent:  
Continuous Index:  
Within 8" of Joint: **NO**  
Remarks:

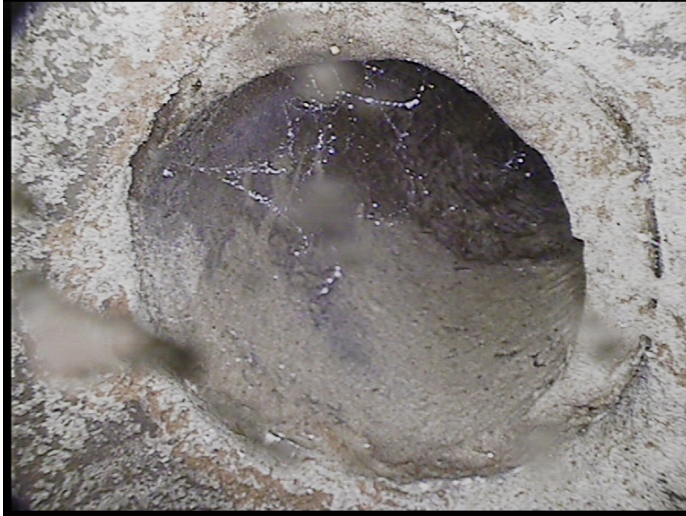
Code: **B**  
Description: **Broken**

Distance (ft): **32.2**  
Structural Grade: **3**  
O&M Grade: **0**  
Clock Start/From: **2**  
Clock To:  
1st Value: **4.000**  
2nd Value:  
Value Percent:  
Continuous Index:  
Within 8" of Joint: **NO**  
Remarks:

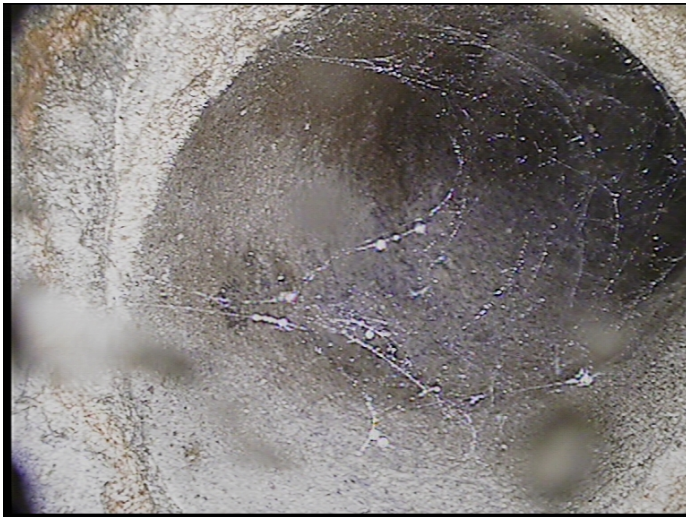
Code: **TB**  
Description: **Tap Break-in**

Distance (ft): **77.4**  
Structural Grade: **0**  
O&M Grade: **0**  
Clock Start/From: **2**  
Clock To:  
1st Value: **4.000**  
2nd Value:  
Value Percent:  
Continuous Index:  
Within 8" of Joint: **NO**  
Remarks:

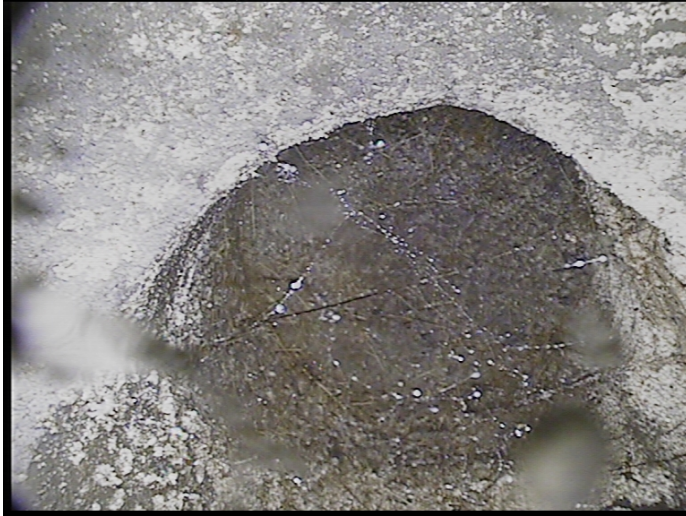
Code: **TFC**  
Description: **Tap Factory Capped**

Distance (ft): **86.8**  
Structural Grade: **0**  
O&M Grade: **0**  
Clock Start/From: **2**  
Clock To:  
1st Value: **4.000**  
2nd Value:  
Value Percent:  
Continuous Index:  
Within 8" of Joint: **NO**  
Remarks:

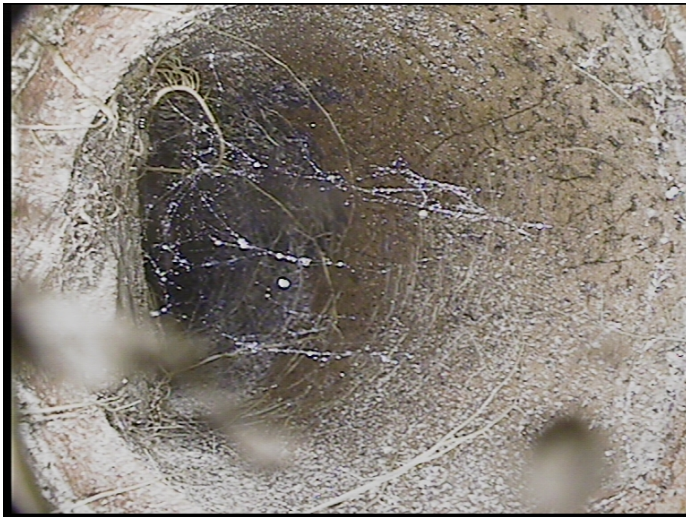
Code: **TB**  
Description: **Tap Break-in**

Distance (ft): **102.2**  
Structural Grade: **0**  
O&M Grade: **0**  
Clock Start/From: **10**  
Clock To:  
1st Value: **4.000**  
2nd Value:  
Value Percent:  
Continuous Index:  
Within 8" of Joint: **NO**  
Remarks:

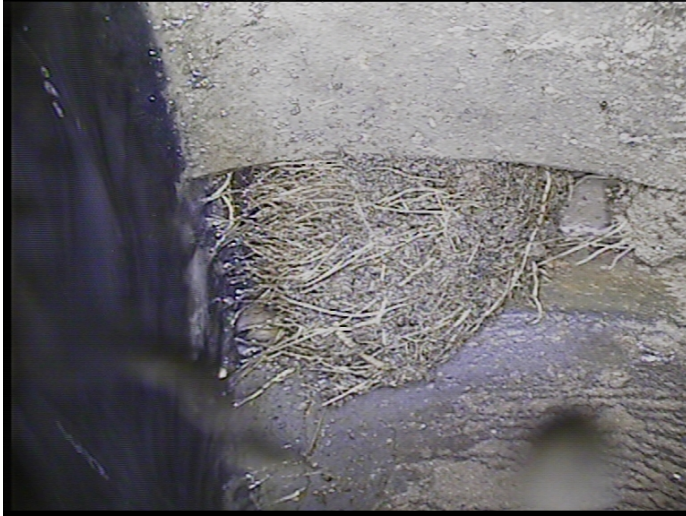
Code: **RFJ**  
Description: **Roots Fine Joint**

Distance (ft): **106.6**  
Structural Grade: **0**  
O&M Grade: **1**  
Clock Start/From: **8**  
Clock To:  
1st Value:  
2nd Value:  
Value Percent:  
Continuous Index:  
Within 8" of Joint: **YES**  
Remarks:

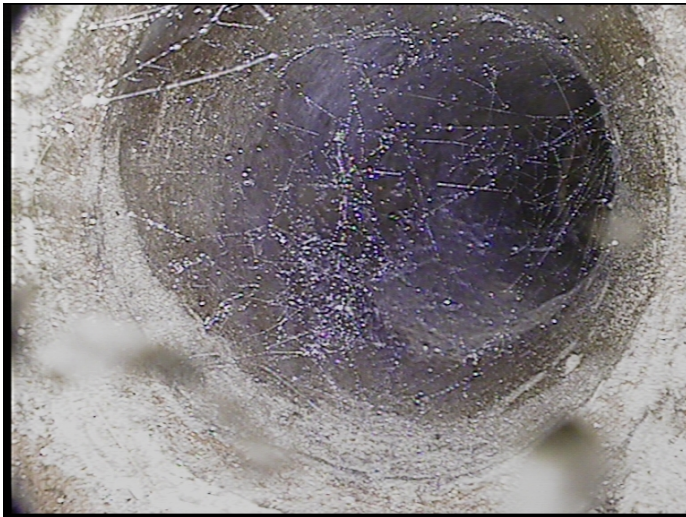
Code: **TF**  
Description: **Tap Factory**

Distance (ft): **124.6**  
Structural Grade: **0**  
O&M Grade: **0**  
Clock Start/From: **2**  
Clock To:  
1st Value: **4.000**  
2nd Value:  
Value Percent:  
Continuous Index:  
Within 8" of Joint: **NO**  
Remarks:

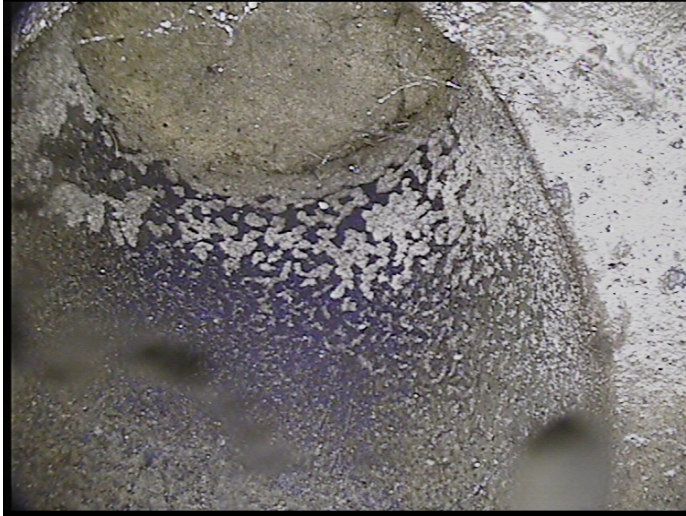
Code: **TF**  
Description: **Tap Factory**

Distance (ft): **169.3**  
Structural Grade: **0**  
O&M Grade: **0**  
Clock Start/From: **12**  
Clock To:  
1st Value: **4.000**  
2nd Value:  
Value Percent:  
Continuous Index:  
Within 8" of Joint: **NO**  
Remarks:

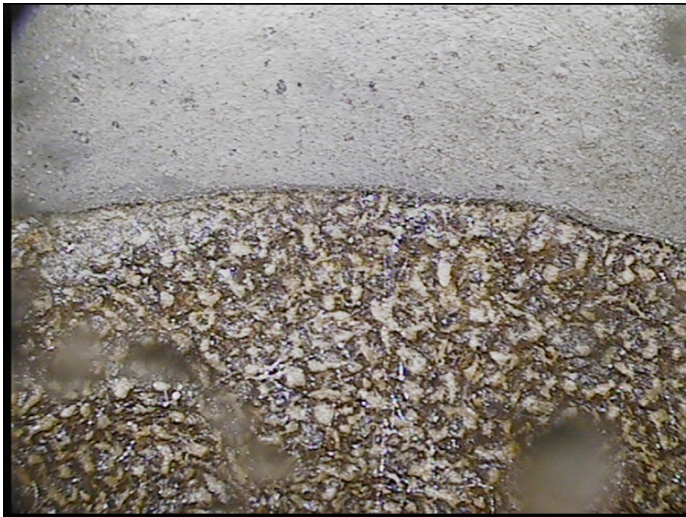
Code: **MMC**  
Description: **Material Change**

Distance (ft): **174.2**  
Structural Grade: **0**  
O&M Grade: **0**  
Clock Start/From:  
Clock To:  
1st Value:  
2nd Value:  
Value Percent:  
Continuous Index:  
Within 8" of Joint: **NO**  
Remarks: **steel**

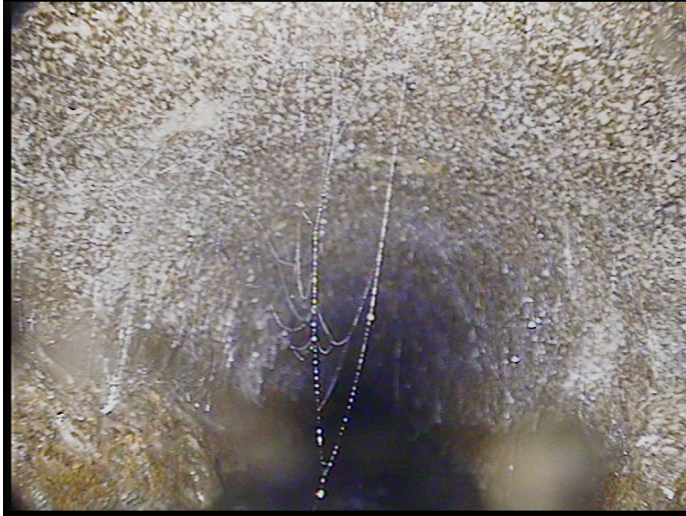
Code: **SRI**  
Description: **Surface Roughness Increased**

Distance (ft): **175.9**  
Structural Grade: **1**  
O&M Grade: **0**  
Clock Start/From: **8**  
Clock To: **4**  
1st Value:  
2nd Value:  
Value Percent:  
Continuous Index:  
Within 8" of Joint: **YES**  
Remarks:

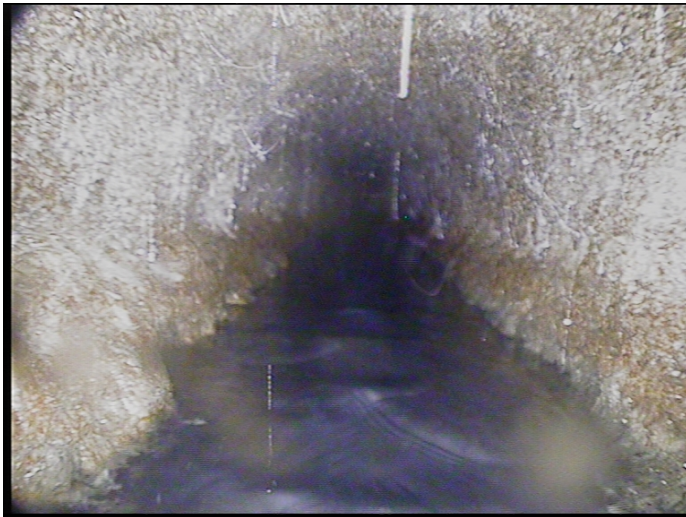
Code: **MSA**  
Description: **Abandoned Survey**

Distance (ft): **176.5**  
Structural Grade: **0**  
O&M Grade: **0**  
Clock Start/From:  
Clock To:  
1st Value:  
2nd Value:  
Value Percent:  
Continuous Index:  
Within 8" of Joint: **NO**  
Remarks: **corroded pipe**
