Profile/Photo Observation Report

Customer: City of Hobart Clean Date: 01/05/2023 Shape: C

Street: South Linda Street Flow Control: Not Controlled

US MH: M-805-051 DS MH: M-805-054 Total Length Surveyed (ft): 350.5

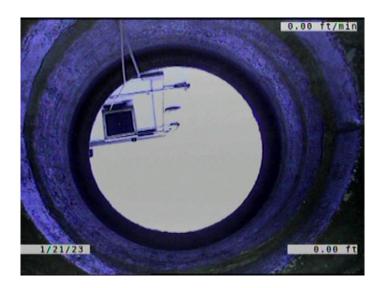
Code: AMH
Description: Manhole

Remarks: M-805-054

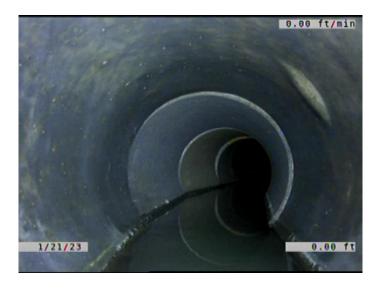
Code: MWL

Description: Miscellaneous Water Level

Value Percent: 10.000

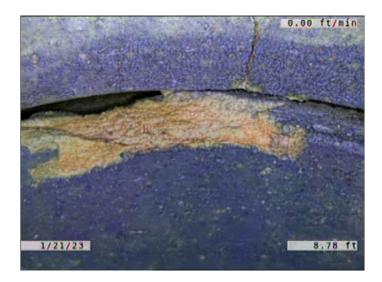
Code: SMW

Description: Surface Damage Missing Wall

Distance (ft): 8.8
Structural Grade: 5
O&M Grade: 0
Clock Start/From: 11
Clock To: 1

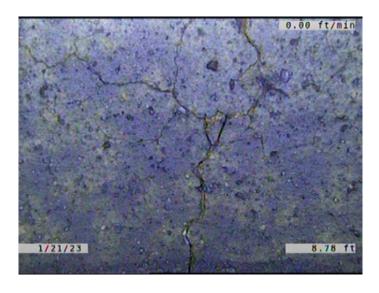
Code: FM

Description: Fracture Multiple

Distance (ft): 8.8
Structural Grade: 4
O&M Grade: 0
Clock Start/From: 11
Clock To: 1
1st Value:

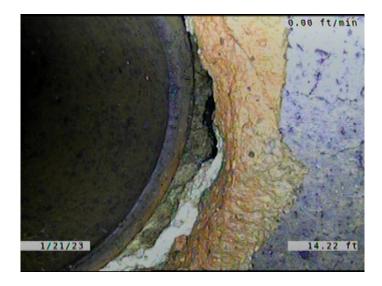
Code: SSS

Description: Surface Damage Surface Spalling

Distance (ft): 14.2
Structural Grade: 2
O&M Grade: 0
Clock Start/From: 9
Clock To: 11

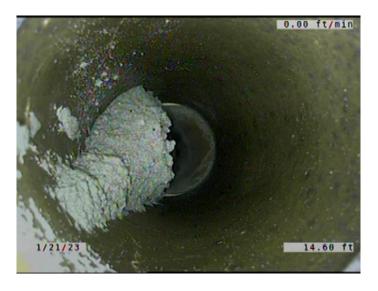
Code: TB

Description: Tap Break-in/Hammer

Distance (ft): 14.6
Structural Grade: 0
O&M Grade: 0
Clock Start/From: 10

Remarks: 50% PLUGGED WITH DIRT.

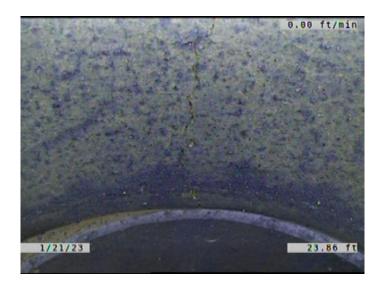
Code: CM

Description: Crack Multiple

Distance (ft): 23.9
Structural Grade: 3
O&M Grade: 0
Clock Start/From: 11
Clock To: 1

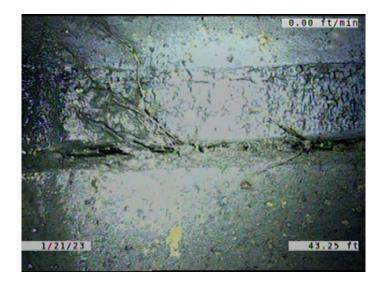
Code: RFJ

Description: Roots Fine Joint

Distance (ft): 43.3
Structural Grade: 0
O&M Grade: 1
Clock Start/From: 8
Clock To: 10

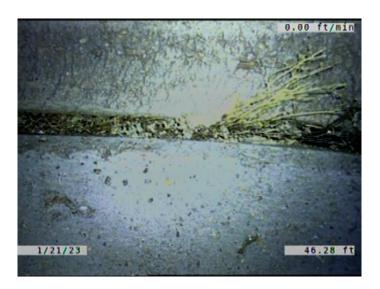
Code: RFJ

Description: Roots Fine Joint

Distance (ft): 46.3
Structural Grade: 0
O&M Grade: 1
Clock Start/From: 8
Clock To: 4
1st Value:
2nd Value:
Value Percent:

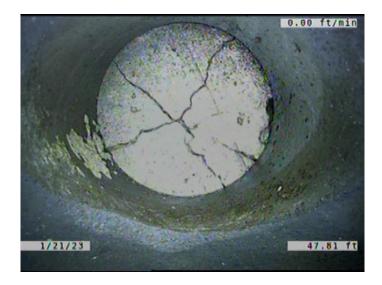
Code: **TFD**

Description: Tap Factory Defective

Distance (ft): 47.8
Structural Grade: 0
O&M Grade: 3
Clock Start/From: 10

Remarks: CAPPED. CAP BROKEN.

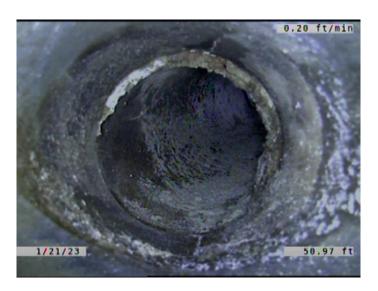
Code: **TFD**

Description: Tap Factory Defective

Distance (ft): 51.0
Structural Grade: 0
O&M Grade: 3
Clock Start/From: 2

Remarks: TAP CRACKED.

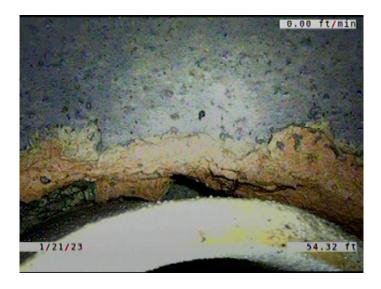
Code: BVV

Description: Broken Void Visible

Distance (ft): 54.3
Structural Grade: 5

Remarks: **SOIL VISIBLE ALSO.**

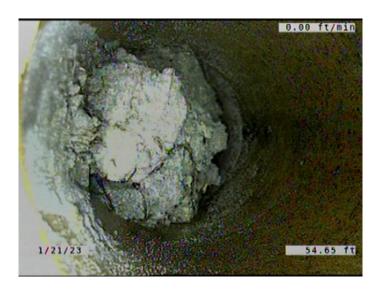
Code: TBI

Description: Tap Break-in Intruding

Distance (ft): 54.6
Structural Grade: 0
O&M Grade: 2
Clock Start/From: 9

Remarks: 100% PLUGGED WITH ROOTS AND

DIRT.

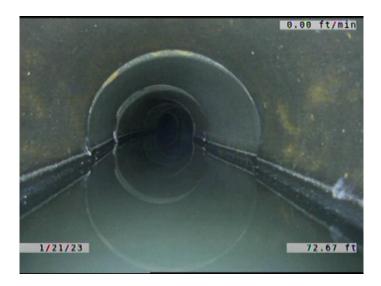
Code: MWLS

Description: Miscellaneous Water Level Sag

Distance (ft): 72.7
Structural Grade: 2
O&M Grade: 0

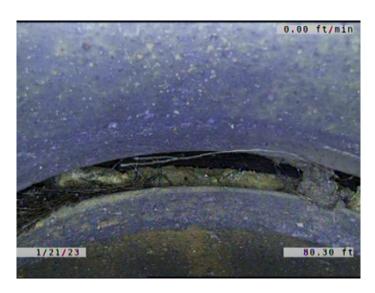
Code: JOMD

Description: Joint Offset Medium Defective

Distance (ft): 80.3
Structural Grade: 3
O&M Grade: 0

Remarks: **SOIL VISIBLE.**

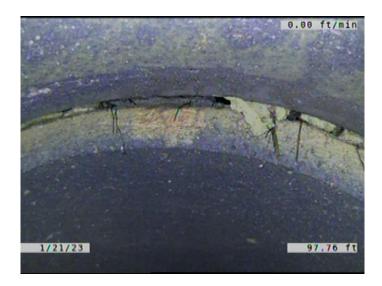
Code: **JOMD**

Description: **Joint Offset Medium Defective**

Distance (ft): 97.8 Structural Grade: 3 0 O&M Grade:

Remarks: **SOIL VISIBLE.**

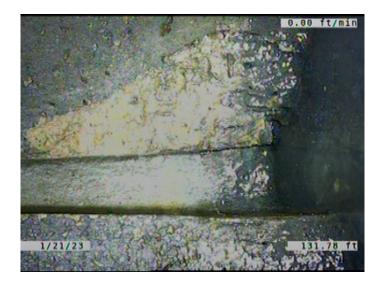
Code: SZ

Description: **Surface Damage Other**

Distance (ft): 131.8 Structural Grade: 0 O&M Grade: 0 Clock Start/From: 8

Remarks: A PIECE CHIPPED AWAY FROM THE

JOINT.

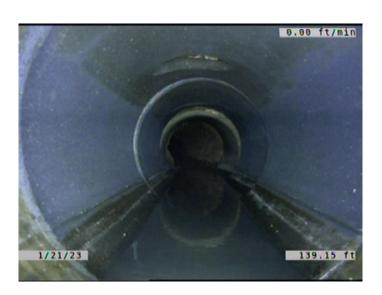
Code: **MWLS**

Description: **Miscellaneous Water Level Sag**

Distance (ft): 139.1 Structural Grade: 2 O&M Grade: 0

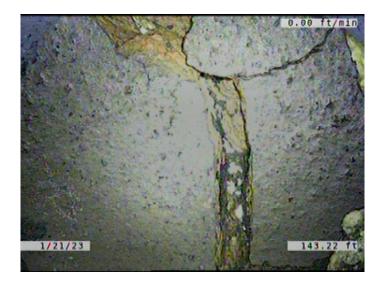
Code: **TFD**

Description: **Tap Factory Defective**

Distance (ft): 143.2 Structural Grade: 0 3 O&M Grade: Clock Start/From: 12

Remarks: CAPPED. CAP BROKEN.

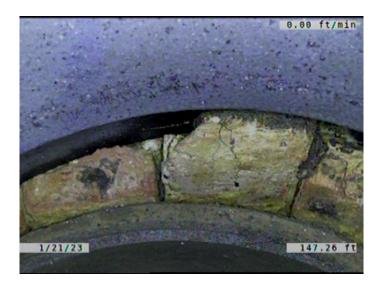
Code: **JOLD**

Description: **Joint Offset Large Defective**

147.3 Distance (ft): Structural Grade: 0 O&M Grade:

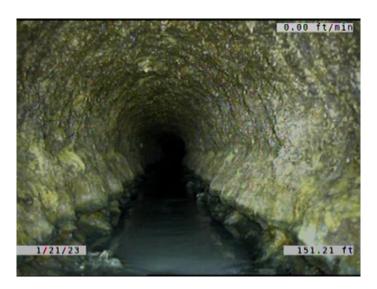
Code: SCP

Description: Surface Damage Corrosion

Distance (ft): 151.2
Structural Grade: 3
O&M Grade: 0
Clock Start/From: 7
Clock To: 5
1st Value:

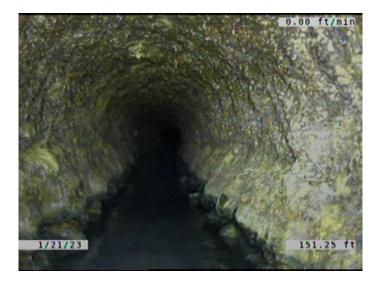
Code: DAE

Description: **Deposits Attached Encrustation**

Distance (ft): 151.2 Structural Grade: 0 3 O&M Grade: Clock Start/From: 7 Clock To: 5

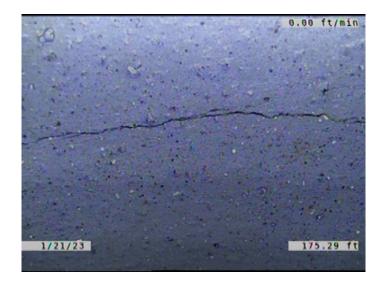
Code: CM

Description: Crack Multiple

Distance (ft): 175.3
Structural Grade: 3
O&M Grade: 0
Clock Start/From: 7
Clock To: 4

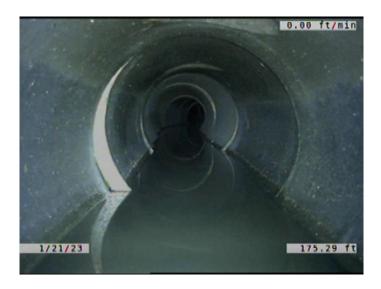
Code: SCP

Description: Surface Damage Corrosion

Distance (ft): 175.3
Structural Grade: 3
O&M Grade: 0
Clock Start/From: 7
Clock To: 5
1st Value:
2nd Value:

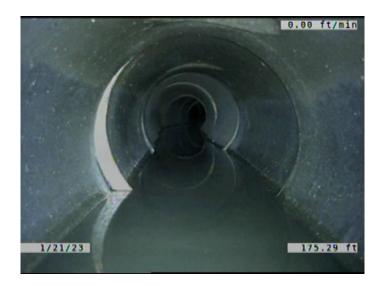
Code: DAE

Description: Deposits Attached Encrustation

Distance (ft): 175.3
Structural Grade: 0
O&M Grade: 3
Clock Start/From: 7
Clock To: 5

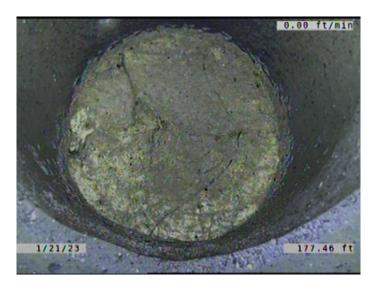
Code: **TFD**

Description: Tap Factory Defective

Distance (ft): 177.5
Structural Grade: 0
O&M Grade: 3
Clock Start/From: 12

Remarks: 100% PLUGGED WITH ROOTS AND

DIRT.

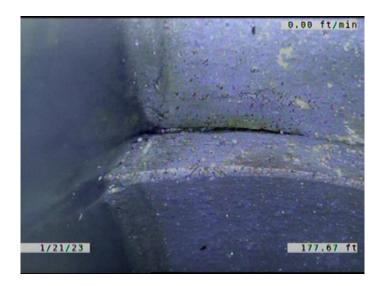
Code: **JOMD**

Description: Joint Offset Medium Defective

Distance (ft): 177.7
Structural Grade: 3
O&M Grade: 0

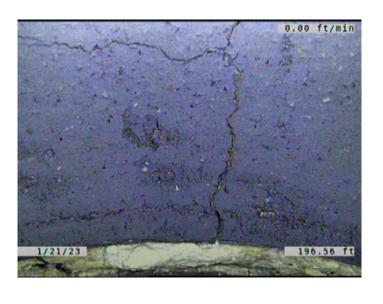
Code: FM

Description: Fracture Multiple

Distance (ft): 196.6
Structural Grade: 4
O&M Grade: 0
Clock Start/From: 8
Clock To: 4
1st Value:
2nd Value:
Value Percent:

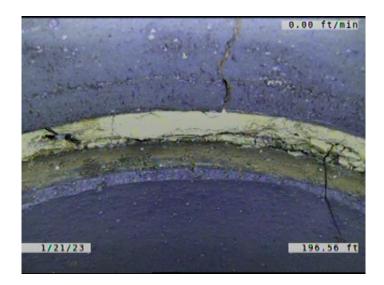
Code: **JOMD**

Description: Joint Offset Medium Defective

Distance (ft): 196.6
Structural Grade: 3
O&M Grade: 0

Remarks: **SOIL VISIBLE.**

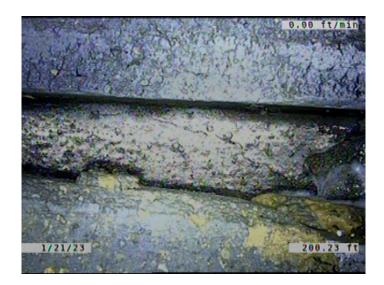
Code: JAM

Description: Joint Angular Medium

Distance (ft): 200.2 Structural Grade: 3 0 O&M Grade:

Remarks: **SOIL VISIBLE.**

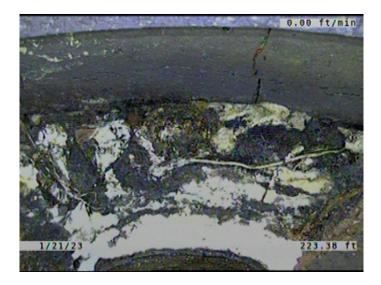
Code: BSV

Description: Broken Soil Visible

Distance (ft): 223.4
Structural Grade: 5
O&M Grade: 0
Clock Start/From: 9
Clock To: 11

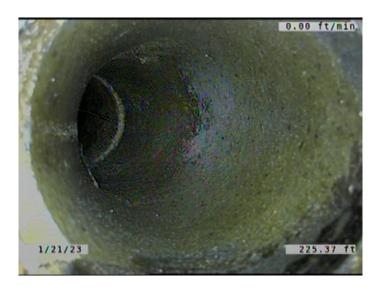
Code: **TBD**

Description: Tap Break-in/Hammer Defective

Distance (ft): 225.4
Structural Grade: 0
O&M Grade: 3
Clock Start/From: 10

Remarks: **Defective**

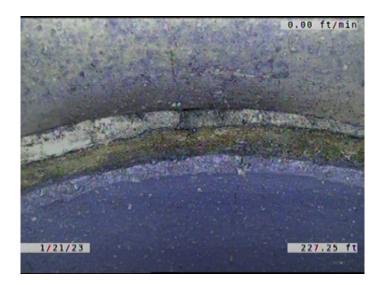
Code: **JOMD**

Description: Joint Offset Medium Defective

Distance (ft): 227.2
Structural Grade: 3
O&M Grade: 0

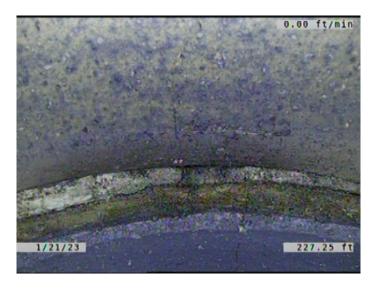
Code: CL

Description: Crack Longitudinal

Distance (ft): 227.3
Structural Grade: 2
O&M Grade: 0
Clock Start/From: 12

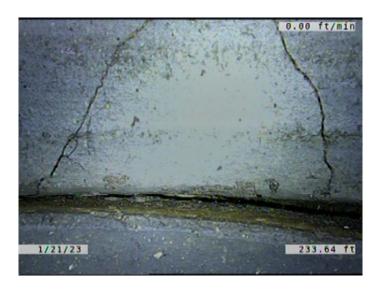
Code: CM

Description: Crack Multiple

Distance (ft): 233.6
Structural Grade: 3
O&M Grade: 0
Clock Start/From: 11
Clock To: 1
1st Value:
2nd Value:
Value Percent:

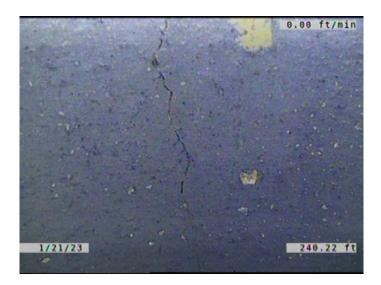
Code: CS

Description: Crack Spiral

Distance (ft): 240.2
Structural Grade: 2
O&M Grade: 0
Clock Start/From: 10

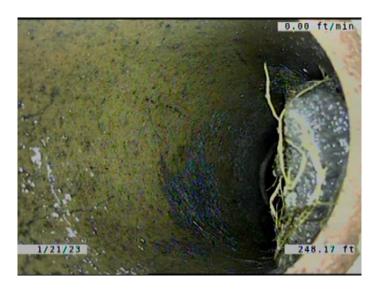
Code: TBI

Description: Tap Break-in Intruding

Distance (ft): 248.2
Structural Grade: 0
O&M Grade: 2
Clock Start/From: 2

Remarks: ROOTS GROWING IN THE SERVICE.

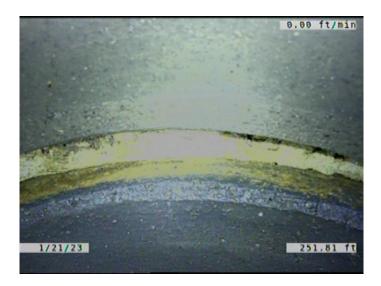
Code: **JOMD**

Description: **Joint Offset Medium Defective**

Distance (ft): 251.8 Structural Grade: 3 0 O&M Grade:

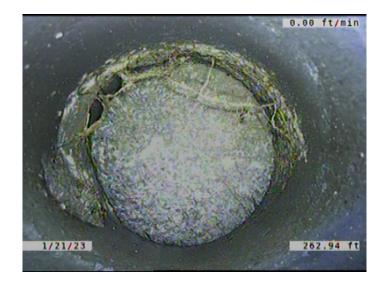
Code: **TFC**

Description: Tap Factory Capped

Distance (ft): 262.9
Structural Grade: 0
O&M Grade: 0
Clock Start/From: 10

Remarks: ROOTS GROWING AROUND THE

CAP.

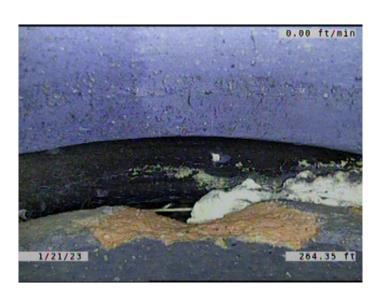
Code: SMW

Description: Surface Damage Missing Wall

Distance (ft): 264.4
Structural Grade: 5
O&M Grade: 0
Clock Start/From: 9
Clock To: 12
1st Value:
2nd Value:

Remarks: **SOIL VISIBLE.**

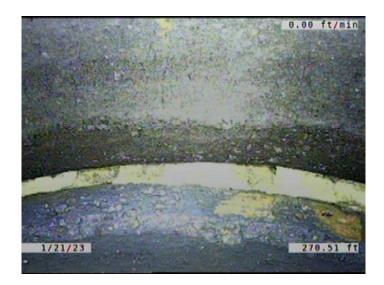
Code: JOMD

Description: Joint Offset Medium Defective

Distance (ft): 270.5
Structural Grade: 3
O&M Grade: 0

Remarks: **SOIL VISIBLE.**

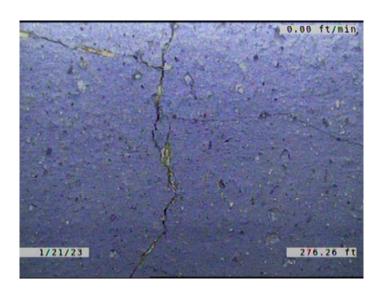
Code: B
Description: Broken

Distance (ft): 276.3
Structural Grade: 4
O&M Grade: 0
Clock Start/From: 12
Clock To: 12
1st Value:
2nd Value:

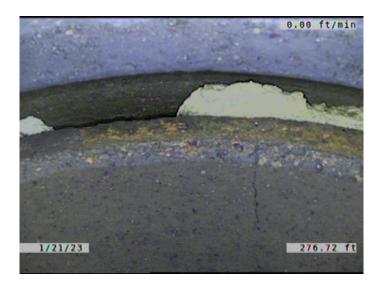
Code: JOMD

Description: Joint Offset Medium Defective

Distance (ft): 276.7
Structural Grade: 3
O&M Grade: 0

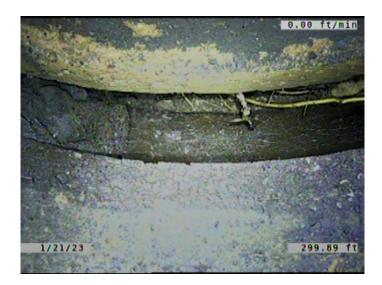
Code: JAM

Description: Joint Angular Medium

Distance (ft): 299.9
Structural Grade: 3
O&M Grade: 0

Remarks: **SOIL VISIBLE.**

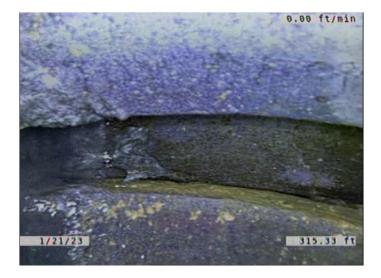
Code: FM

Description: Fracture Multiple

Distance (ft): 315.3
Structural Grade: 4
O&M Grade: 0
Clock Start/From: 7
Clock To: 5

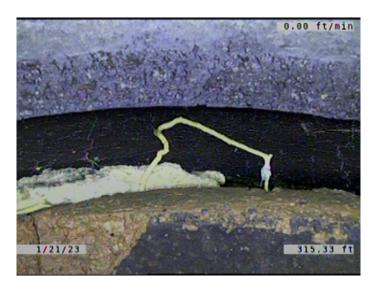
Code: JAL

Description: Joint Angular Large

Distance (ft): 315.3
Structural Grade: 4
O&M Grade: 0

Remarks: **SOIL VISIBLE.**

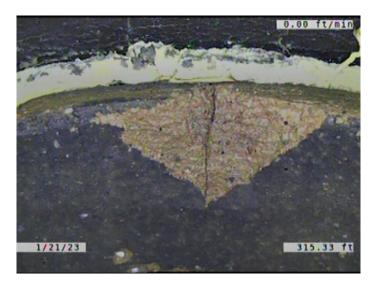
Code: SSS

Description: Surface Damage Surface Spalling

Distance (ft): 315.3
Structural Grade: 2
O&M Grade: 0
Clock Start/From: 9
Clock To: 11

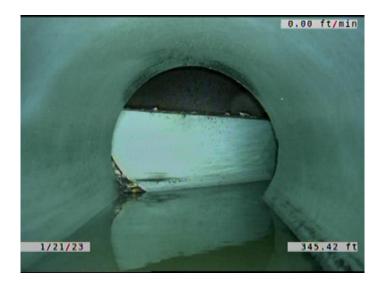
Code: **JOMD**

Description: Joint Offset Medium Defective

Distance (ft): 345.4
Structural Grade: 3
O&M Grade: 0
