Profile/Photo Observation Report

Profile/Photo Observation Report								
Date:	04/30/2018	Weather:			Coding:	PACP 6.0		
Pipe Length (ft	t):	Owner:	City of	Hobart	Pre Clean:	No Pre-Cleaning		
P.O.#:	142	Surveyor:	M. Pie	lacha	PSR:	P-805-055-054		
Customer:	City of Hobart	Clean Date:			Shape:	С		
Street:	Lillian Street		Flow Co	ntrol:	Not Controlled			
City:	Hobart, IN		Year Rei	newed:				
Location:	Light Highway		Tape/M	edia #:	DEP 142			
Purpose:	Routine Assessment		Dia/Hei	ght:	15"			
Use:	Sanitary		Materia	l:	VCP			
Drain Area:			Lining:					
Category:	NA							
Comment:	5-21-2018							
Location Detai	ls:		Directio	n of Survey:	: Downstream			
US MH:	M-805-055	DS MH:	M-805-05	4	Total Length Surveyed (ft)	: 155.0		
O&M Index:	2.88	O&M Quick:		3721	O&M Rating:	23.00		
Structural Index	0.00	Structural Qu		0000	Structural Rating:	0.00		
Overall Index:	2.88	Overall Quicl	k:	3721	Overall Rating:	23.00

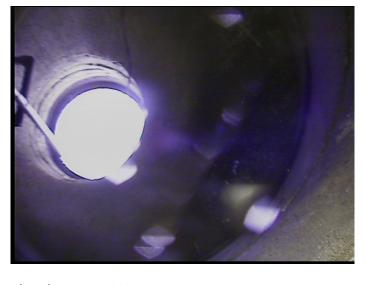
Code:	AMH
Description:	Manhole
Distance (ft):	.0
Structural Grade:	0
O&M Grade:	0
Clock Start/From:	
Clock To:	
1st Value:	
2nd Value:	
Value Percent:	
Continuous Index:	
Within 8" of Joint:	NO
Remarks:	M-805-054

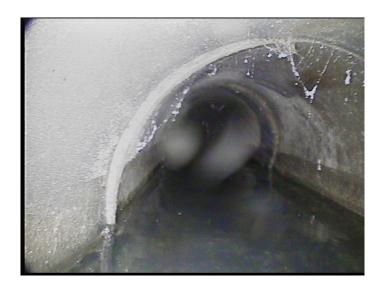
Code: MWL

Description: **Water Level**

Distance (ft): .0 Structural Grade: 0 O&M Grade: 0

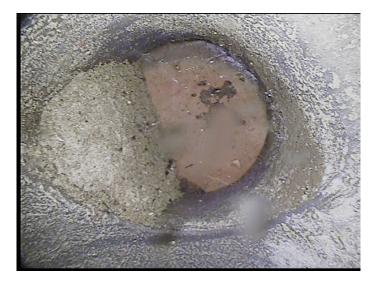
Code: TFC

Description: **Tap Factory Capped**

Distance (ft): 31.2 Structural Grade: 0 O&M Grade: 0 Clock Start/From: 9

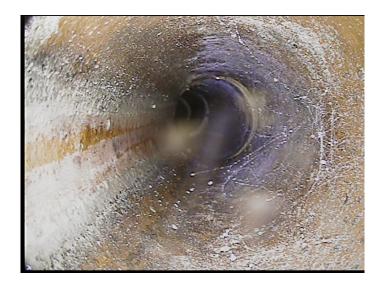
Code: **TB**

Description: Tap Break-in

Distance (ft): 39.2
Structural Grade: 0

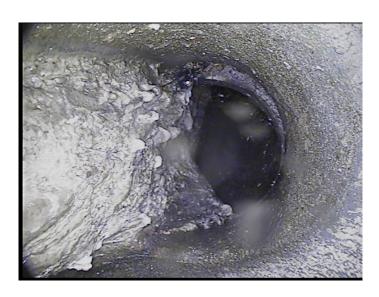
Code: **TF**

Description: Tap Factory

Distance (ft): 70.1
Structural Grade: 0
O&M Grade: 0
Clock Start/From: 9

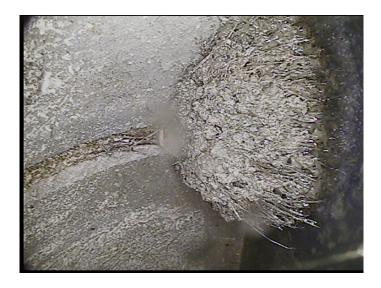
Code: RMJ

Description: Roots Medium Joint

Distance (ft): 95.2
Structural Grade: 0
O&M Grade: 3
Clock Start/From: 4
Clock To: 5

Value Percent: 5.000
Continuous Index: S01
Within 8" of Joint: YES

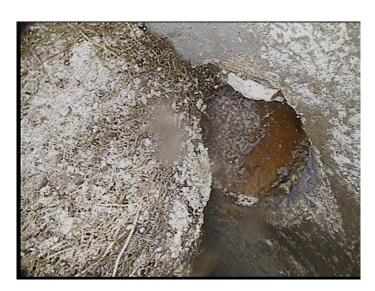
Code: **TFD**

Description: Tap Factory Defective

Distance (ft): 101.9
Structural Grade: 0
O&M Grade: 2
Clock Start/From: 10

Remarks: **Defective**

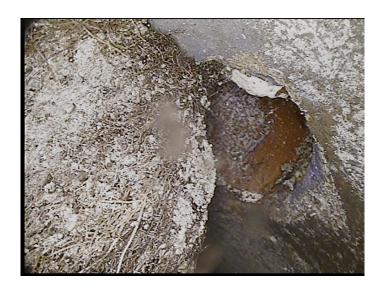
Code: RML

Description: Roots Medium Lateral

Distance (ft): 101.9
Structural Grade: 0
O&M Grade: 3
Clock Start/From: 10

Value Percent: 10.000

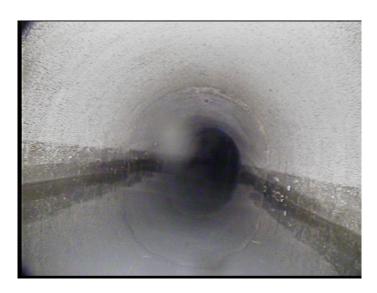
Code: RMJ

Description: Roots Medium Joint

Distance (ft): 119.6
Structural Grade: 0
O&M Grade: 3
Clock Start/From: 4
Clock To: 5
1st Value:

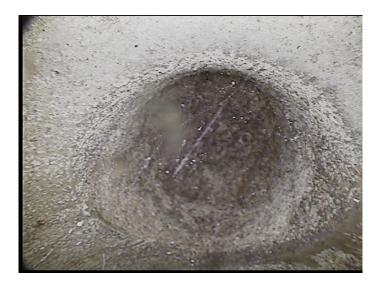
Code: **TFC**

Description: Tap Factory Capped

Distance (ft): 145.5
Structural Grade: 0
O&M Grade: 0
Clock Start/From: 10

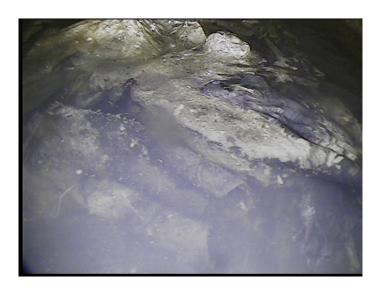
Code: OBZ

Description: Obstacle Other

Distance (ft): 153.8
Structural Grade: 0
O&M Grade: 3
Clock Start/From: 4
Clock To: 8
1st Value:

Value Percent: 20.000

Within 8" of Joint: NO Remarks: Debris

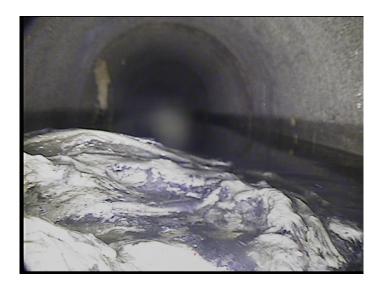
Code: MSA

Description: Abandoned Survey

Distance (ft): 153.8
Structural Grade: 0
O&M Grade: 0

Remarks: debris
