## **Profile/Photo Observation Report**

Thursday, May 4, 2023

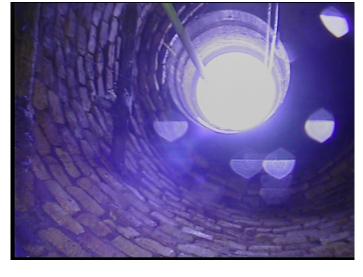
Code:

Description:	Manhole
Distance (ft): Structural Grade:	.0 0
O&M Grade:	0
Clock Start/From: Clock To:	
1st Value: 2nd Value:	
Value Percent: Continuous Index:	
Within 8" of Joint: Remarks:	NO M-805-055

$\mathsf{AMH}$

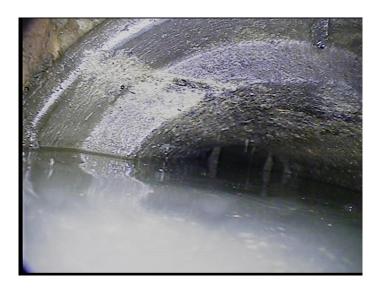
Code: MWL

Description: **Water Level**

Distance (ft): .0 Structural Grade: 0 O&M Grade: 0

Value Percent: 80.000

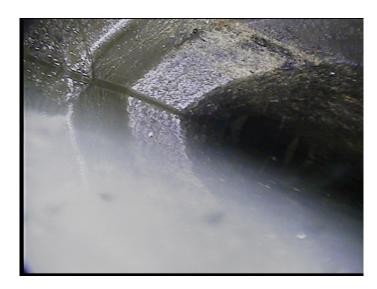
Code: MSA

Description: **Abandoned Survey**

Remarks: heavy sediment/debris
