## Profile/Photo Observation Report

Date:	<b>05/03/2018</b>	Weather:		Coding:	<b>PACP 6.0</b>
Pipe Length (ft):		Owner:	<b>City of Hobart</b>	Pre Clean:	<b>No Pre-Cleaning</b>
P.O.#:	<b>173</b>	Surveyor:	<b>M. Pielacha</b>	PSR:	<b>P-805-055.2-055.1</b>
Customer:	<b>City of Hobart</b>	Clean Date:		Shape:	<b>C</b>

Location Details:		Direction of Survey:	<b>Downstream</b>
US MH:	<b>M-805-055.1</b>	DS MH:	<b>M-805-055.2</b>
		Total Length Surveyed (ft):	<b>49.9</b>

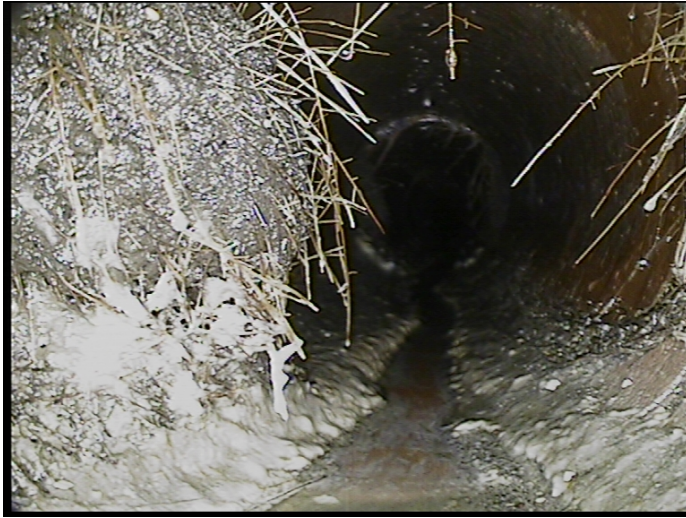
Code:	AMH
Description:	Manhole
Distance (ft):	.0
Structural Grade:	0
O&M Grade:	0
Clock Start/From:	
Clock To:	
1st Value:	
2nd Value:	
Value Percent:	
Continuous Index:	
Within 8" of Joint:	NO
Remarks:	M-805-055.2

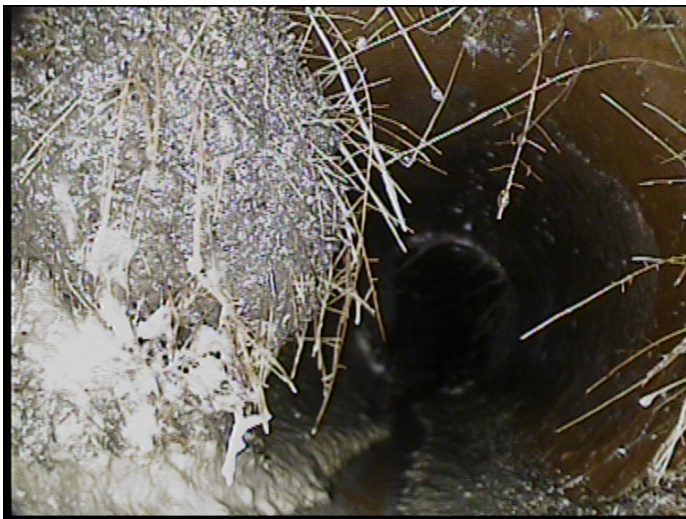
Code: **MWL**  
Description: **Water Level**

Distance (ft): **.0**  
Structural Grade: **0**  
O&M Grade: **0**  
Clock Start/From:  
Clock To:  
1st Value:  
2nd Value:  
Value Percent: **5.000**  
Continuous Index:  
Within 8" of Joint: **NO**  
Remarks:

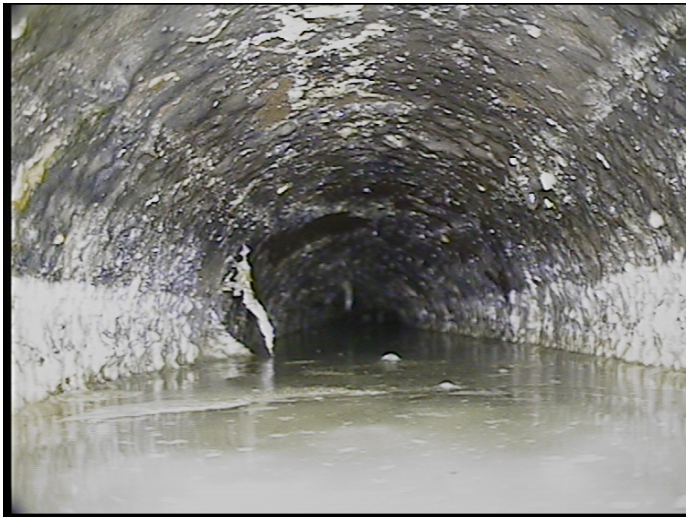
Code: **RMJ**  
Description: **Roots Medium Joint**

Distance (ft): **3.0**  
Structural Grade: **0**  
O&M Grade: **3**  
Clock Start/From: **7**  
Clock To: **5**  
1st Value:  
2nd Value:  
Value Percent: **15.000**  
Continuous Index: **S01**  
Within 8" of Joint: **YES**  
Remarks:

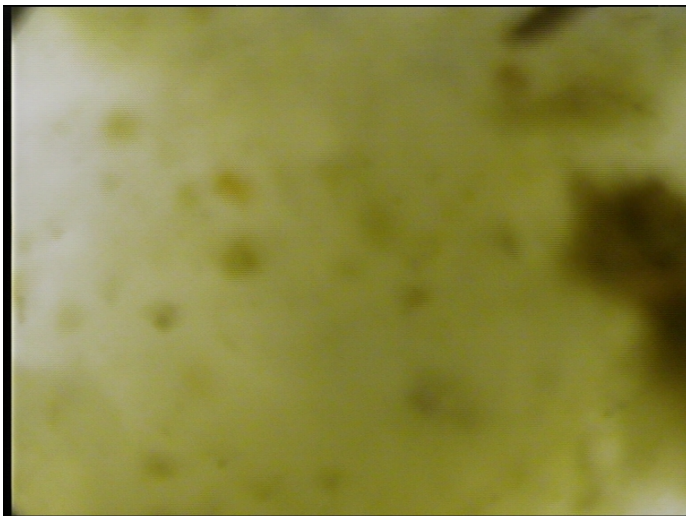
Code: **MWL**  
Description: **Water Level**

Distance (ft): **43.0**  
Structural Grade: **0**  
O&M Grade: **0**  
Clock Start/From:  
Clock To:  
1st Value:  
2nd Value:  
Value Percent: **35.000**  
Continuous Index:  
Within 8" of Joint: **NO**  
Remarks:

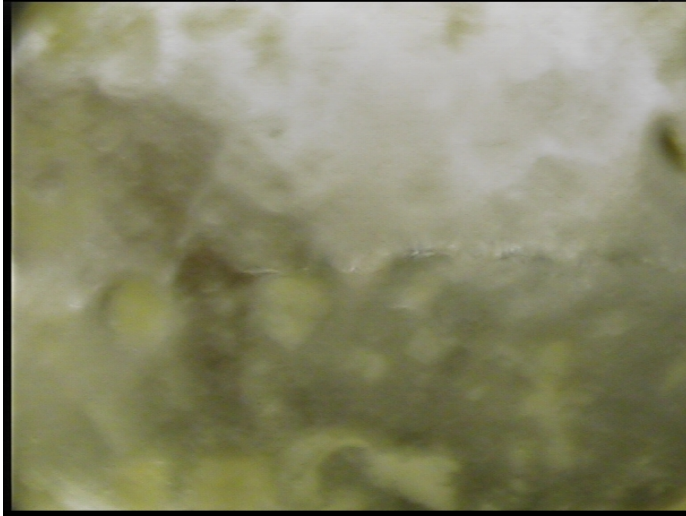
Code: **RMJ**  
Description: **Roots Medium Joint**

Distance (ft): **47.0**  
Structural Grade: **0**  
O&M Grade: **3**  
Clock Start/From: **7**  
Clock To: **5**  
1st Value:  
2nd Value:  
Value Percent: **15.000**  
Continuous Index: **F01**  
Within 8" of Joint: **YES**  
Remarks:

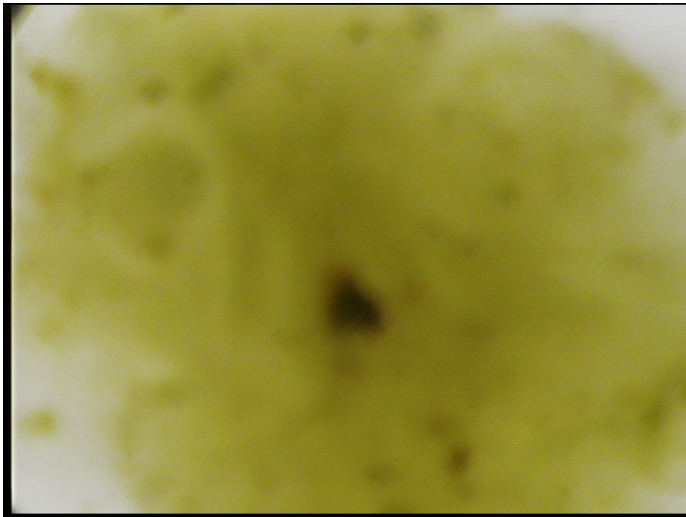
Code: **MCU**  
Description: **Camera Underwater**

Distance (ft): **47.0**  
Structural Grade: **0**  
O&M Grade: **4**  
Clock Start/From:  
Clock To:  
1st Value:  
2nd Value:  
Value Percent:  
Continuous Index:  
Within 8" of Joint: **NO**  
Remarks:
