RedZone
ROBOTICS

Total Length Surveyed (ft): **302.9**

O&M Index:	<u>1.72</u>	O&M Quick:	4131	O&M Rating:	<u>55.00</u>
Structural Index:	<u>2.74</u>	Structural Quick:	4636	Structural Rating:	<u>52.00</u>
Overall Index:	<u>2.10</u>	Overall Quick:	4737	Overall Rating:	<u>107.00</u>

M-805-055

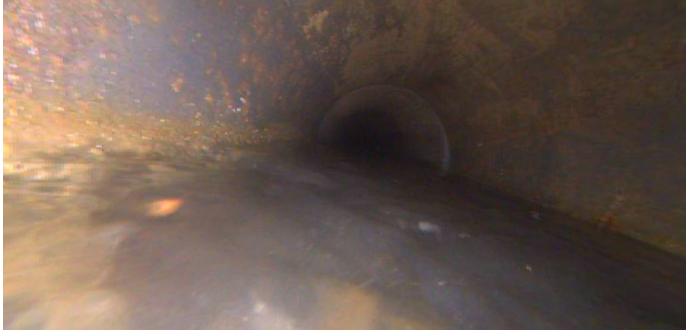
Code: **AMH**
Description: **Manhole**

Distance (ft): **.0**
Structural Grade: **0**
O&M Grade: **0**
Clock Start/From:
Clock To:
1st Value:
2nd Value:
Value Percent:
Continuous Index:
Within 8" of Joint: **NO**
Remarks: **M-805-056**

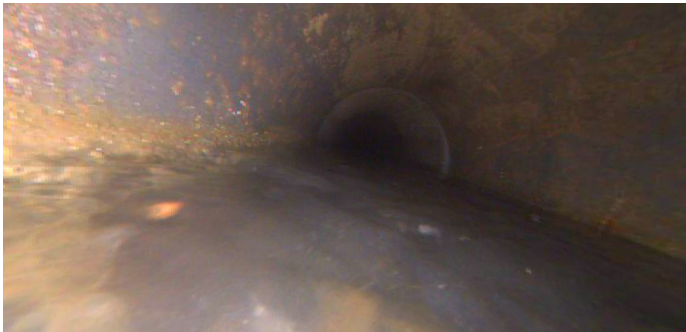
Code: **MWL**
Description: **Water Level**

Distance (ft): **.0**
Structural Grade: **0**
O&M Grade: **0**
Clock Start/From:
Clock To:
1st Value:
2nd Value:
Value Percent: **15.000**
Continuous Index:
Within 8" of Joint: **NO**
Remarks:

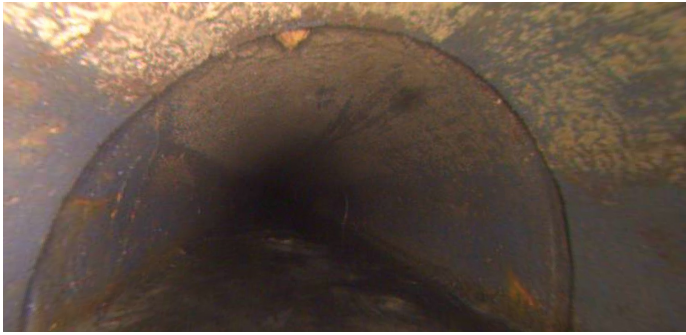
Code: **CM**
Description: **Crack Multiple**

Distance (ft): **5.0**
Structural Grade: **3**
O&M Grade: **0**
Clock Start/From: **8**
Clock To: **11**
1st Value:
2nd Value:
Value Percent:
Continuous Index:
Within 8" of Joint: **YES**
Remarks:

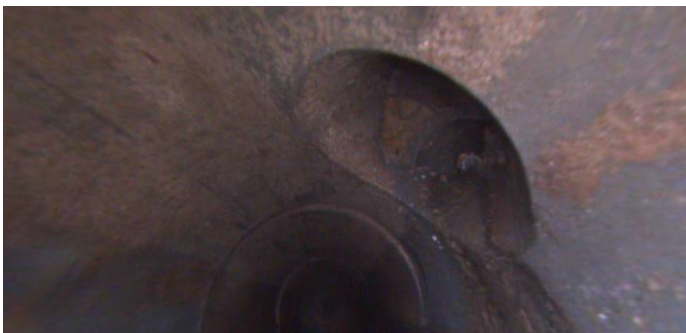
Code: **TF**
Description: **Tap Factory**

Distance (ft): **13.2**
Structural Grade: **0**
O&M Grade: **0**
Clock Start/From: **10**
Clock To:
1st Value: **4.000**
2nd Value:
Value Percent:
Continuous Index:
Within 8" of Joint:
Remarks:

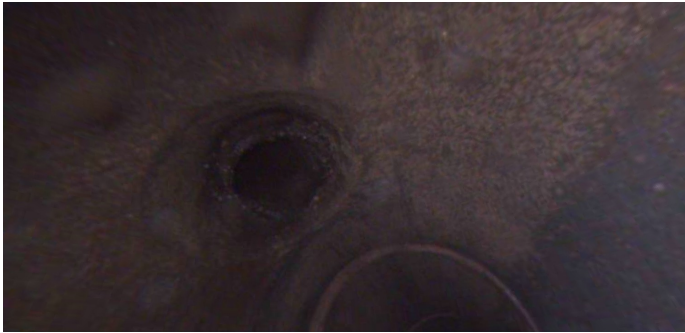
Code: **TF**
Description: **Tap Factory**

Distance (ft): **31.6**
Structural Grade: **0**
O&M Grade: **0**
Clock Start/From: **2**
Clock To:
1st Value: **4.000**
2nd Value:
Value Percent:
Continuous Index:
Within 8" of Joint:
Remarks:

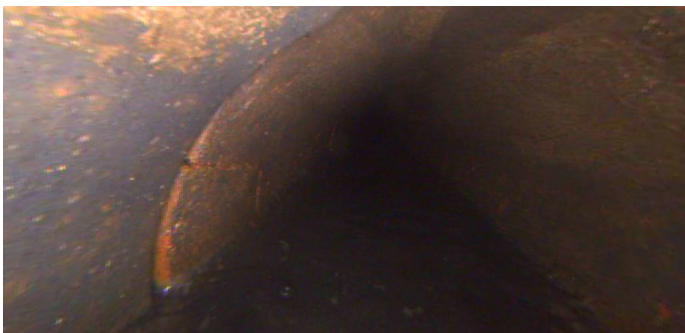
Code: **FS**
Description: **Fracture Spiral**

Distance (ft): **35.8**
Structural Grade: **3**
O&M Grade: **0**
Clock Start/From: **7**
Clock To: **9**
1st Value:
2nd Value:
Value Percent:
Continuous Index:
Within 8" of Joint: **YES**
Remarks:

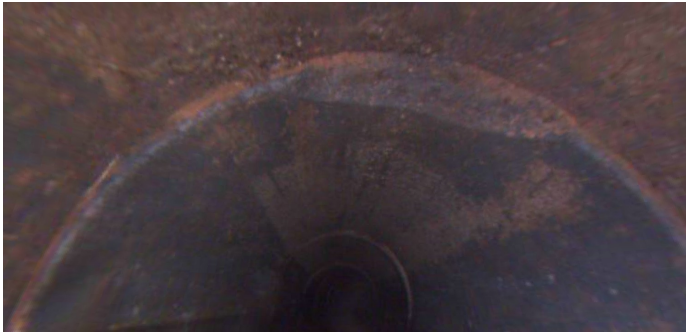
Code: **SSS**
Description: **Surface Spalling**

Distance (ft): **36.7**
Structural Grade: **2**
O&M Grade: **0**
Clock Start/From: **11**
Clock To: **1**
1st Value:
2nd Value:
Value Percent:
Continuous Index:
Within 8" of Joint: **YES**
Remarks:

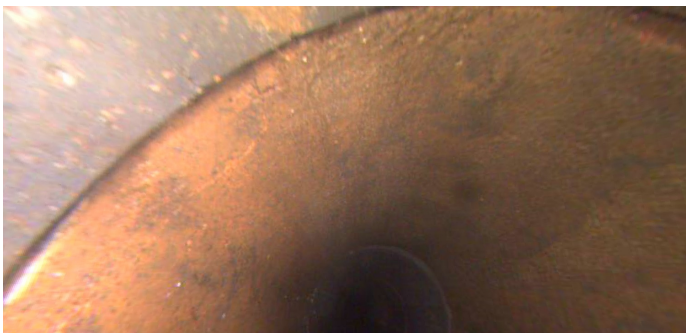
Code: **CS**
Description: **Crack Spiral**

Distance (ft): **46.1**
Structural Grade: **2**
O&M Grade: **0**
Clock Start/From: **9**
Clock To: **11**
1st Value:
2nd Value:
Value Percent:
Continuous Index:
Within 8" of Joint: **YES**
Remarks:

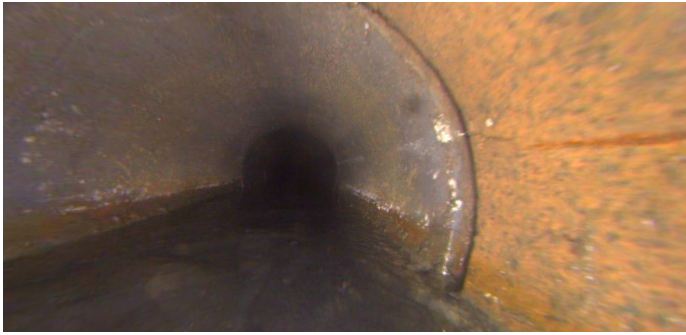
Code: **FL**
Description: **Fracture Longitudinal**

Distance (ft): **52.0**
Structural Grade: **3**
O&M Grade: **0**
Clock Start/From: **3**
Clock To:
1st Value:
2nd Value:
Value Percent:
Continuous Index:
Within 8" of Joint: **YES**
Remarks:

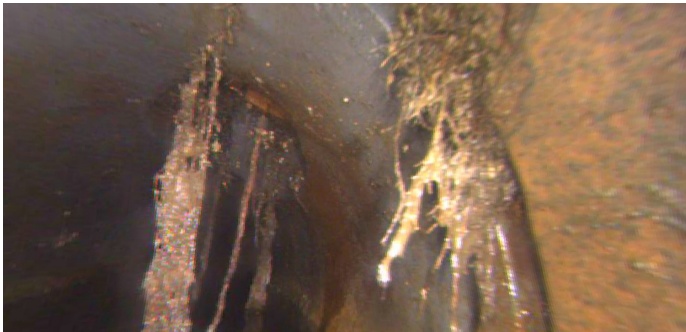
Code: **RFJ**
Description: **Roots Fine Joint**

Distance (ft): **70.8**
Structural Grade: **0**
O&M Grade: **1**
Clock Start/From: **2**
Clock To:
1st Value:
2nd Value:
Value Percent:
Continuous Index:
Within 8" of Joint: **YES**
Remarks:

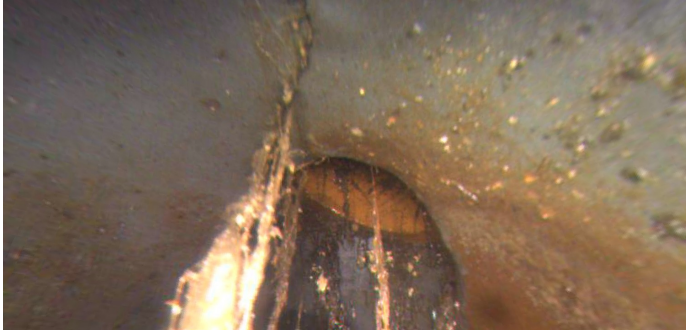
Code: **FL**
Description: **Fracture Longitudinal**

Distance (ft): **71.2**
Structural Grade: **3**
O&M Grade: **0**
Clock Start/From: **12**
Clock To:
1st Value:
2nd Value:
Value Percent:
Continuous Index:
Within 8" of Joint:
Remarks:

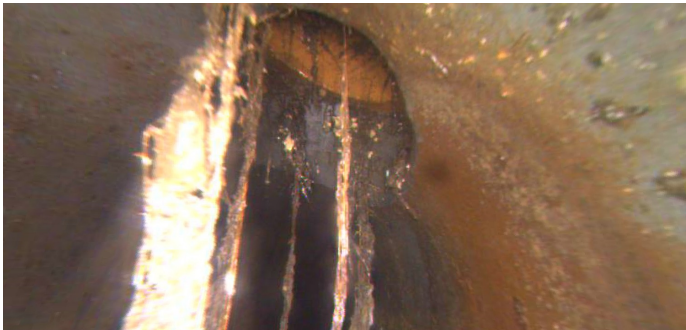
Code: **RFL**
Description: **Roots Fine Lateral**

Distance (ft): **71.2**
Structural Grade: **0**
O&M Grade: **1**
Clock Start/From: **12**
Clock To: **1**
1st Value:
2nd Value:
Value Percent:
Continuous Index:
Within 8" of Joint: **NO**
Remarks:

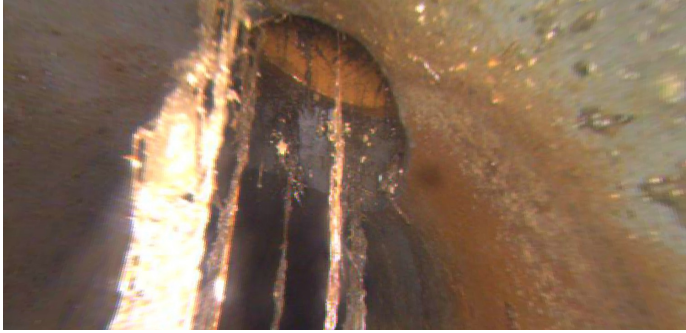
Code: **RFB**
Description: **Roots Fine Barrel**

Distance (ft): **71.2**
Structural Grade: **0**
O&M Grade: **2**
Clock Start/From: **12**
Clock To:
1st Value:
2nd Value:
Value Percent:
Continuous Index:
Within 8" of Joint: **NO**
Remarks:

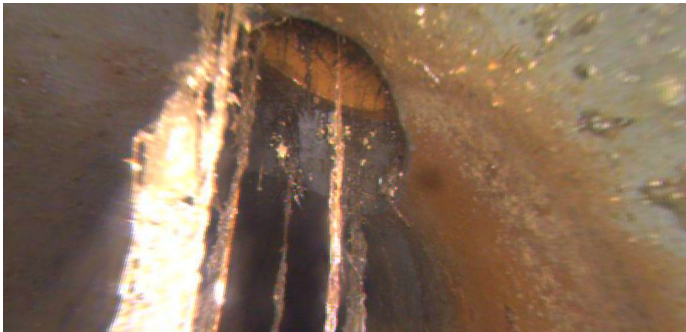
Code: **TFD**
Description: **Tap Factory Defective**

Distance (ft): **71.2**
Structural Grade: **0**
O&M Grade: **2**
Clock Start/From: **1**
Clock To:
1st Value: **4.000**
2nd Value:
Value Percent:
Continuous Index:
Within 8" of Joint:
Remarks: **ROOTS COMING FROM TAP**

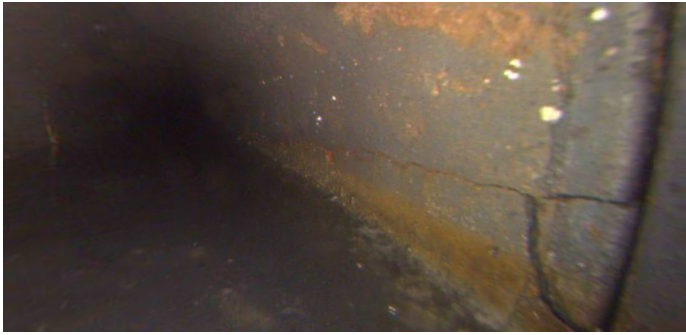
Code: **FM**
Description: **Fracture Multiple**

Distance (ft): **75.0**
Structural Grade: **4**
O&M Grade: **0**
Clock Start/From: **3**
Clock To: **4**
1st Value:
2nd Value:
Value Percent:
Continuous Index:
Within 8" of Joint: **YES**
Remarks:

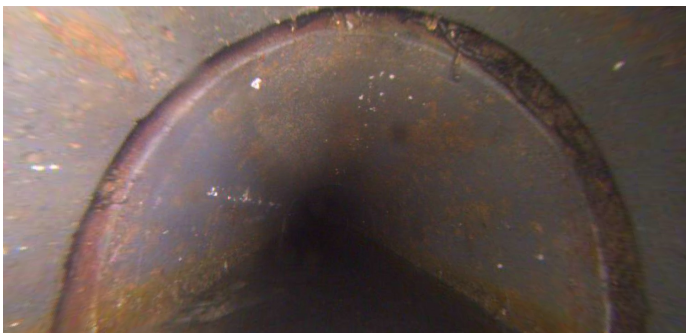
Code: **RFJ**
Description: **Roots Fine Joint**

Distance (ft): **87.0**
Structural Grade: **0**
O&M Grade: **1**
Clock Start/From: **9**
Clock To: **12**
1st Value:
2nd Value:
Value Percent:
Continuous Index:
Within 8" of Joint: **YES**
Remarks:

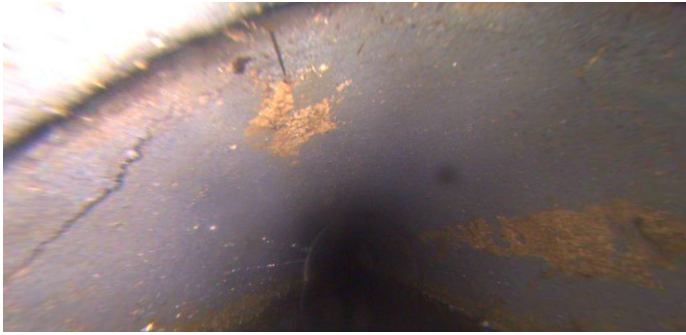
Code: **FM**
Description: **Fracture Multiple**

Distance (ft): **91.3**
Structural Grade: **4**
O&M Grade: **0**
Clock Start/From: **9**
Clock To: **11**
1st Value:
2nd Value:
Value Percent:
Continuous Index:
Within 8" of Joint: **YES**
Remarks:

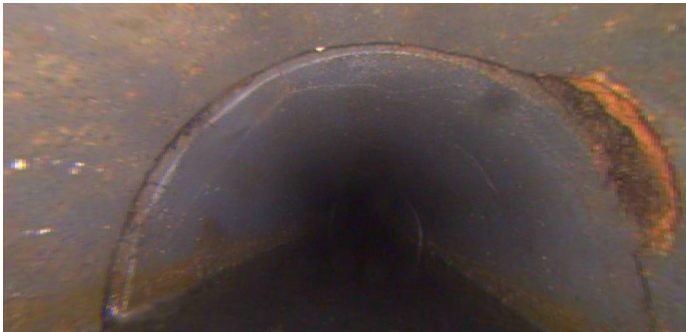
Code: **CM**
Description: **Crack Multiple**

Distance (ft): **95.0**
Structural Grade: **3**
O&M Grade: **0**
Clock Start/From: **8**
Clock To: **1**
1st Value:
2nd Value:
Value Percent:
Continuous Index:
Within 8" of Joint:
Remarks:

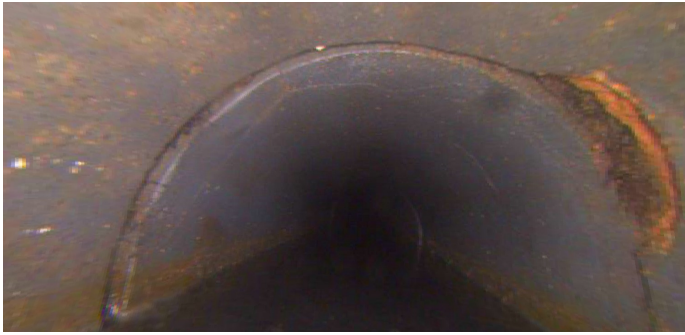
Code: **RFJ**
Description: **Roots Fine Joint**

Distance (ft): **95.0**
Structural Grade: **0**
O&M Grade: **1**
Clock Start/From: **1**
Clock To: **3**
1st Value:
2nd Value:
Value Percent:
Continuous Index:
Within 8" of Joint: **YES**
Remarks:

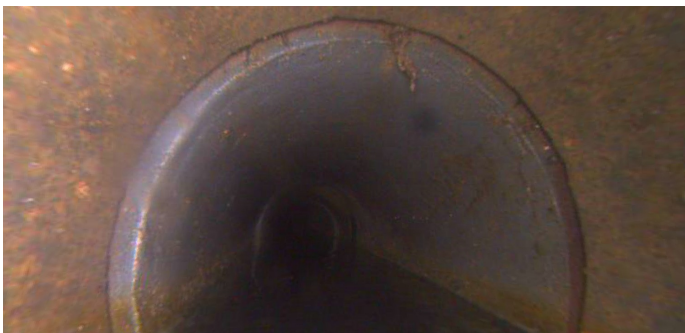
Code: **RFJ**
Description: **Roots Fine Joint**

Distance (ft): **103.2**
Structural Grade: **0**
O&M Grade: **1**
Clock Start/From: **11**
Clock To: **1**
1st Value:
2nd Value:
Value Percent:
Continuous Index:
Within 8" of Joint: **YES**
Remarks:

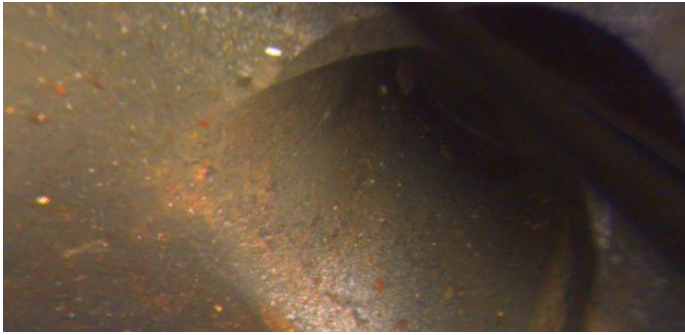
Code: **TF**
Description: **Tap Factory**

Distance (ft): **106.3**
Structural Grade: **0**
O&M Grade: **0**
Clock Start/From: **2**
Clock To:
1st Value: **4.000**
2nd Value:
Value Percent:
Continuous Index:
Within 8" of Joint:
Remarks:

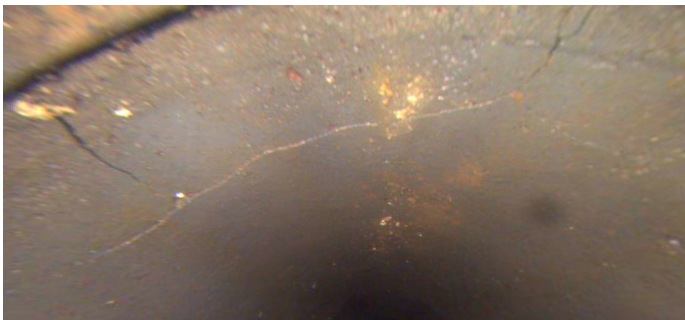
Code: **FM**
Description: **Fracture Multiple**

Distance (ft): **107.7**
Structural Grade: **4**
O&M Grade: **0**
Clock Start/From: **10**
Clock To: **12**
1st Value:
2nd Value:
Value Percent:
Continuous Index:
Within 8" of Joint: **YES**
Remarks:

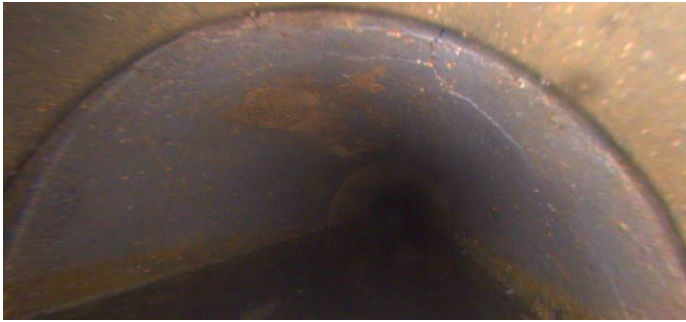
Code: **FM**
Description: **Fracture Multiple**

Distance (ft): **111.6**
Structural Grade: **4**
O&M Grade: **0**
Clock Start/From: **11**
Clock To: **1**
1st Value:
2nd Value:
Value Percent:
Continuous Index:
Within 8" of Joint: **YES**
Remarks:

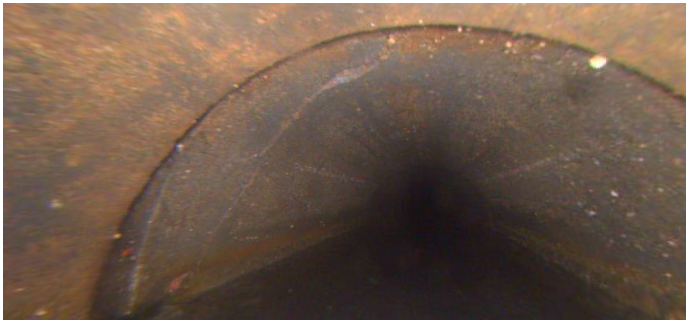
Code: **FS**
Description: **Fracture Spiral**

Distance (ft): **150.4**
Structural Grade: **3**
O&M Grade: **0**
Clock Start/From: **8**
Clock To: **12**
1st Value:
2nd Value:
Value Percent:
Continuous Index:
Within 8" of Joint: **YES**
Remarks:

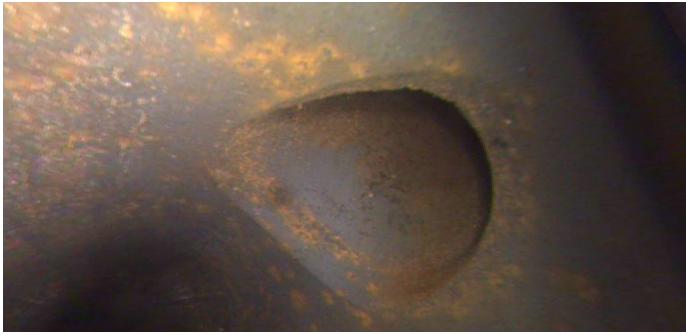
Code: **TF**
Description: **Tap Factory**

Distance (ft): **165.4**
Structural Grade: **0**
O&M Grade: **0**
Clock Start/From: **1**
Clock To:
1st Value: **4.000**
2nd Value:
Value Percent:
Continuous Index:
Within 8" of Joint:
Remarks:

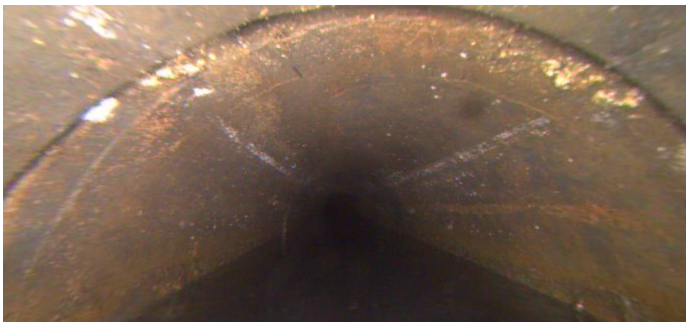
Code: **CC**
Description: **Crack Circumferential**

Distance (ft): **187.2**
Structural Grade: **1**
O&M Grade: **0**
Clock Start/From: **10**
Clock To: **12**
1st Value:
2nd Value:
Value Percent:
Continuous Index:
Within 8" of Joint: **YES**
Remarks:

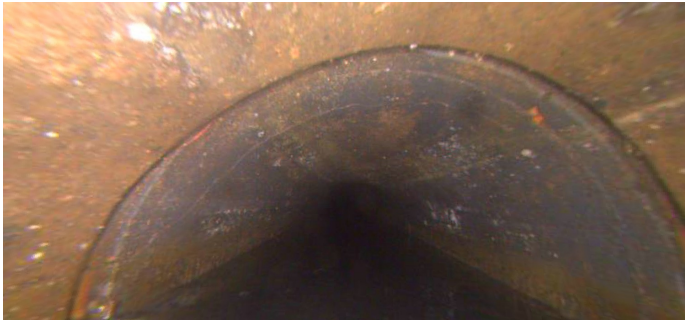
Code: **CC**
Description: **Crack Circumferential**

Distance (ft): **189.1**
Structural Grade: **1**
O&M Grade: **0**
Clock Start/From: **9**
Clock To: **1**
1st Value:
2nd Value:
Value Percent:
Continuous Index:
Within 8" of Joint: **YES**
Remarks:

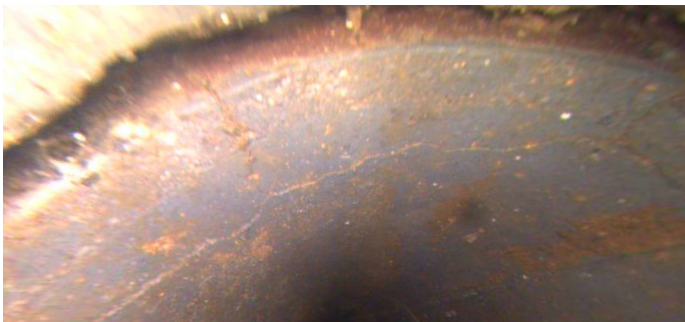
Code: **FM**
Description: **Fracture Multiple**

Distance (ft): **193.5**
Structural Grade: **4**
O&M Grade: **0**
Clock Start/From: **10**
Clock To: **1**
1st Value:
2nd Value:
Value Percent:
Continuous Index:
Within 8" of Joint: **YES**
Remarks:

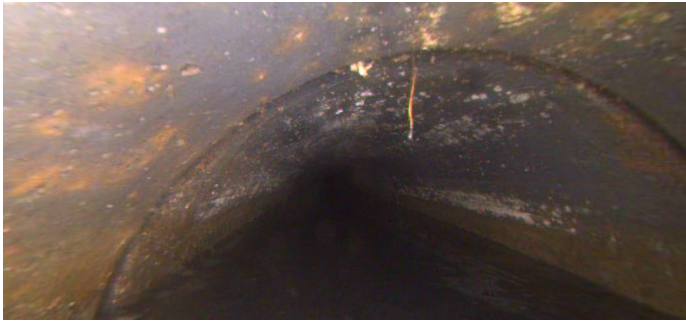
Code: **RFJ**
Description: **Roots Fine Joint**

Distance (ft): **207.7**
Structural Grade: **0**
O&M Grade: **1**
Clock Start/From: **12**
Clock To:
1st Value:
2nd Value:
Value Percent:
Continuous Index:
Within 8" of Joint: **YES**
Remarks:

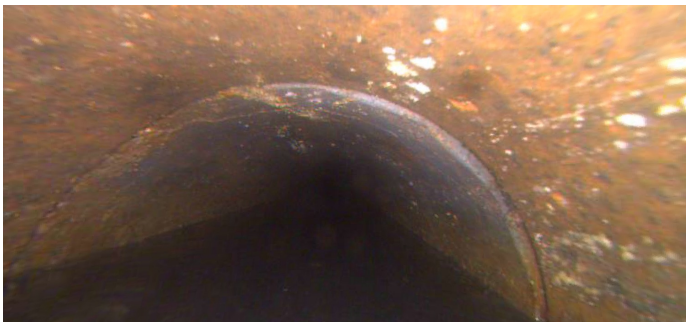
Code: **FC**
Description: **Fracture Circumferential**

Distance (ft): **213.7**
Structural Grade: **2**
O&M Grade: **0**
Clock Start/From: **10**
Clock To: **1**
1st Value:
2nd Value:
Value Percent:
Continuous Index:
Within 8" of Joint: **YES**
Remarks:

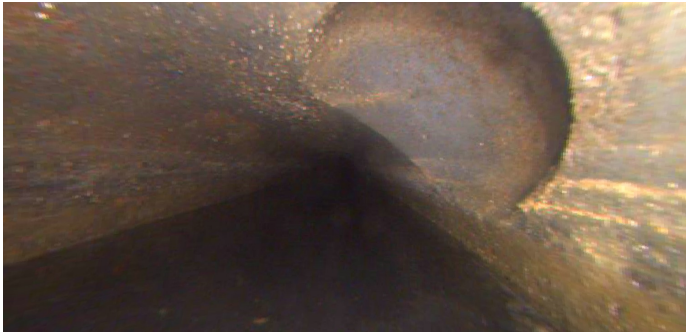
Code: **TF**
Description: **Tap Factory**

Distance (ft): **220.8**
Structural Grade: **0**
O&M Grade: **0**
Clock Start/From: **2**
Clock To:
1st Value: **4.000**
2nd Value:
Value Percent:
Continuous Index:
Within 8" of Joint:
Remarks:

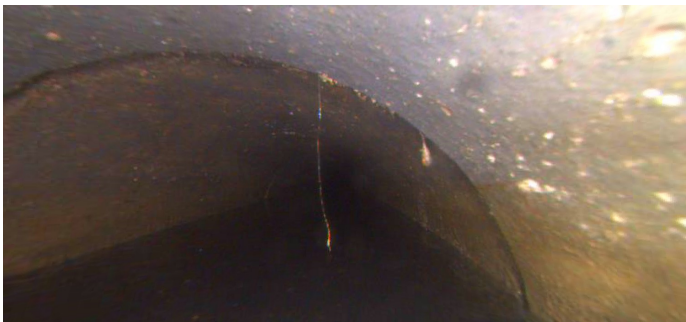
Code: **RFJ**
Description: **Roots Fine Joint**

Distance (ft): **226.3**
Structural Grade: **0**
O&M Grade: **1**
Clock Start/From: **1**
Clock To:
1st Value:
2nd Value:
Value Percent:
Continuous Index:
Within 8" of Joint: **YES**
Remarks:

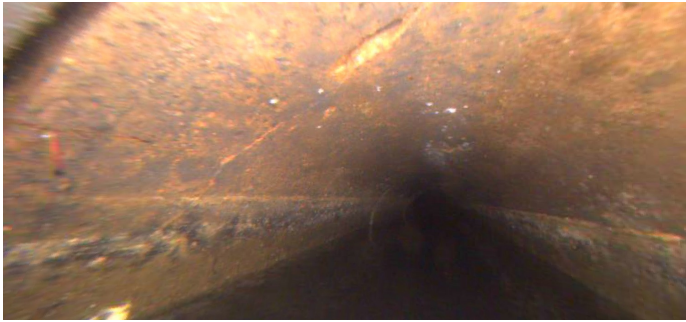
Code: **FM**
Description: **Fracture Multiple**

Distance (ft): **230.7**
Structural Grade: **4**
O&M Grade: **0**
Clock Start/From: **8**
Clock To: **12**
1st Value:
2nd Value:
Value Percent:
Continuous Index:
Within 8" of Joint: **YES**
Remarks:

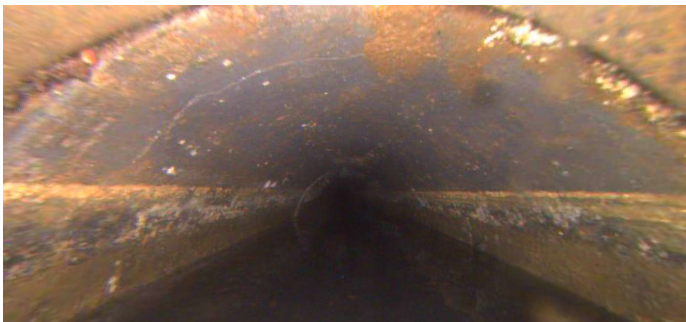
Code: **CC**
Description: **Crack Circumferential**

Distance (ft): **232.6**
Structural Grade: **1**
O&M Grade: **0**
Clock Start/From: **10**
Clock To: **12**
1st Value:
2nd Value:
Value Percent:
Continuous Index:
Within 8" of Joint: **YES**
Remarks:

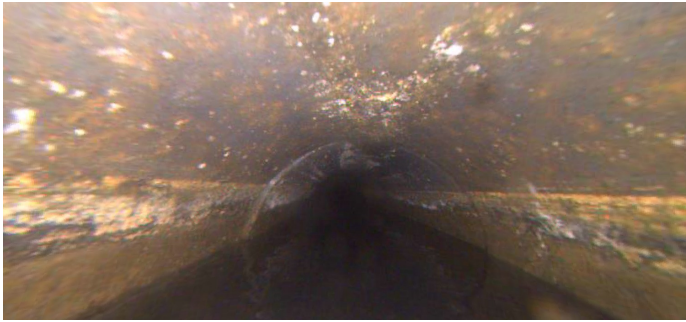
Code: **DAGS**
Description: **Deposits Attached Grease**

Distance (ft): **233.7**
Structural Grade: **0**
O&M Grade: **2**
Clock Start/From: **8**
Clock To: **4**
1st Value:
2nd Value:
Value Percent: **5.000**
Continuous Index: **S01**
Within 8" of Joint: **NO**
Remarks:

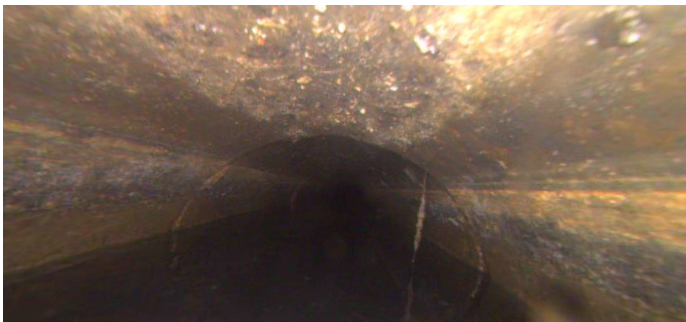
Code: **RFJ**
Description: **Roots Fine Joint**

Distance (ft): **242.3**
Structural Grade: **0**
O&M Grade: **1**
Clock Start/From: **1**
Clock To:
1st Value:
2nd Value:
Value Percent:
Continuous Index:
Within 8" of Joint: **YES**
Remarks:

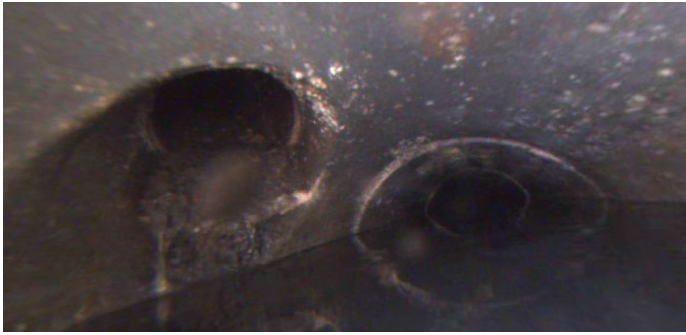
Code: **TFD**
Description: **Tap Factory Defective**

Distance (ft): **252.7**
Structural Grade: **0**
O&M Grade: **2**
Clock Start/From: **2**
Clock To:
1st Value: **4.000**
2nd Value:
Value Percent:
Continuous Index:
Within 8" of Joint:
Remarks: **rfl**

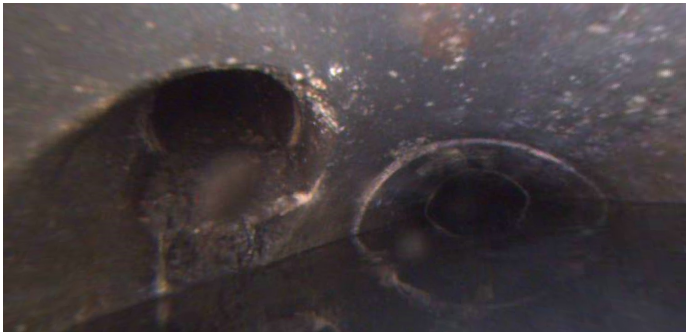
Code: **RFL**
Description: **Roots Fine Lateral**

Distance (ft): **252.7**
Structural Grade: **0**
O&M Grade: **1**
Clock Start/From: **3**
Clock To:
1st Value:
2nd Value:
Value Percent:
Continuous Index:
Within 8" of Joint: **NO**
Remarks:

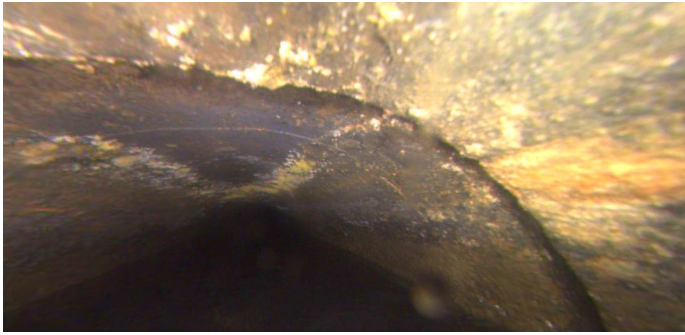
Code: **CC**
Description: **Crack Circumferential**

Distance (ft): **257.4**
Structural Grade: **1**
O&M Grade: **0**
Clock Start/From: **11**
Clock To: **3**
1st Value:
2nd Value:
Value Percent:
Continuous Index:
Within 8" of Joint:
Remarks:

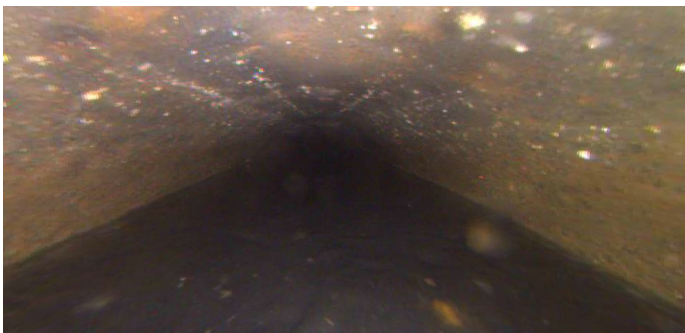
Code: **MWL**
Description: **Water Level**

Distance (ft): **260.5**
Structural Grade: **0**
O&M Grade: **0**
Clock Start/From:
Clock To:
1st Value:
2nd Value:
Value Percent: **15.000**
Continuous Index:
Within 8" of Joint: **NO**
Remarks:

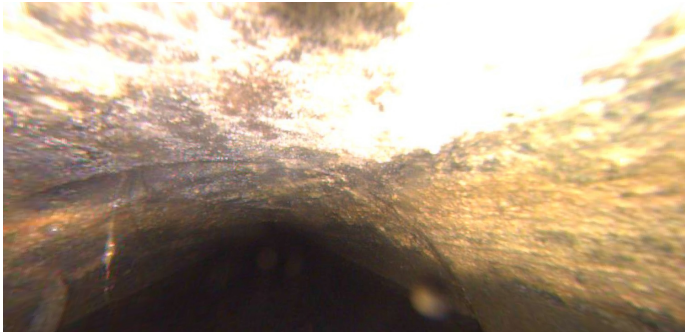
Code: **RFJ**
Description: **Roots Fine Joint**

Distance (ft): **269.6**
Structural Grade: **0**
O&M Grade: **1**
Clock Start/From: **11**
Clock To:
1st Value:
2nd Value:
Value Percent:
Continuous Index:
Within 8" of Joint: **YES**
Remarks:

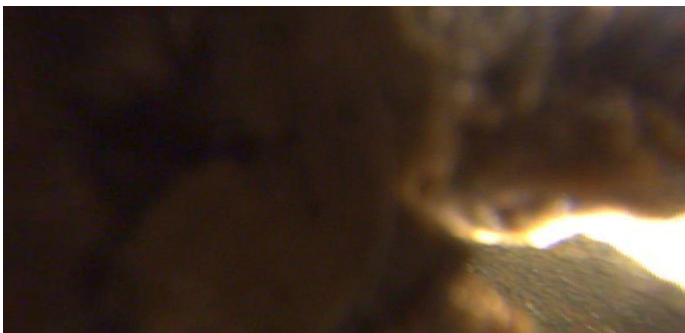
Code: **MGO**
Description: **General Observation**

Distance (ft): **272.6**
Structural Grade: **0**
O&M Grade: **0**
Clock Start/From:
Clock To:
1st Value:
2nd Value:
Value Percent:
Continuous Index:
Within 8" of Joint: **NO**
Remarks: **FRONT LENS OBSTRUCTED**

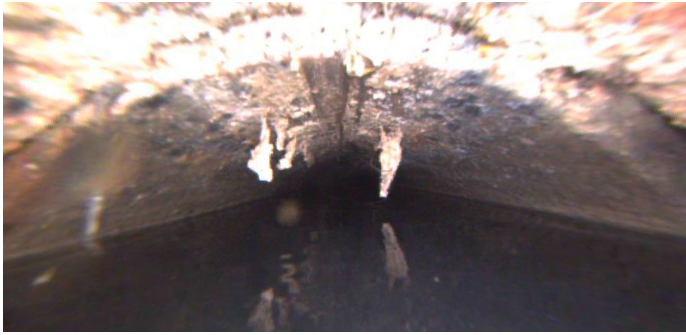
Code: **RFJ**
Description: **Roots Fine Joint**

Distance (ft): **282.7**
Structural Grade: **0**
O&M Grade: **1**
Clock Start/From: **1**
Clock To:
1st Value:
2nd Value:
Value Percent:
Continuous Index:
Within 8" of Joint: **YES**
Remarks:

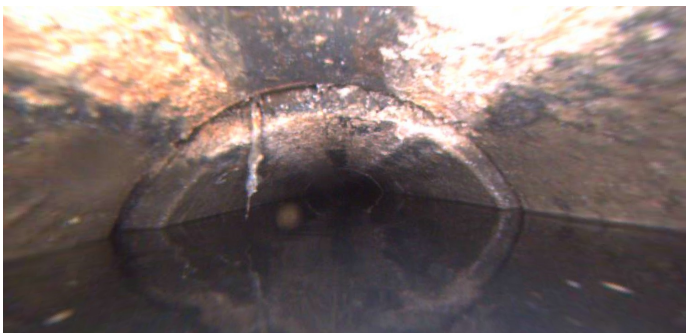
Code: **RFJ**
Description: **Roots Fine Joint**

Distance (ft): **289.1**
Structural Grade: **0**
O&M Grade: **1**
Clock Start/From: **12**
Clock To: **1**
1st Value:
2nd Value:
Value Percent:
Continuous Index:
Within 8" of Joint: **YES**
Remarks:

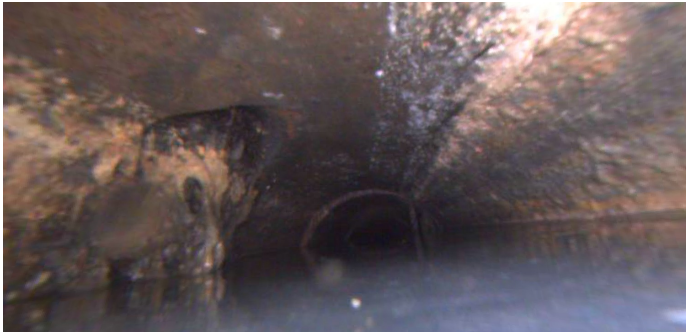
Code: **RML**
Description: **Roots Medium Lateral**

Distance (ft): **294.7**
Structural Grade: **0**
O&M Grade: **3**
Clock Start/From: **2**
Clock To:
1st Value:
2nd Value:
Value Percent: **5.000**
Continuous Index:
Within 8" of Joint: **NO**
Remarks:

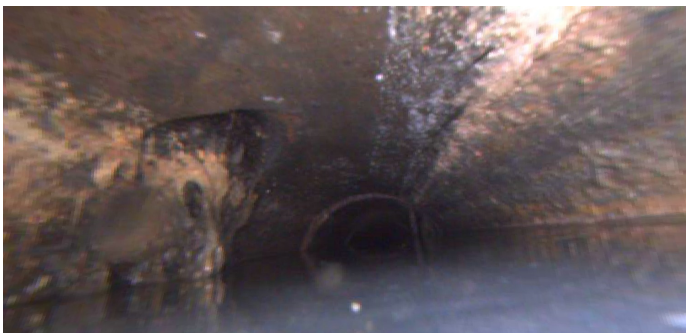
Code: **TFD**
Description: **Tap Factory Defective**

Distance (ft): **294.7**
Structural Grade: **0**
O&M Grade: **2**
Clock Start/From: **2**
Clock To:
1st Value: **4.000**
2nd Value:
Value Percent:
Continuous Index:
Within 8" of Joint:
Remarks: **ROOTS BLOCKING MOUTH OF TAP**

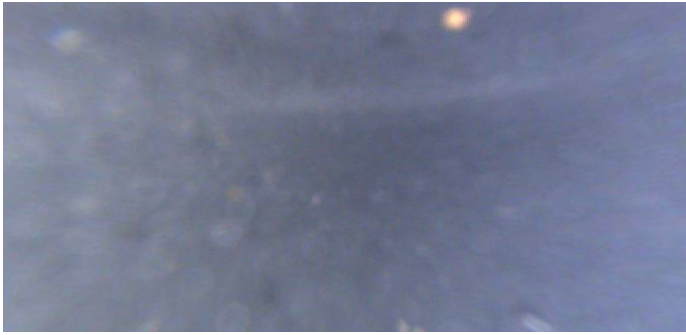
Code: **MCU**
Description: **Camera Underwater**

Distance (ft): **295.5**
Structural Grade: **0**
O&M Grade: **4**
Clock Start/From:
Clock To:
1st Value:
2nd Value:
Value Percent:
Continuous Index:
Within 8" of Joint: **NO**
Remarks:

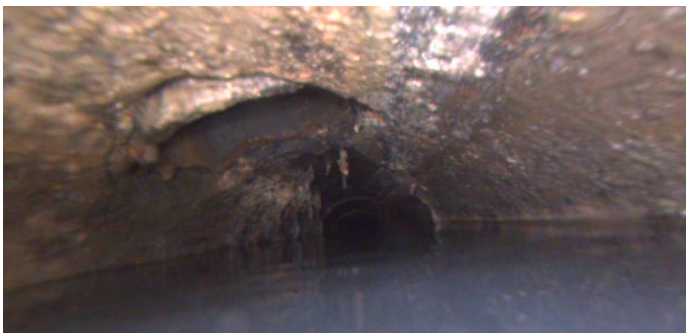
Code: **TBI**
Description: **Tap Break-in Intruding**

Distance (ft): **296.6**
Structural Grade: **0**
O&M Grade: **2**
Clock Start/From: **1**
Clock To:
1st Value: **4.000**
2nd Value: **1.000**
Value Percent:
Continuous Index:
Within 8" of Joint:
Remarks:

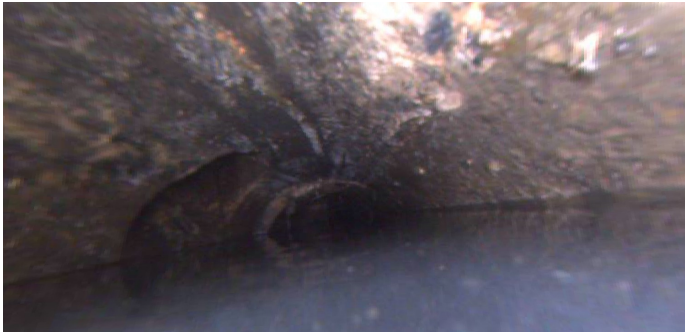
Code: **TF**
Description: **Tap Factory**

Distance (ft): **298.6**
Structural Grade: **0**
O&M Grade: **0**
Clock Start/From: **2**
Clock To:
1st Value: **4.000**
2nd Value:
Value Percent:
Continuous Index:
Within 8" of Joint:
Remarks:

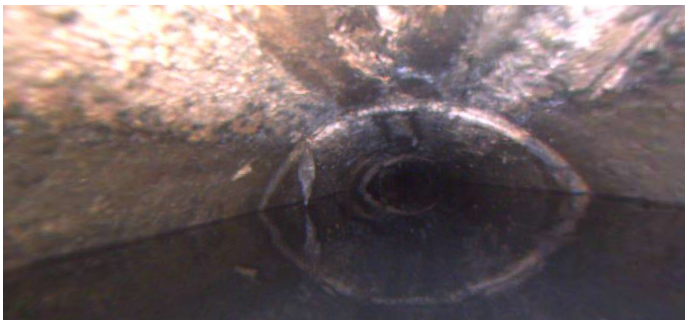
Code: **DAGS**
Description: **Deposits Attached Grease**

Distance (ft): **299.5**
Structural Grade: **0**
O&M Grade: **2**
Clock Start/From: **8**
Clock To: **4**
1st Value:
2nd Value:
Value Percent: **5.000**
Continuous Index: **F01**
Within 8" of Joint: **NO**
Remarks:

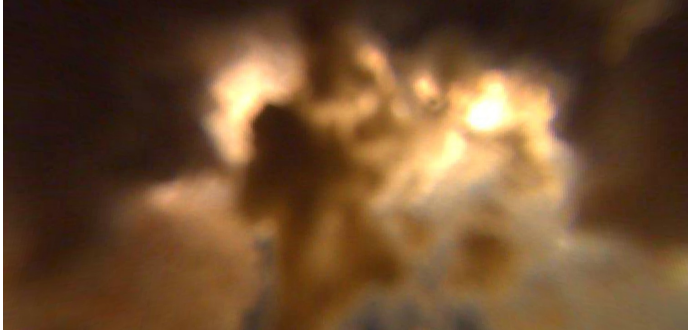
Code:	MSA
Description:	Abandoned Survey
Distance (ft):	302.9
Structural Grade:	0
O&M Grade:	0
Clock Start/From:	
Clock To:	
1st Value:	
2nd Value:	
Value Percent:	
Continuous Index:	
Within 8" of Joint:	NO
Remarks:	MCU
