Profile/Photo Observation Report

Street:	LILLIAN ST	Flow Control:	Not Controlled
City:	Hobart, IN	Year Renewed:	
Location:	Other	Tape/Media #:	
Purpose:	Not Known	Dia/Height:	12"
Use:	Sanitary	Material:	VCP
Drain Area:	NA	Lining:	
Category:	NA		
Comment:

Location Details:		Direction of Survey:	Upstream
US MH:	M-805-056	DS MH:	M-805-055
		Total Length Surveyed (ft):	24.3

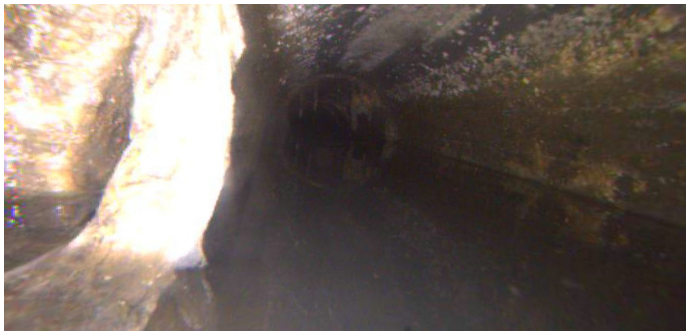
Code: **AMH**
Description: **Manhole**

Distance (ft): **.0**
Structural Grade: **0**
O&M Grade: **0**
Clock Start/From:
Clock To:
1st Value:
2nd Value:
Value Percent:
Continuous Index:
Within 8" of Joint: **NO**
Remarks: **M-805-055**

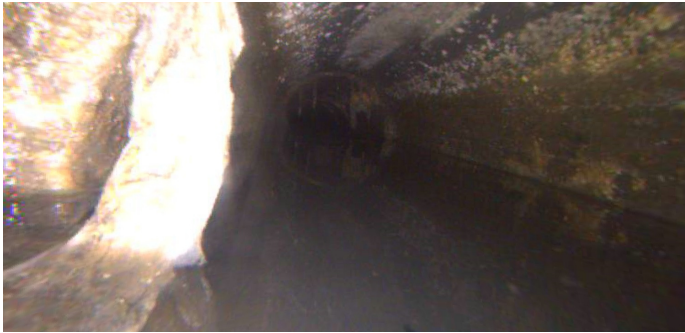
Code:	MWL
Description:	Water Level

Distance (ft):	.0
Structural Grade:	0
O&M Grade:	0
Clock Start/From:	
Clock To:	
1st Value:	
2nd Value:	
Value Percent:	30.000
Continuous Index:	
Within 8" of Joint:	NO
Remarks:

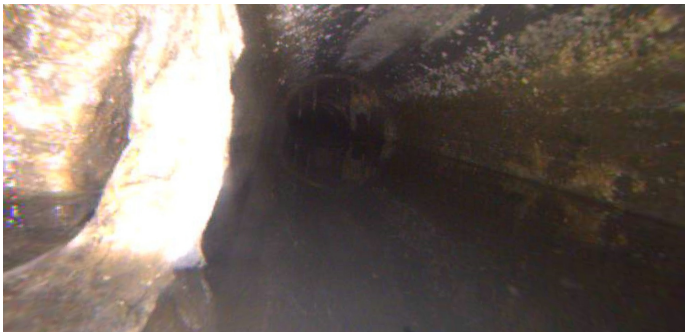
Code:	DAR
Description:	Deposits Attached Ragging

Distance (ft):	.0
Structural Grade:	0
O&M Grade:	2
Clock Start/From:	10
Clock To:	12
1st Value:	
2nd Value:	
Value Percent:	10.000
Continuous Index:	
Within 8" of Joint:	YES
Remarks:

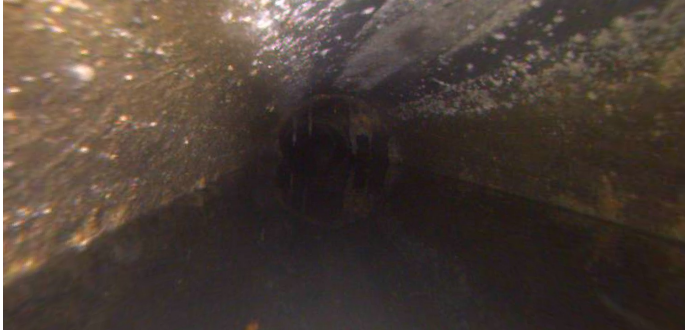
Code: **DAGS**
Description: **Deposits Attached Grease**

Distance (ft): **.9**
Structural Grade: **0**
O&M Grade: **2**
Clock Start/From: **8**
Clock To: **4**
1st Value:
2nd Value:
Value Percent: **5.000**
Continuous Index: **S02**
Within 8" of Joint: **NO**
Remarks:

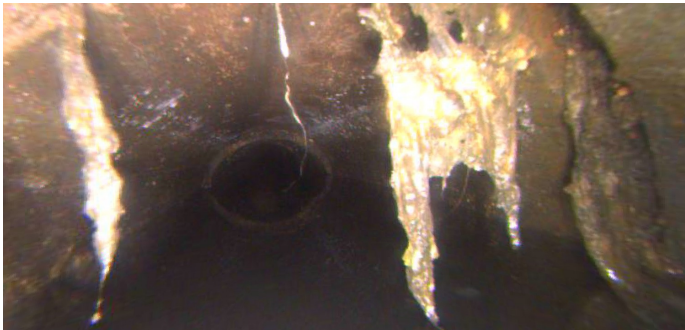
Code: **DAR**
Description: **Deposits Attached Ragging**

Distance (ft): **2.9**
Structural Grade: **0**
O&M Grade: **2**
Clock Start/From: **8**
Clock To: **4**
1st Value:
2nd Value:
Value Percent: **10.000**
Continuous Index:
Within 8" of Joint: **YES**
Remarks:

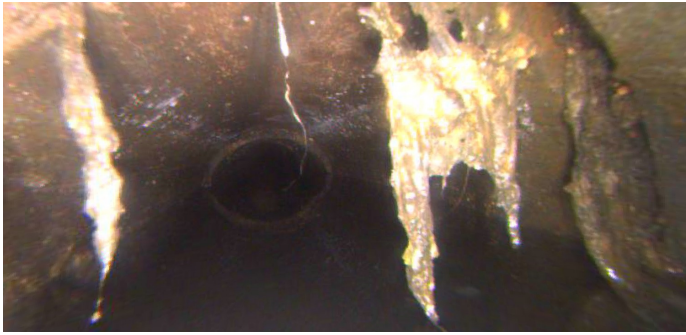
Code: **RFJ**
Description: **Roots Fine Joint**

Distance (ft): **2.9**
Structural Grade: **0**
O&M Grade: **1**
Clock Start/From: **8**
Clock To: **4**
1st Value:
2nd Value:
Value Percent:
Continuous Index: **S01**
Within 8" of Joint: **YES**
Remarks:

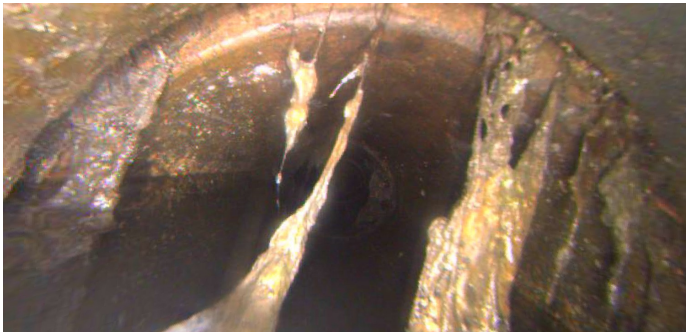
Code: **DAR**
Description: **Deposits Attached Ragging**

Distance (ft): **20.6**
Structural Grade: **0**
O&M Grade: **3**
Clock Start/From: **8**
Clock To: **4**
1st Value:
2nd Value:
Value Percent: **15.000**
Continuous Index:
Within 8" of Joint: **YES**
Remarks:

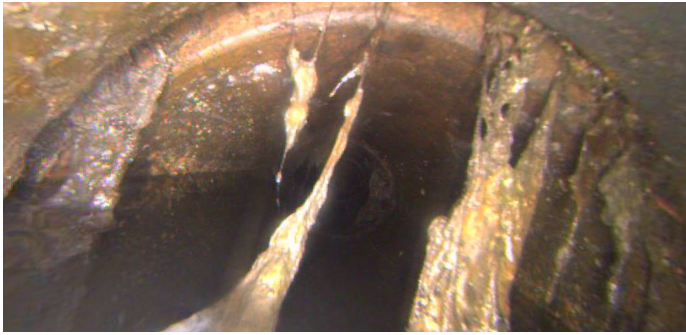
Code: **RFJ**
Description: **Roots Fine Joint**

Distance (ft): **20.6**
Structural Grade: **0**
O&M Grade: **1**
Clock Start/From: **8**
Clock To: **4**
1st Value:
2nd Value:
Value Percent:
Continuous Index: **F01**
Within 8" of Joint: **YES**
Remarks:

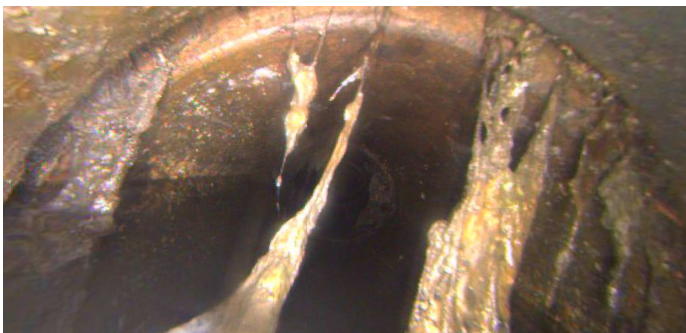
Code: **DAGS**
Description: **Deposits Attached Grease**

Distance (ft): **20.6**
Structural Grade: **0**
O&M Grade: **2**
Clock Start/From: **8**
Clock To: **4**
1st Value:
2nd Value:
Value Percent: **5.000**
Continuous Index: **F02**
Within 8" of Joint: **NO**
Remarks:

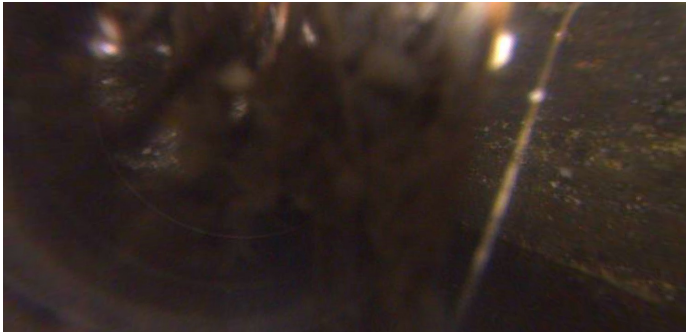
Code: **RMJ**
Description: **Roots Medium Joint**

Distance (ft): **22.8**
Structural Grade: **0**
O&M Grade: **3**
Clock Start/From: **8**
Clock To: **4**
1st Value:
2nd Value:
Value Percent: **15.000**
Continuous Index:
Within 8" of Joint: **YES**
Remarks:

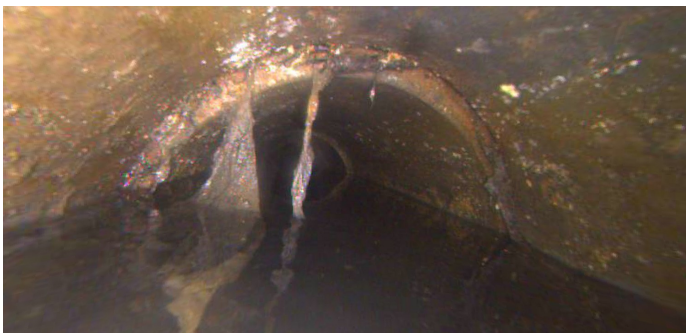
Code: **MSA**
Description: **Abandoned Survey**

Distance (ft): **24.3**
Structural Grade: **0**
O&M Grade: **0**
Clock Start/From:
Clock To:
1st Value:
2nd Value:
Value Percent:
Continuous Index:
Within 8" of Joint: **NO**
Remarks: **debris under water**
