# Profile/Photo Observation Report

Date:	01/21/2023	Weather:		Coding:	PACP 7.0
Pipe Length (ft):	402.0	Owner:	City of Hobart	Pre Clean:	Heavy Cleaning
P.O.#:	YES502259	Surveyor:	S. Bucklin	PSR:	P-805-056-055
Customer:	City of Hobart	Clean Date:	12/19/2022	Shape:	C

Street:	South Lillian Street	Flow Control:	Not Controlled
City:	Hobart, IN	Year Renewed:	
Location:	Local rural streets with light traffic, t	Tape/Media #:	
Purpose:	Routine Assessment	Dia/Height:	15"
Use:	Sanitary Sewage Pipe	Material:	VCP
Drain Area:		Lining:	None
Category:	NA		
Comment:			
Location Details:		Direction of Survey:	Downstream
US MH:	M-805-056	DS MH:	M-805-055
		Total Length Surveyed (ft):	396.6

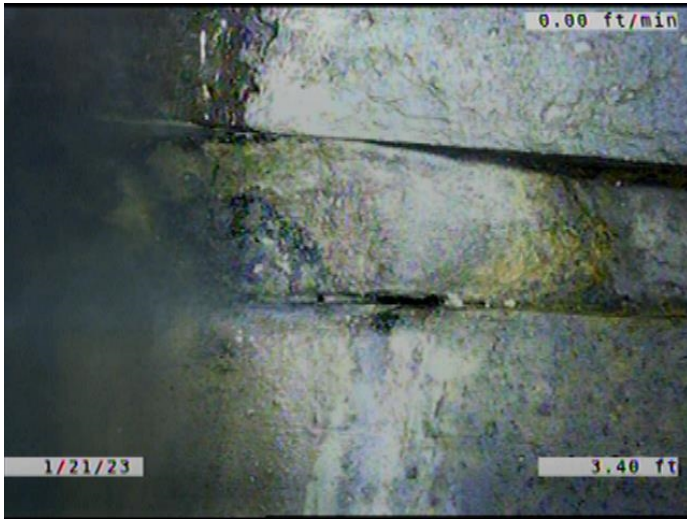
Code: **JAM**  
Description: **Joint Angular Medium**

Distance (ft): **3.4**  
Structural Grade: **3**  
O&M Grade: **0**  
Clock Start/From:  
Clock To:  
1st Value:  
2nd Value:  
Value Percent:  
Continuous Index:  
Within 8" of Joint: **NO**  
Remarks:

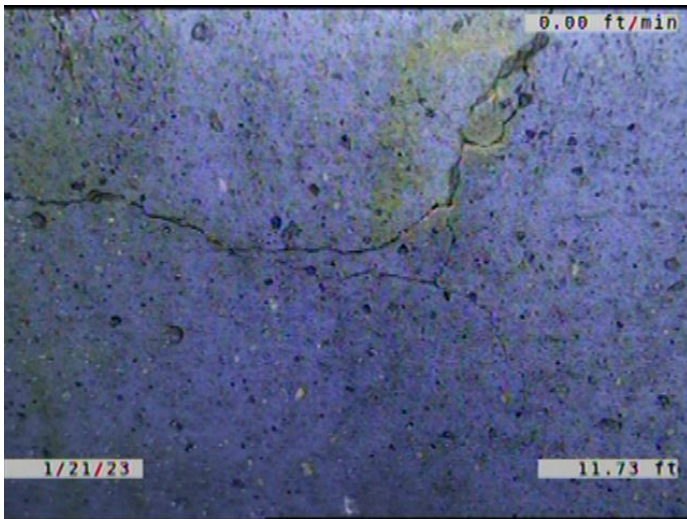
Code: **CM**  
Description: **Crack Multiple**

Distance (ft): **11.7**  
Structural Grade: **3**  
O&M Grade: **0**  
Clock Start/From: **8**  
Clock To: **10**  
1st Value:  
2nd Value:  
Value Percent:  
Continuous Index:  
Within 8" of Joint: **YES**  
Remarks:

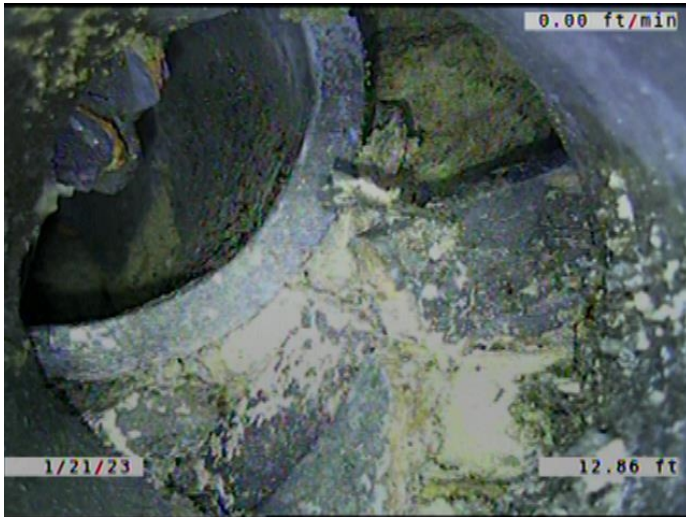
Code: **TFD**  
 Description: **Tap Factory Defective**

Distance (ft): **12.9**  
 Structural Grade: **0**  
 O&M Grade: **3**  
 Clock Start/From: **10**  
 Clock To:  
 1st Value: **6.000**  
 2nd Value:  
 Value Percent:  
 Continuous Index:  
 Within 8" of Joint: **YES**  
 Remarks: **TAP BROKEN. SERVICE LARGE OFFSET. SOIL VISIBLE AT MULTIPLE J**

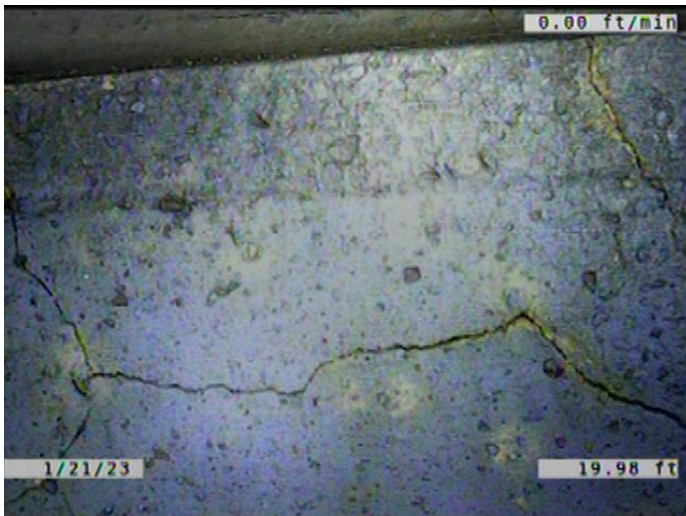
Code: **FM**  
 Description: **Fracture Multiple**

Distance (ft): **20.0**  
 Structural Grade: **4**  
 O&M Grade: **0**  
 Clock Start/From: **7**  
 Clock To: **12**  
 1st Value:  
 2nd Value:  
 Value Percent:  
 Continuous Index:  
 Within 8" of Joint: **YES**  
 Remarks:

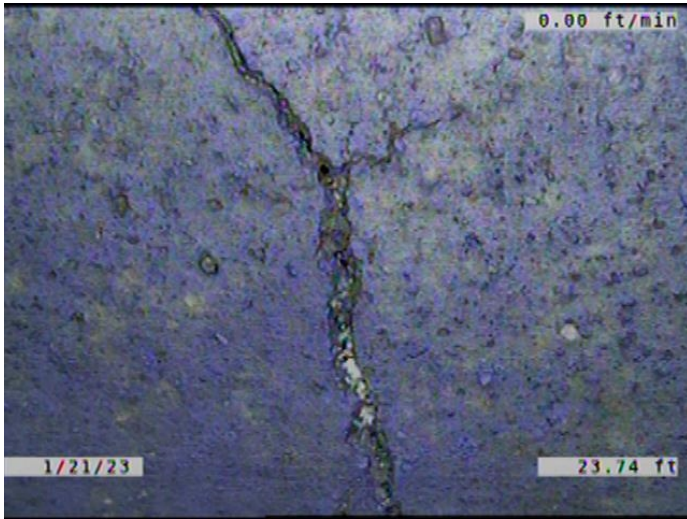
Code: **FM**  
Description: **Fracture Multiple**

Distance (ft): **23.7**  
Structural Grade: **4**  
O&M Grade: **0**  
Clock Start/From: **7**  
Clock To: **5**  
1st Value:  
2nd Value:  
Value Percent:  
Continuous Index:  
Within 8" of Joint: **YES**  
Remarks:

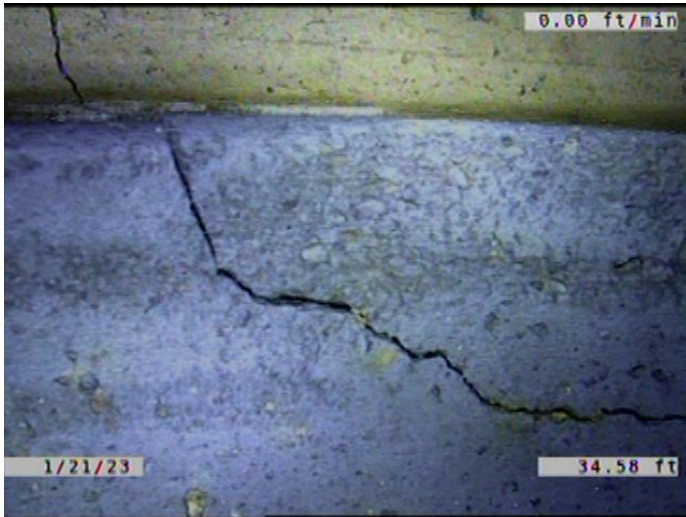
Code: **FM**  
 Description: **Fracture Multiple**

Distance (ft): **34.6**  
 Structural Grade: **4**  
 O&M Grade: **0**  
 Clock Start/From: **2**  
 Clock To: **4**  
 1st Value:  
 2nd Value:  
 Value Percent:  
 Continuous Index:  
 Within 8" of Joint: **YES**  
 Remarks:

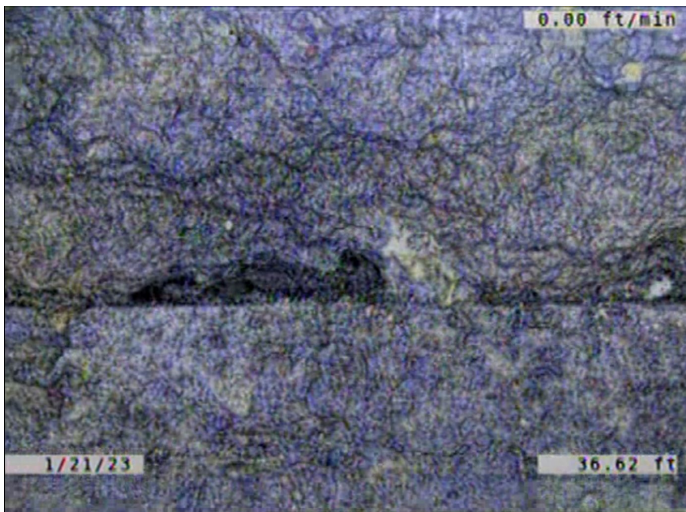
Code: **SSS**  
 Description: **Surface Damage Surface Spalling**

Distance (ft): **36.6**  
 Structural Grade: **2**  
 O&M Grade: **0**  
 Clock Start/From: **1**  
 Clock To:  
 1st Value:  
 2nd Value:  
 Value Percent:  
 Continuous Index:  
 Within 8" of Joint: **YES**  
 Remarks:

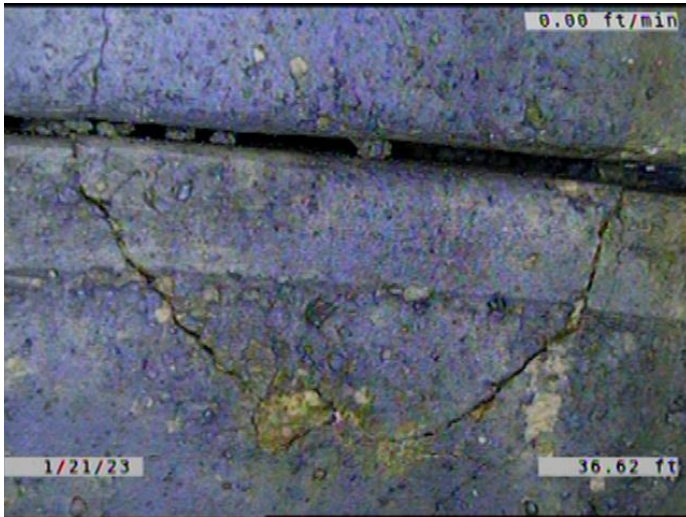
Code: **B**  
Description: **Broken**

Distance (ft): **36.6**  
Structural Grade: **4**  
O&M Grade: **0**  
Clock Start/From: **2**  
Clock To: **4**  
1st Value:  
2nd Value:  
Value Percent:  
Continuous Index:  
Within 8" of Joint: **YES**  
Remarks:

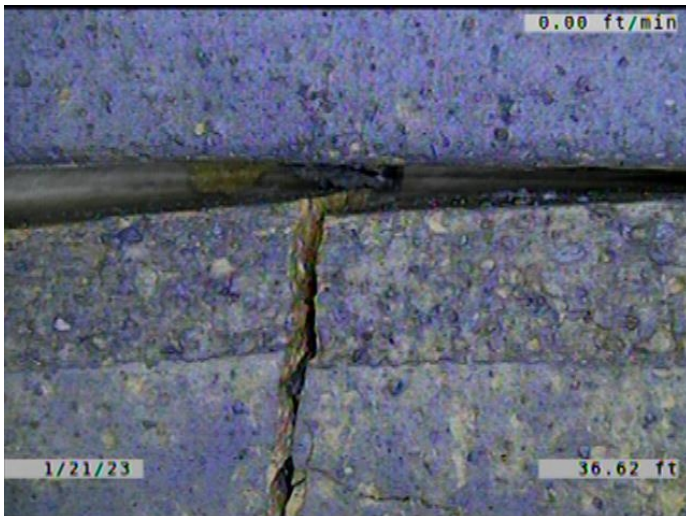
Code: **B**  
Description: **Broken**

Distance (ft): **36.6**  
Structural Grade: **4**  
O&M Grade: **0**  
Clock Start/From: **7**  
Clock To: **12**  
1st Value:  
2nd Value:  
Value Percent:  
Continuous Index:  
Within 8" of Joint: **YES**  
Remarks:

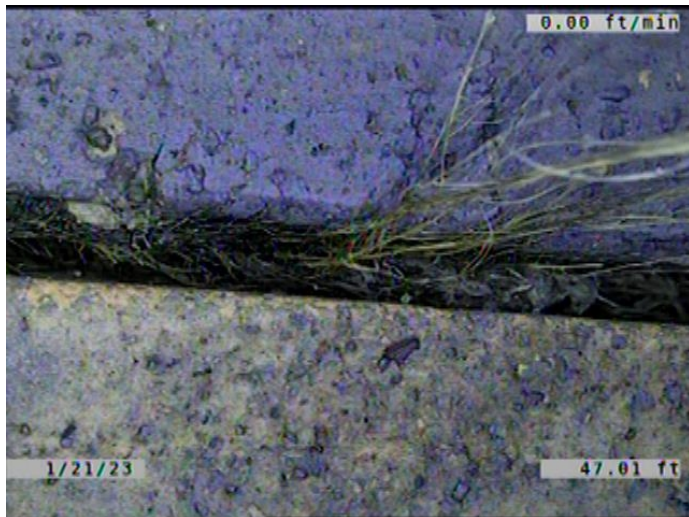
Code: **RFJ**  
 Description: **Roots Fine Joint**

Distance (ft): **47.0**  
 Structural Grade: **0**  
 O&M Grade: **1**  
 Clock Start/From: **9**  
 Clock To: **3**  
 1st Value:  
 2nd Value:  
 Value Percent:  
 Continuous Index: **S01**  
 Within 8" of Joint: **YES**  
 Remarks:

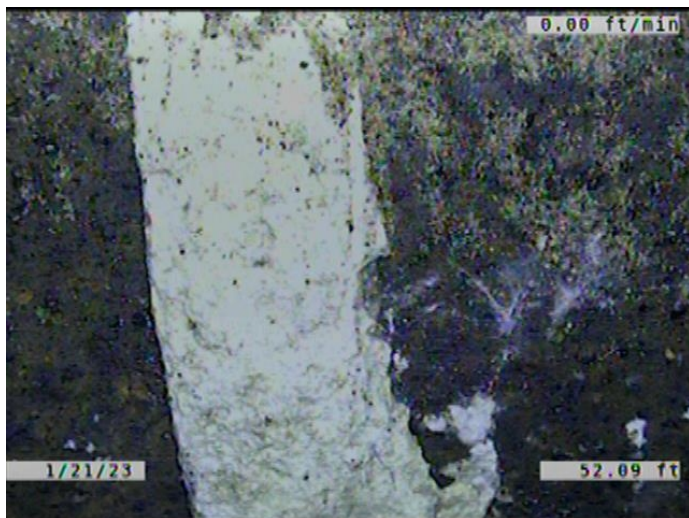
Code: **DAGS**  
 Description: **Deposits Attached Grease**

Distance (ft): **52.1**  
 Structural Grade: **0**  
 O&M Grade: **2**  
 Clock Start/From: **12**  
 Clock To:  
 1st Value:  
 2nd Value:  
 Value Percent: **5.000**  
 Continuous Index:  
 Within 8" of Joint: **NO**  
 Remarks:

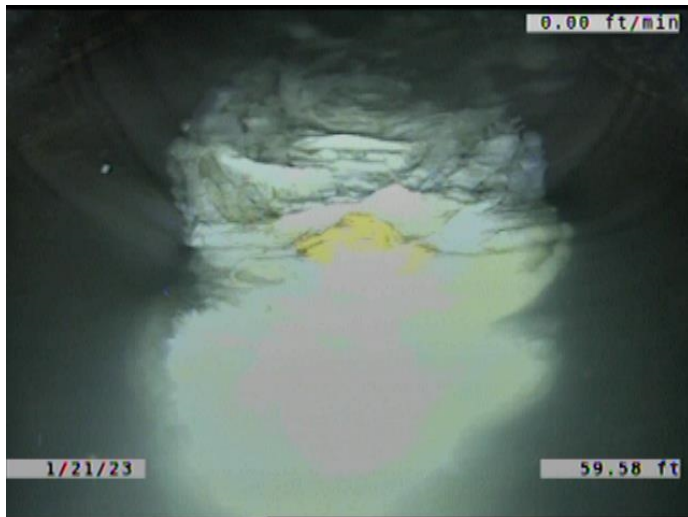
Code:	<b>DAR</b>
Description:	<b>Deposits Attached Ragging</b>
Distance (ft):	<b>59.6</b>
Structural Grade:	<b>0</b>
O&M Grade:	<b>2</b>
Clock Start/From:	<b>6</b>
Clock To:	
1st Value:	
2nd Value:	
Value Percent:	<b>5.000</b>
Continuous Index:	
Within 8" of Joint:	<b>NO</b>
Remarks:

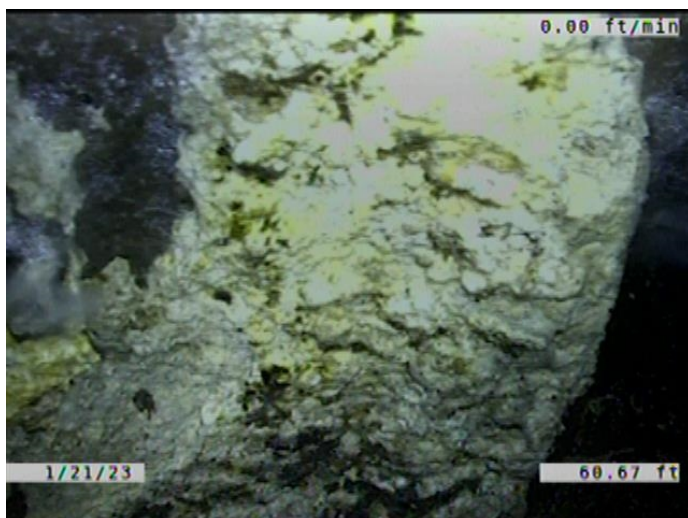
Code:	<b>DAGS</b>
Description:	<b>Deposits Attached Grease</b>
Distance (ft):	<b>60.7</b>
Structural Grade:	<b>0</b>
O&M Grade:	<b>2</b>
Clock Start/From:	<b>10</b>
Clock To:	<b>2</b>
1st Value:	
2nd Value:	
Value Percent:	<b>5.000</b>
Continuous Index:	<b>S02</b>
Within 8" of Joint:	<b>YES</b>
Remarks:

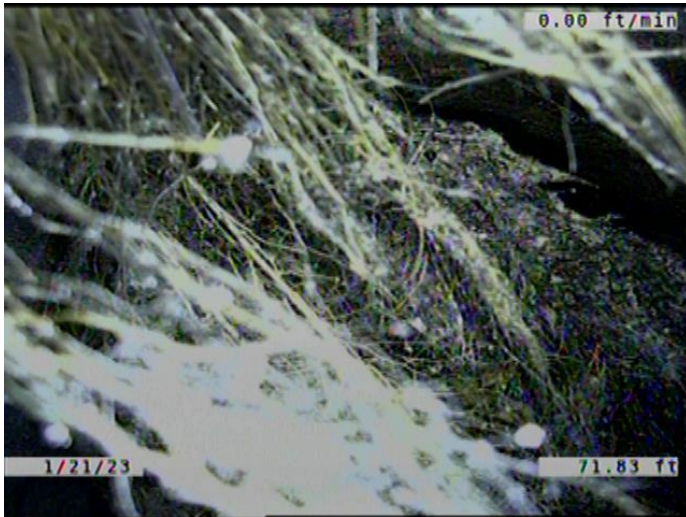
Code: **RMB**  
 Description: **Roots Medium Barrel**

Distance (ft): **71.8**  
 Structural Grade: **0**  
 O&M Grade: **4**  
 Clock Start/From: **9**  
 Clock To: **3**  
 1st Value:  
 2nd Value:  
 Value Percent: **40.000**  
 Continuous Index:  
 Within 8" of Joint: **NO**  
 Remarks:

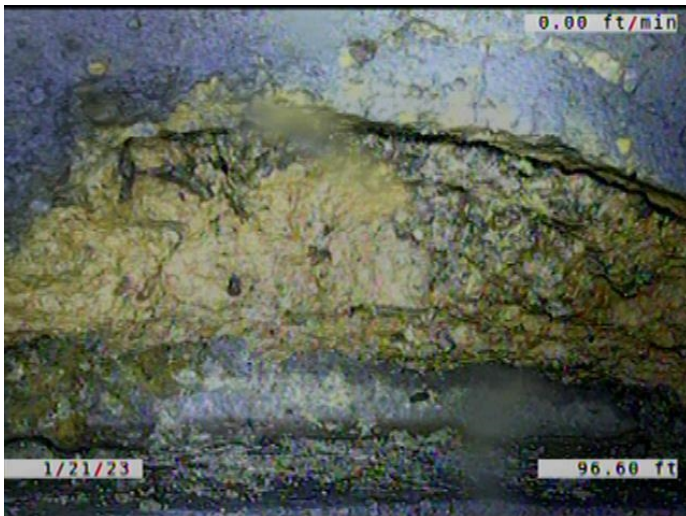
Code: **SZ**  
 Description: **Surface Damage Other**

Distance (ft): **96.6**  
 Structural Grade: **0**  
 O&M Grade: **0**  
 Clock Start/From: **2**  
 Clock To: **4**  
 1st Value:  
 2nd Value:  
 Value Percent:  
 Continuous Index:  
 Within 8" of Joint: **YES**  
 Remarks: **A PIECE CHIPPED AWAY FROM THE JOINT.**

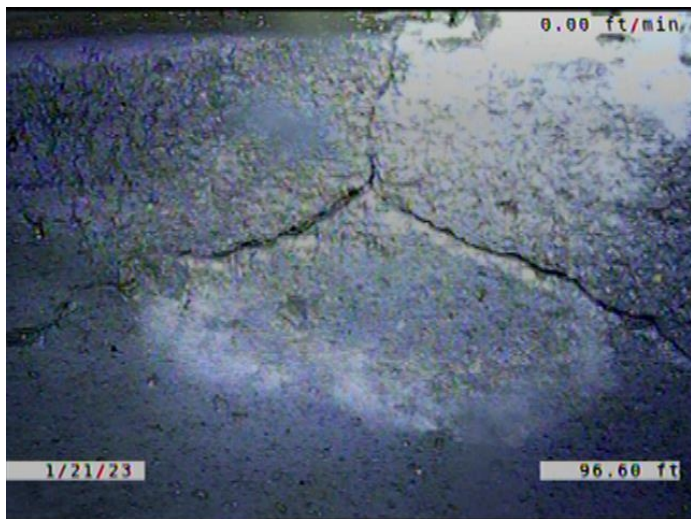
Code: **B**  
 Description: **Broken**

Distance (ft): **96.6**  
 Structural Grade: **4**  
 O&M Grade: **0**  
 Clock Start/From: **8**  
 Clock To: **1**  
 1st Value:  
 2nd Value:  
 Value Percent:  
 Continuous Index:  
 Within 8" of Joint: **YES**  
 Remarks:

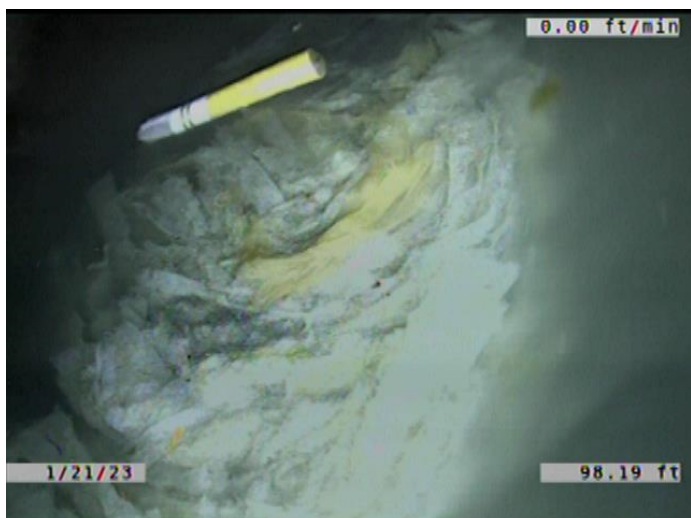
Code: **DAR**  
 Description: **Deposits Attached Ragging**

Distance (ft): **98.2**  
 Structural Grade: **0**  
 O&M Grade: **2**  
 Clock Start/From: **7**  
 Clock To:  
 1st Value:  
 2nd Value:  
 Value Percent: **5.000**  
 Continuous Index:  
 Within 8" of Joint: **YES**  
 Remarks:

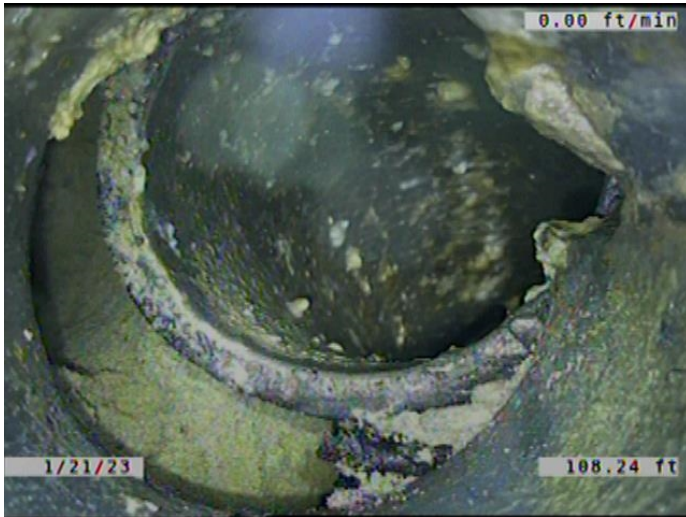
Code:	<b>TFD</b>
Description:	<b>Tap Factory Defective</b>
Distance (ft):	<b>108.2</b>
Structural Grade:	<b>0</b>
O&M Grade:	<b>3</b>
Clock Start/From:	<b>1</b>
Clock To:	
1st Value:	<b>6.000</b>
2nd Value:	
Value Percent:	
Continuous Index:	
Within 8" of Joint:	<b>YES</b>
Remarks:	<b>TAP BROKEN. SERVICE BROKEN. OFFSET AND ANGLED. VOID AND SOI</b>

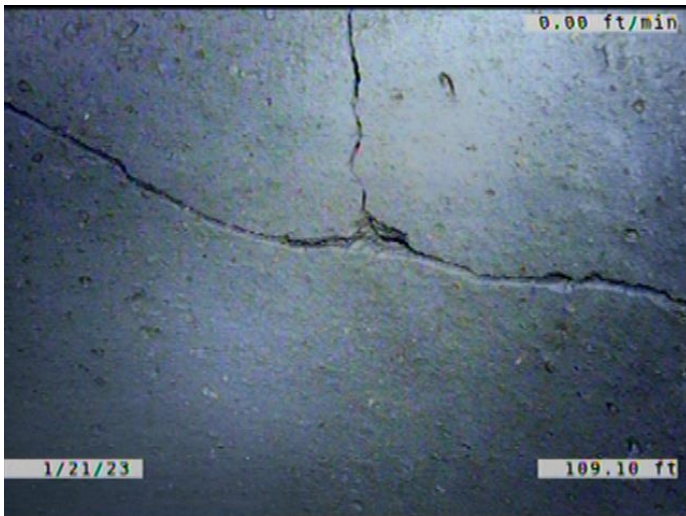
Code:	<b>FM</b>
Description:	<b>Fracture Multiple</b>
Distance (ft):	<b>109.1</b>
Structural Grade:	<b>4</b>
O&M Grade:	<b>0</b>
Clock Start/From:	<b>7</b>
Clock To:	<b>4</b>
1st Value:	
2nd Value:	
Value Percent:	
Continuous Index:	
Within 8" of Joint:	<b>YES</b>
Remarks:

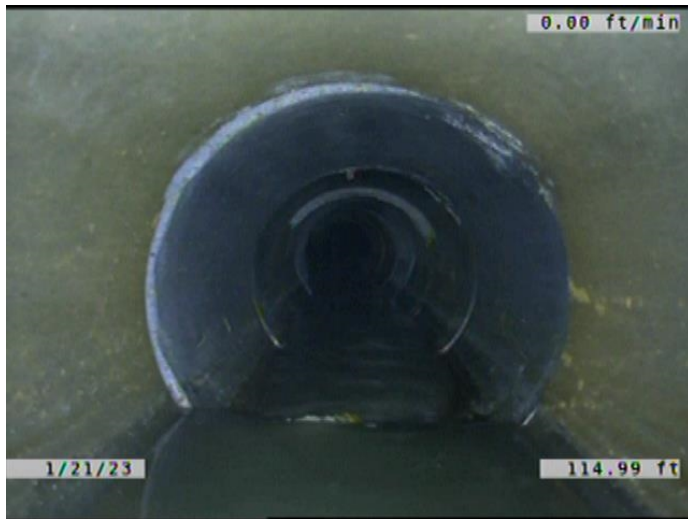
Code: **RFJ**  
Description: **Roots Fine Joint**

Distance (ft): **115.0**  
Structural Grade: **0**  
O&M Grade: **1**  
Clock Start/From: **9**  
Clock To: **3**  
1st Value:  
2nd Value:  
Value Percent:  
Continuous Index: **F01**  
Within 8" of Joint: **YES**  
Remarks:

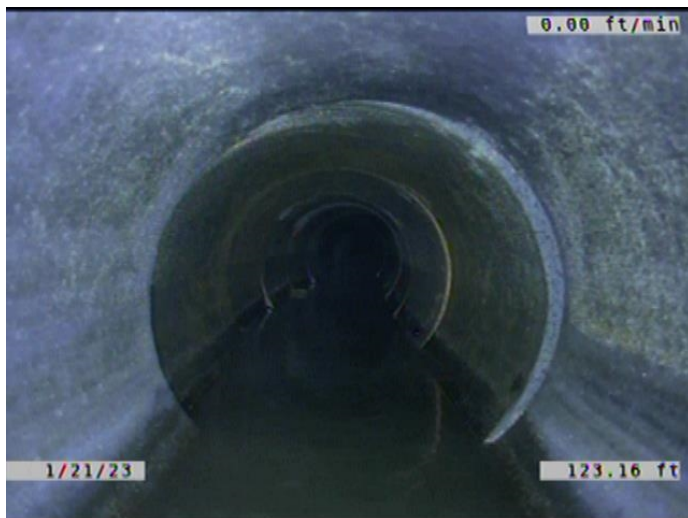
Code: **DAGS**  
Description: **Deposits Attached Grease**

Distance (ft): **123.2**  
Structural Grade: **0**  
O&M Grade: **2**  
Clock Start/From: **10**  
Clock To: **2**  
1st Value:  
2nd Value:  
Value Percent: **5.000**  
Continuous Index: **F02**  
Within 8" of Joint: **YES**  
Remarks:

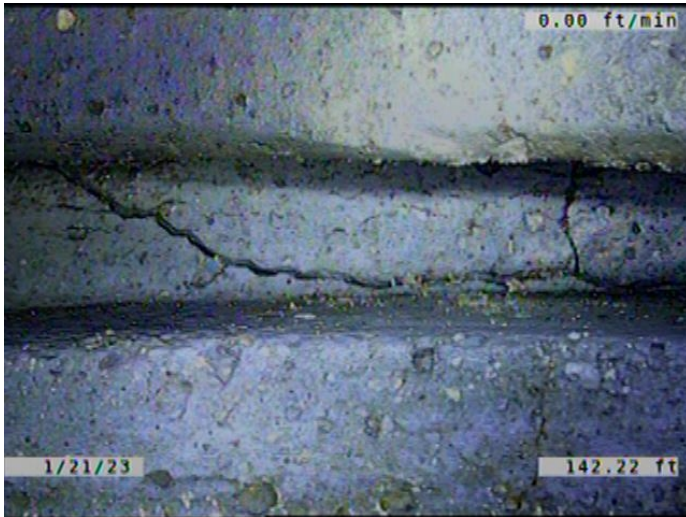
Code: **FM**  
 Description: **Fracture Multiple**

Distance (ft): **142.2**  
 Structural Grade: **4**  
 O&M Grade: **0**  
 Clock Start/From: **8**  
 Clock To: **11**  
 1st Value:  
 2nd Value:  
 Value Percent:  
 Continuous Index:  
 Within 8" of Joint: **YES**  
 Remarks:

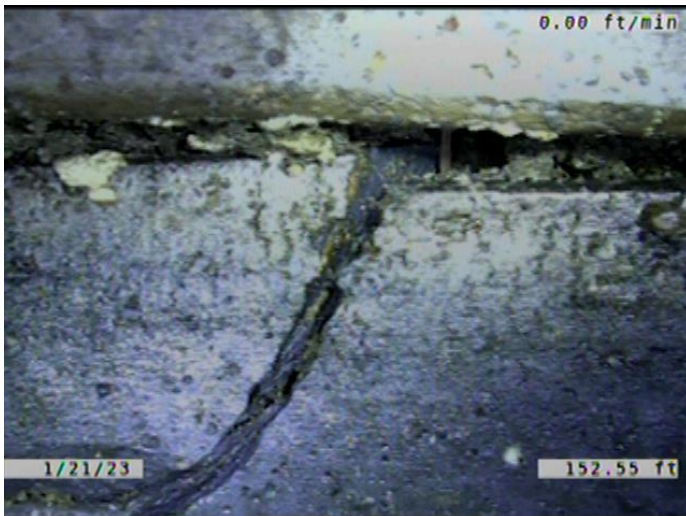
Code: **BSV**  
 Description: **Broken Soil Visible**

Distance (ft): **152.5**  
 Structural Grade: **5**  
 O&M Grade: **0**  
 Clock Start/From: **8**  
 Clock To: **12**  
 1st Value:  
 2nd Value:  
 Value Percent:  
 Continuous Index:  
 Within 8" of Joint: **YES**  
 Remarks:

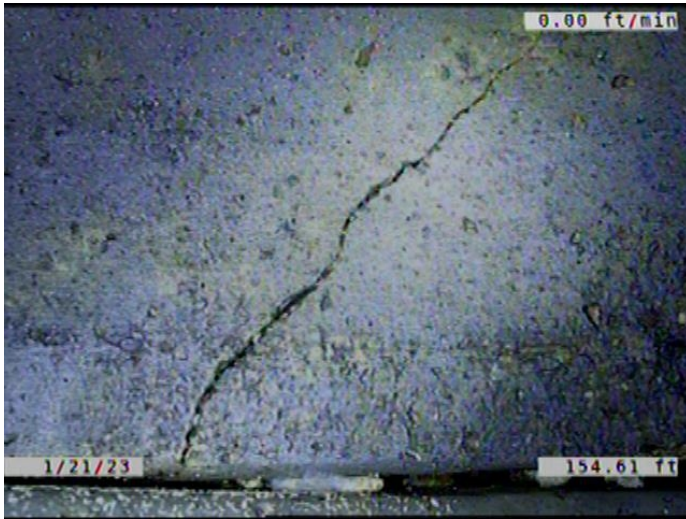
Code: **FM**  
Description: **Fracture Multiple**

Distance (ft): **154.6**  
Structural Grade: **4**  
O&M Grade: **0**  
Clock Start/From: **7**  
Clock To: **9**  
1st Value:  
2nd Value:  
Value Percent:  
Continuous Index:  
Within 8" of Joint: **YES**  
Remarks:

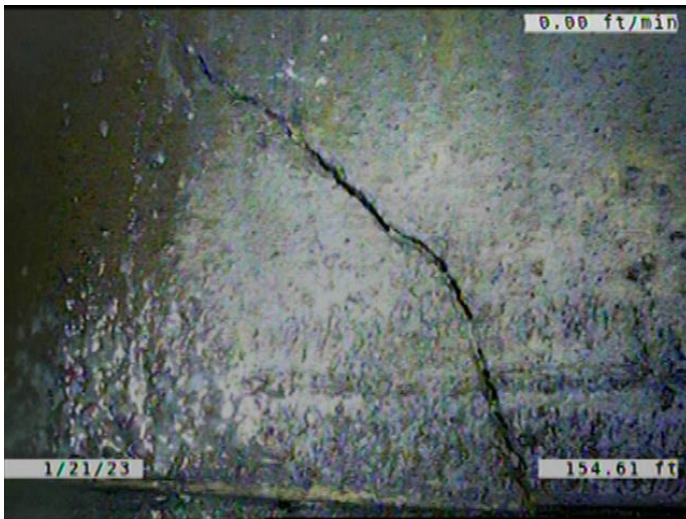
Code: **FM**  
Description: **Fracture Multiple**

Distance (ft): **154.6**  
Structural Grade: **4**  
O&M Grade: **0**  
Clock Start/From: **3**  
Clock To: **5**  
1st Value:  
2nd Value:  
Value Percent:  
Continuous Index:  
Within 8" of Joint: **YES**  
Remarks:

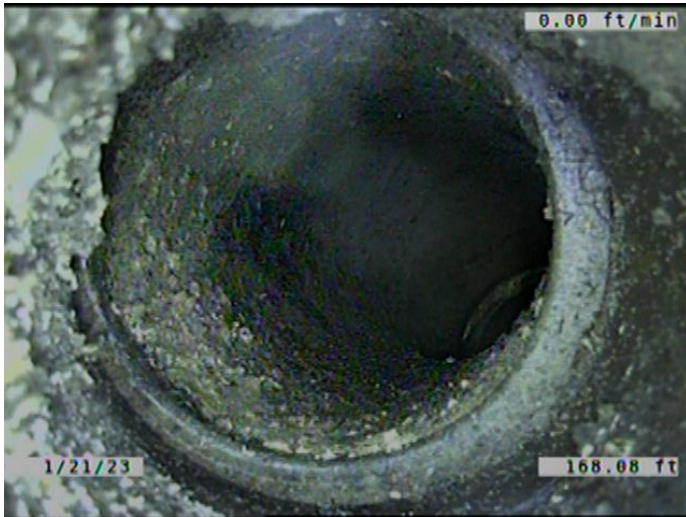
Code:	<b>TFD</b>
Description:	<b>Tap Factory Defective</b>
Distance (ft):	<b>168.1</b>
Structural Grade:	<b>0</b>
O&M Grade:	<b>3</b>
Clock Start/From:	<b>1</b>
Clock To:	
1st Value:	<b>6.000</b>
2nd Value:	
Value Percent:	
Continuous Index:	
Within 8" of Joint:	<b>YES</b>
Remarks:	<b>TAP BROKEN. SERVICE ANGLED. SOIL VISIBLE AT THE SERVICE TO MAIN C</b>

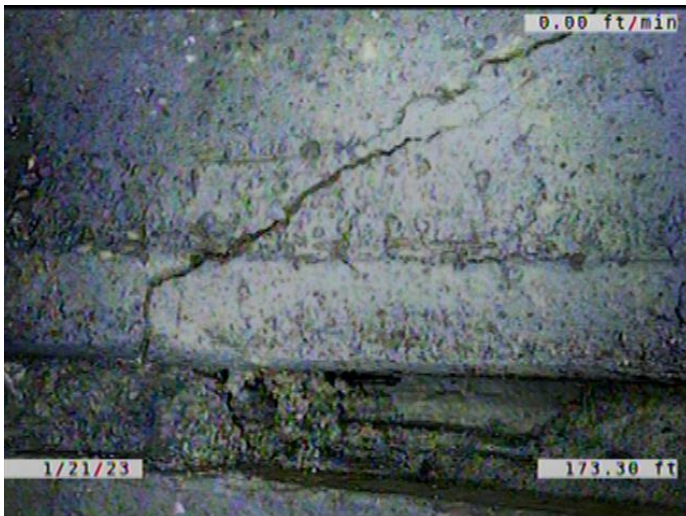
Code:	<b>FM</b>
Description:	<b>Fracture Multiple</b>
Distance (ft):	<b>173.3</b>
Structural Grade:	<b>4</b>
O&M Grade:	<b>0</b>
Clock Start/From:	<b>2</b>
Clock To:	<b>4</b>
1st Value:	
2nd Value:	
Value Percent:	
Continuous Index:	
Within 8" of Joint:	<b>YES</b>
Remarks:

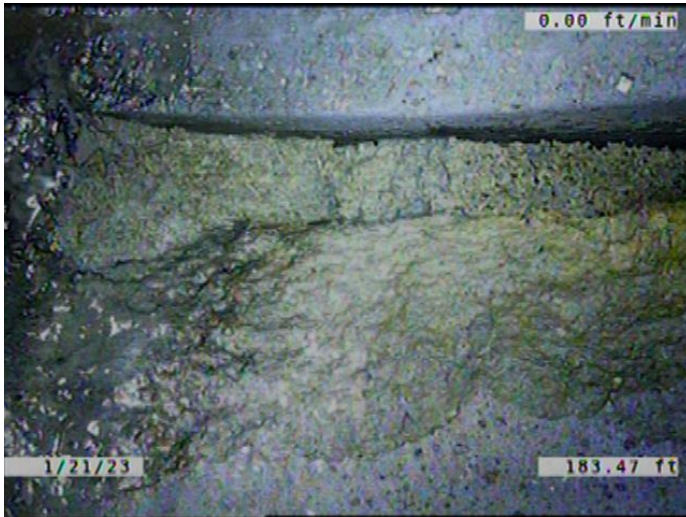
Code:	<b>SZ</b>
Description:	<b>Surface Damage Other</b>
Distance (ft):	<b>183.5</b>
Structural Grade:	<b>0</b>
O&M Grade:	<b>0</b>
Clock Start/From:	<b>3</b>
Clock To:	<b>5</b>
1st Value:	
2nd Value:	
Value Percent:	
Continuous Index:	
Within 8" of Joint:	<b>YES</b>
Remarks:	<b>A PIECE CHIPPED AWAY FROM THE JOINT.</b>

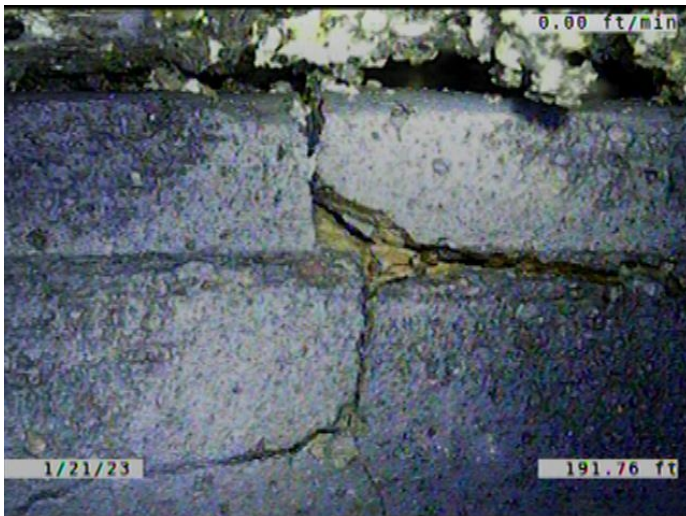
Code:	<b>FM</b>
Description:	<b>Fracture Multiple</b>
Distance (ft):	<b>191.8</b>
Structural Grade:	<b>4</b>
O&M Grade:	<b>0</b>
Clock Start/From:	<b>7</b>
Clock To:	<b>4</b>
1st Value:	
2nd Value:	
Value Percent:	
Continuous Index:	<b>S03</b>
Within 8" of Joint:	<b>YES</b>
Remarks:

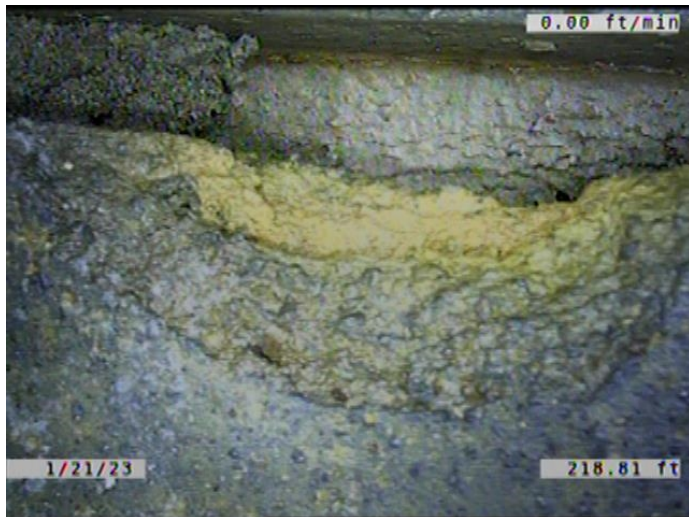
Code: **SZ**  
Description: **Surface Damage Other**

Distance (ft): **218.8**  
Structural Grade: **0**  
O&M Grade: **0**  
Clock Start/From: **2**  
Clock To: **4**  
1st Value:  
2nd Value:  
Value Percent:  
Continuous Index:  
Within 8" of Joint: **YES**  
Remarks: **A PIECE CHIPPED AWAY FROM THE JOINT.**

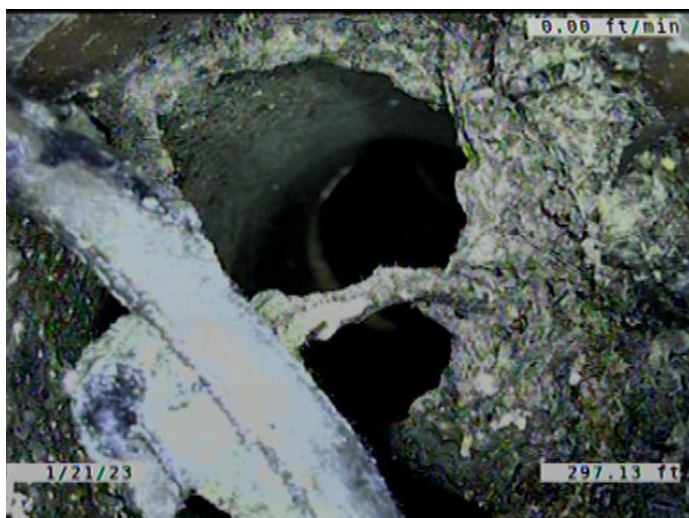
Code: **TBD**  
 Description: **Tap Break-in/Hammer Defective**

Distance (ft): **297.1**  
 Structural Grade: **0**  
 O&M Grade: **3**  
 Clock Start/From: **2**  
 Clock To:  
 1st Value: **6.000**  
 2nd Value:  
 Value Percent:  
 Continuous Index:  
 Within 8" of Joint: **YES**  
 Remarks: **SOIL VISIBLE AROUND THE SERVICE TO MAIN CONNECTION .**

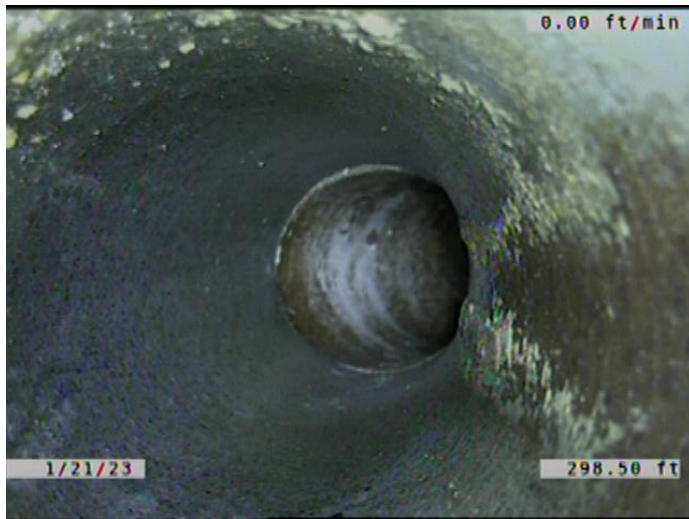
Code:	<b>TBD</b>
Description:	<b>Tap Break-in/Hammer Defective</b>
Distance (ft):	<b>298.5</b>
Structural Grade:	<b>0</b>
O&M Grade:	<b>3</b>
Clock Start/From:	<b>1</b>
Clock To:	
1st Value:	<b>6.000</b>
2nd Value:	
Value Percent:	
Continuous Index:	
Within 8" of Joint:	<b>YES</b>
Remarks:	<b>SOIL VISIBLE AROUND THE SERVICE TO MAIN CONNECTION .</b>

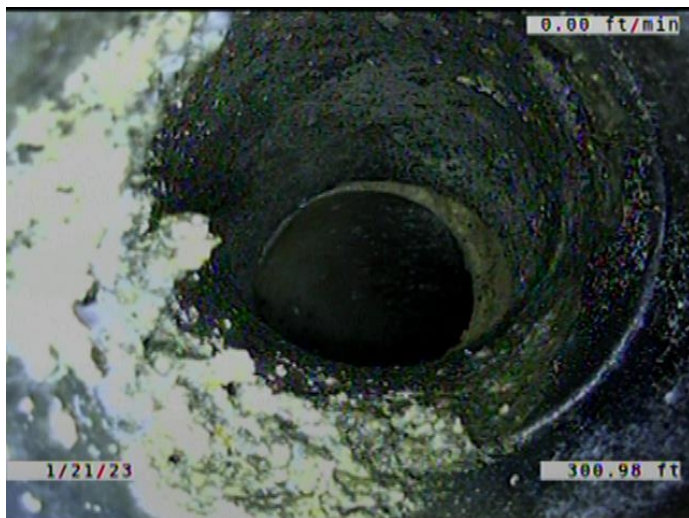
Code:	<b>TFD</b>
Description:	<b>Tap Factory Defective</b>
Distance (ft):	<b>301.0</b>
Structural Grade:	<b>0</b>
O&M Grade:	<b>3</b>
Clock Start/From:	<b>2</b>
Clock To:	
1st Value:	<b>6.000</b>
2nd Value:	
Value Percent:	
Continuous Index:	
Within 8" of Joint:	<b>YES</b>
Remarks:	<b>SOIL VISIBLE IN THE SERVICE.</b>

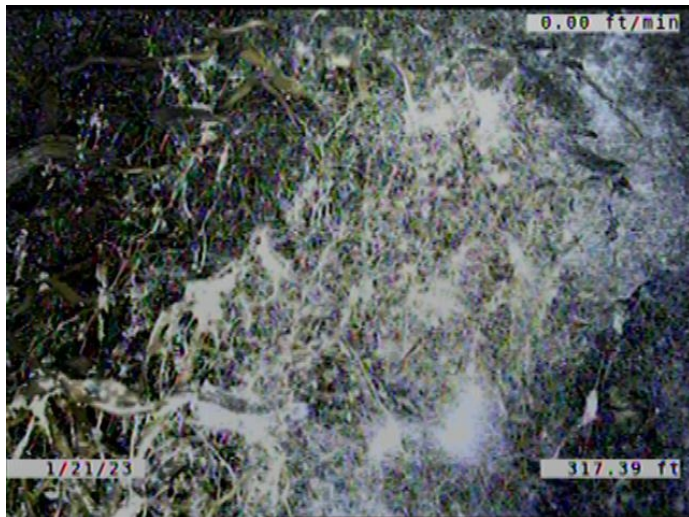
Code: **TFD**  
 Description: **Tap Factory Defective**

Distance (ft): **317.4**  
 Structural Grade: **0**  
 O&M Grade: **3**  
 Clock Start/From: **2**  
 Clock To:  
 1st Value: **6.000**  
 2nd Value:  
 Value Percent:  
 Continuous Index:  
 Within 8" of Joint: **YES**  
 Remarks: **100% PLUGGED WITH ROOTS.**

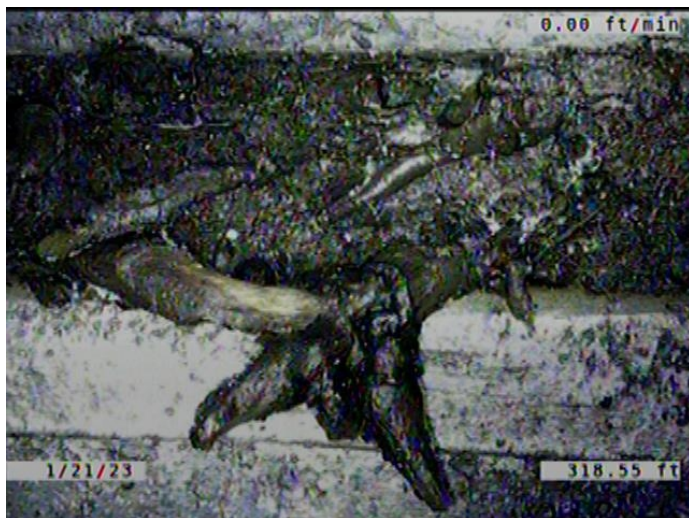
Code: **RFJ**  
 Description: **Roots Fine Joint**

Distance (ft): **318.5**  
 Structural Grade: **0**  
 O&M Grade: **1**  
 Clock Start/From: **8**  
 Clock To: **4**  
 1st Value:  
 2nd Value:  
 Value Percent:  
 Continuous Index:  
 Within 8" of Joint: **YES**  
 Remarks:

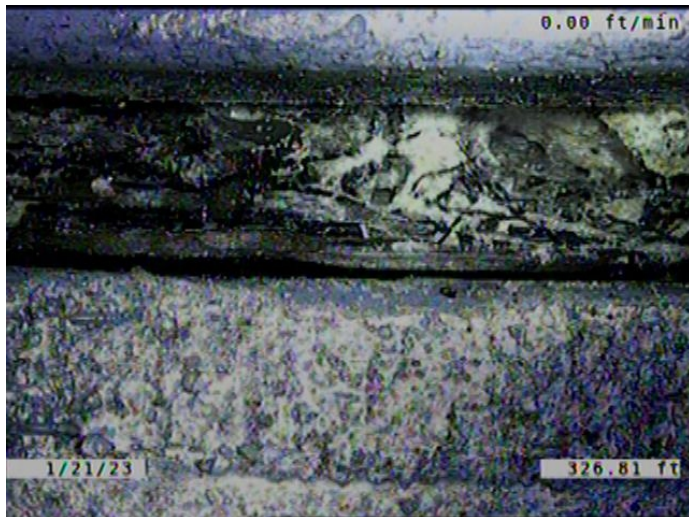
Code: **RFJ**  
 Description: **Roots Fine Joint**

Distance (ft): **326.8**  
 Structural Grade: **0**  
 O&M Grade: **1**  
 Clock Start/From: **10**  
 Clock To: **2**  
 1st Value:  
 2nd Value:  
 Value Percent:  
 Continuous Index:  
 Within 8" of Joint: **YES**  
 Remarks:

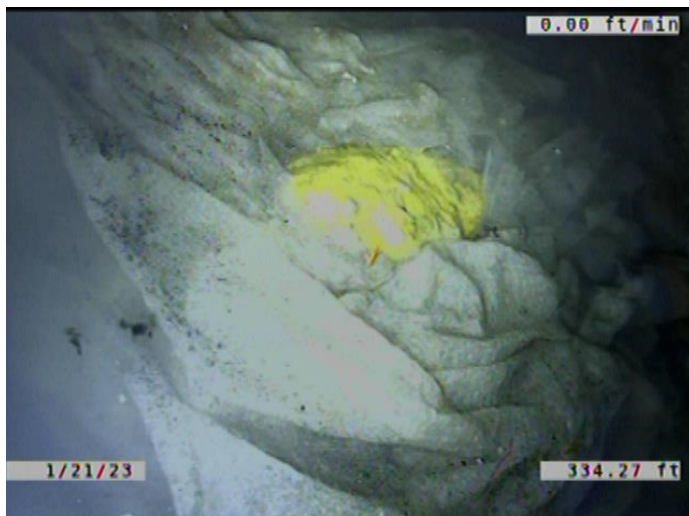
Code: **DAR**  
 Description: **Deposits Attached Ragging**

Distance (ft): **334.3**  
 Structural Grade: **0**  
 O&M Grade: **2**  
 Clock Start/From: **5**  
 Clock To:  
 1st Value:  
 2nd Value:  
 Value Percent: **5.000**  
 Continuous Index:  
 Within 8" of Joint: **NO**  
 Remarks:

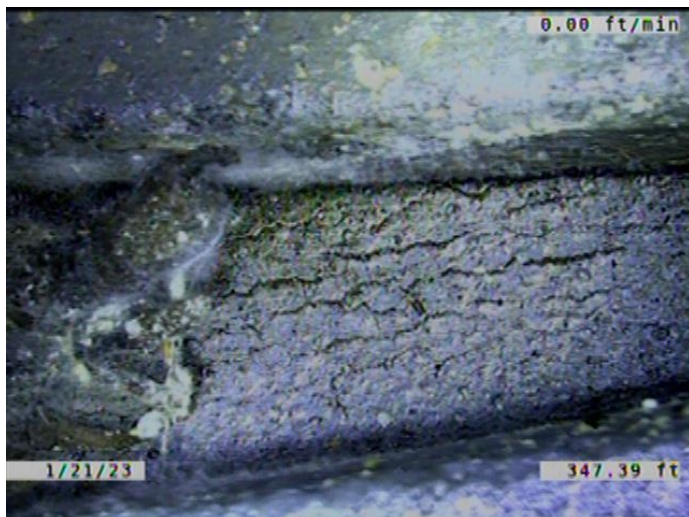
Code: **JAL**  
 Description: **Joint Angular Large**

Distance (ft): **347.4**  
 Structural Grade: **4**  
 O&M Grade: **0**  
 Clock Start/From:  
 Clock To:  
 1st Value:  
 2nd Value:  
 Value Percent:  
 Continuous Index:  
 Within 8" of Joint: **NO**  
 Remarks:

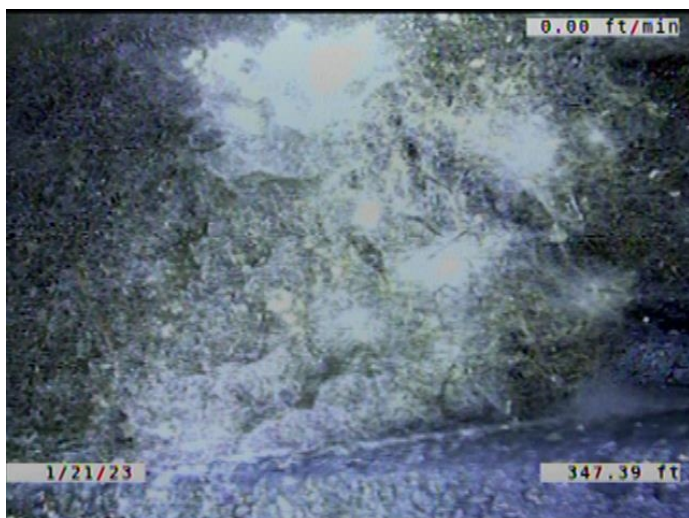
Code: **RFJ**  
 Description: **Roots Fine Joint**

Distance (ft): **347.4**  
 Structural Grade: **0**  
 O&M Grade: **1**  
 Clock Start/From: **8**  
 Clock To: **10**  
 1st Value:  
 2nd Value:  
 Value Percent:  
 Continuous Index:  
 Within 8" of Joint: **YES**  
 Remarks:

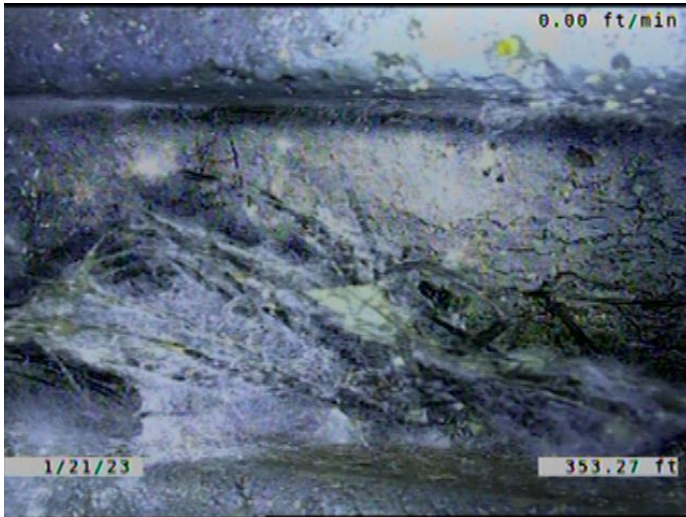
Code: **RFJ**  
Description: **Roots Fine Joint**

Distance (ft): **353.3**  
Structural Grade: **0**  
O&M Grade: **1**  
Clock Start/From: **8**  
Clock To: **4**  
1st Value:  
2nd Value:  
Value Percent:  
Continuous Index: **S04**  
Within 8" of Joint: **YES**  
Remarks:

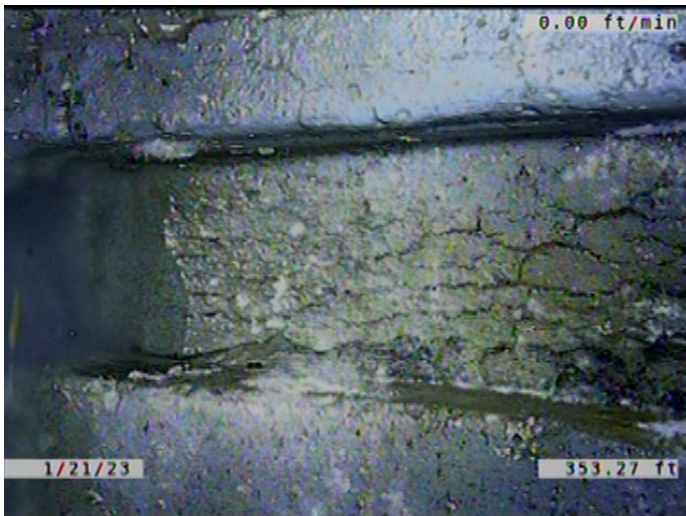
Code: **JAM**  
Description: **Joint Angular Medium**

Distance (ft): **353.3**  
Structural Grade: **3**  
O&M Grade: **0**  
Clock Start/From:  
Clock To:  
1st Value:  
2nd Value:  
Value Percent:  
Continuous Index:  
Within 8" of Joint: **NO**  
Remarks:

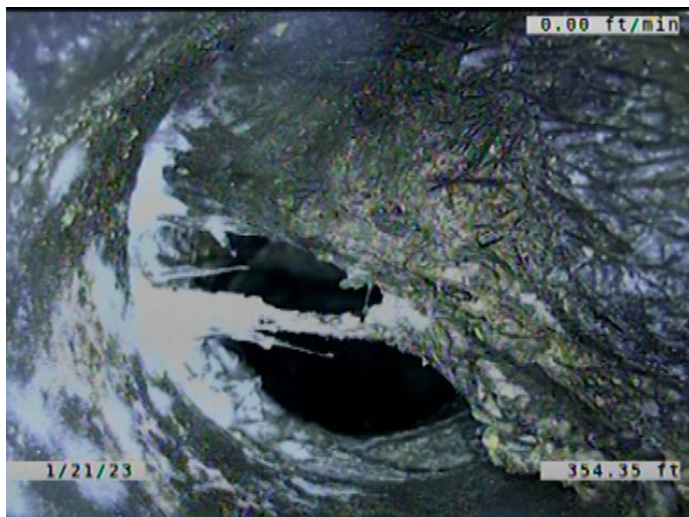
Code: **TF**  
Description: **Tap Factory**

Distance (ft): **354.4**  
Structural Grade: **0**  
O&M Grade: **0**  
Clock Start/From: **2**  
Clock To:  
1st Value: **6.000**  
2nd Value:  
Value Percent:  
Continuous Index:  
Within 8" of Joint: **YES**  
Remarks: **ROOTS GROWING FROM THE SERVICE TO MAIN CONNECTION.**

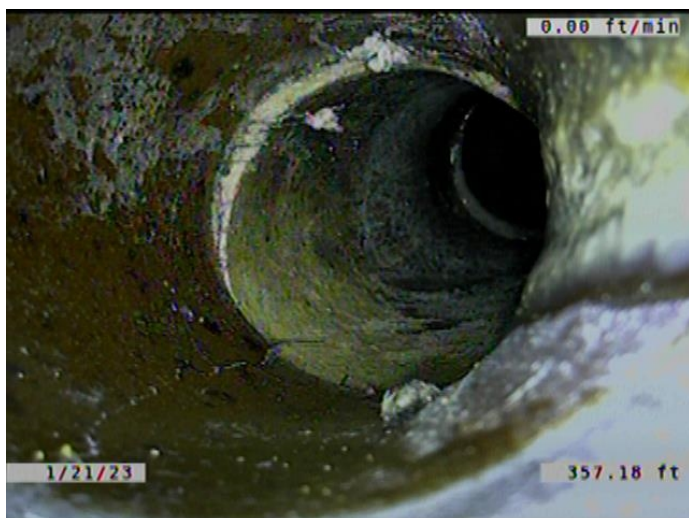
Code: **TBI**  
Description: **Tap Break-in Intruding**

Distance (ft): **357.2**  
Structural Grade: **0**  
O&M Grade: **2**  
Clock Start/From: **1**  
Clock To:  
1st Value: **6.000**  
2nd Value: **1.000**  
Value Percent:  
Continuous Index:  
Within 8" of Joint: **YES**  
Remarks: **SERVICE BROKEN. SOIL VISIBLE AT THE SERVICE TO MAIN CONNECTION.**

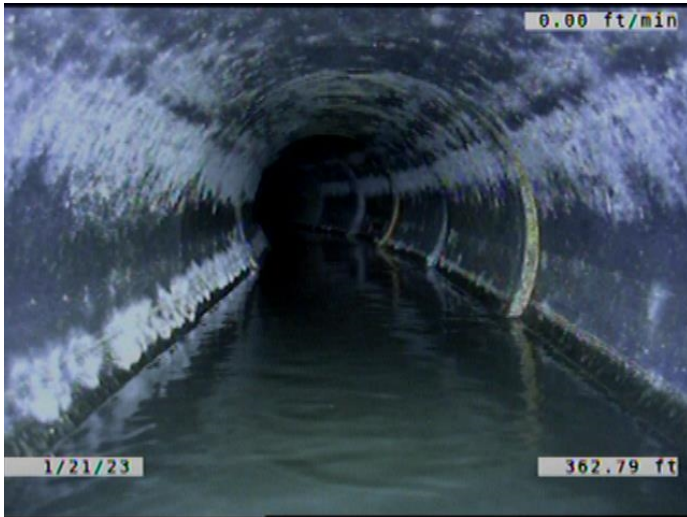
Code: **LL**  
 Description: **Line Left**

Distance (ft): **362.8**  
 Structural Grade: **0**  
 O&M Grade: **1**  
 Clock Start/From:  
 Clock To:  
 1st Value:  
 2nd Value:  
 Value Percent: **10.000**  
 Continuous Index:  
 Within 8" of Joint: **NO**  
 Remarks:

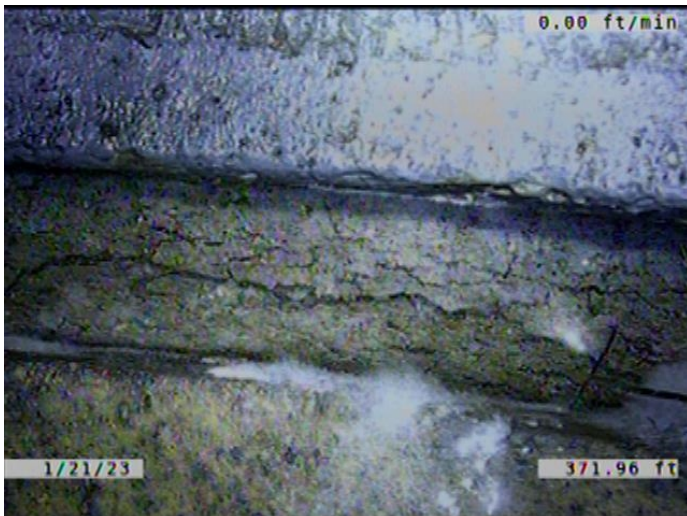
Code: **JAM**  
 Description: **Joint Angular Medium**

Distance (ft): **372.0**  
 Structural Grade: **3**  
 O&M Grade: **0**  
 Clock Start/From:  
 Clock To:  
 1st Value:  
 2nd Value:  
 Value Percent:  
 Continuous Index:  
 Within 8" of Joint: **NO**  
 Remarks:

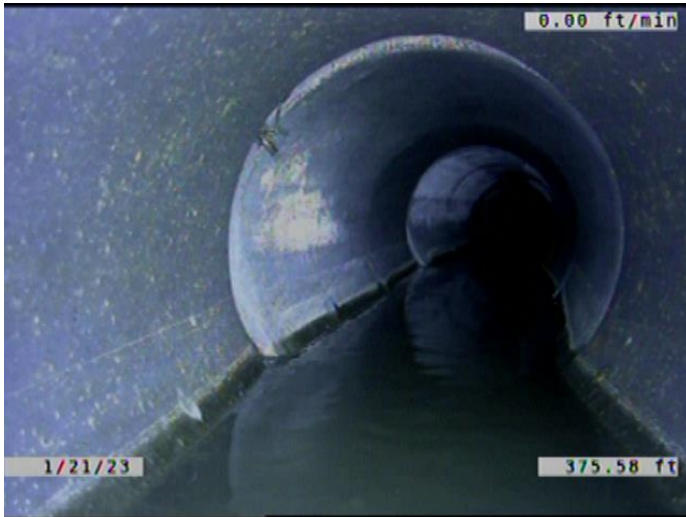
Code: **LR**  
 Description: **Line Right**

Distance (ft): **375.6**  
 Structural Grade: **0**  
 O&M Grade: **1**  
 Clock Start/From:  
 Clock To:  
 1st Value:  
 2nd Value:  
 Value Percent: **10.000**  
 Continuous Index:  
 Within 8" of Joint: **NO**  
 Remarks:

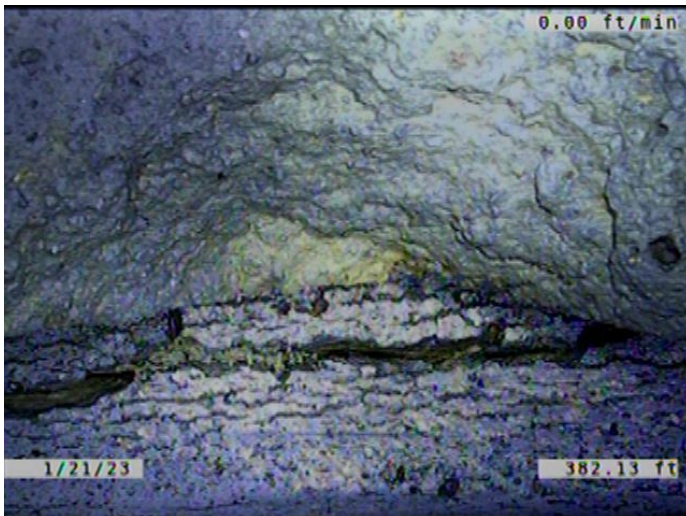
Code: **SZ**  
 Description: **Surface Damage Other**

Distance (ft): **382.1**  
 Structural Grade: **0**  
 O&M Grade: **0**  
 Clock Start/From: **11**  
 Clock To:  
 1st Value:  
 2nd Value:  
 Value Percent:  
 Continuous Index:  
 Within 8" of Joint: **YES**  
 Remarks: **A PIECE CHIPPED AWAY FROM THE JOINT.**

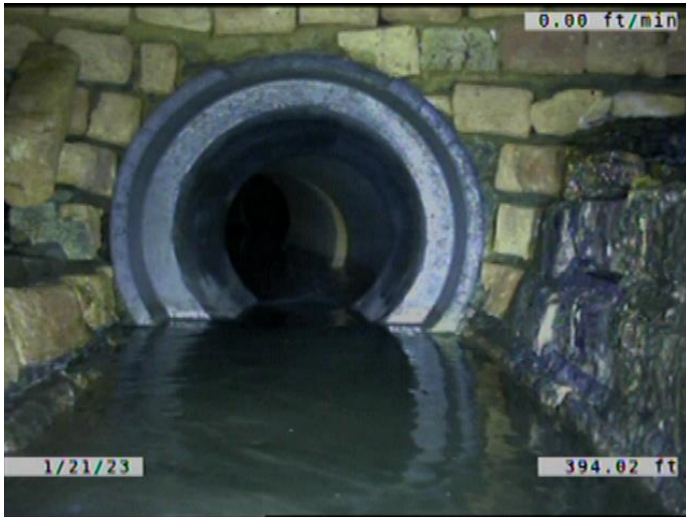
Code: **FM**  
 Description: **Fracture Multiple**

Distance (ft): **394.0**  
 Structural Grade: **4**  
 O&M Grade: **0**  
 Clock Start/From: **7**  
 Clock To: **4**  
 1st Value:  
 2nd Value:  
 Value Percent:  
 Continuous Index: **F03**  
 Within 8" of Joint: **YES**  
 Remarks:

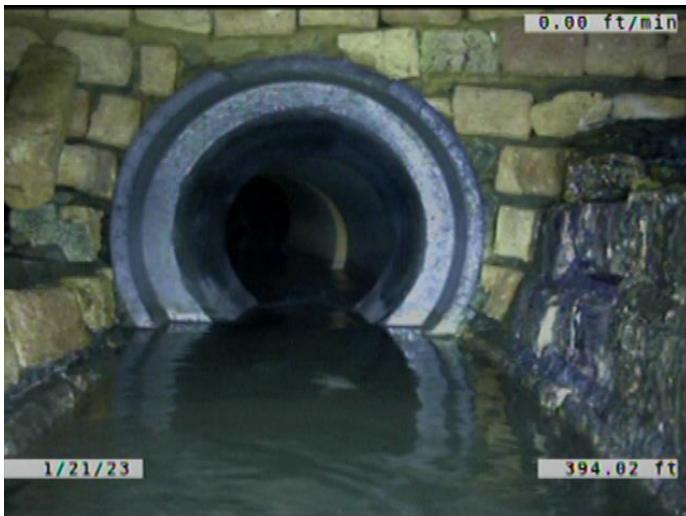
Code: **RFJ**  
 Description: **Roots Fine Joint**

Distance (ft): **394.0**  
 Structural Grade: **0**  
 O&M Grade: **1**  
 Clock Start/From: **8**  
 Clock To: **4**  
 1st Value:  
 2nd Value:  
 Value Percent:  
 Continuous Index: **F04**  
 Within 8" of Joint: **YES**  
 Remarks:
