Profile/Photo Observation Report

Street:	LILLIAN ST	Flow Control:	Not Controlled
City:	Hobart, IN	Year Renewed:	
Location:	Other	Tape/Media #:	
Purpose:	Not Known	Dia/Height:	8"
Use:	Sanitary	Material:	PVC
Drain Area:	NA	Lining:	
Category:	NA		
Comment:

Location Details:		Direction of Survey:	Upstream
US MH:	M-805-056	DS MH:	M-805-057
		Total Length Surveyed (ft):	14.2

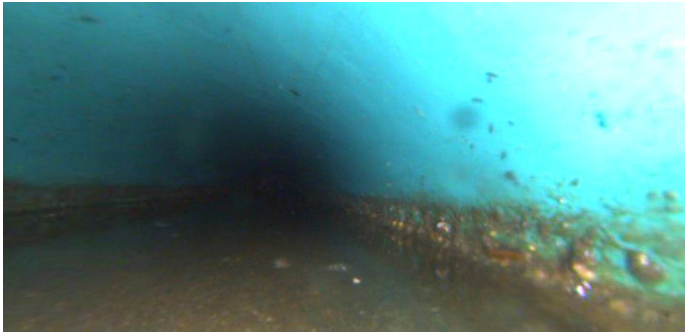
Code:	MWL
Description:	Water Level

Distance (ft):	.0
Structural Grade:	0
O&M Grade:	0
Clock Start/From:	
Clock To:	
1st Value:	
2nd Value:	
Value Percent:	30.000
Continuous Index:	
Within 8" of Joint:	NO
Remarks:

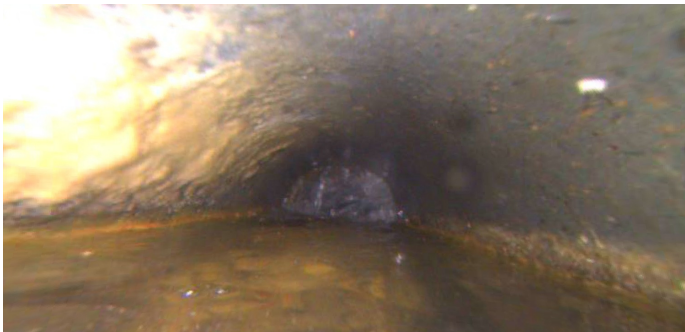
Code:	MMC
Description:	Material Change

Distance (ft):	4.1
Structural Grade:	0
O&M Grade:	0
Clock Start/From:	
Clock To:	
1st Value:	
2nd Value:	
Value Percent:	
Continuous Index:	
Within 8" of Joint:	NO
Remarks:	VCP

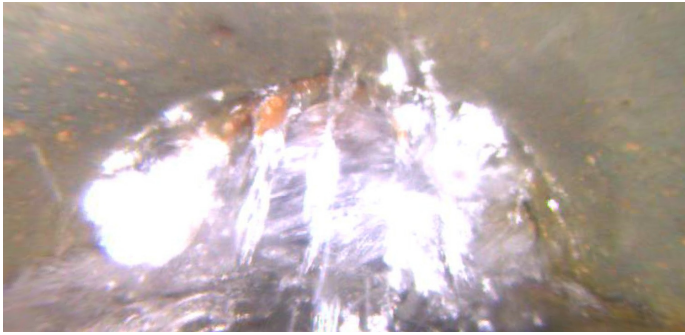
Code: **IG**
Description: **Infil Gusher**

Distance (ft): **5.2**
Structural Grade: **0**
O&M Grade: **5**
Clock Start/From: **8**
Clock To: **4**
1st Value:
2nd Value:
Value Percent:
Continuous Index:
Within 8" of Joint: **YES**
Remarks:

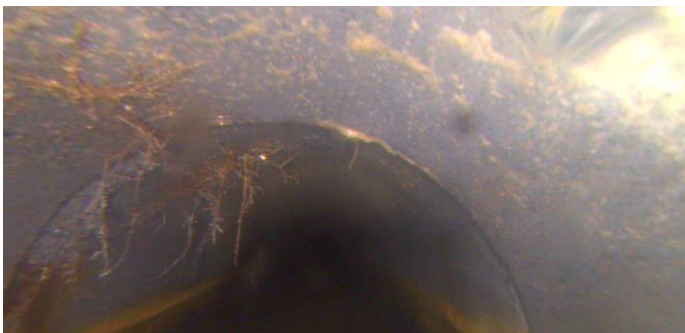
Code: **FM**
Description: **Fracture Multiple**

Distance (ft): **7.4**
Structural Grade: **4**
O&M Grade: **0**
Clock Start/From: **10**
Clock To: **2**
1st Value:
2nd Value:
Value Percent:
Continuous Index:
Within 8" of Joint: **YES**
Remarks:

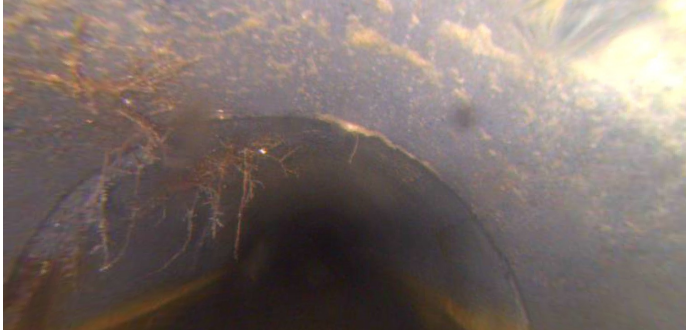
Code: **RFJ**
Description: **Roots Fine Joint**

Distance (ft): **7.4**
Structural Grade: **0**
O&M Grade: **1**
Clock Start/From: **9**
Clock To: **12**
1st Value:
2nd Value:
Value Percent:
Continuous Index:
Within 8" of Joint: **YES**
Remarks:

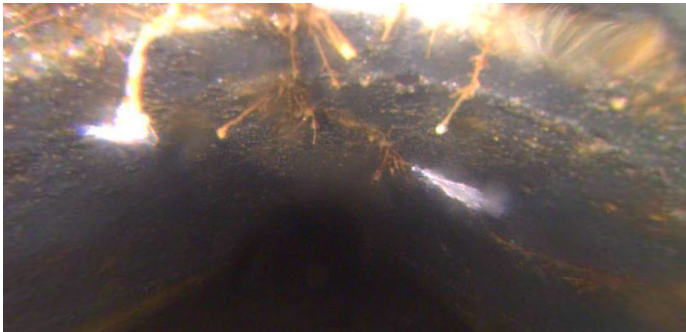
Code: **RFJ**
Description: **Roots Fine Joint**

Distance (ft): **13.9**
Structural Grade: **0**
O&M Grade: **1**
Clock Start/From: **8**
Clock To: **4**
1st Value:
2nd Value:
Value Percent:
Continuous Index:
Within 8" of Joint: **YES**
Remarks:

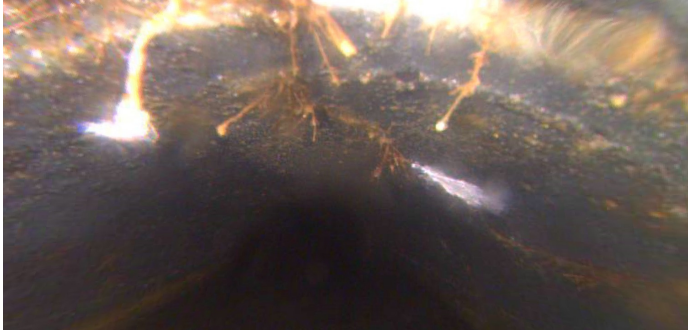
Code:	MSA
Description:	Abandoned Survey
Distance (ft):	13.9
Structural Grade:	0
O&M Grade:	0
Clock Start/From:	
Clock To:	
1st Value:	
2nd Value:	
Value Percent:	
Continuous Index:	
Within 8" of Joint:	NO
Remarks:	DEBRIS UNDER WATER
