Profile/Photo Observation Report

Street:	Lillian St.	Flow Control:	Not Controlled
City:	Hobart, IN	Year Renewed:	
Location:	Other	Tape/Media #:	
Purpose:	Not Known	Dia/Height:	8"
Use:	Sanitary	Material:	PVC
Drain Area:	NA	Lining:	
Category:	NA		
Comment:

Location Details:		Direction of Survey:	Upstream
US MH:	M-805-056	DS MH:	M-805-057
		Total Length Surveyed (ft):	14.2

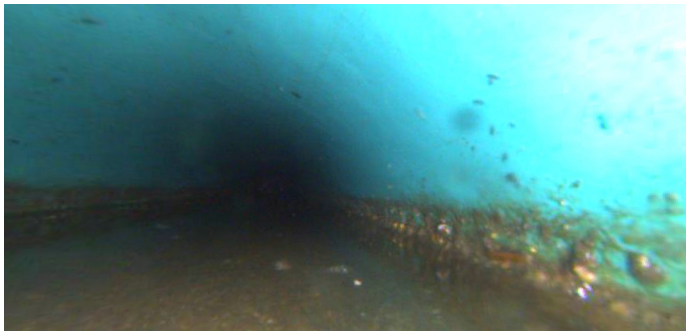
Code: **AMH**
Description: **Manhole**

Distance (ft): **.0**
Structural Grade: **0**
O&M Grade: **0**
Clock Start/From:
Clock To:
1st Value:
2nd Value:
Value Percent:
Continuous Index:
Within 8" of Joint: **NO**
Remarks: **M-805-057**

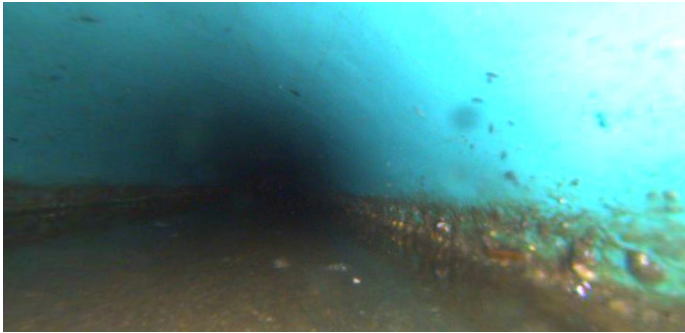
Code:	MWL
Description:	Water Level

Distance (ft):	.0
Structural Grade:	0
O&M Grade:	0
Clock Start/From:	
Clock To:	
1st Value:	
2nd Value:	
Value Percent:	30.000
Continuous Index:	
Within 8" of Joint:	NO
Remarks:

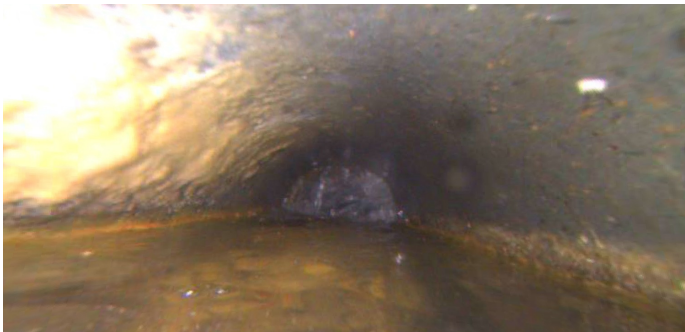
Code:	MMC
Description:	Material Change

Distance (ft):	4.1
Structural Grade:	0
O&M Grade:	0
Clock Start/From:	
Clock To:	
1st Value:	
2nd Value:	
Value Percent:	
Continuous Index:	
Within 8" of Joint:	NO
Remarks:	VCP

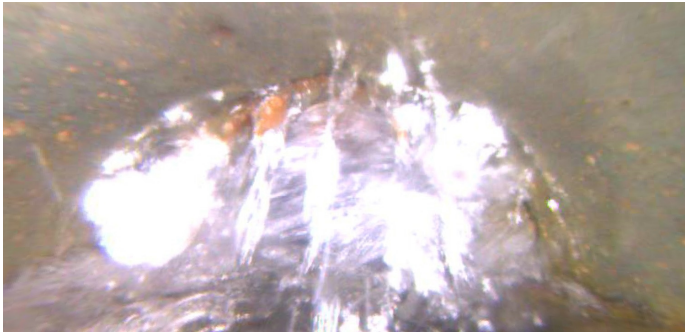
Code: **IG**
Description: **Infil Gusher**

Distance (ft): **5.2**
Structural Grade: **0**
O&M Grade: **5**
Clock Start/From: **8**
Clock To: **4**
1st Value:
2nd Value:
Value Percent:
Continuous Index:
Within 8" of Joint: **YES**
Remarks:

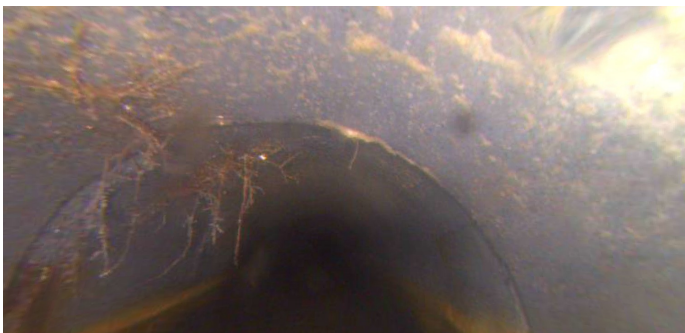
Code: **FM**
Description: **Fracture Multiple**

Distance (ft): **7.4**
Structural Grade: **4**
O&M Grade: **0**
Clock Start/From: **10**
Clock To: **2**
1st Value:
2nd Value:
Value Percent:
Continuous Index:
Within 8" of Joint: **YES**
Remarks:

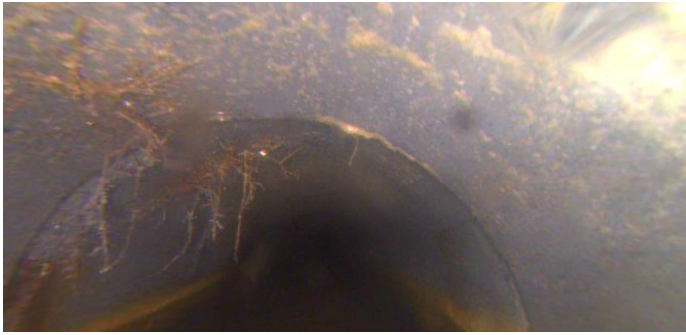
Code: **RFJ**
Description: **Roots Fine Joint**

Distance (ft): **7.4**
Structural Grade: **0**
O&M Grade: **1**
Clock Start/From: **9**
Clock To: **12**
1st Value:
2nd Value:
Value Percent:
Continuous Index:
Within 8" of Joint: **YES**
Remarks:

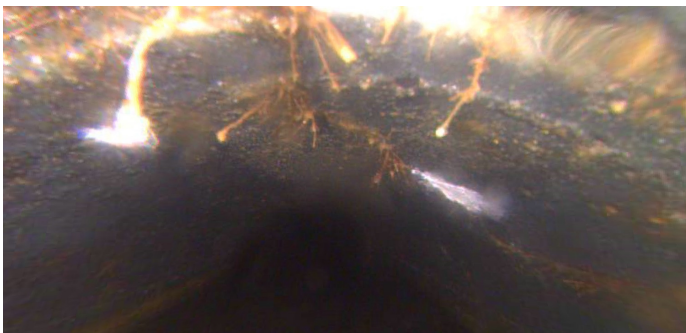
Code: **RFJ**
Description: **Roots Fine Joint**

Distance (ft): **13.9**
Structural Grade: **0**
O&M Grade: **1**
Clock Start/From: **8**
Clock To: **4**
1st Value:
2nd Value:
Value Percent:
Continuous Index:
Within 8" of Joint: **YES**
Remarks:

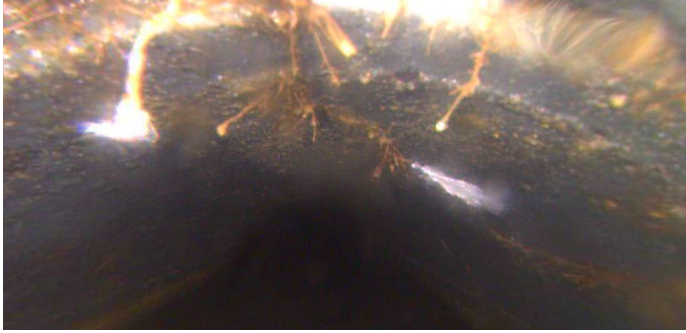
Code:	MSA
Description:	Abandoned Survey
Distance (ft):	13.9
Structural Grade:	0
O&M Grade:	0
Clock Start/From:	
Clock To:	
1st Value:	
2nd Value:	
Value Percent:	
Continuous Index:	
Within 8" of Joint:	NO
Remarks:	DEBRIS UNDER WATER
