## Profile/Photo Observation Report

Street:	<b>S OHIO ST &amp; LILLIAN ST</b>	Flow Control:	<b>Not Controlled</b>
City:	<b>Hobart, IN</b>	Year Renewed:	
Location:	<b>Other</b>	Tape/Media #:	
Purpose:	<b>Not Known</b>	Dia/Height:	<b>8"</b>
Use:	<b>Sanitary</b>	Material:	<b>PVC</b>
Drain Area:	<b>NA</b>	Lining:	
Category:	<b>NA</b>		
Comment:

Location Details:		Direction of Survey:	<b>Downstream</b>
US MH:	<b>M-805-057</b>	DS MH:	<b>M-805-042</b>
		Total Length Surveyed (ft):	<b>157.0</b>

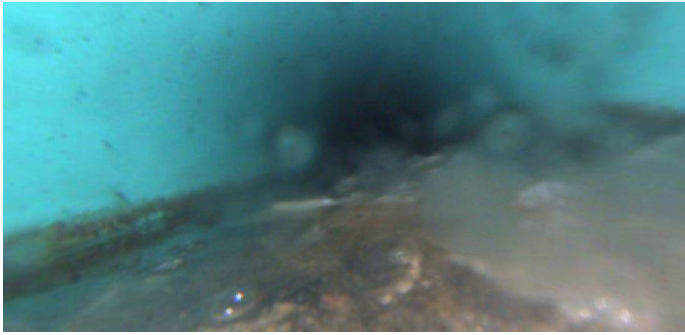
Code: **AMH**  
Description: **Manhole**

Distance (ft): **.0**  
Structural Grade: **0**  
O&M Grade: **0**  
Clock Start/From:  
Clock To:  
1st Value:  
2nd Value:  
Value Percent:  
Continuous Index:  
Within 8" of Joint: **NO**  
Remarks: **M-805-057**

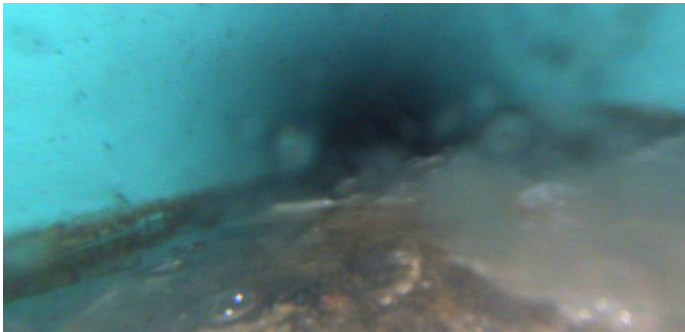
Code: **MWL**  
Description: **Water Level**

Distance (ft): **.0**  
Structural Grade: **0**  
O&M Grade: **0**  
Clock Start/From:  
Clock To:  
1st Value:  
2nd Value:  
Value Percent: **15.000**  
Continuous Index:  
Within 8" of Joint: **NO**  
Remarks:

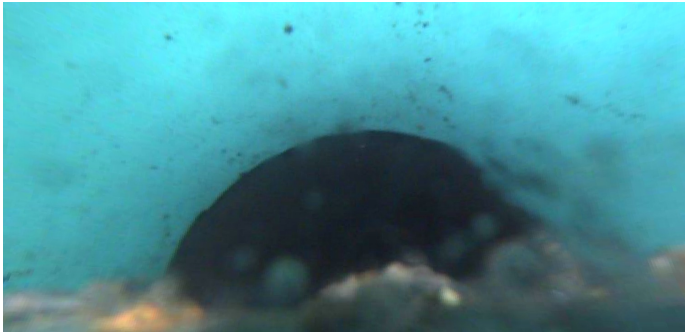
Code: **MMC**  
Description: **Material Change**

Distance (ft): **2.7**  
Structural Grade: **0**  
O&M Grade: **0**  
Clock Start/From:  
Clock To:  
1st Value:  
2nd Value:  
Value Percent:  
Continuous Index:  
Within 8" of Joint: **NO**  
Remarks: **PVC TO VCP**

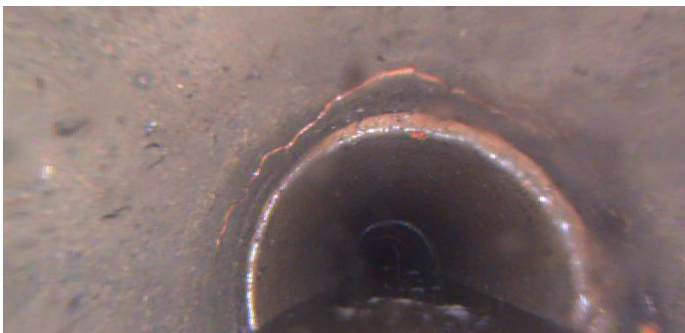
Code: **FC**  
Description: **Fracture Circumferential**

Distance (ft): **4.6**  
Structural Grade: **2**  
O&M Grade: **0**  
Clock Start/From: **7**  
Clock To: **5**  
1st Value:  
2nd Value:  
Value Percent:  
Continuous Index:  
Within 8" of Joint:  
Remarks:

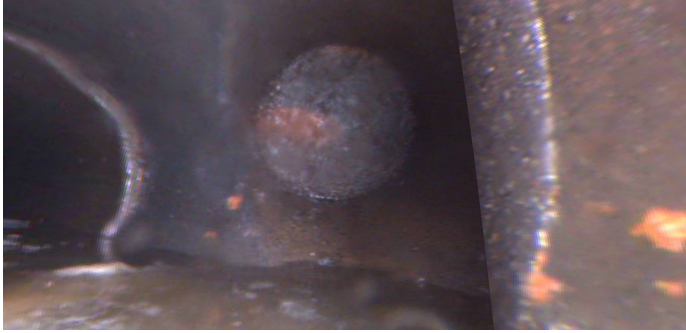
Code: **TFC**  
Description: **Tap Factory Capped**

Distance (ft): **10.1**  
Structural Grade: **0**  
O&M Grade: **0**  
Clock Start/From: **3**  
Clock To:  
1st Value: **4.000**  
2nd Value:  
Value Percent:  
Continuous Index:  
Within 8" of Joint:  
Remarks:

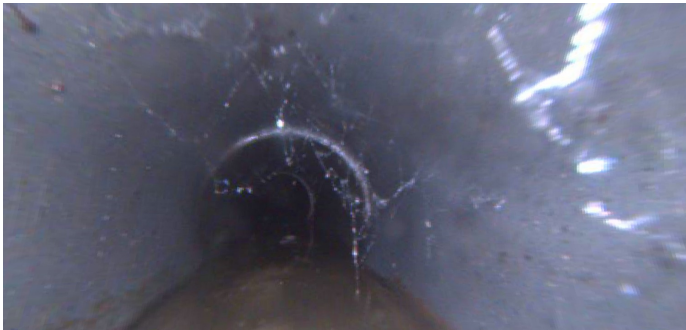
Code: **MGO**  
Description: **General Observation**

Distance (ft): **15.9**  
Structural Grade: **0**  
O&M Grade: **0**  
Clock Start/From:  
Clock To:  
1st Value:  
2nd Value:  
Value Percent:  
Continuous Index:  
Within 8" of Joint: **NO**  
Remarks: **SPIDER WEBS**

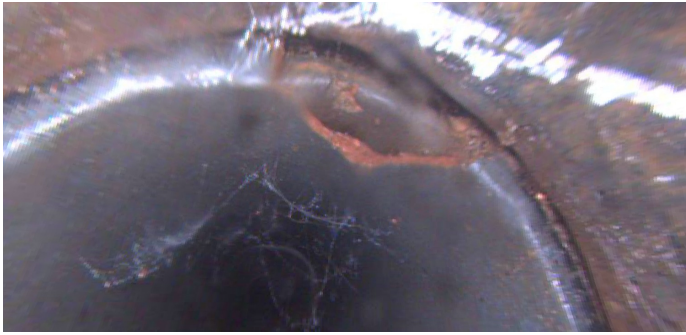
Code: **FC**  
Description: **Fracture Circumferential**

Distance (ft): **28.9**  
Structural Grade: **2**  
O&M Grade: **0**  
Clock Start/From: **12**  
Clock To: **2**  
1st Value:  
2nd Value:  
Value Percent:  
Continuous Index:  
Within 8" of Joint: **YES**  
Remarks:

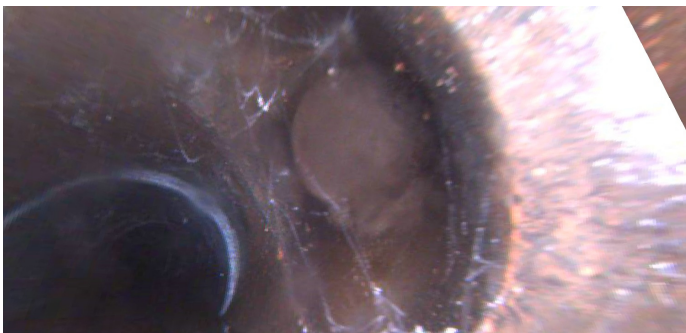
Code: **TFC**  
Description: **Tap Factory Capped**

Distance (ft): **36.0**  
Structural Grade: **0**  
O&M Grade: **0**  
Clock Start/From: **2**  
Clock To:  
1st Value: **4.000**  
2nd Value:  
Value Percent:  
Continuous Index:  
Within 8" of Joint:  
Remarks:

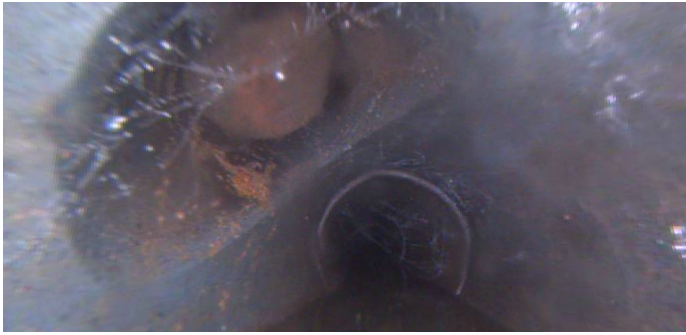
Code: **TFC**  
Description: **Tap Factory Capped**

Distance (ft): **37.8**  
Structural Grade: **0**  
O&M Grade: **0**  
Clock Start/From: **10**  
Clock To:  
1st Value: **4.000**  
2nd Value:  
Value Percent:  
Continuous Index:  
Within 8" of Joint:  
Remarks:

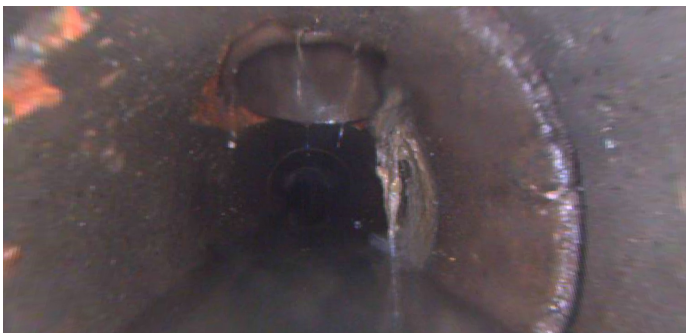
Code: **TBI**  
Description: **Tap Break-in Intruding**

Distance (ft): **48.9**  
Structural Grade: **0**  
O&M Grade: **2**  
Clock Start/From: **12**  
Clock To:  
1st Value: **4.000**  
2nd Value: **1.000**  
Value Percent:  
Continuous Index:  
Within 8" of Joint:  
Remarks:

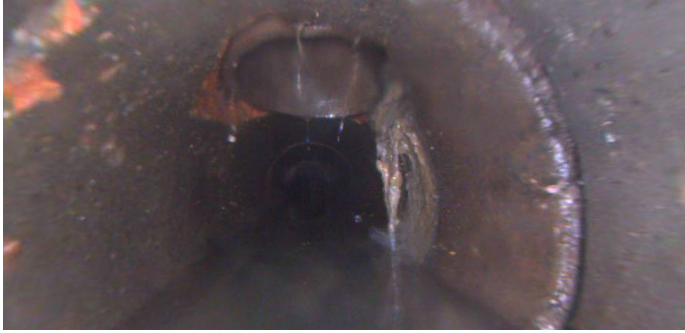
Code: **RFC**  
Description: **Roots Fine Connection**

Distance (ft): **48.9**  
Structural Grade: **0**  
O&M Grade: **1**  
Clock Start/From: **1**  
Clock To:  
1st Value:  
2nd Value:  
Value Percent:  
Continuous Index:  
Within 8" of Joint: **NO**  
Remarks:

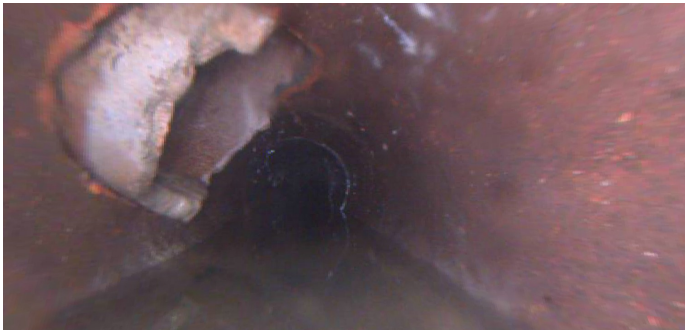
Code: **TBI**  
Description: **Tap Break-in Intruding**

Distance (ft): **53.2**  
Structural Grade: **0**  
O&M Grade: **2**  
Clock Start/From: **10**  
Clock To:  
1st Value: **4.000**  
2nd Value: **1.000**  
Value Percent:  
Continuous Index:  
Within 8" of Joint:  
Remarks:

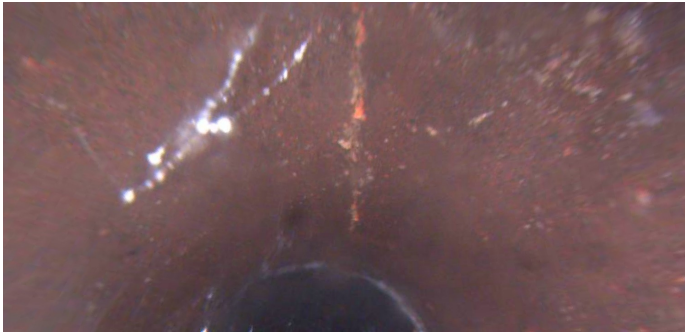
Code: **FL**  
Description: **Fracture Longitudinal**

Distance (ft): **54.3**  
Structural Grade: **3**  
O&M Grade: **0**  
Clock Start/From: **12**  
Clock To:  
1st Value:  
2nd Value:  
Value Percent:  
Continuous Index:  
Within 8" of Joint: **YES**  
Remarks:

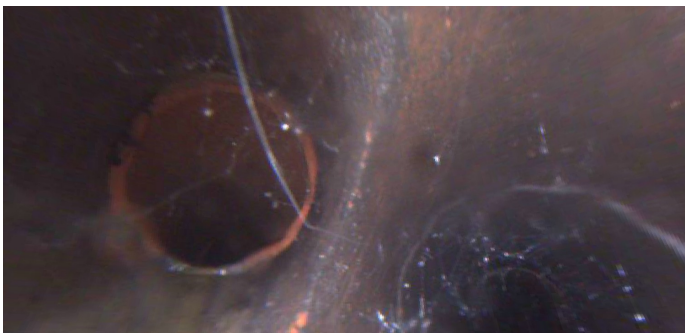
Code: **TF**  
Description: **Tap Factory**

Distance (ft): **58.1**  
Structural Grade: **0**  
O&M Grade: **0**  
Clock Start/From: **9**  
Clock To:  
1st Value: **4.000**  
2nd Value:  
Value Percent:  
Continuous Index:  
Within 8" of Joint:  
Remarks:

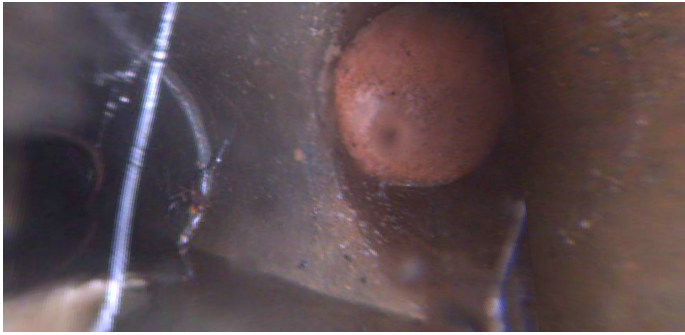
Code: **TFC**  
Description: **Tap Factory Capped**

Distance (ft): **65.8**  
Structural Grade: **0**  
O&M Grade: **0**  
Clock Start/From: **2**  
Clock To:  
1st Value: **4.000**  
2nd Value:  
Value Percent:  
Continuous Index:  
Within 8" of Joint:  
Remarks:

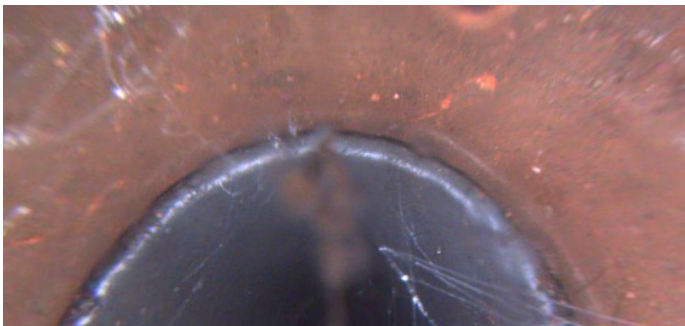
Code: **CM**  
Description: **Crack Multiple**

Distance (ft): **70.1**  
Structural Grade: **3**  
O&M Grade: **0**  
Clock Start/From: **10**  
Clock To: **1**  
1st Value:  
2nd Value:  
Value Percent:  
Continuous Index:  
Within 8" of Joint: **YES**  
Remarks:

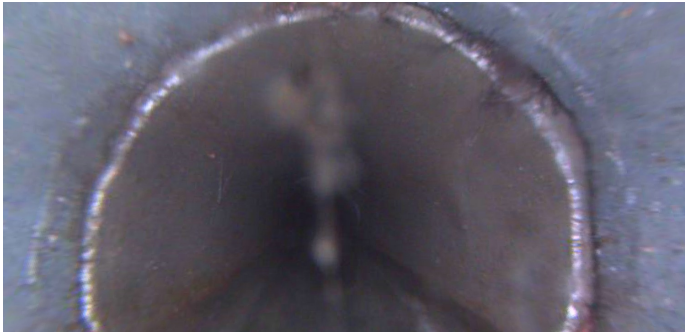
Code: **RFJ**  
Description: **Roots Fine Joint**

Distance (ft): **72.2**  
Structural Grade: **0**  
O&M Grade: **1**  
Clock Start/From: **12**  
Clock To: **3**  
1st Value:  
2nd Value:  
Value Percent:  
Continuous Index:  
Within 8" of Joint: **YES**  
Remarks:

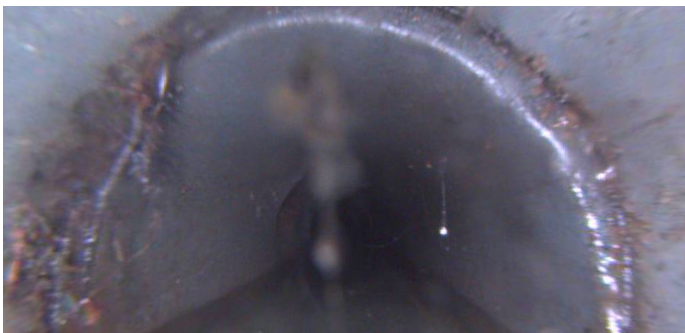
Code: **RFJ**  
Description: **Roots Fine Joint**

Distance (ft): **80.3**  
Structural Grade: **0**  
O&M Grade: **1**  
Clock Start/From: **8**  
Clock To: **4**  
1st Value:  
2nd Value:  
Value Percent:  
Continuous Index:  
Within 8" of Joint: **YES**  
Remarks:

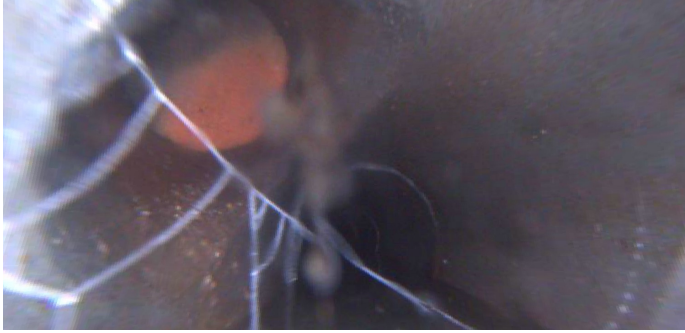
Code: **TFC**  
Description: **Tap Factory Capped**

Distance (ft): **81.4**  
Structural Grade: **0**  
O&M Grade: **0**  
Clock Start/From: **10**  
Clock To:  
1st Value: **4.000**  
2nd Value:  
Value Percent:  
Continuous Index:  
Within 8" of Joint:  
Remarks:

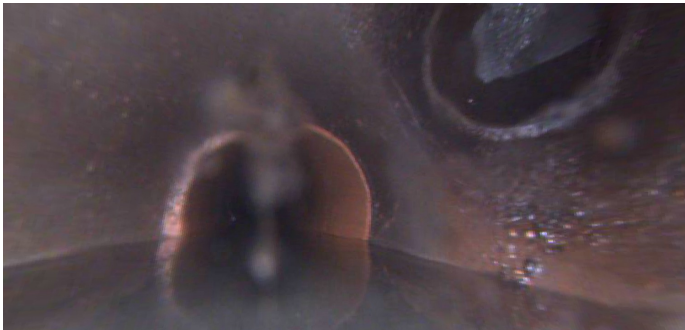
Code: **TF**  
Description: **Tap Factory**

Distance (ft): **89.6**  
Structural Grade: **0**  
O&M Grade: **0**  
Clock Start/From: **2**  
Clock To:  
1st Value: **4.000**  
2nd Value:  
Value Percent:  
Continuous Index:  
Within 8" of Joint:  
Remarks:

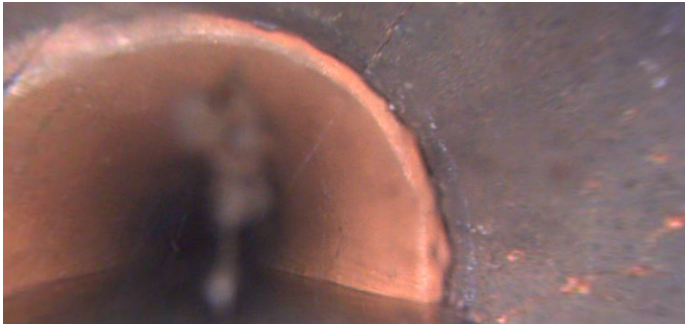
Code: **FM**  
Description: **Fracture Multiple**

Distance (ft): **90.2**  
Structural Grade: **4**  
O&M Grade: **0**  
Clock Start/From: **1**  
Clock To: **3**  
1st Value:  
2nd Value:  
Value Percent:  
Continuous Index:  
Within 8" of Joint: **YES**  
Remarks:

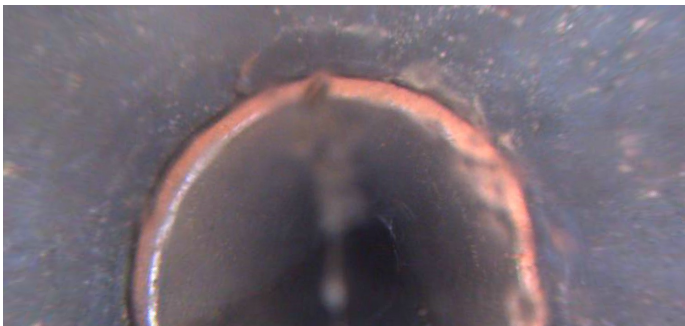
Code: **FM**  
Description: **Fracture Multiple**

Distance (ft): **96.3**  
Structural Grade: **4**  
O&M Grade: **0**  
Clock Start/From: **11**  
Clock To: **4**  
1st Value:  
2nd Value:  
Value Percent:  
Continuous Index:  
Within 8" of Joint: **YES**  
Remarks:

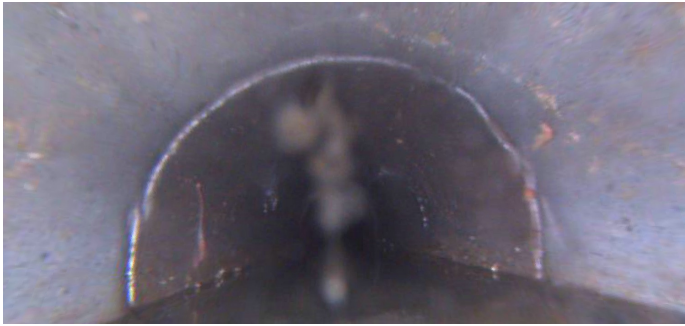
Code: **CM**  
Description: **Crack Multiple**

Distance (ft): **100.4**  
Structural Grade: **3**  
O&M Grade: **0**  
Clock Start/From: **12**  
Clock To: **3**  
1st Value:  
2nd Value:  
Value Percent:  
Continuous Index:  
Within 8" of Joint: **YES**  
Remarks:

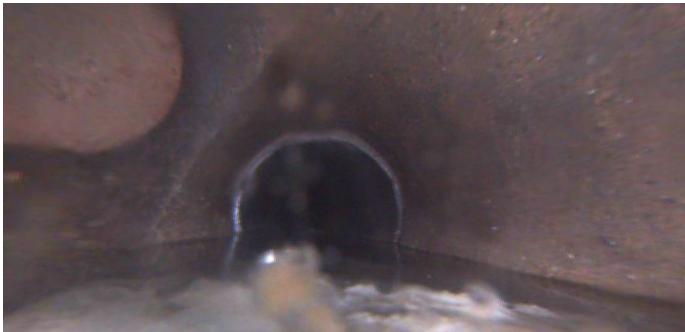
Code: **TFC**  
Description: **Tap Factory Capped**

Distance (ft): **113.9**  
Structural Grade: **0**  
O&M Grade: **0**  
Clock Start/From: **10**  
Clock To:  
1st Value: **4.000**  
2nd Value:  
Value Percent:  
Continuous Index:  
Within 8" of Joint:  
Remarks:

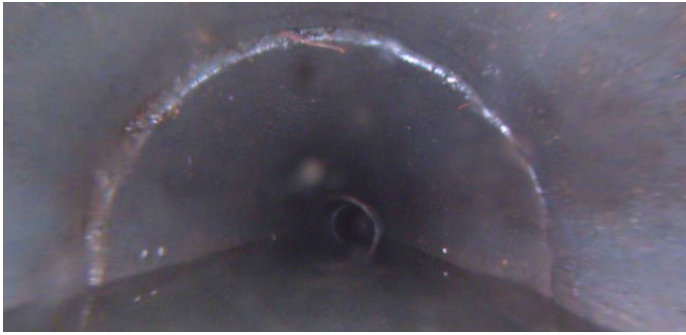
Code: **RFJ**  
Description: **Roots Fine Joint**

Distance (ft): **118.6**  
Structural Grade: **0**  
O&M Grade: **1**  
Clock Start/From: **12**  
Clock To:  
1st Value:  
2nd Value:  
Value Percent:  
Continuous Index:  
Within 8" of Joint: **YES**  
Remarks:

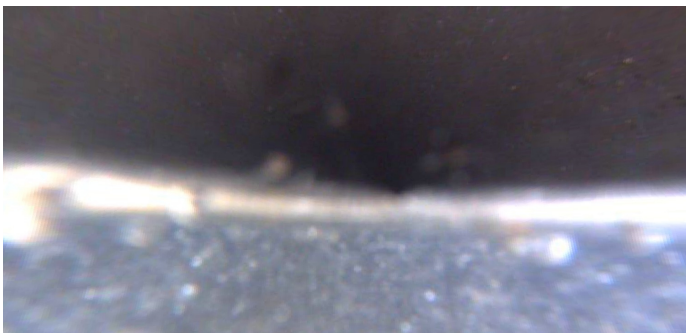
Code: **MCU**  
Description: **Camera Underwater**

Distance (ft): **121.0**  
Structural Grade: **0**  
O&M Grade: **4**  
Clock Start/From:  
Clock To:  
1st Value:  
2nd Value:  
Value Percent:  
Continuous Index:  
Within 8" of Joint: **NO**  
Remarks:

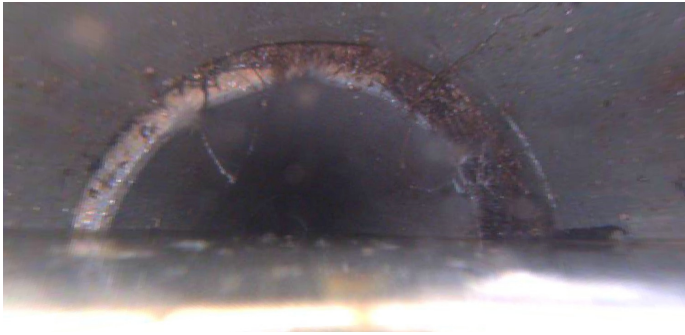
Code: **RFJ**  
Description: **Roots Fine Joint**

Distance (ft): **122.7**  
Structural Grade: **0**  
O&M Grade: **1**  
Clock Start/From: **11**  
Clock To: **3**  
1st Value:  
2nd Value:  
Value Percent:  
Continuous Index:  
Within 8" of Joint: **YES**  
Remarks:

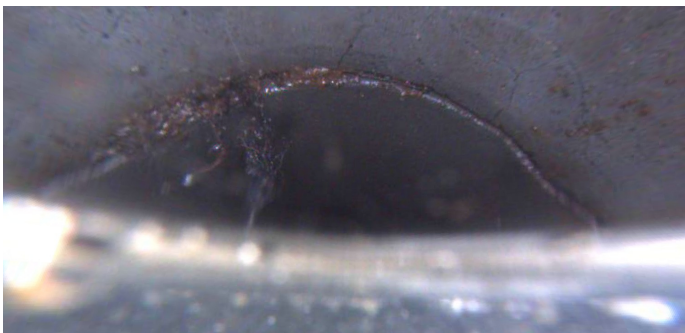
Code: **FM**  
Description: **Fracture Multiple**

Distance (ft): **124.8**  
Structural Grade: **4**  
O&M Grade: **0**  
Clock Start/From: **12**  
Clock To: **3**  
1st Value:  
2nd Value:  
Value Percent:  
Continuous Index:  
Within 8" of Joint: **YES**  
Remarks:

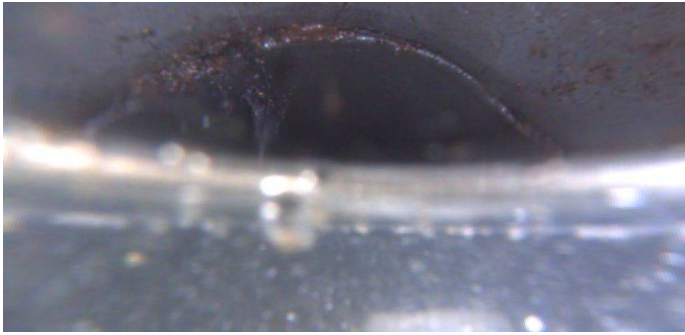
Code: **RFJ**  
Description: **Roots Fine Joint**

Distance (ft): **124.8**  
Structural Grade: **0**  
O&M Grade: **1**  
Clock Start/From: **10**  
Clock To: **12**  
1st Value:  
2nd Value:  
Value Percent:  
Continuous Index:  
Within 8" of Joint: **YES**  
Remarks:

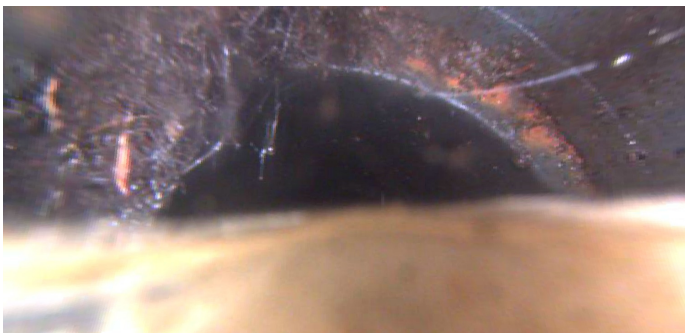
Code: **RFJ**  
Description: **Roots Fine Joint**

Distance (ft): **127.0**  
Structural Grade: **0**  
O&M Grade: **1**  
Clock Start/From: **9**  
Clock To: **12**  
1st Value:  
2nd Value:  
Value Percent:  
Continuous Index:  
Within 8" of Joint: **YES**  
Remarks:

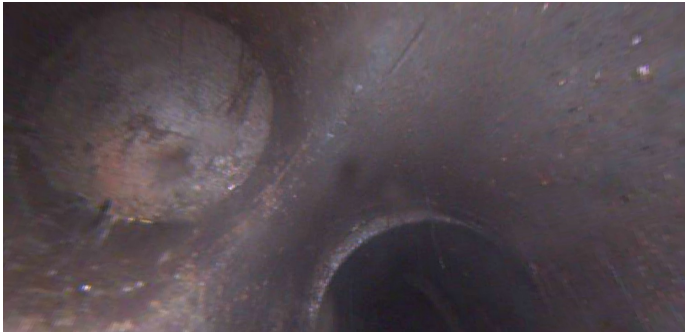
Code: **TFC**  
Description: **Tap Factory Capped**

Distance (ft): **130.3**  
Structural Grade: **0**  
O&M Grade: **0**  
Clock Start/From: **10**  
Clock To:  
1st Value: **4.000**  
2nd Value:  
Value Percent:  
Continuous Index:  
Within 8" of Joint:  
Remarks:

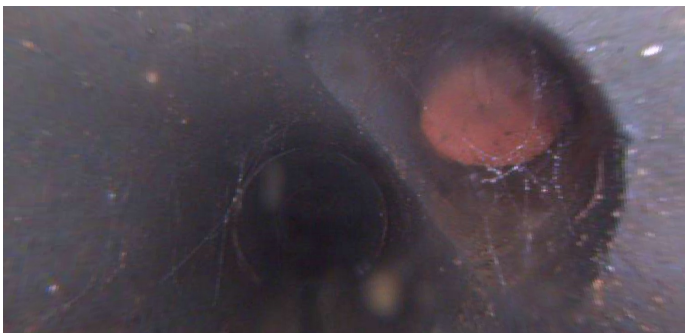
Code: **TFC**  
Description: **Tap Factory Capped**

Distance (ft): **131.9**  
Structural Grade: **0**  
O&M Grade: **0**  
Clock Start/From: **2**  
Clock To:  
1st Value: **4.000**  
2nd Value:  
Value Percent:  
Continuous Index:  
Within 8" of Joint:  
Remarks:

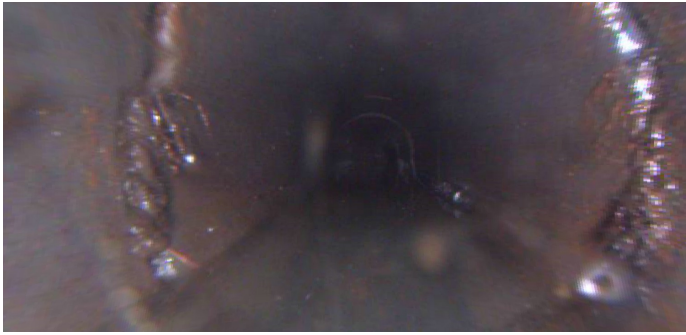
Code: **RFJ**  
Description: **Roots Fine Joint**

Distance (ft): **151.1**  
Structural Grade: **0**  
O&M Grade: **1**  
Clock Start/From: **7**  
Clock To: **5**  
1st Value:  
2nd Value:  
Value Percent:  
Continuous Index:  
Within 8" of Joint: **YES**  
Remarks:

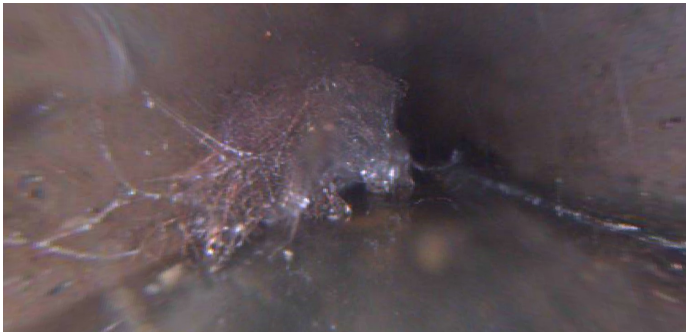
Code: **RBB**  
Description: **Roots Ball Barrel**

Distance (ft): **155.4**  
Structural Grade: **0**  
O&M Grade: **5**  
Clock Start/From: **7**  
Clock To: **12**  
1st Value:  
2nd Value:  
Value Percent: **60.000**  
Continuous Index:  
Within 8" of Joint: **NO**  
Remarks:

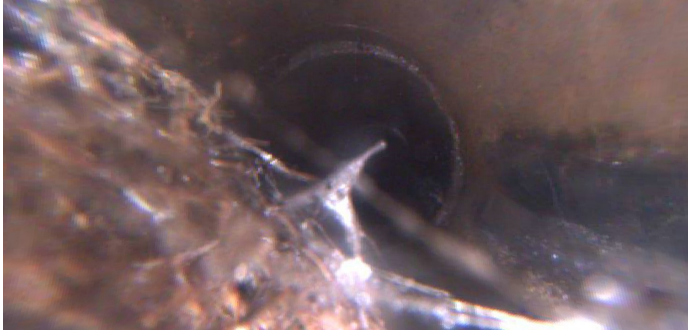
Code:	<b>MSA</b>
Description:	<b>Abandoned Survey</b>
Distance (ft):	<b>157.0</b>
Structural Grade:	<b>0</b>
O&M Grade:	<b>0</b>
Clock Start/From:	
Clock To:	
1st Value:	
2nd Value:	
Value Percent:	
Continuous Index:	
Within 8" of Joint:	<b>NO</b>
Remarks:	<b>CANNOT PASS RBB</b>
